# Manchester Art Gallery

Heritage Assessment  
May 2024

Project name: Manchester Art Gallery  
Project number: 9604  
Document number: MAG-BUT-08-B2-RP-A-00-0001

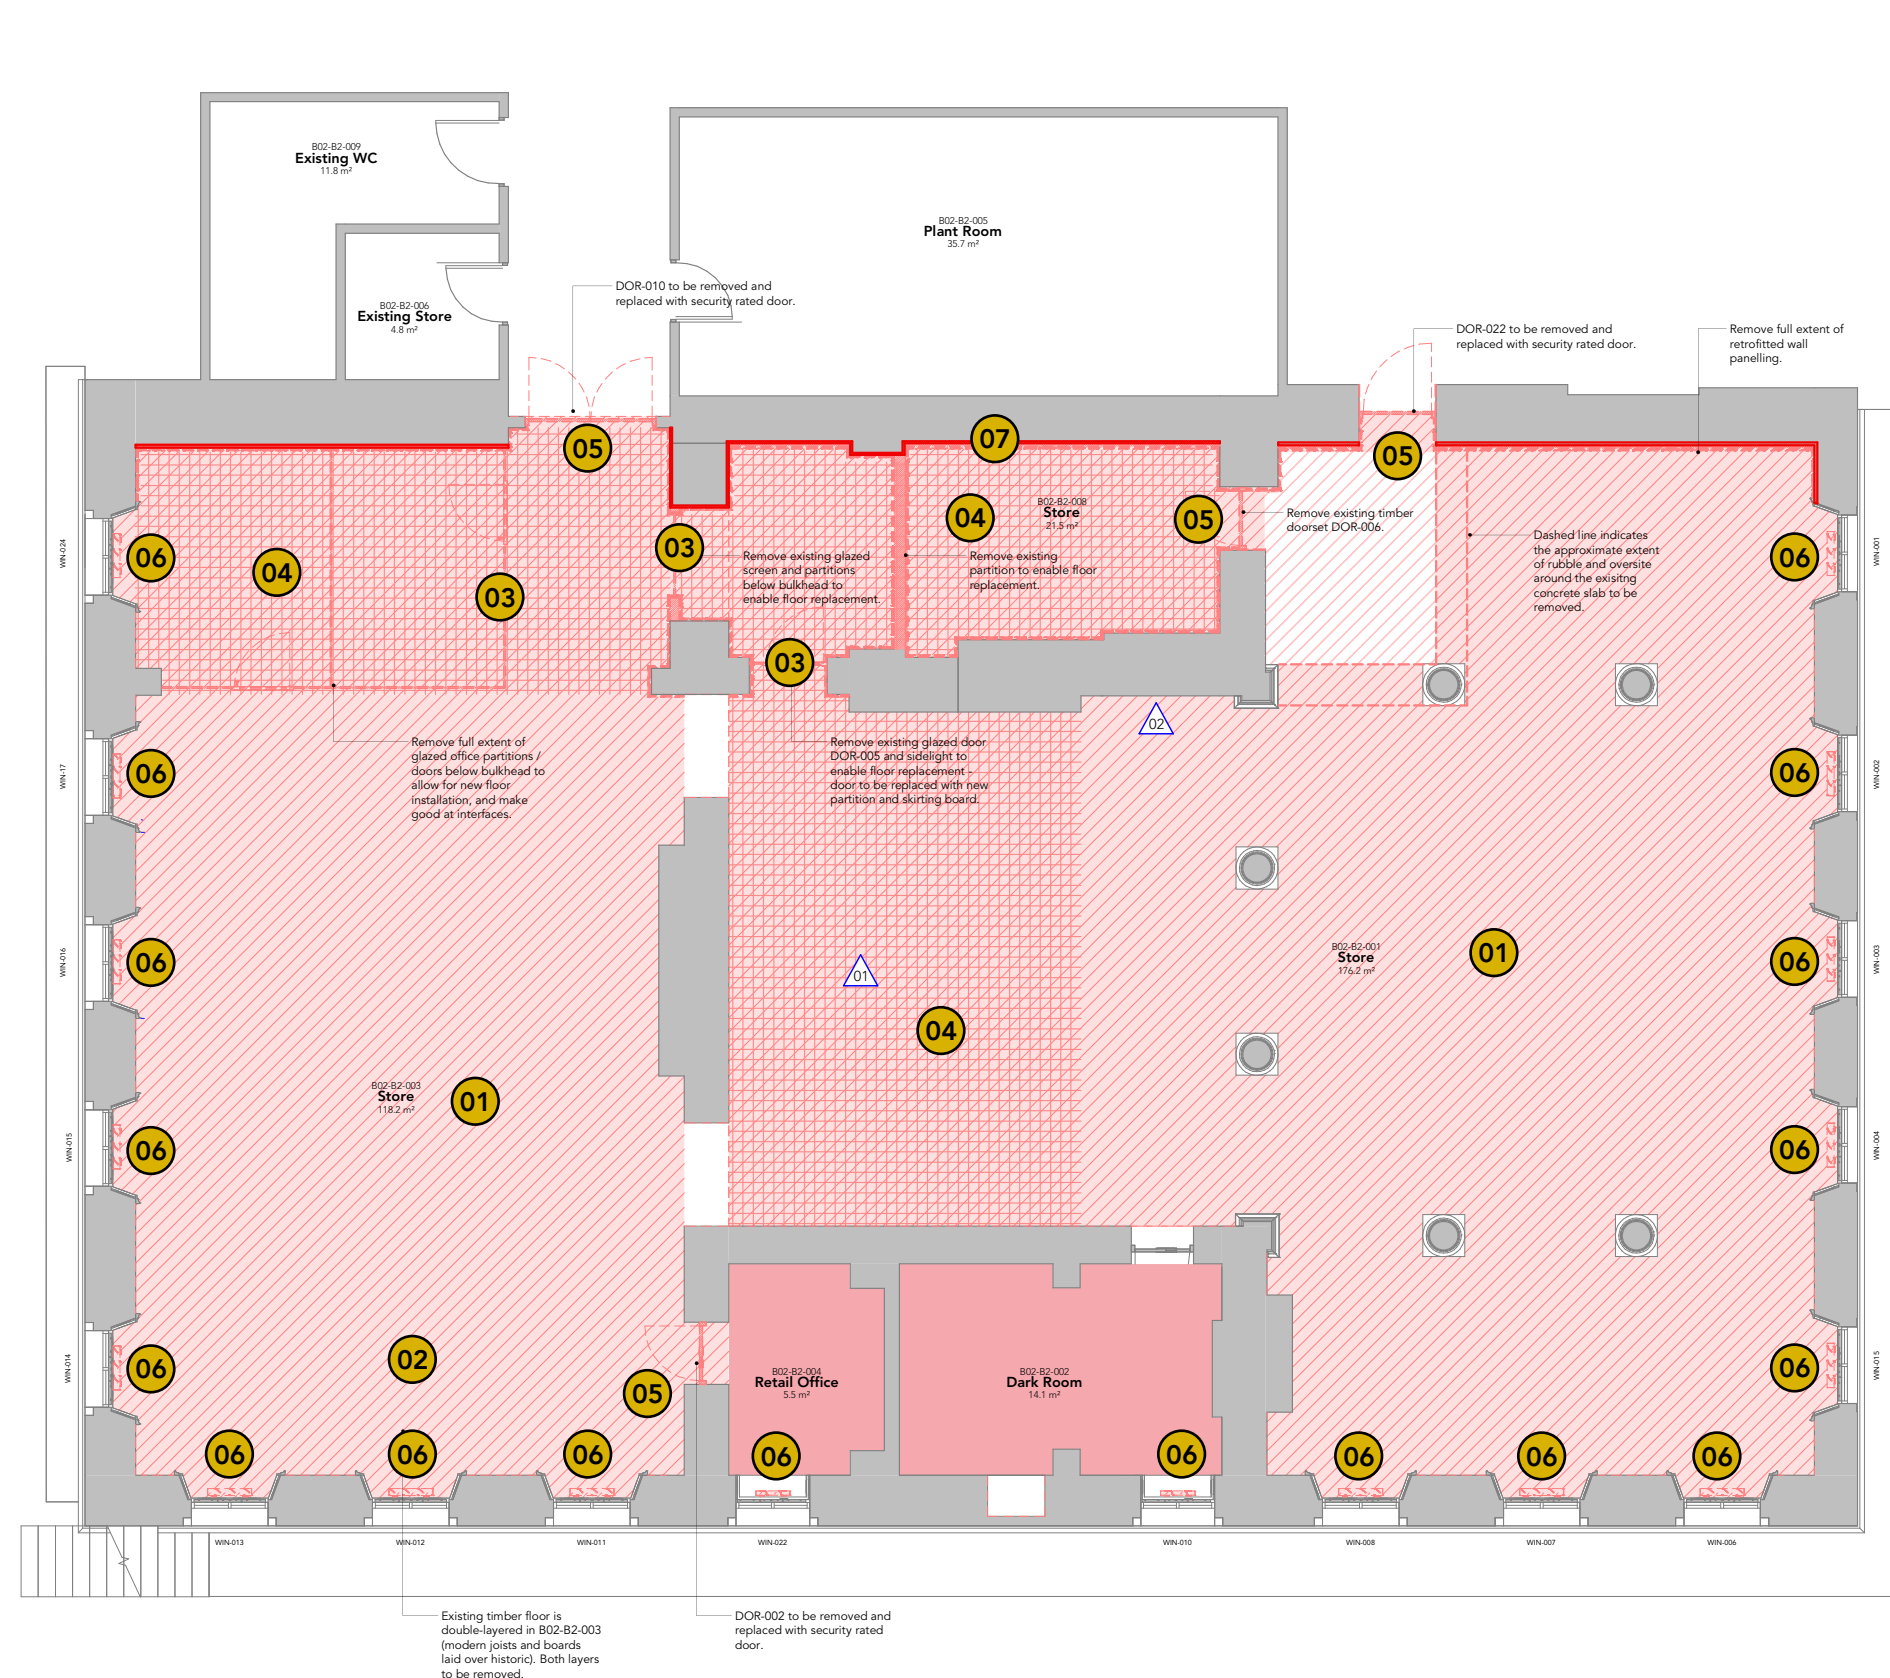
Figure 12 Proposed Alterations Plan

- Remove the existing rotten/ damaged timber floor and reduce subfloor ground level to approximately 1/3 of the space, including removal of below floor MEP services (See Item 1 on Figure 12)
- Infill existing redundant manhole (See Item 2 for approximate location on Figure 12)
- Remove existing modern glazed partitions and screens (See Item 3 on Figure 12)
- Remove modern suspended ceilings to allow for removal of MEP services including FCU, heating and cooling pipework, lights and containment prior to reinstatement (See Item 4 on Figure 12)
- Remove modern doors prior to reinstatement for upgraded security and fire resistance (See Item 5 on Figure 12)
- Remove existing modern radiators prior to replacement with new system (See Item 6 on Figure 12)

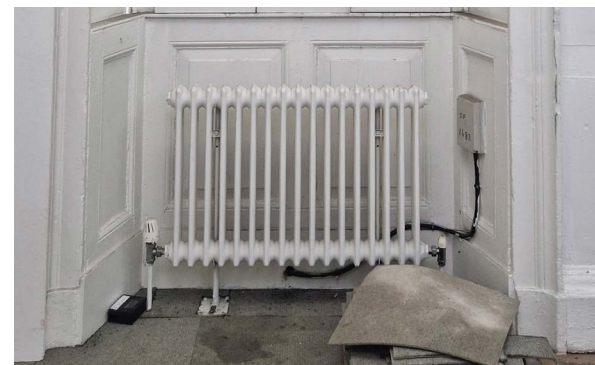
Remove existing modern radiators prior to replacement with new system.

Figure 21 Photograph showing existing modern radiators

The existing radiators are required to be removed as a result of removing the existing floor where the heating pipework is currently run. New radiators are to be installed to replace the existing (albeit in a new position) therefore there will be no perceptible change to the existing condition.

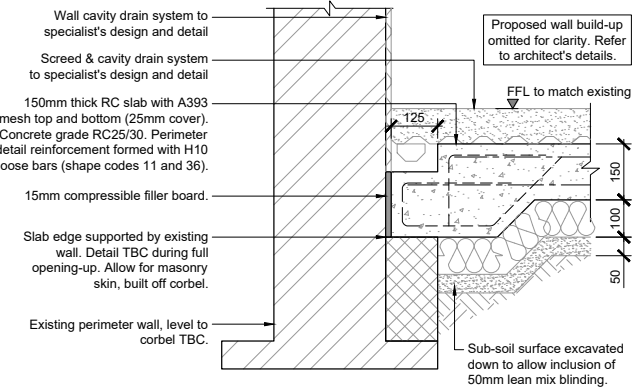
New suspended concrete floor with new screed and linoleum floor finish throughout.

Figure 22 Proposed concrete slab detail at perimeter walls [Source: Booth King]<sup>17</sup>

The main intervention to floors is the installation of the new suspended concrete floor to replace the existing timber construction. Consideration was given to the installation of a concrete beam and block floor however this was discounted for the following reasons:

- If/when water comes to bear from underneath (for example, in a flood event) the water would rise through the floor unrestricted and cause upthrust floatation forces on the screed, lifting and cracking and flooding the basement. This would present a risk to both the artworks and building fabric.
- Use of a beam and block floor with the proposed Type C waterproofing system would be in contravention of the design rationale in BS8102 which states that when installing internal waterproofing and damp proofing systems, the structure should provide the first line of defence in acting to reduce the rate of any potential water ingress through it.
- It would not be a suitable structure for the proposed roller racking required for the works on paper.

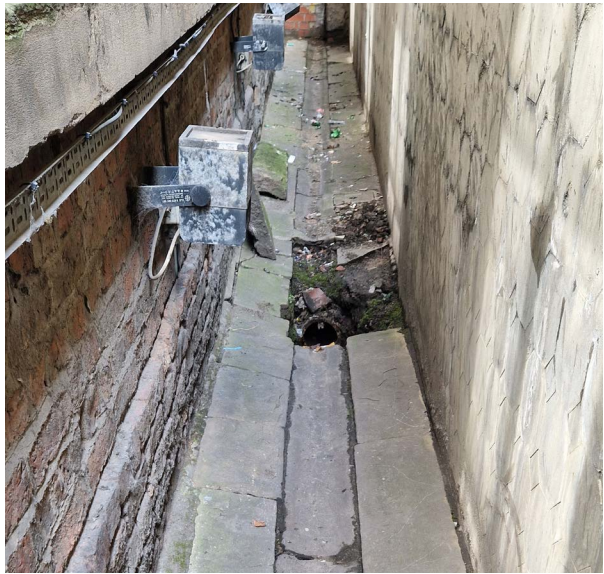
Remediate failed lightwell drainage including capping off a collapsed pipe, the rebuilding of a buried manhole adjacent to Princess Street, reinstatement of a yard gully where the existing has been removed adjacent to George Steet, and a corner inspection chamber to connect the two (reference Booth King drawing MAG-BKP-18-ZZ-DR-C-90-0515). Damaged paving slabs will be replaced to match existing as part of the works, and a new DPM installed at the interface with the building. External walls to be core drilled in 2no. locations below floor level to allow for connection of sump pump drainage into existing lightwell drainage.

Figure 23 Photograph showing cracked paving slabs and broken out gully

Works to remediate failed drainage in the lightwell will address a primary cause of water ingress to the building, particularly in the east corner. There is no adverse change to the existing condition and removal is considered beneficial as it prevents continued deterioration of the fabric.

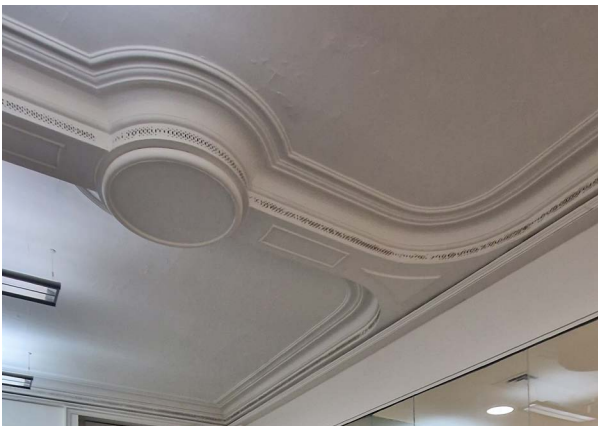
Infilling metal grilles to downstand beams to reduce uncontrolled air infiltration (please refer to MAG-BUT-08-B2-DR-A-06-6002 and section RS8 in MAG-BUT-XX-XX-SP-A-00-0001 for further details). The metal grilles are present to the downstand beams in B02-B2-003 as part of the old redundant heating system and no longer serve a functional purpose. The apertures in the grilles are proposed to be infilled with fine paste filler and sanded to a fine sanded finish, painted white to match the adjacent fabric.

Figure 28 Photograph showing high level metal grilles in B02-B2-003

- Infilling metal grilles to downstand beams to reduce uncontrolled air infiltration
- Internal partition infills with access panels to all windows (with the exception of WIN-022) to reduce uncontrolled air infiltration and improve thermal efficiency of windows (See example Item 9 on Figure 13)

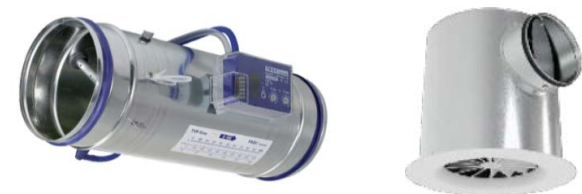
Extend and amend existing ventilation ductwork from existing plantroom with new VAV and CAV units and extend ductwork runs into space, to be suspended from modern suspended and original ceilings.

Figure 30 Images of proposed duct fittings (Left: Variable air volume unit, Right: Variable air volume diffuser)

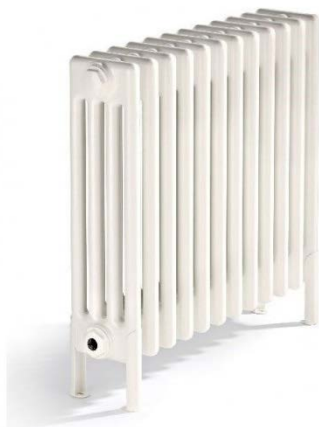
New radiator system and LTHW pipework.

Figure 31 Image of proposed column radiator with welded feet

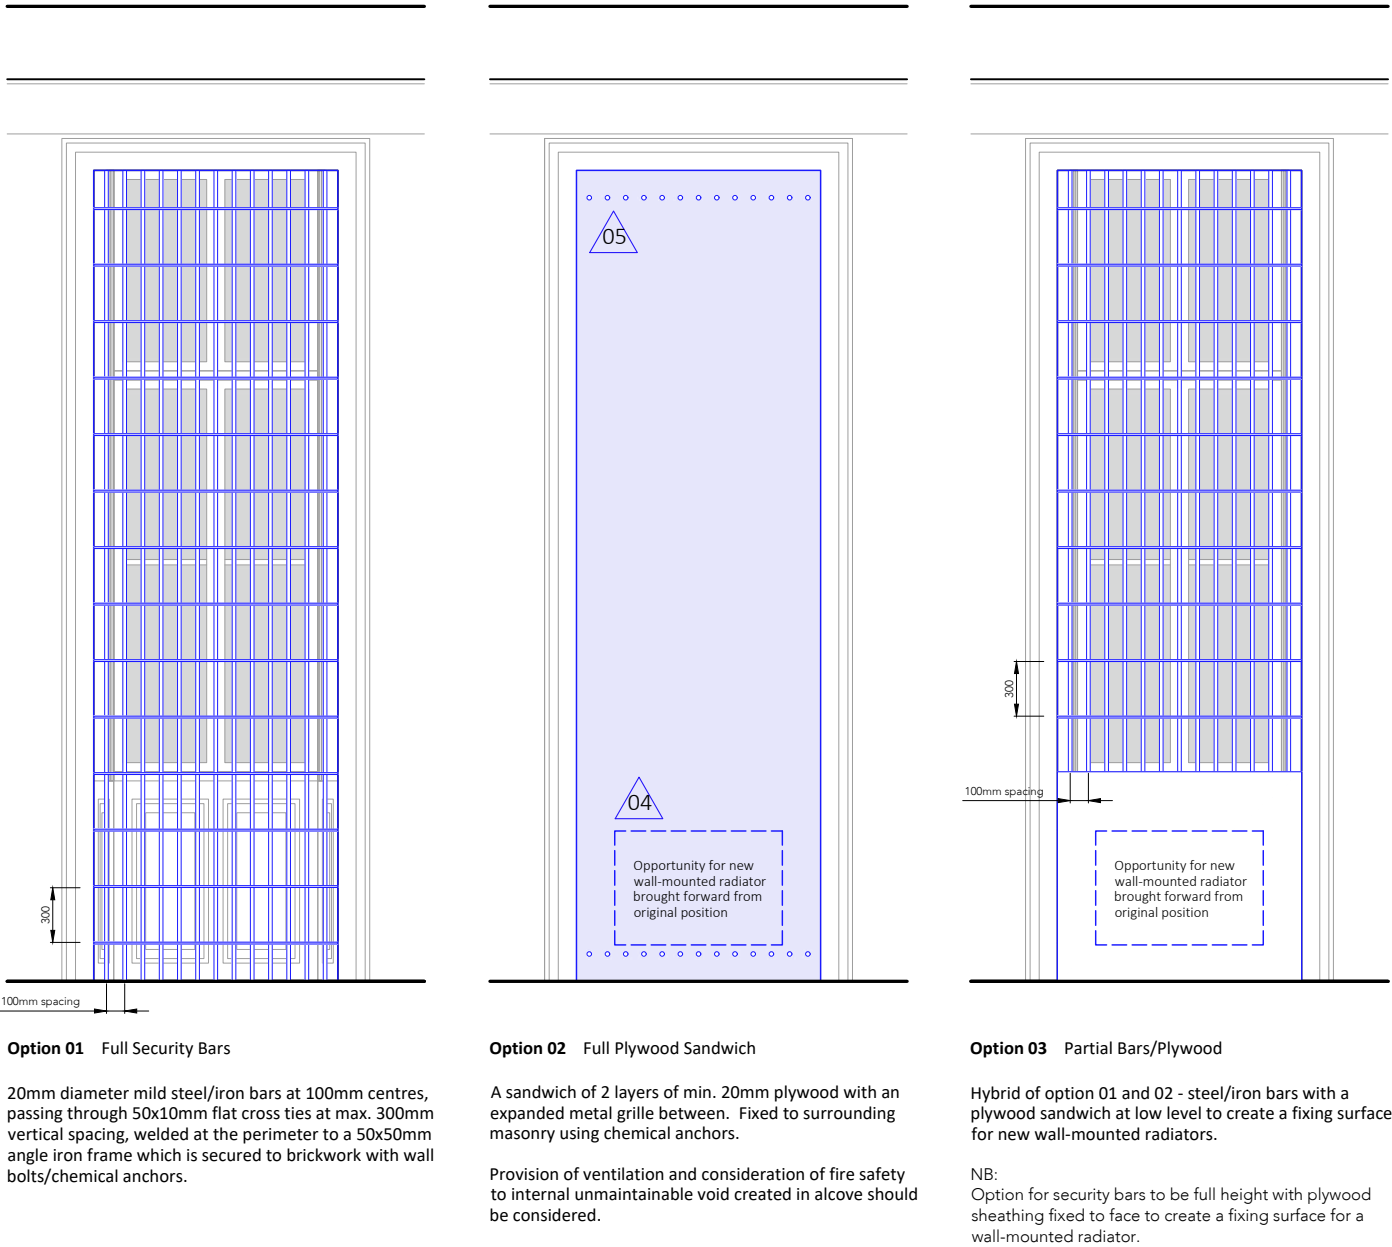
A number of options were investigated to provide the necessary resistance-to-attack upgrades to the internal side of the windows as outlined in Figure 34 including internal bars; a plywood sandwich panel reinforced with steel mesh; and a hybrid of the two. These options were discounted due to the chemical anchor fixings that would be required to fix through the historic timber panelling back to the masonry substrate which would cause irreversible damage. In order to minimise harm caused by the selected external option the design is aligned with the existing security bars installed on the adjacent Grade I listed City Art Gallery for design coherence across the building group.

Figure 34 Alternative discounted window security options

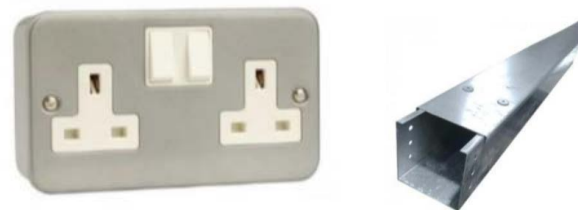
New wall mounted small power requirements and data outlets

Figure 36 Image showing proposed wall mounted socket box and high level containment trunking

The new containment results in a slight adverse impact on the character of the space due to fixings and apertures required to existing fabric but are necessary for the new use. Harm to the fabric is minimised through the use of surface mounted containment which avoids destructive chasing in of plaster.

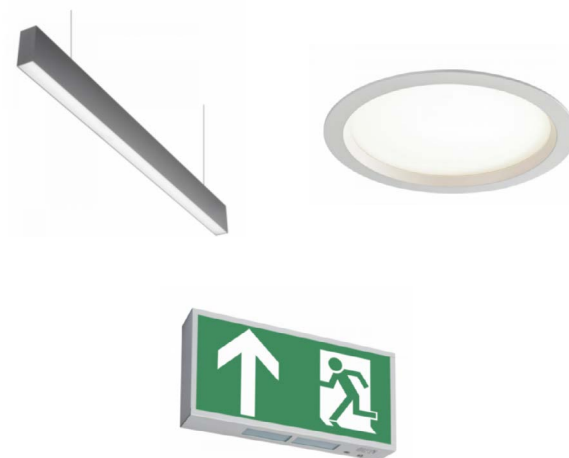
New lighting throughout with local switching, including new high quality suspended light fittings and recessed spots to the existing suspended plasterboard ceilings in the paper store.

Figure 37 Images showing proposed light fittings
