# Contaminated Land Phase Two Intrusive Investigation for proposed commercial development at 48 Derby Street, Manchester, M8 8HN.

Prepared for

Building Design Services  
6 Stock Close  
Rochdale  
OL12 6BB

July 2024

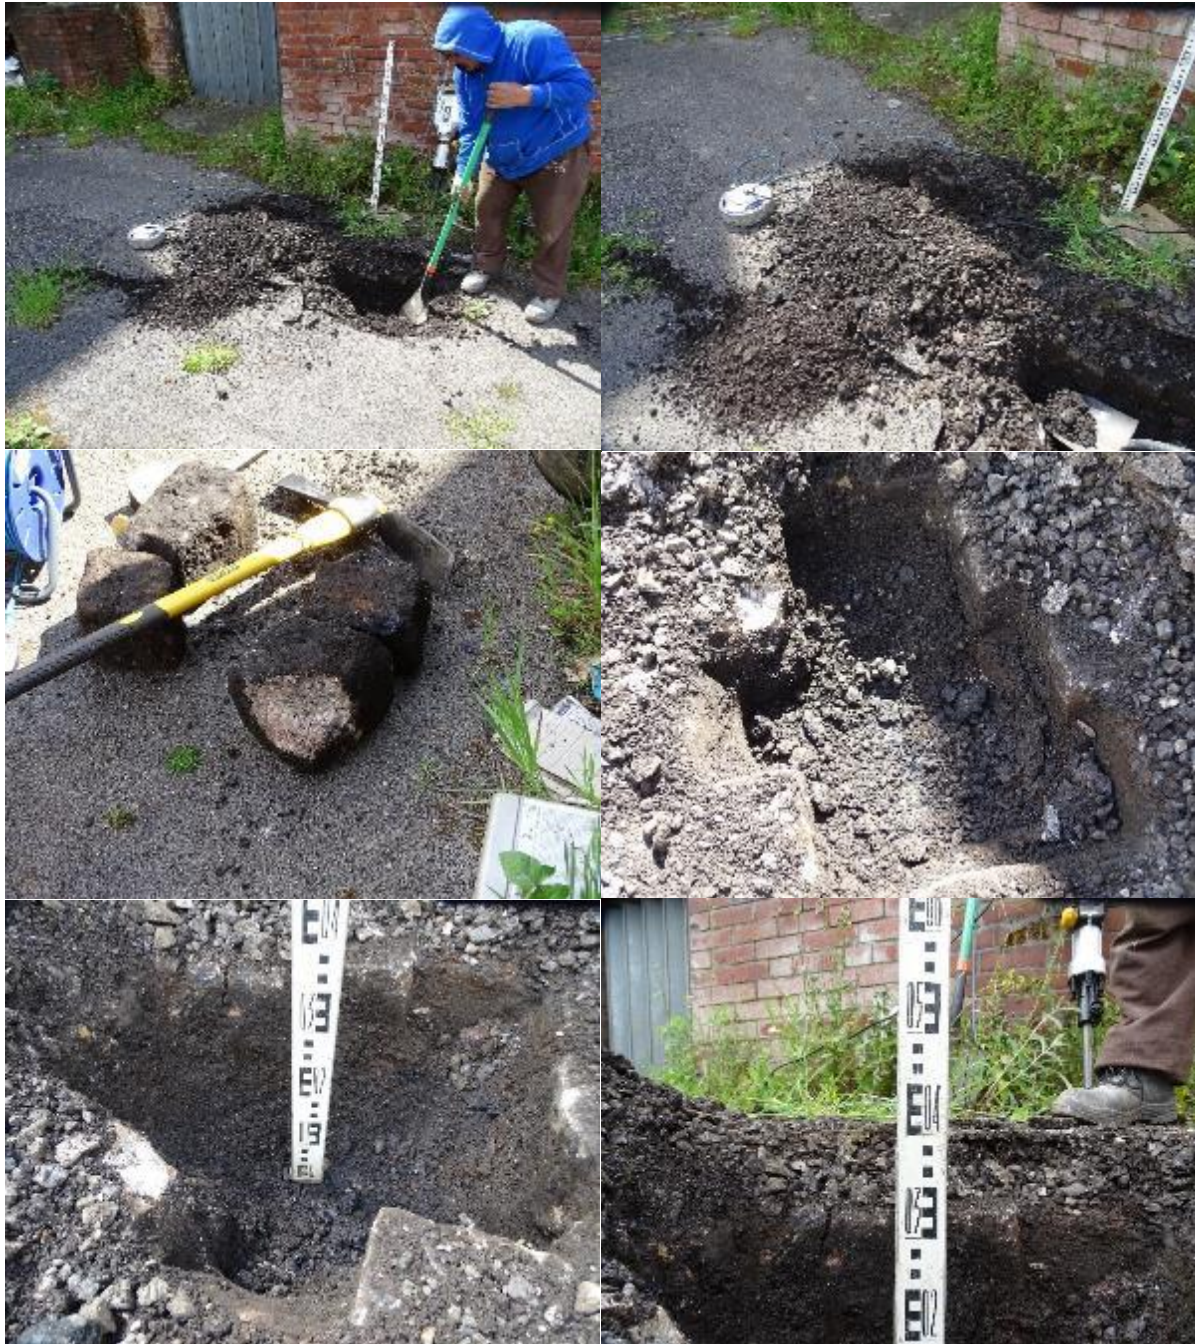
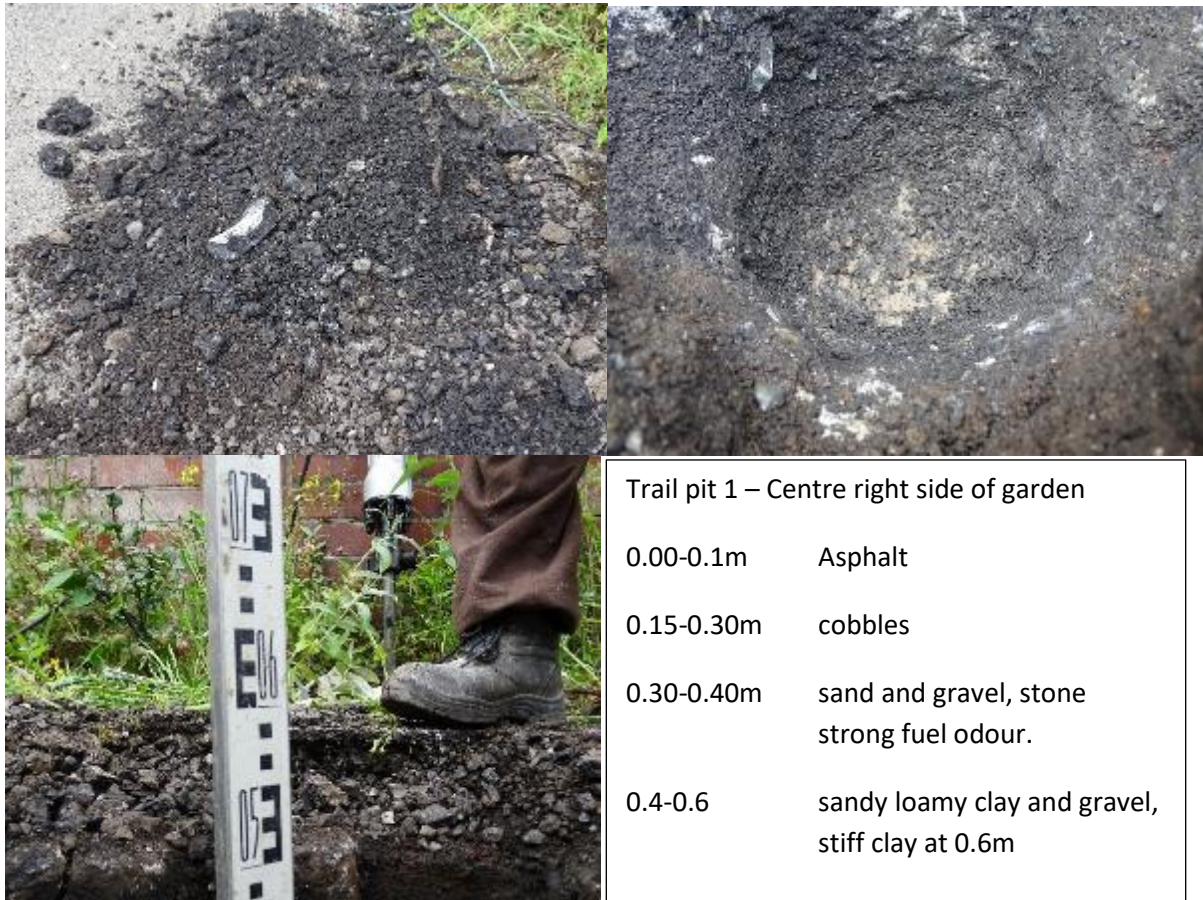
### TP1 – Centre right side of site (adjacent to existing building)

However, elevated levels of PAH's were identified within trail pit 1 and 3. A strong odour was also present near the surface of TP1 at the time of excavation. These exceedances were significantly above the identified LQM/CIEH S4UL's levels.

The source of the PAH contamination is unknown but combined with the odour detected within the TP1 it is considered likely that either asphalt or fuel oil/diesel may be the source.

1. Excavate the contaminated material on site. Excavated material will need to be appropriately disposed of with waste transfer notes kept for evidence.
2. New services installed shall be installed in trenches which are backfilled with clean imported material.
3. All drinking water supply pipes and connections shall be of a MDPE barrier pipe design.
4. All construction workers to be given suitable advice and training on the risks from contamination with adequate welfare facilities provided for handwashing etc.

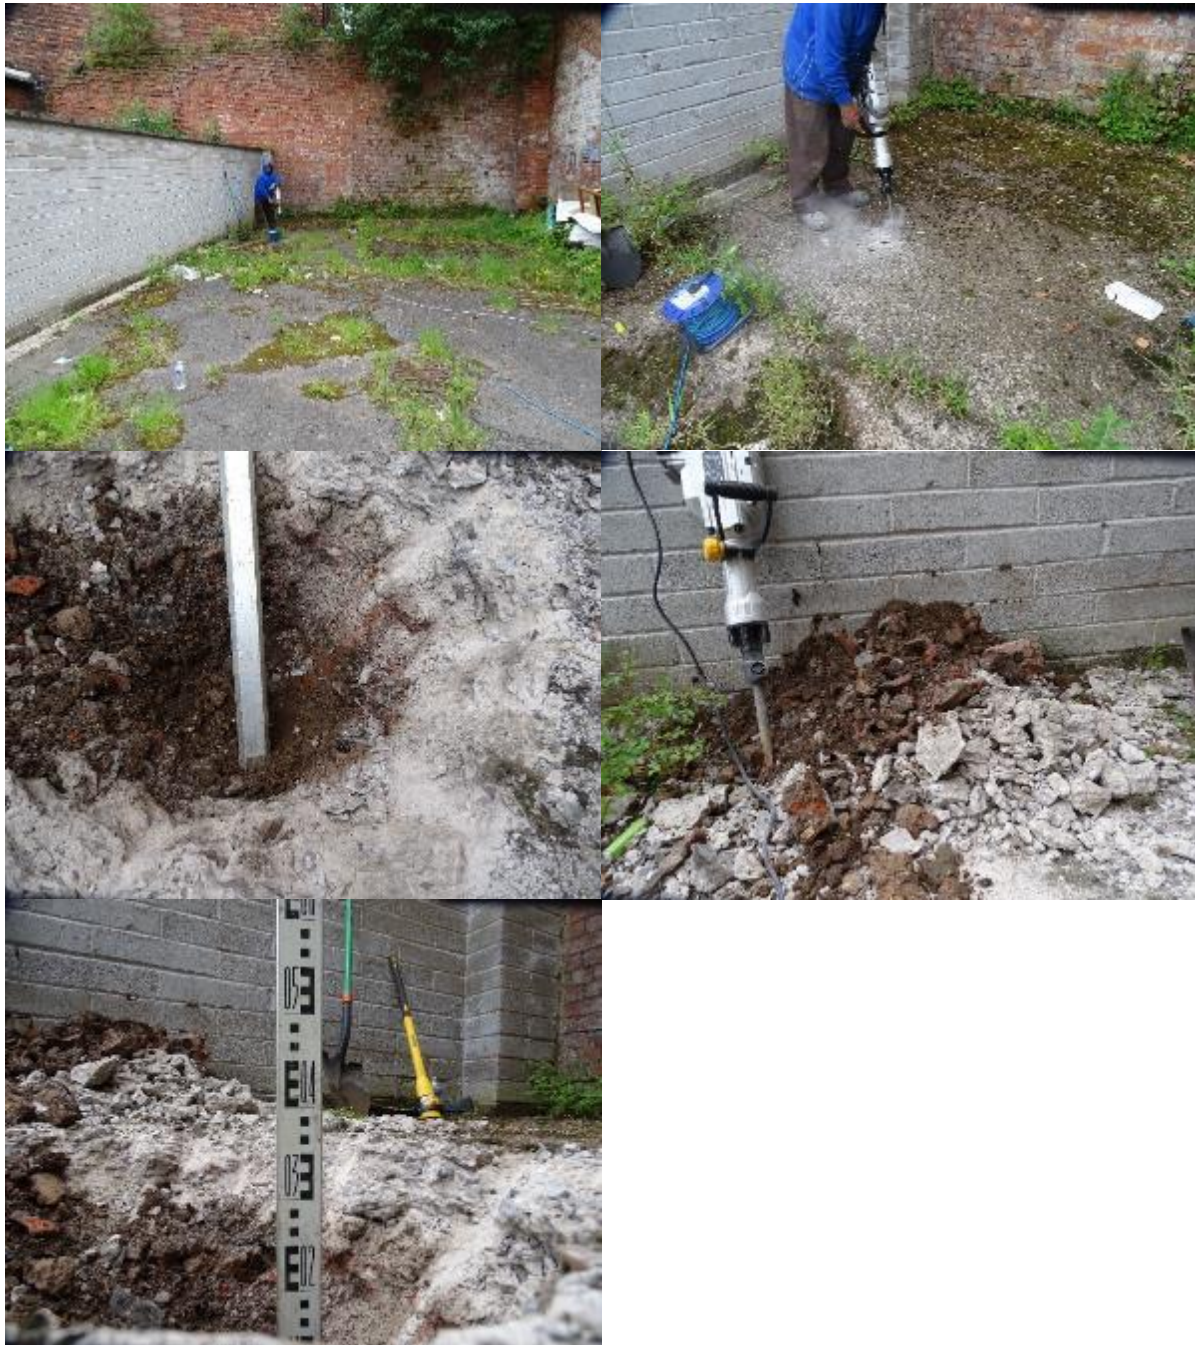
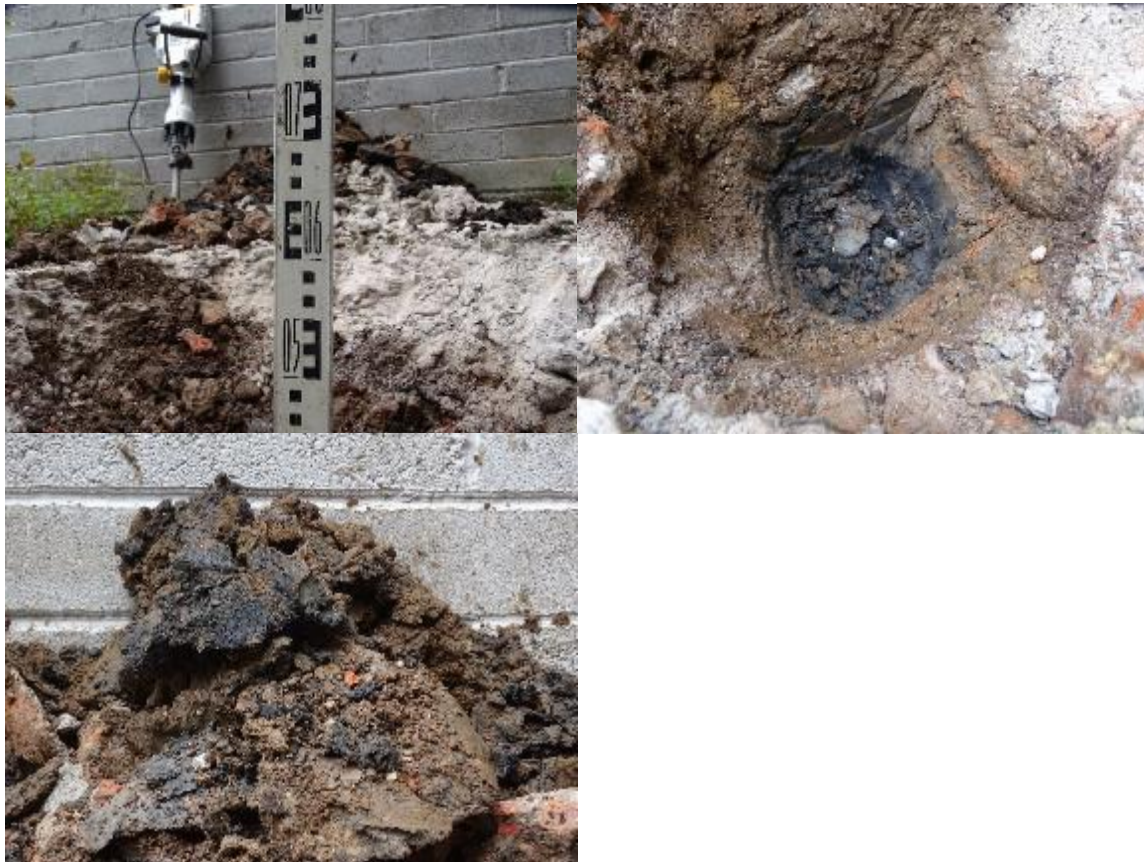
**TP2 – Rear left side of site**

Trail Pit 2 – Rear left side of garden

| 0.38-0.65m | sandy loamy clay, gravel. Clay light orange to dark brown, no odour. |

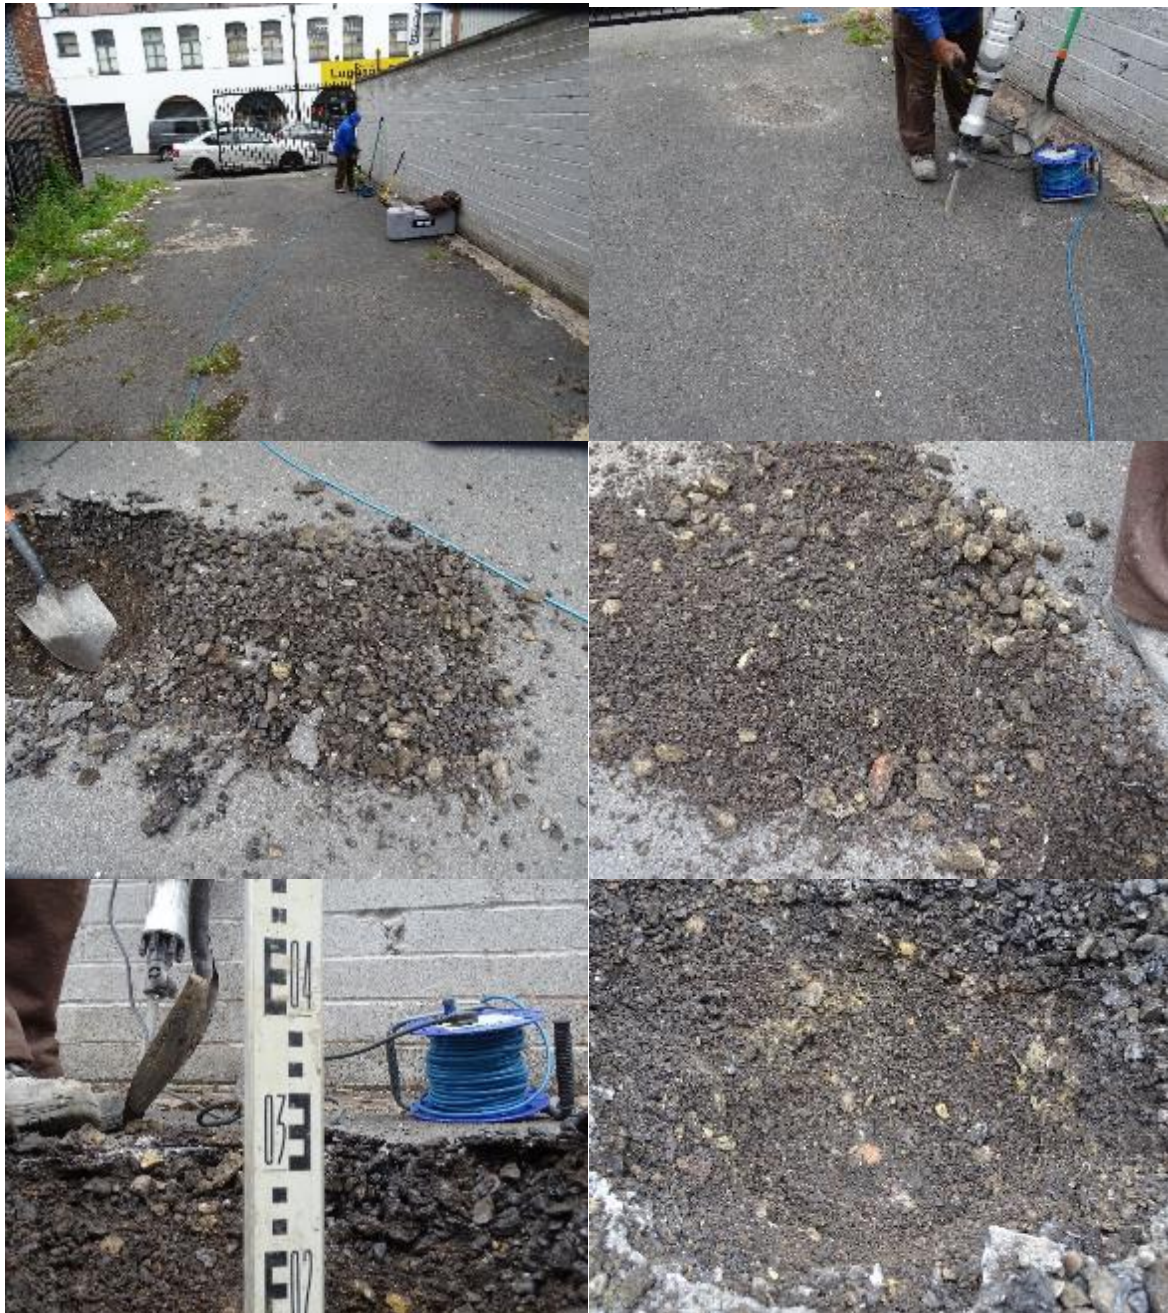
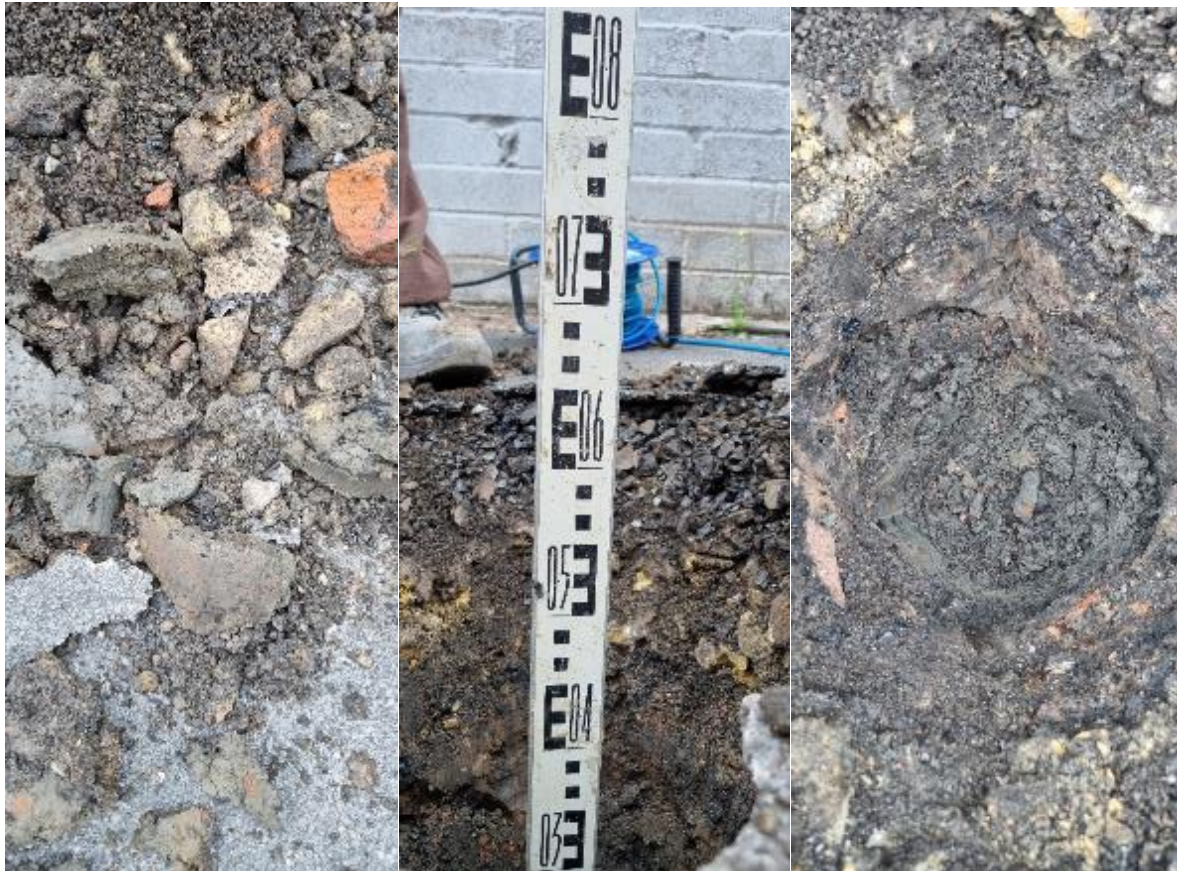
**TP3 – Front left side of site**

Trail Pit 3 – Front left side of site

| 0.00-0.05m | asphalt |
