## Phase 1 GeoEnvironmental Desk Study

**PHASE I GEOENVIRONMENTAL DESK STUDY**  
**EASTLANDS PRIMARY SUBSTATION**  
**FOR**  
**ELECTRICITY NORTH WEST LTD**

**Report No. A3738/20**

**MAY 2024**

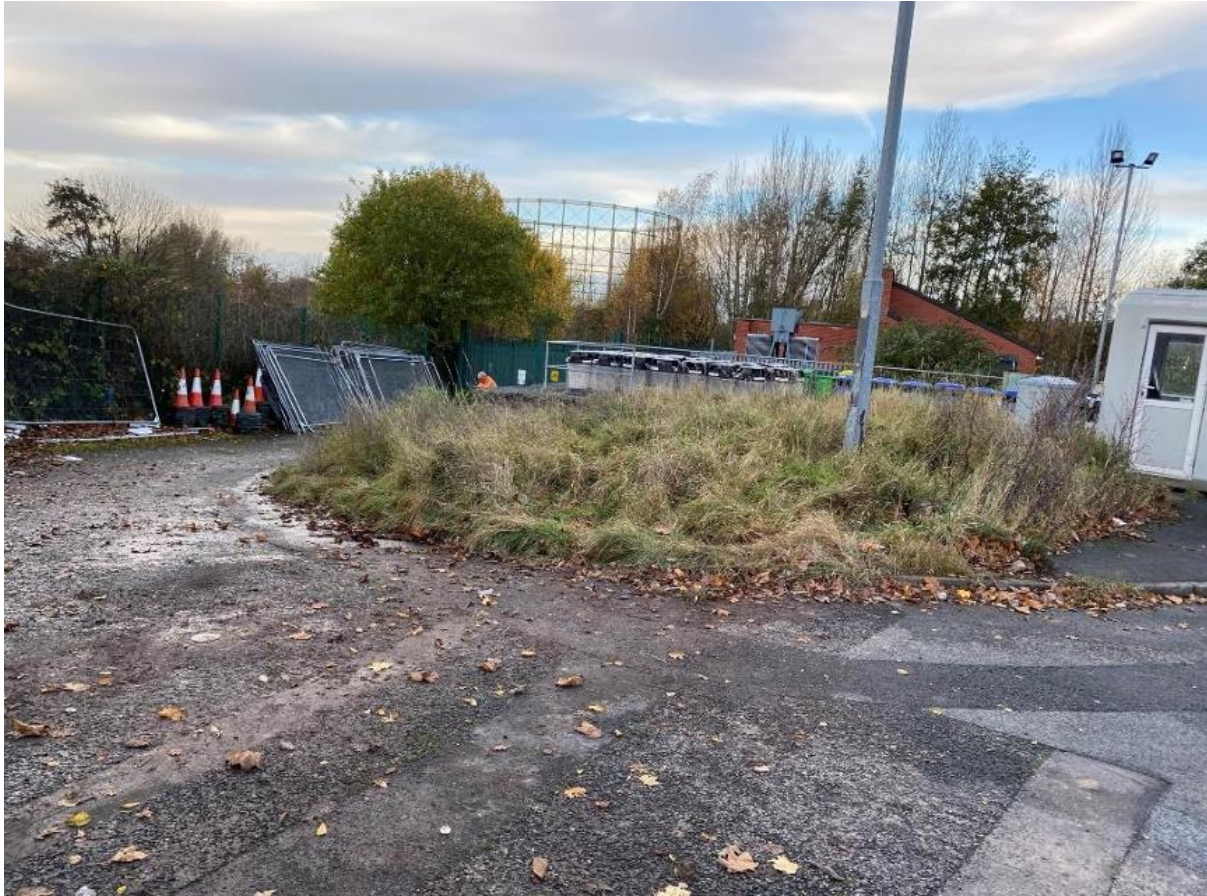
**Figure 3 Site Photograph**

- 2.5 The land is surfaced with a mixture of soft and hard cover, with some areas used for storage. The site is currently bound by palisade fencing.
- 2.6 The site is surrounded by a mixture of industrial and commercial land use with a small industrial estate directly to the east and the Etihad Campus Stadiums directly to the west. Two trainlines also run adjacent to the site, directly to the east and north.

- 2.7 A location plan is shown below as Figure 2, together with a recent site photograph as Figure 3 (overleaf).

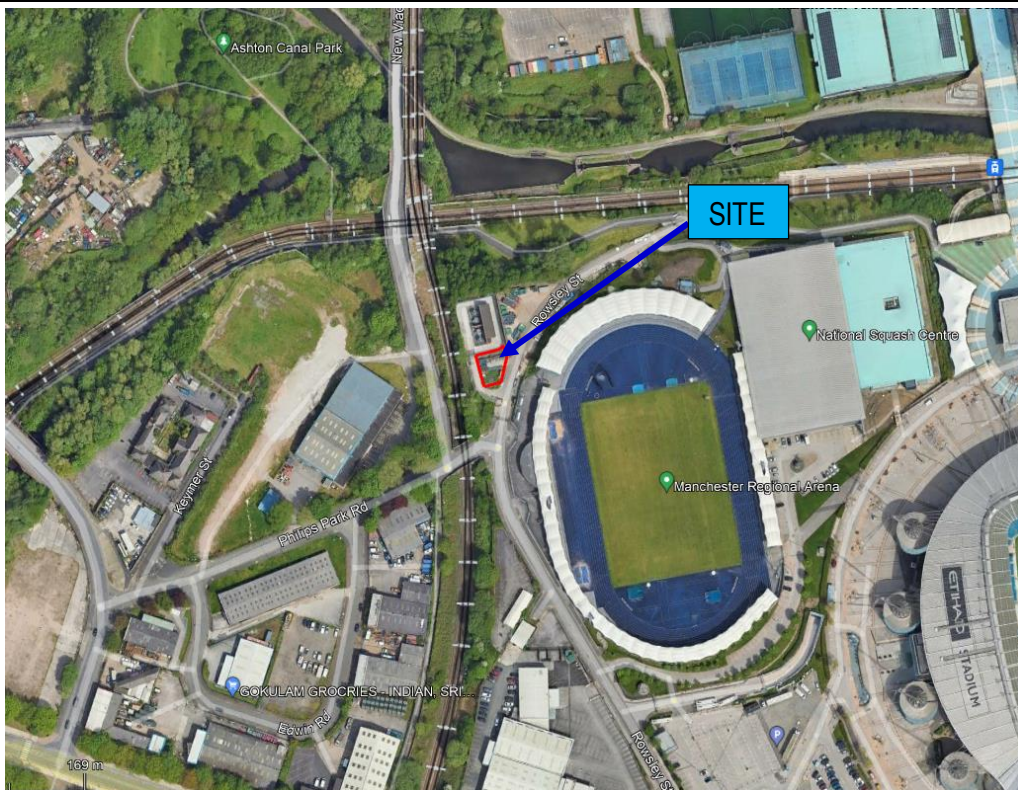
Figure 8 Aerial Photograph 2023

| Date | On-Site History | Surrounding Land Use History |
|---|---|---|
| 2003, 2005,<br>2009, 2013,<br>2016, 2017,<br>2018, 2019,<br>2020, 2021,<br>2022, 2023<br>Google Earth<br>Satellite<br>Imagery | The site currently comprises a vegetated surface with an electricity substation directly north of the site, | The Etihad Campus, including Manchester Regional Arena, Manchester City Football Club Stadium, Manchester Tennis and Football Centre and Manchester Squash Centre has been developed directly east/southeast of the site. |
