## Phase II GeoEnvironmental Investigation

Bradstone Road

Manchester

**Report Ref: A2333/18/V2**

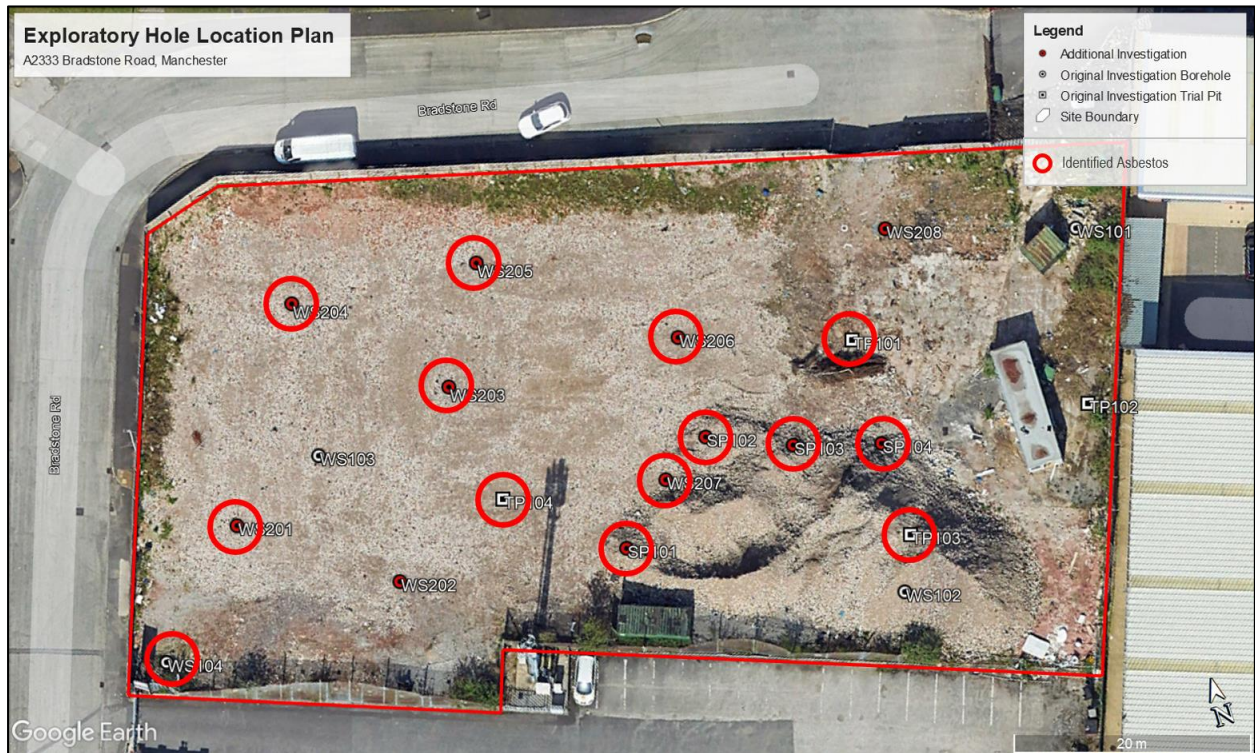
**Figure 1 Asbestos Sampling Plan**

In addition to the four locations identified as containing asbestos in the original site investigation report, another ten samples were found to be positive for containing asbestos. The samples contained mostly chrysotile, with some amosite also present, and to contain between <0.001% to 0.255% asbestos by weight. A plan of the sampling is included overleaf as Figure 1.

An overall risk of low to medium was given to the asbestos risk during construction. Construction activities were assessed to be suitable for classification as Non-Licensed Work. EN140 type respiratory protective equipment with P3 filter half mask was deemed suitable for workers during construction. Localised mechanical dust suppression was recommended as well localised and enhanced personal decontamination facilities. Further, more detailed recommendations on asbestos control measures, personal protective equipment, asbestos air monitoring and unexpected asbestos contamination can be found within the Asbestos Management Plan and should be carried out during construction activities.

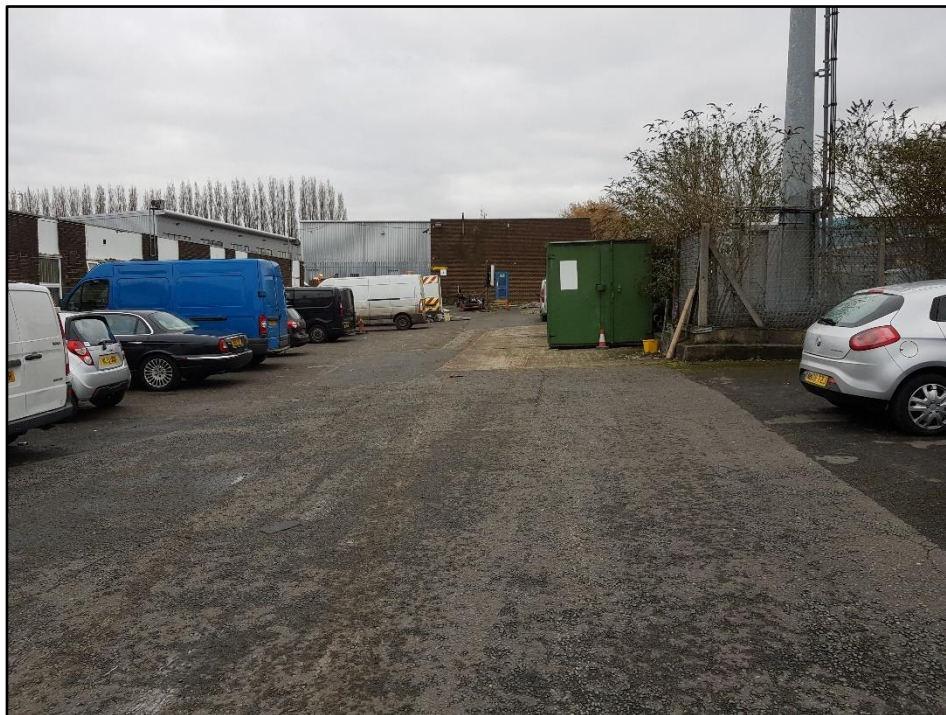
**Figure 3 View across the south of the site during 2017 investigation, facing east.**

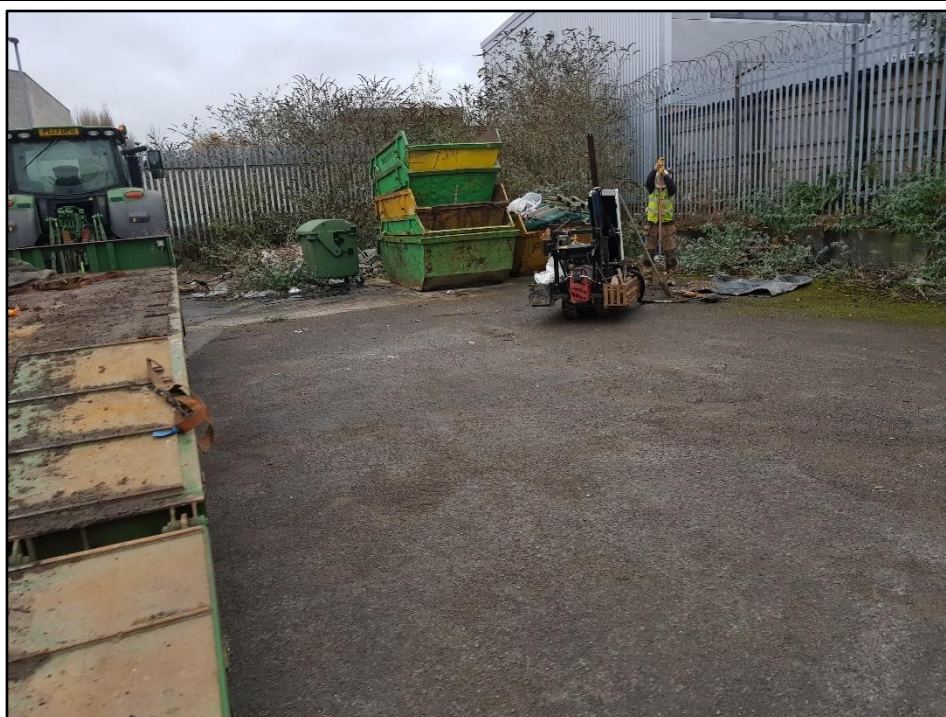
**Figure 4 WS101 drilling in progress during 2017 investigation, facing north.**

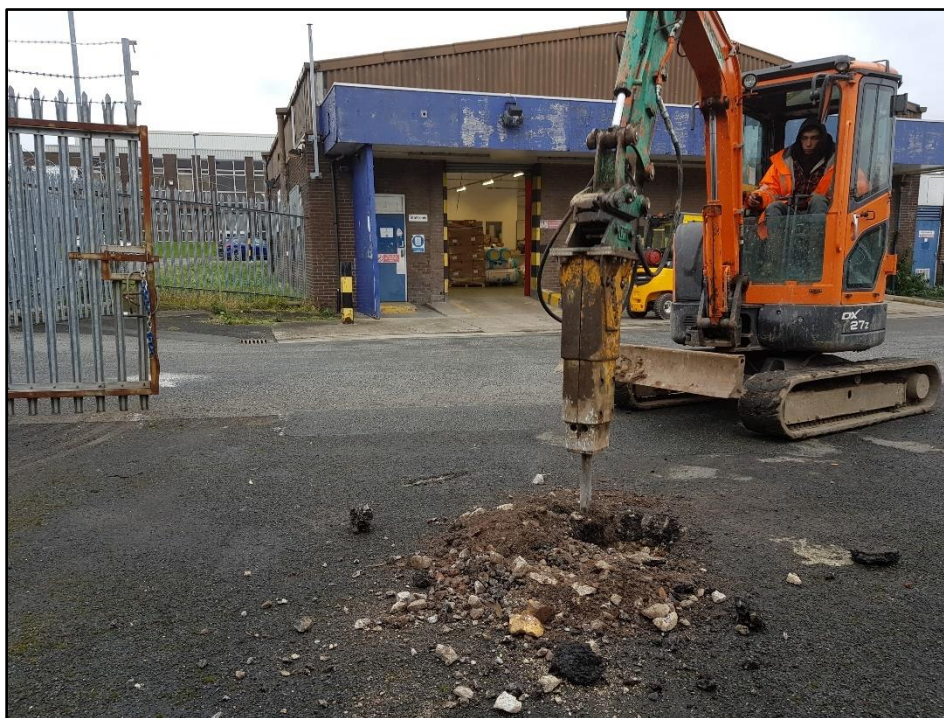
**Figure 5 Excavation in progress during 2017 investigation, southwest of the site.**

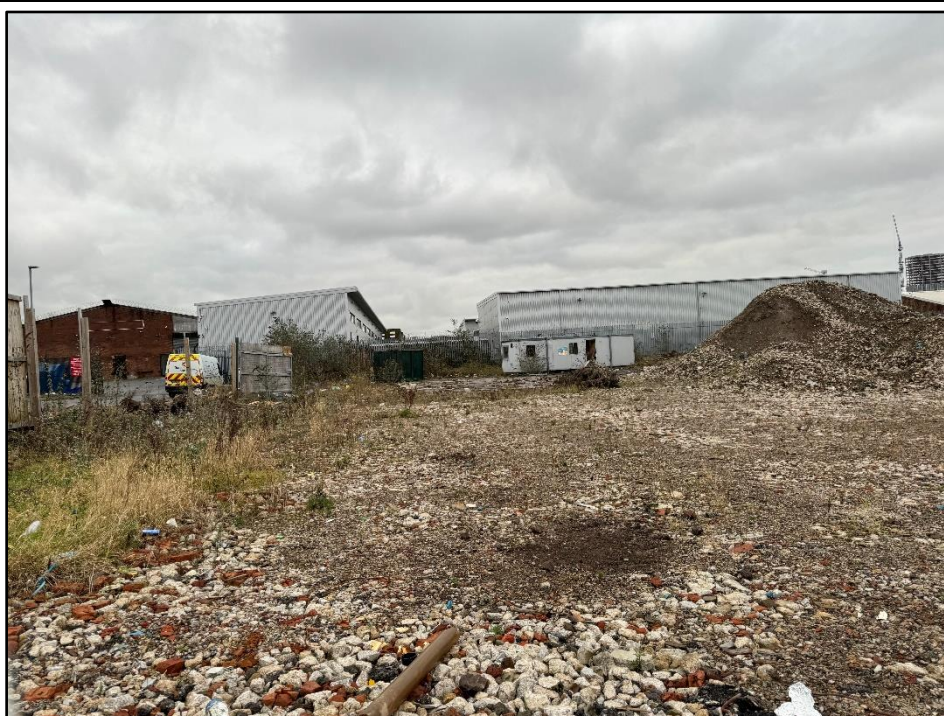
**Figure 6 View across site during 2023 investigation, facing east.**

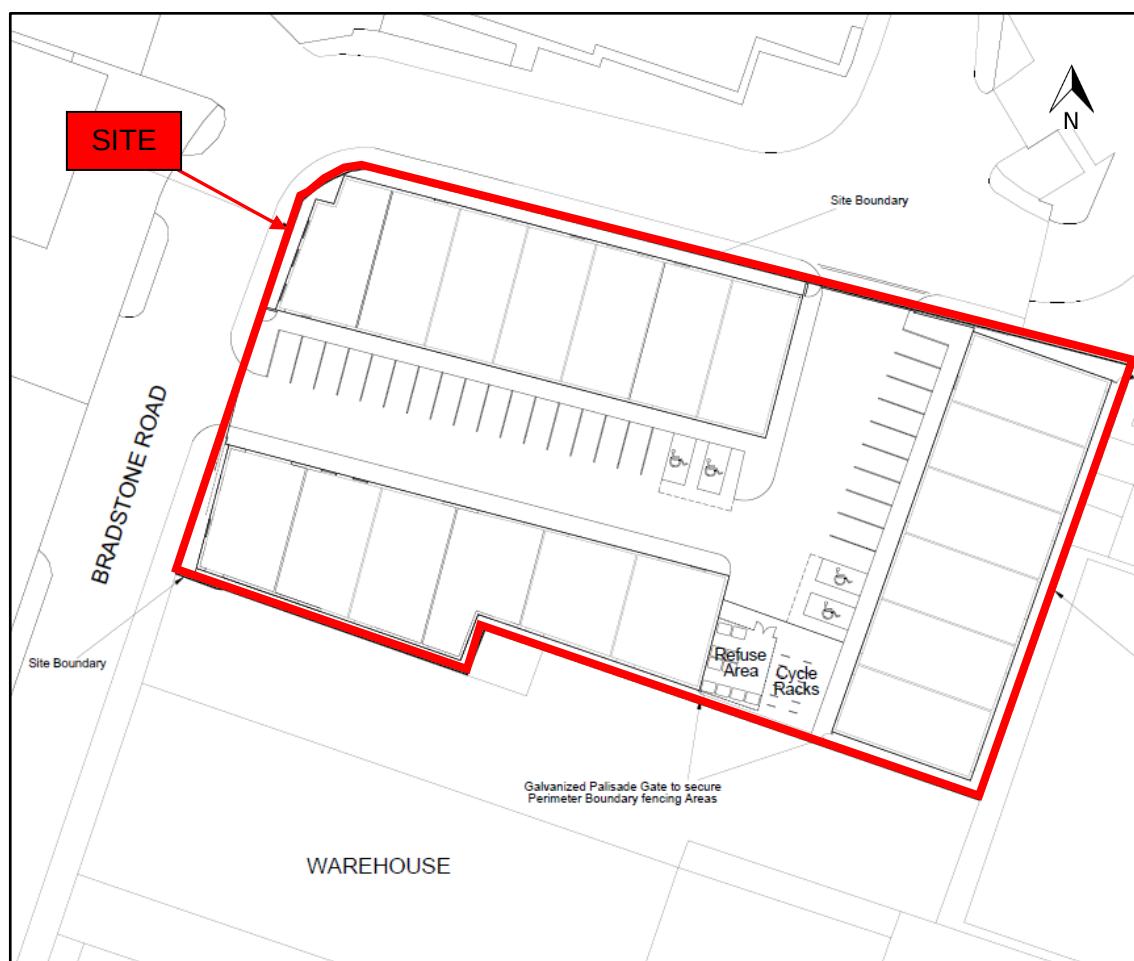
**Figure 7 Development Layout Plan**

It is understood that permission has been granted by Manchester Council for the demolition of the existing buildings and structures and the erection of 3no. three-storey buildings to form 19no. cash and carry units with associated roads and (Planning Reference: 115485/FO/2017).

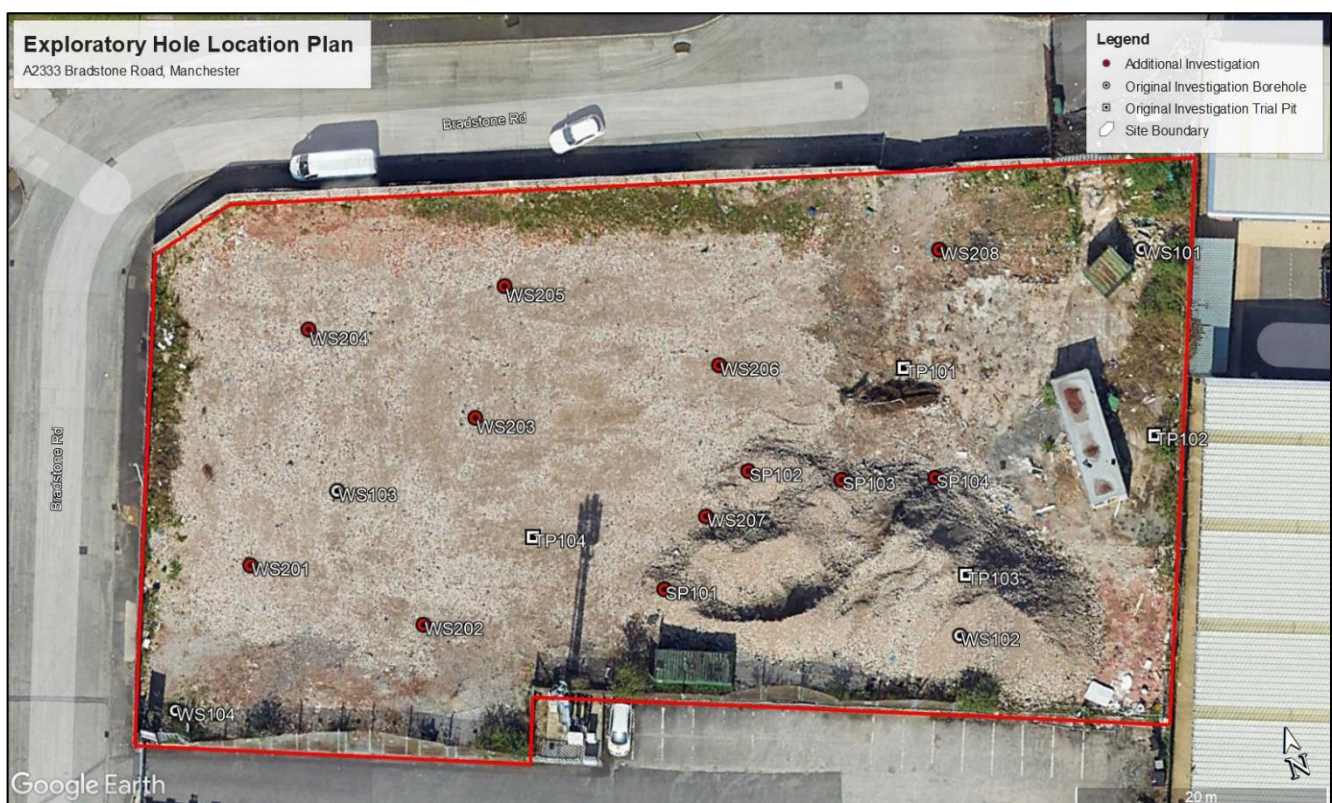
**Figure 8 Exploratory Hole Location Plan**

- Four trial pits (designated TP101-TP04) were excavated by use of a hydraulic excavator, to a nominal depth of 2.30m bgl for the purpose of assessing ground conditions and collecting environmental and geotechnical samples. Exploratory Hole logs for the trial pits are also included in Appendix 1.

- Additionally, four samples were retrieved from a stockpile during the follow-up investigation for environmental testing, located in the southern corner of the site.

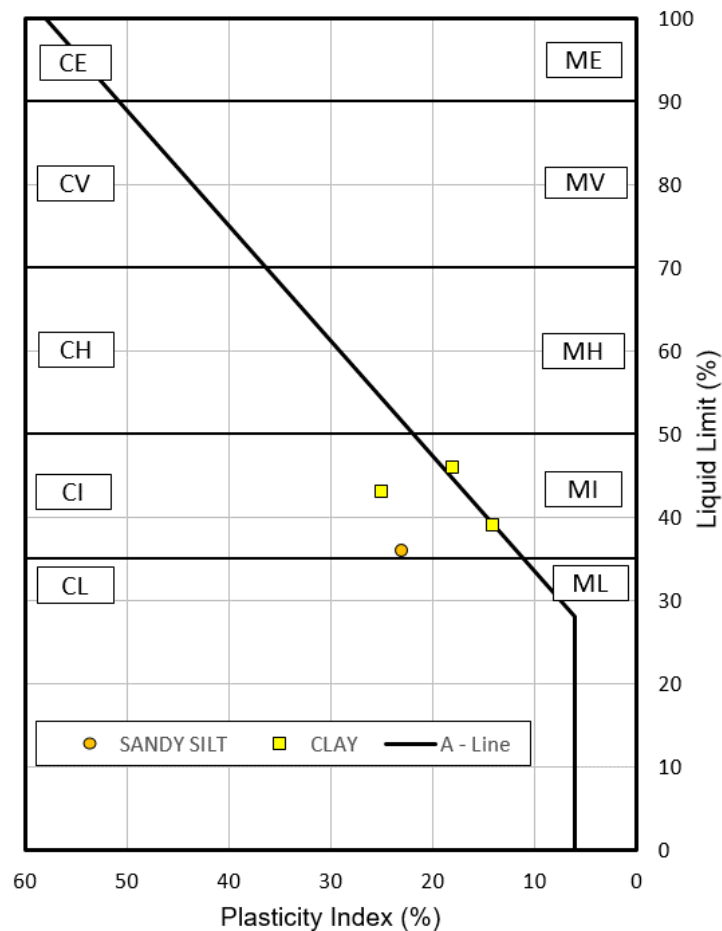
Figure 9 Plasticity Chart

Atterberg Limit testing has given a value of **liquid limit** of 36% and a **plastic limit** value 13%, resulting in a value of **plasticity index** of 23%. These results suggest the samples tested are clay of intermediate plasticity as shown on the Plasticity Chart below. For design purposes, a value of plasticity index = 23% is recommended, based on the results.

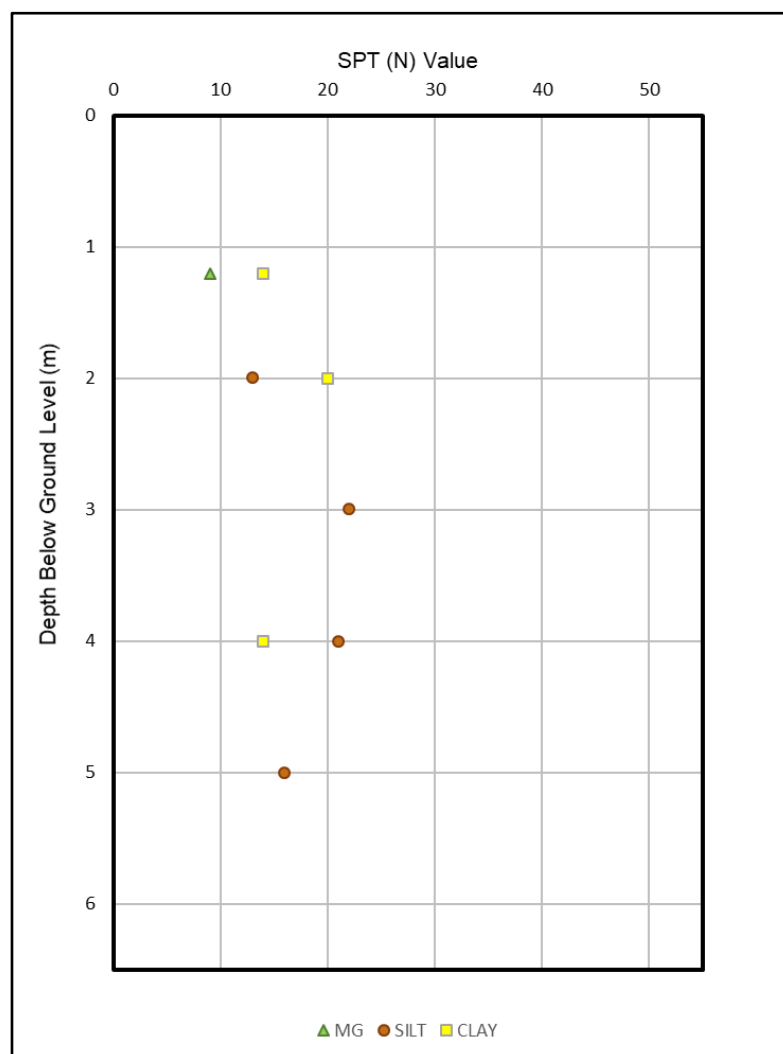
**Figure 10 SPT v Depth Plot**

It is recommended that for assessing ultimate bearing capacities, where the lower values are critical, the lower quartile value of N is used. For assessing settlements, lower quartile ground conditions will give a more realistic value of settlements and the lower quartile of N values should be used.
