# BIODIVERSITY TECHNICAL NOTE

**Job Name:** The Embassy Village,  
Castlefield's, Manchester

## The Embassy Village Castlefield's – Aerial Endoscope Inspection Technical Note

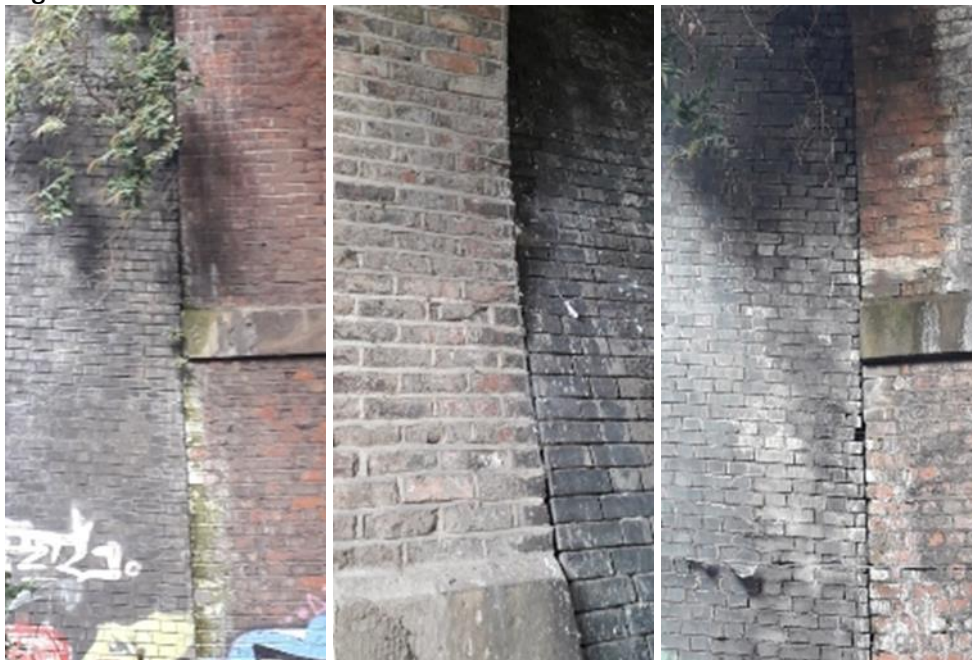
Figure 2a

- 2.3 Gaps in the brickwork in arches 1-4 along the southern abutments were inspected. The gaps were 3-10cm deep, running with water and filled with soil. There was no evidence of any bat activity (bats, droppings, fur rubbing or scratching) associated with these gaps. There was no evidence that the gaps had been used by bats. (Figure 2a & 2b)

- 3.1 No evidence of bat roosting activity was found in either survey 12/12/22 or 31/08/23.
- 3.2 The cold store should be inspected once the roller door has been removed. This should be carried out before any clearing-up has been carried out on the interior of the cold store.
- 3.3 As was noted in the letter 7/2/23 the proposed structures will leave a 3m gap between the walls of the arches and the accommodation, staff and village pods. There will also be a minimum gap of 3m from the top of the pods to the top of the arches.
- 3.4 The gaps identified and inspected will not be closed as part of the works but will remain in place.

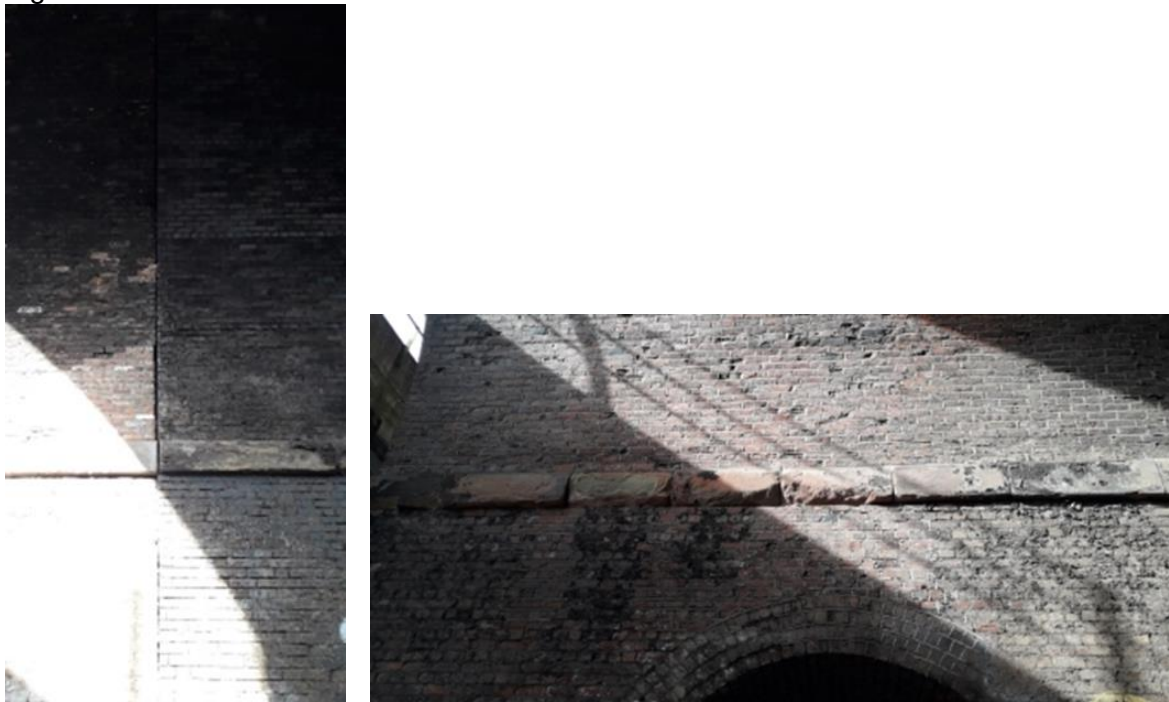
Figure 3a & 3b

- 2.4 Gaps above and below the stone plinth in the centre of the arch walls were inspected in arches 2-8. In some areas the stonework is crumbling but the gaps were less than 5cm in depth. There was no evidence of any bat activity (bats, droppings, fur rubbing or scratching) associated with these gaps. There was no evidence that the gaps had been used by bats. (Figure 3a & 3b)

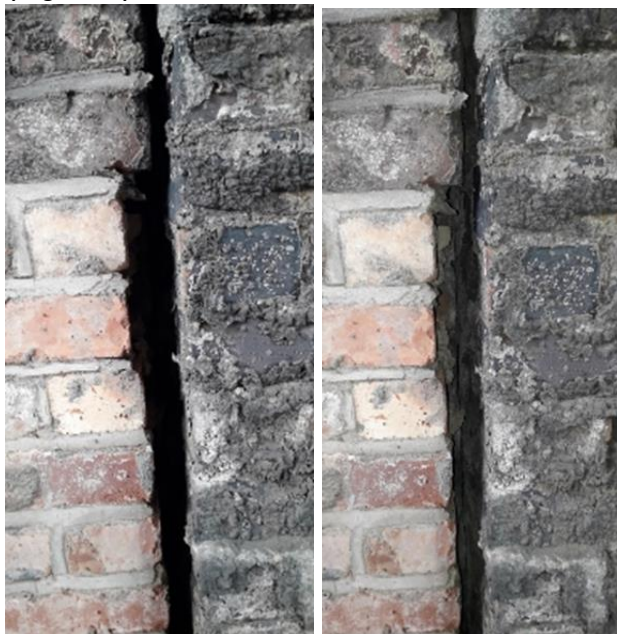
- 2.5 Gaps in the brickwork at the centre of the walls of arches 6 and 7. The gaps were the deepest of all inspected 5-15cm deep. The gaps were very damp and filled with rubble and soil. There was no evidence of any bat activity (bats, droppings, fur rubbing or scratching) associated with these gaps. There was no evidence that the gaps had been used by bats. (Figure 4)
