**THE POWER HALL, MUSEUM OF SCIENCE AND INDUSTRY, MANCHESTER**  
**ARCHITECTURAL HISTORIC PAINT RESEARCH AND ANALYSIS REPORT**  
**SPECIFIED EXTERIOR AND INTERIORS AREAS AND ELEMENTS**

**PROJECT CONTACT: SUZANNE M<sup>C</sup>NICHOLAS**

**PROJECT CLIENT: SCIENCE MUSEUM GROUP**

**12<sup>th</sup> AUGUST 2020**

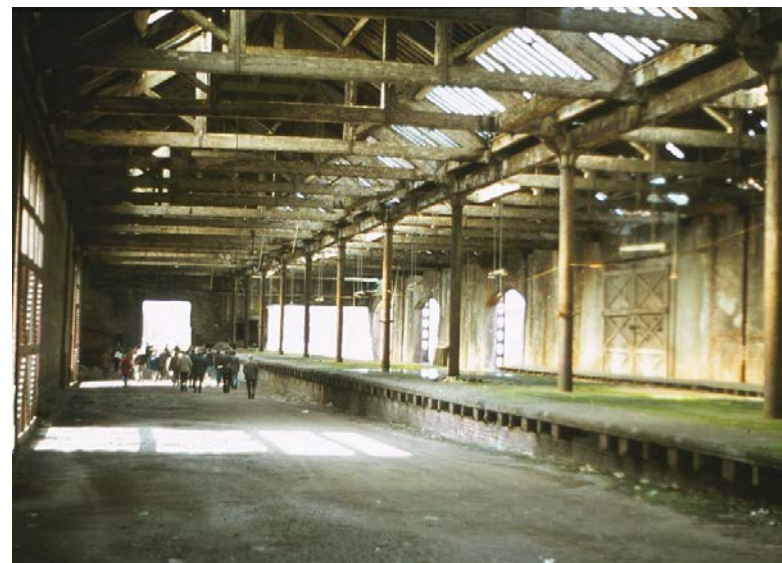
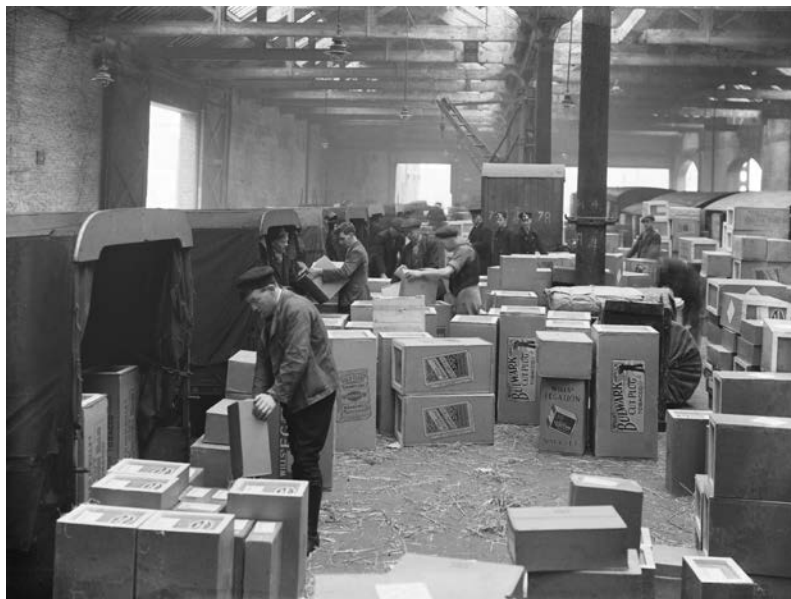
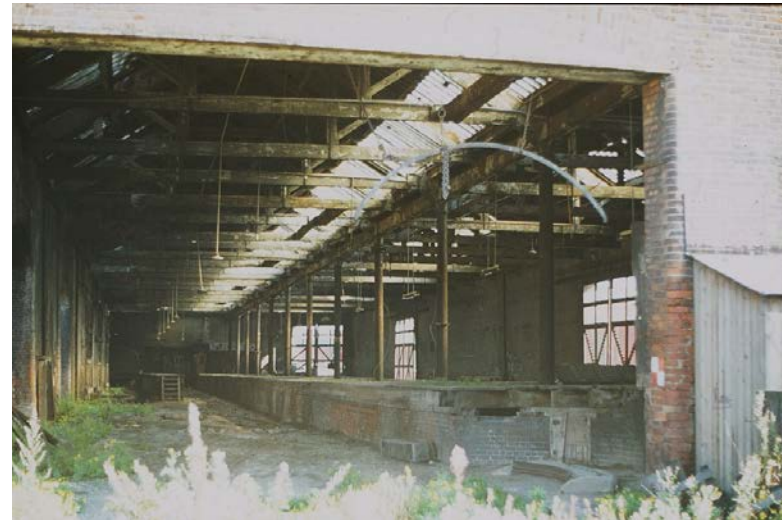
This limewash treatment is seen in figures 1 to 3, which record the beams in this much paler finish

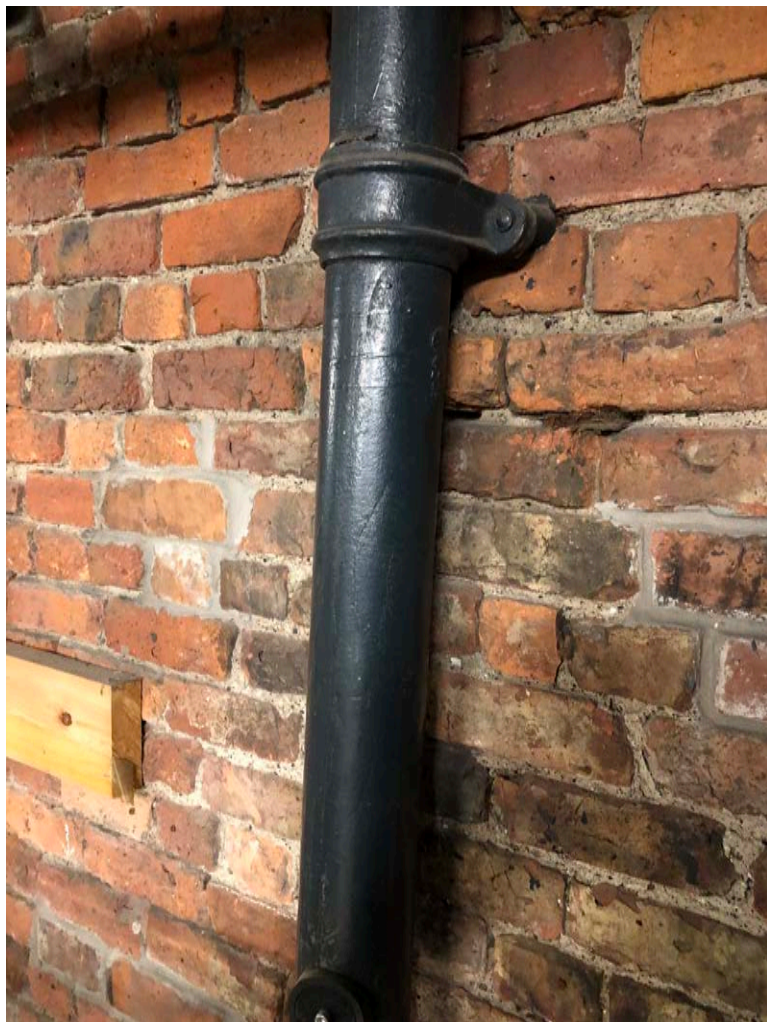
**Figure 8: Representative rain water goods, section of internal downpipe (now identified as late C20th replacements)**

The research, as recorded in the preceding chart clearly identifies the rain water goods as modern replacements. It also records that the main iron columns were not frequently maintained at the earlier period, as surface pitting and general oxidation has occurred. It is only at scheme 10, that the columns have been cleaned down and painted. Figures 1 to 3, earlier in this report, clearly record how the surface of the columns slowly discoloured and deteriorated over time. It is in figure 4, from the 1980s that they appear to have been repainted. In contrast, the cast iron column capitals, which relate to the plates and strapwork fitted to reinforce and support the roof timbers, have been frequently repainted over the years. The first 8 schemes being in variations of stone colour, cream in scheme 9, and then black from scheme 10 until the last decoration, attributed as museum period.

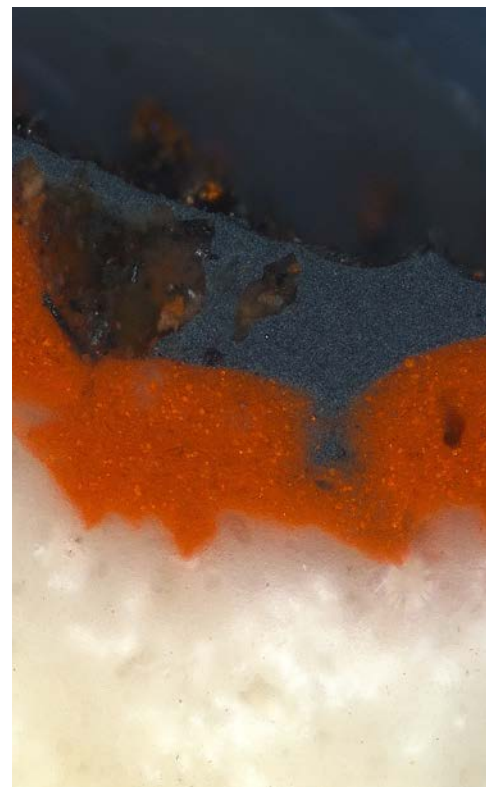
**Figure 9: Sample no. MoSI/PH/ 1.1**

**Interior rain water goods, including high level elements**

Current scheme of black oil paint over a fine grey oil paint undercoat. C20th in material and appearance

Two thick coats of red lead based red coloured oil paint. These again are typically earlier C20th.

A very thick putty repair to the section joint on the drainpipe. Most samples from the rain water goods readily fragmented due to the thin and few number of paint layers. The putty of the joint has held this sample together.

All of the rainwater good sampled, at floor level and at high level, revealed the same evidence. The lack of earlier schemes on all of the items sampled suggests either extensive refurbishment of all of the rain water goods, or full replacement during the early twentieth century.

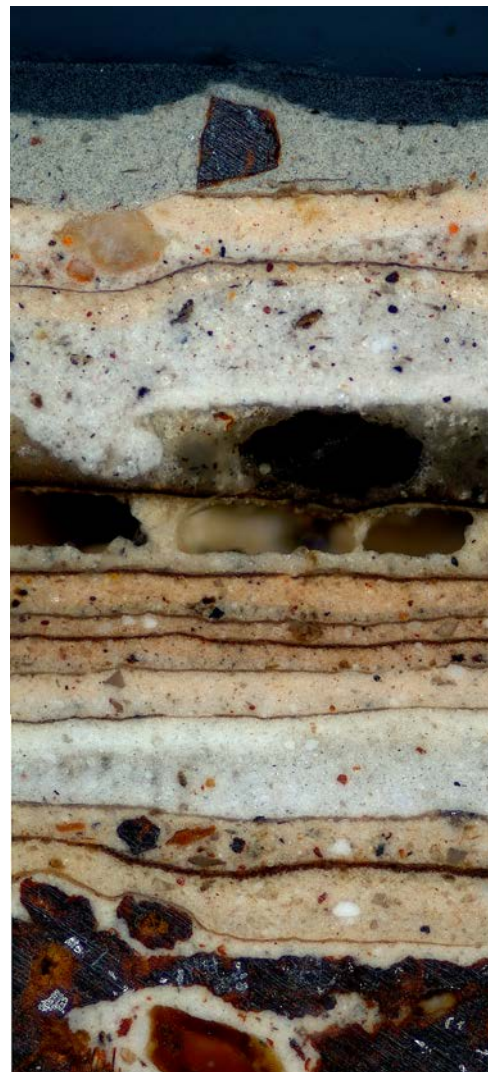
Figure 13: Sample no. MoSI/PH/ 1.4

Large iron column capital

Final scheme of pale grey oil undercoat with a dark grey/black top coat

Two schemes of mid cream stone coloured lead oil paint

*Deposits of dirt and oily matter*

a single scheme of paler pinky-cream lead oil paint

A phase of warm pinky-cream stone coloured lead oil paints, very similar to the earliest schemes

A single scheme of pale creamy stone coloured lead oil paint. Paler than the earlier phase.

The earliest phase of schemes consists of 3 mid stone coloured lead oil paints. these each have oil dirt deposit on the surfaces.

Substrate iron, which is very rusty and surface degraded. The first paint layer over this has seeped into the open surface.

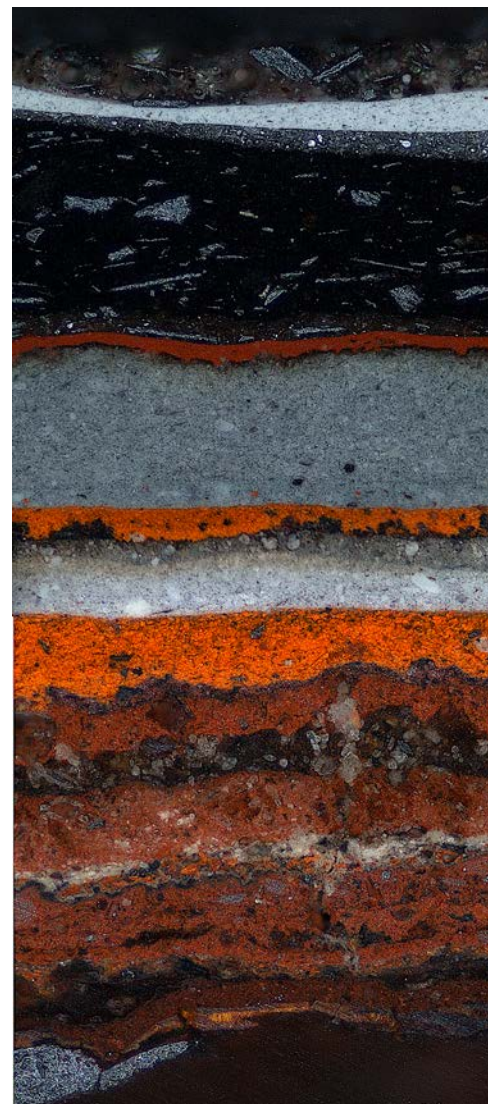
Figure 19: Sample no. MoSI/PH/ 2.9

All of the Crane Gantry samples showed the same surviving history or traces of, that tie in with the representative sample shown here.

Modern grey lead undercoat with a dark grey top coat

A thin red lead primer, with a thick coat of aluminium in a dark varnish base as an additional primer.

There is then a dark grey lead oil paint top coat

This scheme repeats the previous decoration.

A move away from the earliest phase is this scheme of red lead primer with a mid grey undercoat and finish coat.  
The surface of the scheme has extensive sooty deposits.

The earliest and highly significant paint schemes identified on the crane gantry all consist of this phase of at least 4 decorations. Each is virtually identical, in dark red/brown ochre and iron oxide pigmented lead oil paints.

Substrate iron, some mill scale

Similarly, the history of paint types and colours applied to the Crane/Gantry is also interesting. The whole structure has always been painted in a single colour as one would expect. The early and most significant phase of schemes, again continues up to scheme 8. Unlike the more recent grey oil paints, the earlier decorations were in very similar, but slightly differing red/brown lead oil paints. These colours being commonly used on industrial sites. The current grey appearing in later schemes but having no historic precedent for the original and earlier period of the structure.
