## Supplementary Geoenvironmental and Geotechnical Site Assessment

Crabtree Lane, Manchester  
Former Walkers Site  
Crabtree Lane  
Manchester  
M11 4GU

February 2024

546629.0002.0000

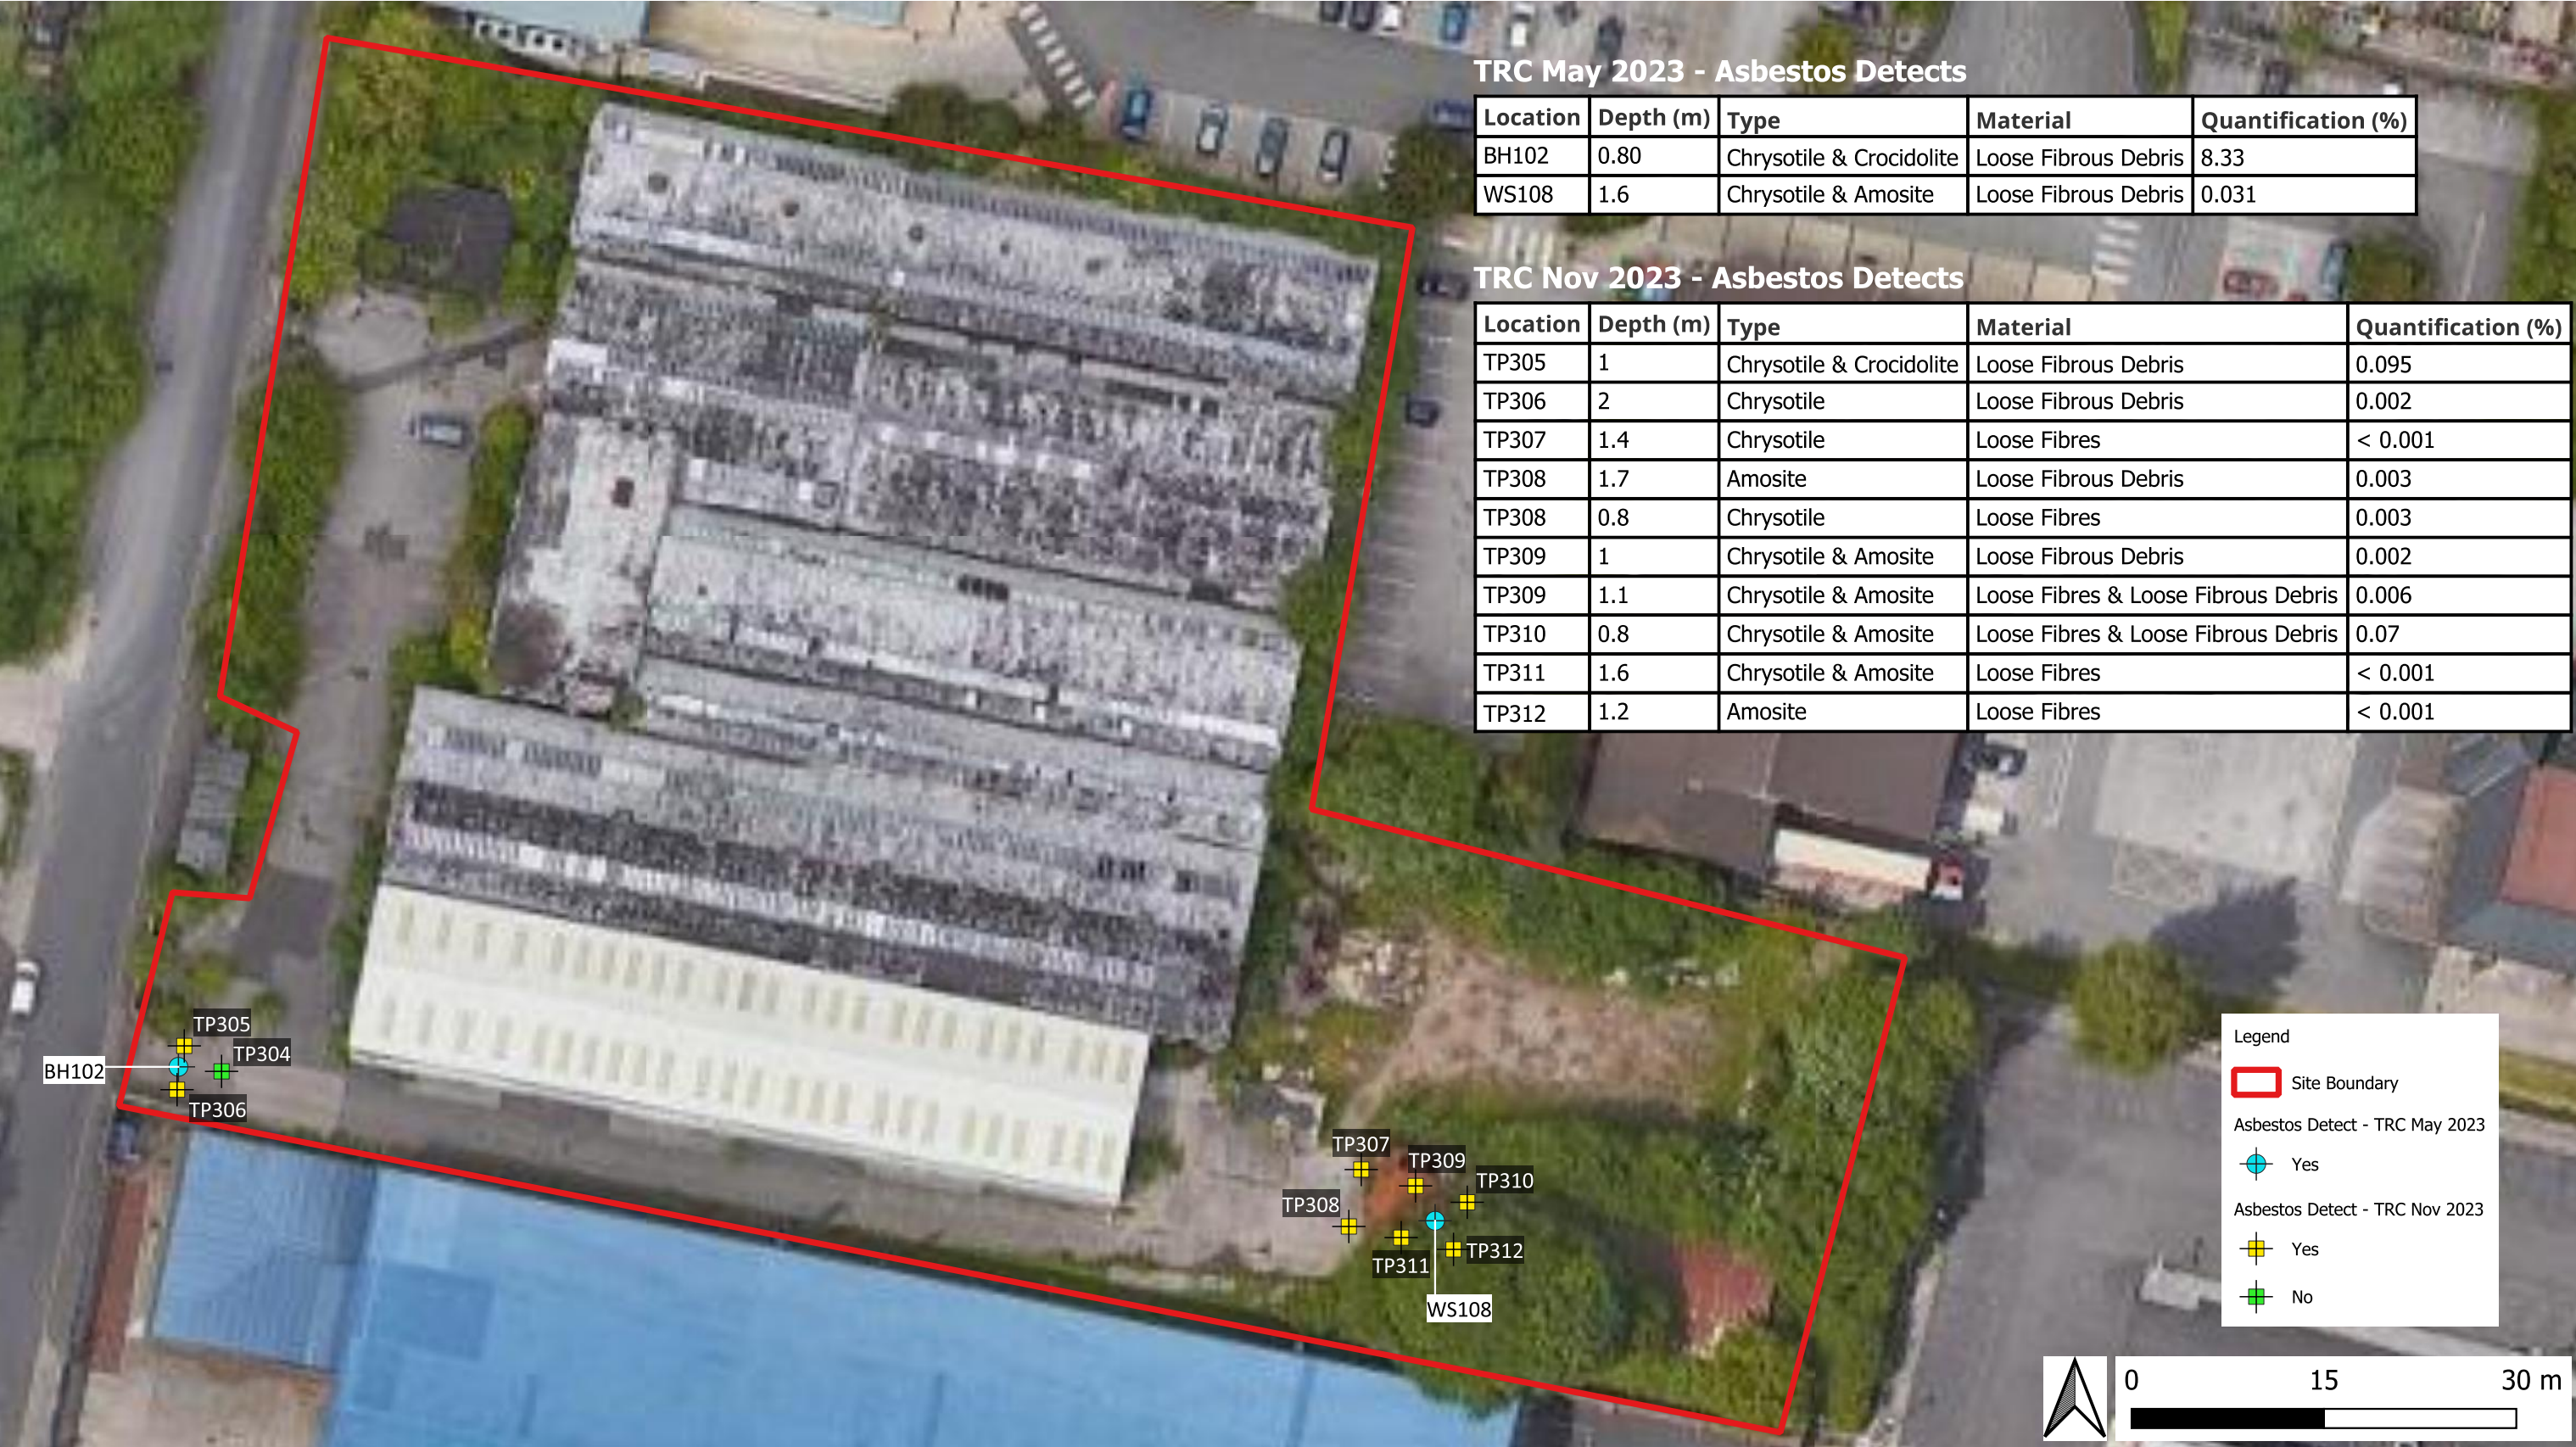
TRC May 2023 - Asbestos Detects

| Location | Depth (m) | Type | Material | Quantification (%) |
|---|---|---|---|---|
| BH102 | 0.80 | Chrysotile & Crocidolite | Loose Fibrous Debris | 8.33 |
| WS108 | 1.6 | Chrysotile & Amosite | Loose Fibrous Debris | 0.031 |

| Location | Depth (m) | Type | Material | Quantification (%) |
|---|---|---|---|---|
| TP305 | 1 | Chrysotile & Crocidolite | Loose Fibrous Debris | 0.095 |
| TP306 | 2 | Chrysotile | Loose Fibrous Debris | 0.002 |
| TP307 | 1.4 | Chrysotile | Loose Fibres | < 0.001 |
| TP308 | 1.7 | Amosite | Loose Fibrous Debris | 0.003 |
| TP308 | 0.8 | Chrysotile | Loose Fibres | 0.003 |
| TP309 | 1 | Chrysotile & Amosite | Loose Fibrous Debris | 0.002 |
| TP309 | 1.1 | Chrysotile & Amosite | Loose Fibres & Loose Fibrous Debris | 0.006 |
| TP310 | 0.8 | Chrysotile & Amosite | Loose Fibres & Loose Fibrous Debris | 0.07 |
| TP311 | 1.6 | Chrysotile & Amosite | Loose Fibres | < 0.001 |
| TP312 | 1.2 | Amosite | Loose Fibres | < 0.001 |

Due to the presence of asbestos within soils above 0.001%, any works which have the potential to disturb asbestos must be carried out under a Plan of Work in accordance with Control of Asbestos Regulations 2012 (CAR2012). TRC recommends that an asbestos in soils management plan is produced to assess the risks associated with working with asbestos contaminated soils during the construction phase, identify the Health and Safety Executive's (HSE) licensing regime in relation to the proposed works on site, and identify suitable control measures which should be in place to manage risks from asbestos.

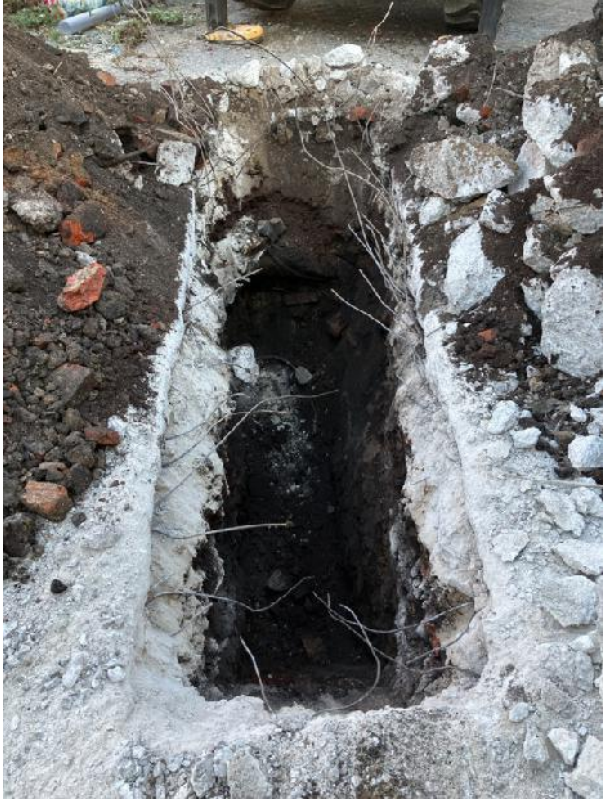
| Client: | | Site Location: | Project No.: |
|---|---|---|---|
| <b>Description</b><br>Trench incorporating TP304 & TP306 | | | |

| Exploratory Hole | Depth (m bgl) | Type | Material | Quantification (%) |
|---|---|---|---|---|
| TP306 | 2.0 | Chrysotile | Loose Fibrous Debris | 0.002 |

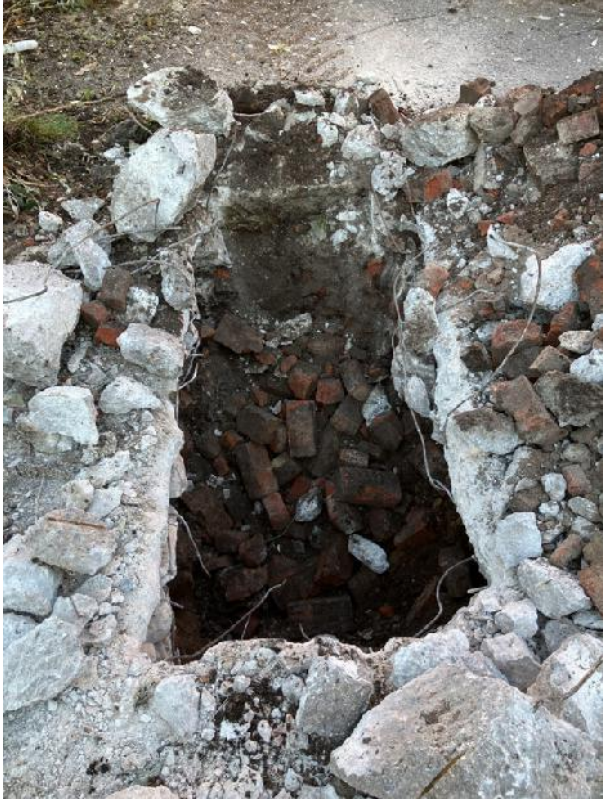
| Client: | | Site Location: | Project No.: |
|---|---|---|---|
| TP305 | | | |

| Exploratory Hole | Depth (m bgl) | Type | Material | Quantification (%) |
|---|---|---|---|---|
| TP305 | 1.0 | Chrysotile & Crocidolite | Loose Fibrous Debris | 0.095 |

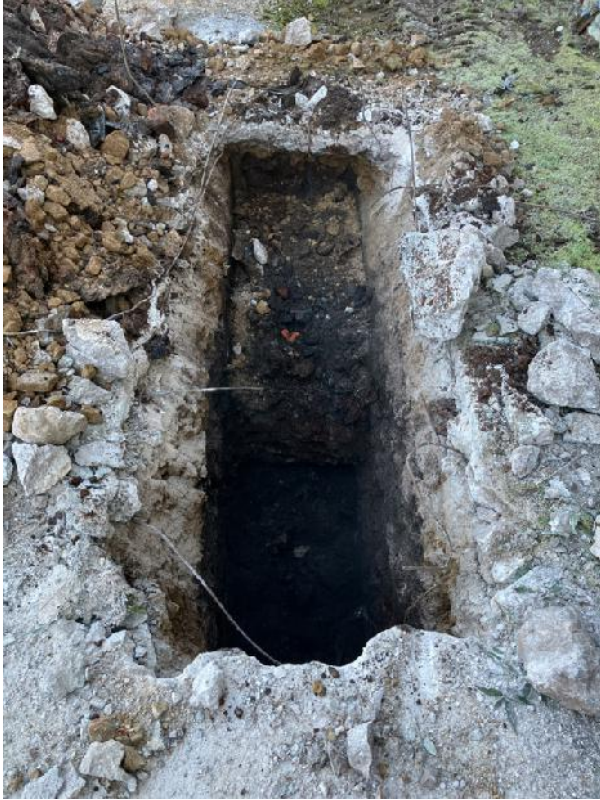
| Client: | | Site Location: | Project No.: |
|---|---|---|---|
| TP307 | | | |

| Exploratory Hole | Depth (m bgl) | Type | Material | Quantification (%) |
|---|---|---|---|---|
| TP307 | 1.40 | Chrysotile | Loose Fibres | < 0.001 |

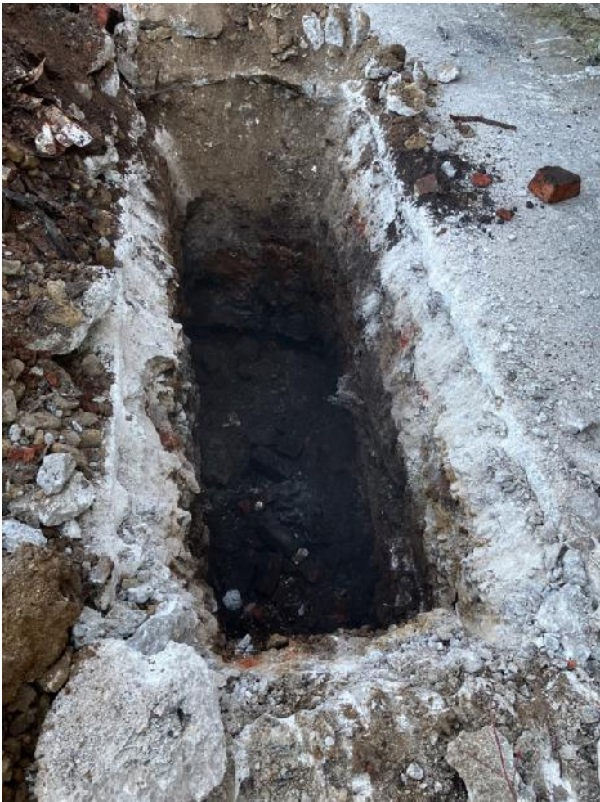
| <b>Description</b><br>TP308 | | | |

| Exploratory Hole | Depth (m bgl) | Type | Material | Quantification (%) |
|---|---|---|---|---|
| TP308 | 1.70 | Amosite | Loose Fibrous Debris | 0.003 |
| TP308 | 0.80 | Chrysotile | Loose Fibres | 0.003 |

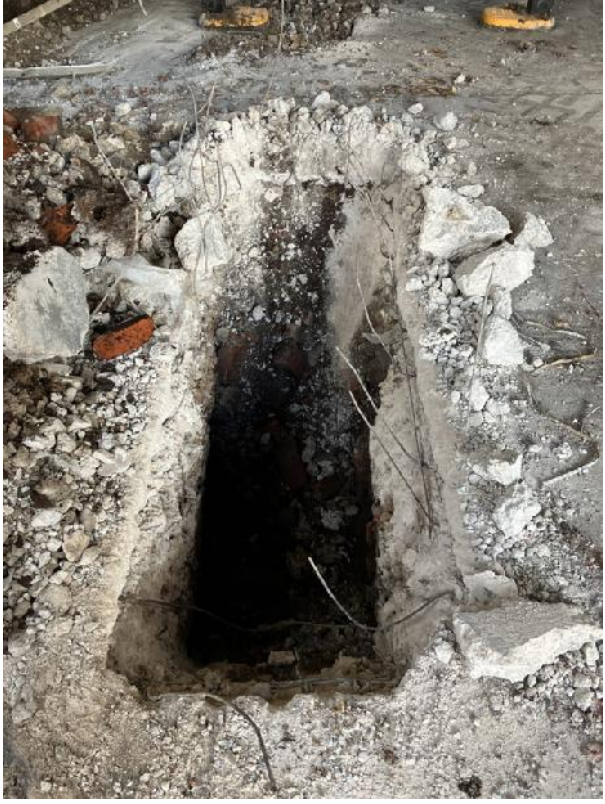
| Client: | | Site Location: | Project No.: |
|---|---|---|---|
| TP309 | | | |

| Exploratory Hole | Depth (m bgl) | Type | Material | Quantification (%) |
|---|---|---|---|---|
| TP309 | 1.0 | Chrysotile & Amosite | Loose Fibrous Debris | 0.002 |
| TP309 | 1.10 | Chrysotile & Amosite | Loose Fibres & Loose Fibrous Debris | 0.006 |

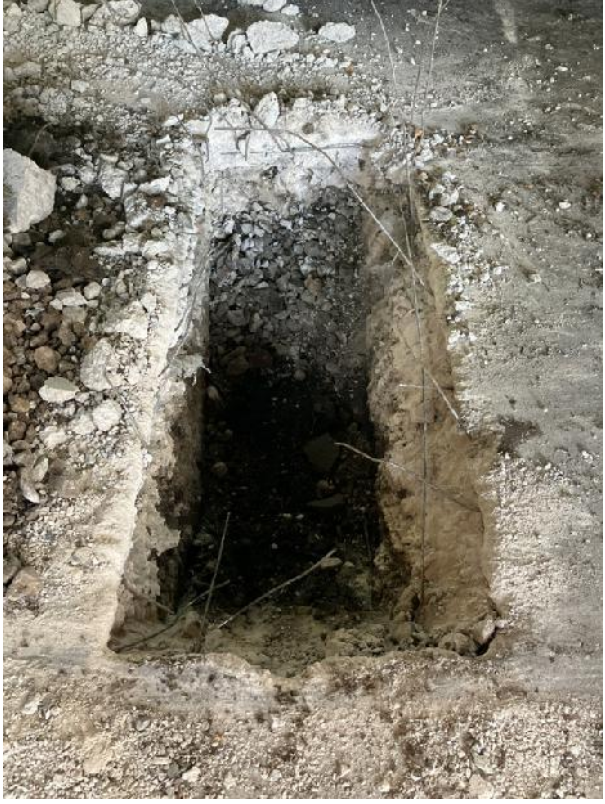
| Client: | | Site Location: | Project No.: |
|---|---|---|---|
| TP310 | | | |

| Exploratory Hole | Depth (m bgl) | Type | Material | Quantification (%) |
|---|---|---|---|---|
| TP310 | 0.80 | Chrysotile & Amosite | Loose Fibres & Loose Fibrous Debris | 0.07 |

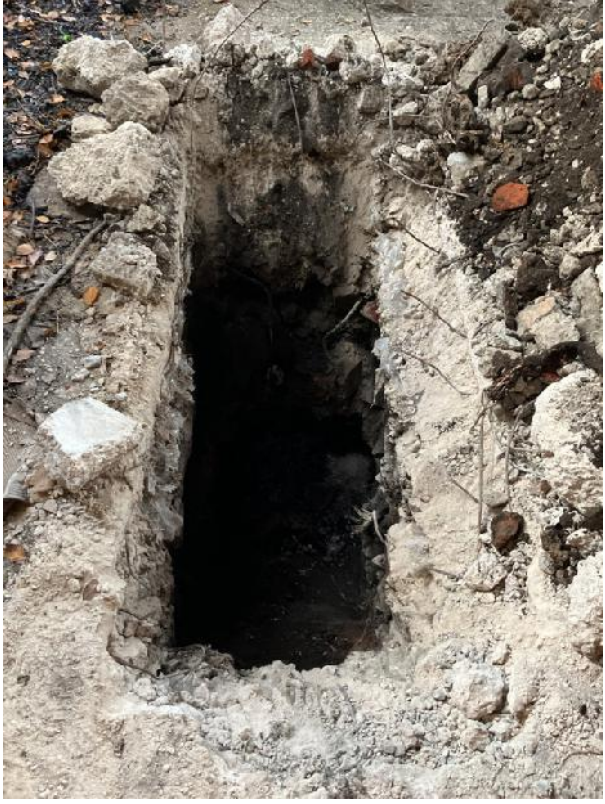
| Client: | | Site Location: | Project No.: |
|---|---|---|---|
| TP311 | | | |

| Exploratory Hole | Depth (m bgl) | Type | Material | Quantification (%) |
|---|---|---|---|---|
| TP311 | 1.60 | Chrysotile & Amosite | Loose Fibres | < 0.001 |

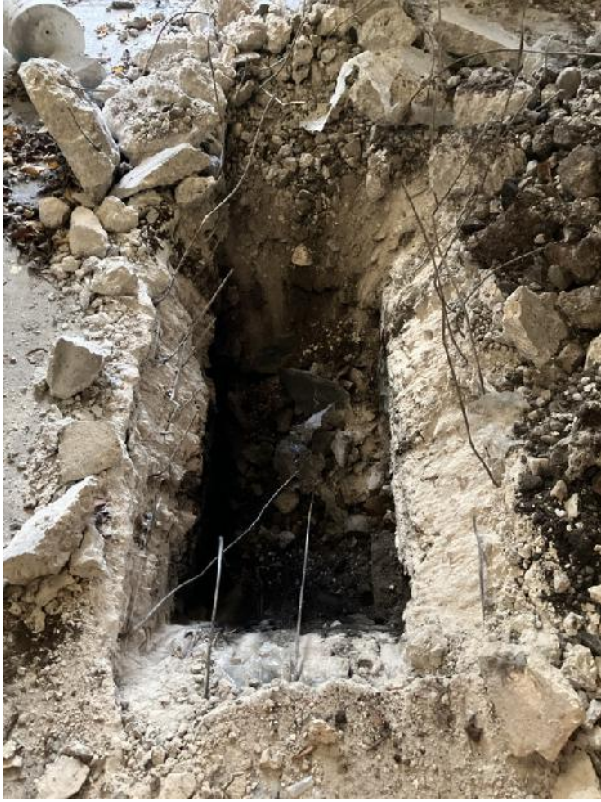
| Client: | | Site Location: | Project No.: |
|---|---|---|---|
| TP312 | | | |

| Exploratory Hole | Depth (m bgl) | Type | Material | Quantification (%) |
|---|---|---|---|---|
| TP312 | 1.20 | Amosite | Loose Fibres | < 0.001 |

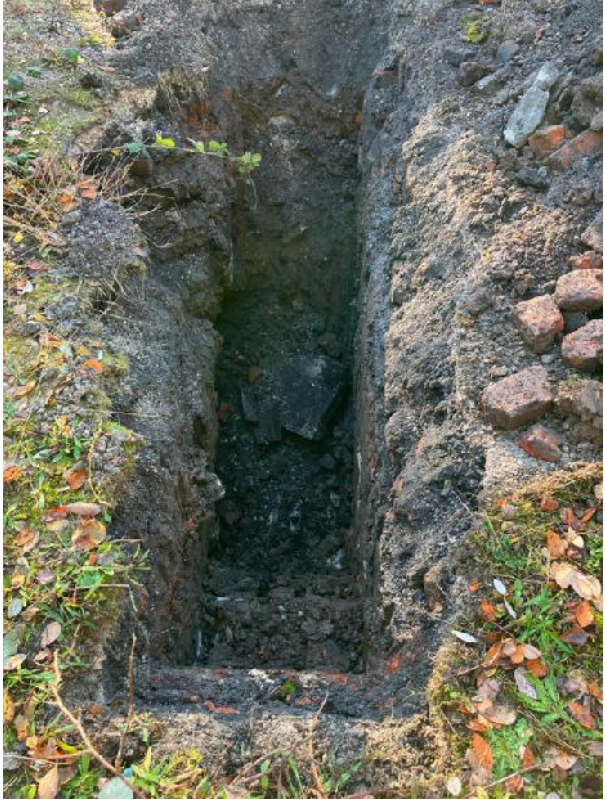
| Client: | | Site Location: | Project No.: |
|---|---|---|---|
| TP313 | | | |

The Made Ground was heterogeneous in nature but generally comprised of either dark brown clayey sandy gravel or clayey gravelly sand. TP313 and TP314 in the east of the Site encountered dark brown slightly sandy very gravelly clay. Sand was fine to coarse grained. Gravel was angular to rounded, fine to coarse grained and generally comprised of brick and concrete. There was a high cobble and boulder content of brick and concrete across the majority of trial pits. Pieces of metal, wood and glass were observed in multiple trial pits across the Site.
