**FOR THE APPLICATION OF A RENDER SYSTEM TO COVER THE  
EXTERNAL TILES**

**CHATSWORTH HOUSE APARTMENTS**

**PREPARED FOR AND ON BEHALF OF LIVING CITY**

**12/23 ARCHITECTURE DESIGN LTD**

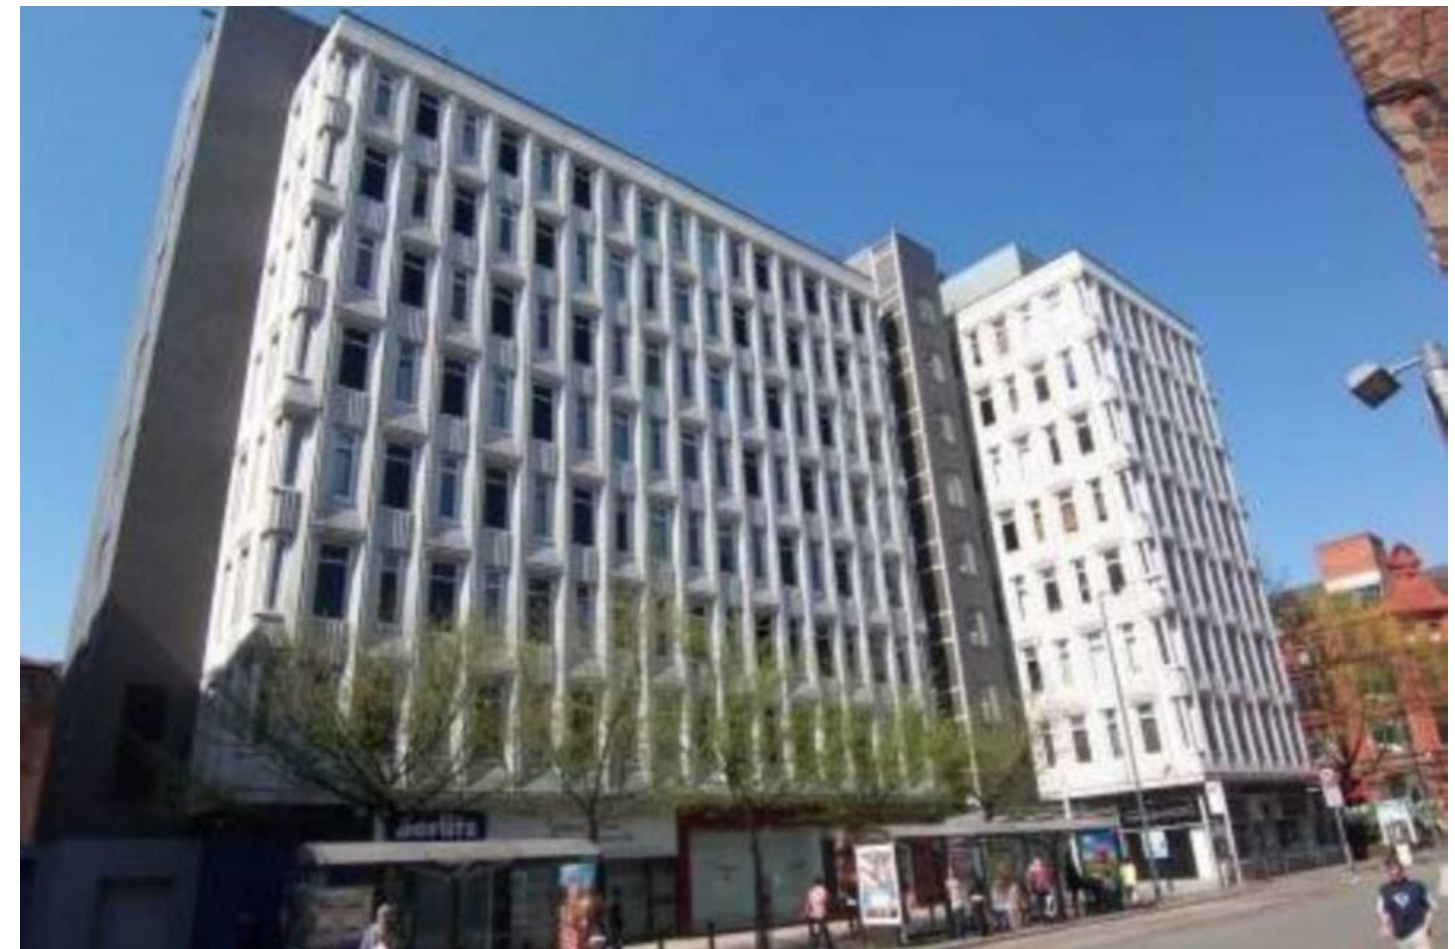
Over time the building has been exposed to some extreme weather conditions, particularly on the South West elevation on Back Piccadilly. Water egress has occurred which has caused the reinforcement bars within the in-site poured concrete to rust.

The effect of the rusted re-bar has caused visible spalling on the internal and external surfaces. Internally the concrete has spalled in large areas and has exosed the etremely corroded metals. The same affect has happened externally but instead of visible spalling on the concrete, the tiles are being pushed out and in many cases have losened and fallen to the external gorund level.

TOP RIGHT IMAGE: shows the South West staircore and the current damage circled in white

The treatment of the rusting re-bar will be done internally and externally where visible. A specialist has issued details and instrucion on how this should be carried out.

The propsoal is to apply a mechanically fixed layer of insulation against all tiled areas of the building, this will hold the tiles on to the building and prevent further failing tiles falling to the ground and causing harm/damage. A conversation between CityLiving and MCC planning department indicated that whichever solution was proven to be viable should be applied to all tiled areas to ensure the uniformity of materials that the builing currently benefitst from. The surfaces are those that cover the staircores and the penthouse apartment at roof level.

Over the insulation the new surface will be prepared to receive a coloured render finish with a fire spread rating of A1 as outlined by the Building Safety Regulator. The final colour will be similar in shade to the existing surface. The final colour will be Wetherby colour 6000N found at [Render Colours | Wide range of render colour options \(wbs-ltd.co.uk\)](#)
