# Room2 Homotel Piccadilly, Manchester

**PHASE I GEO-ENVIRONMENTAL SITE ASSESSMENT**  
**12 – 16 PICCADILLY, MANCHESTER**  
**M1 3AQ**

**REC REFERENCE: 101145P1R0**

**REC Report: 44934p2r0  
Issued: October 2013**

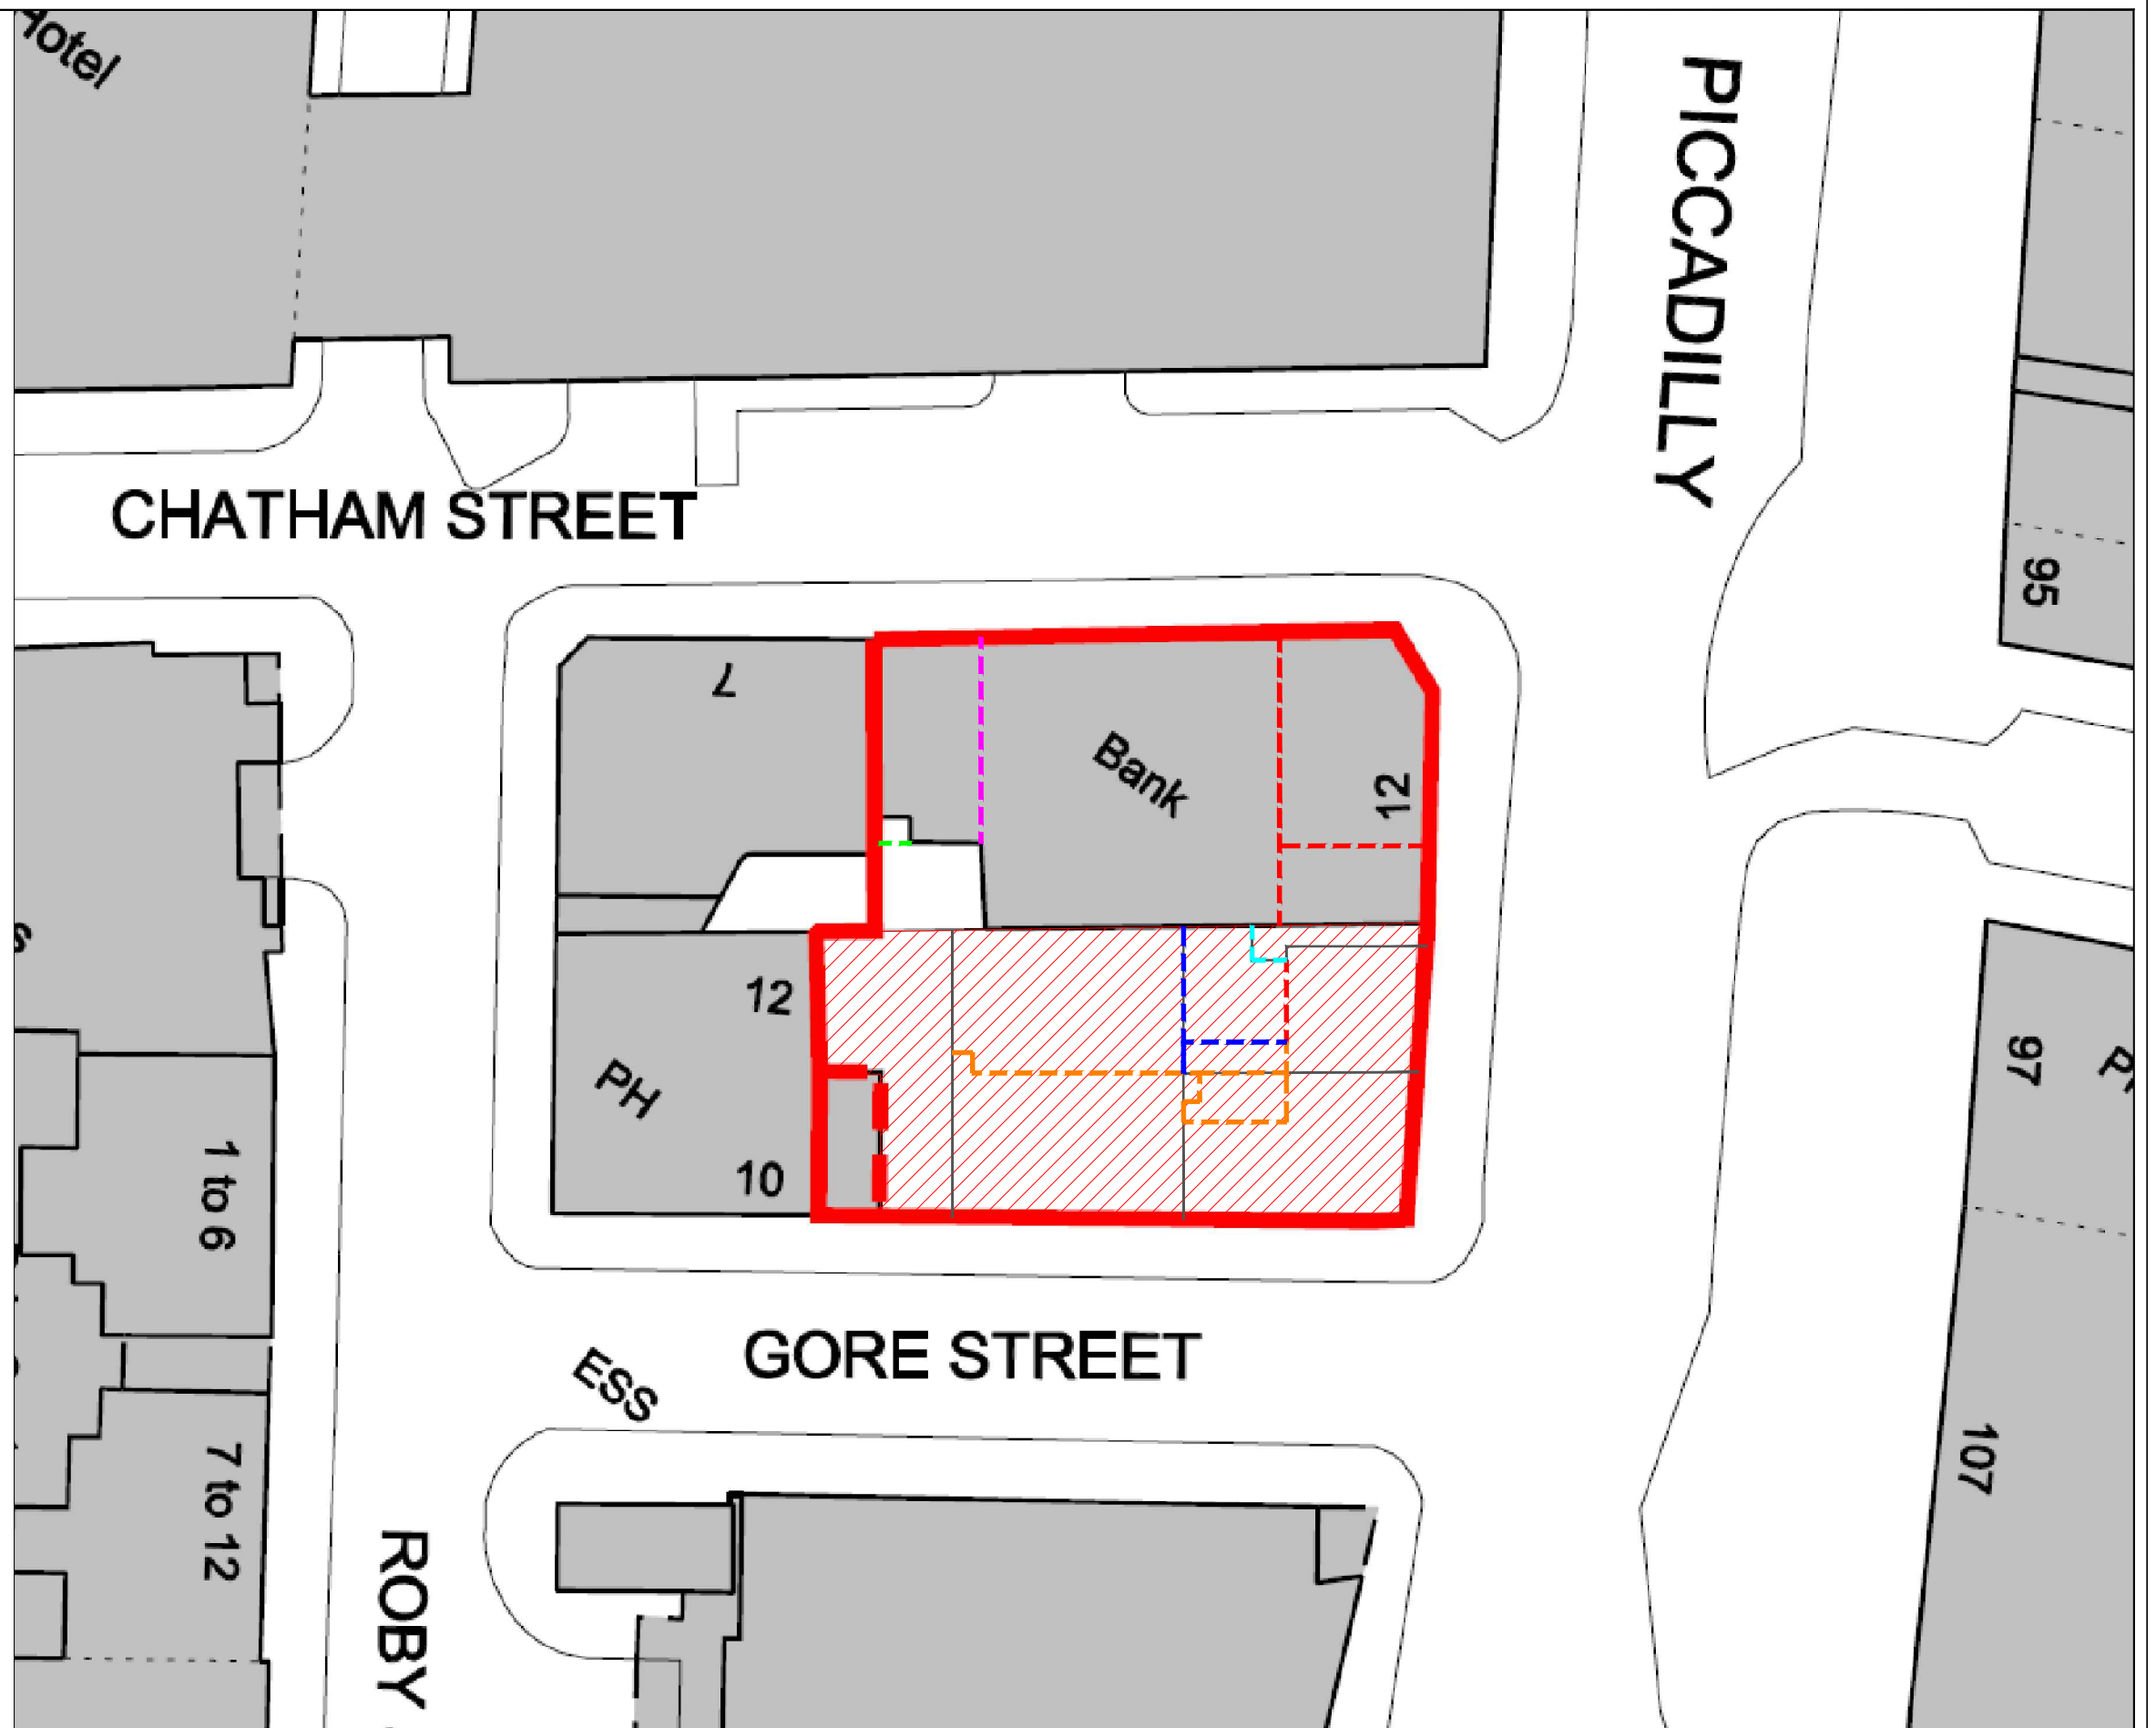
44934p1r0-005  
Exploratory Hole  
Location Plan

- WS101      Approximate Window Sample  
Probehole Location
- FP101      Approximate Foundation  
Pit Location
- FP101(ND)      Approximate Foundation  
Pit Location (Not Done)
- RB101      Approximate Rotary Borehole  
Location

The window sample probeholes were designed to provide geotechnical information and confirm the findings of the Initial Conceptual Site Model (ICSM). Dual purpose monitoring wells were installed in five no window sample holes. The ground conditions encountered and details of monitoring well response zones are indicated on the logs which are provided in Appendix V.

Three rotary open hole boreholes were advanced to depths ranging from 18.00 to 31.50m bgl, to investigate the geotechnical properties of the ground conditions and identify competent sandstone bedrock to facilitate a safe and cost effective piling design.

Foundation pits were excavated to inspect the existing building's foundations. The ground conditions encountered and foundations are indicated on the logs which are provided in Appendix V. The existing foundation constructions are presented within Appendix III.

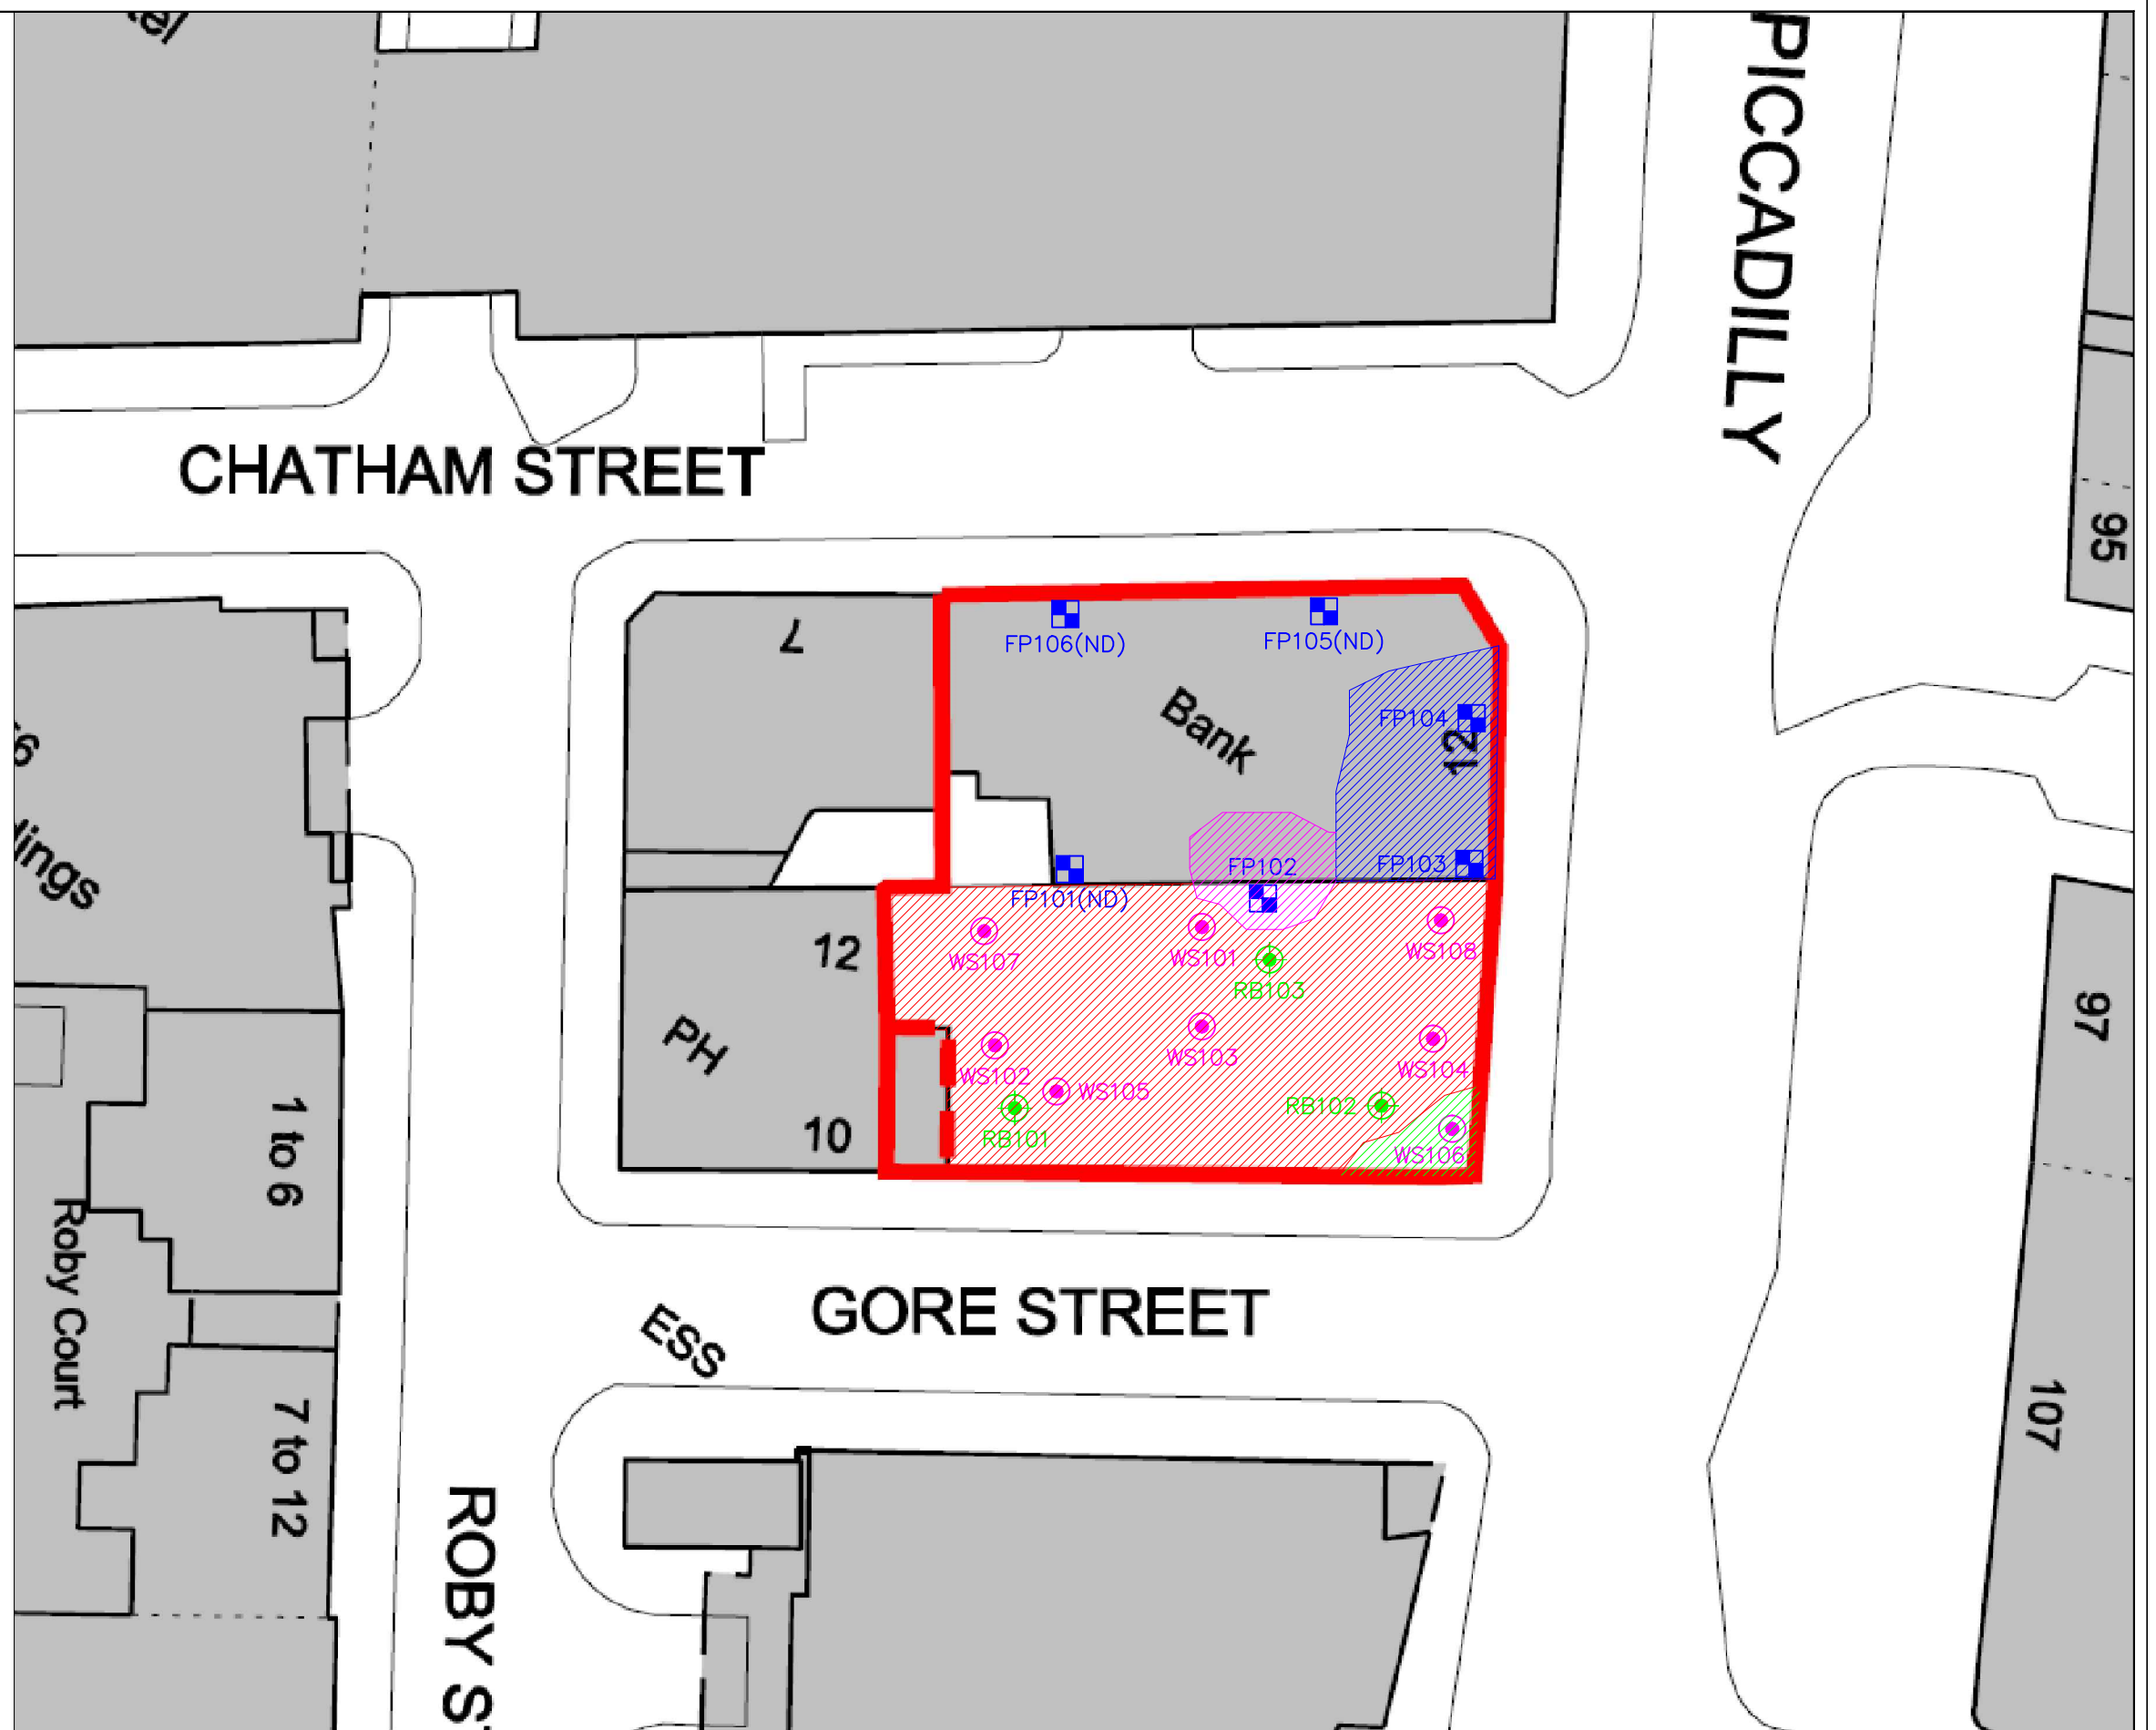
- Unable to penetrate concrete slab due to thickness & Strength
- Concrete Slab, Possible basement floor identified
- Elevated Lead Concentrations Identified

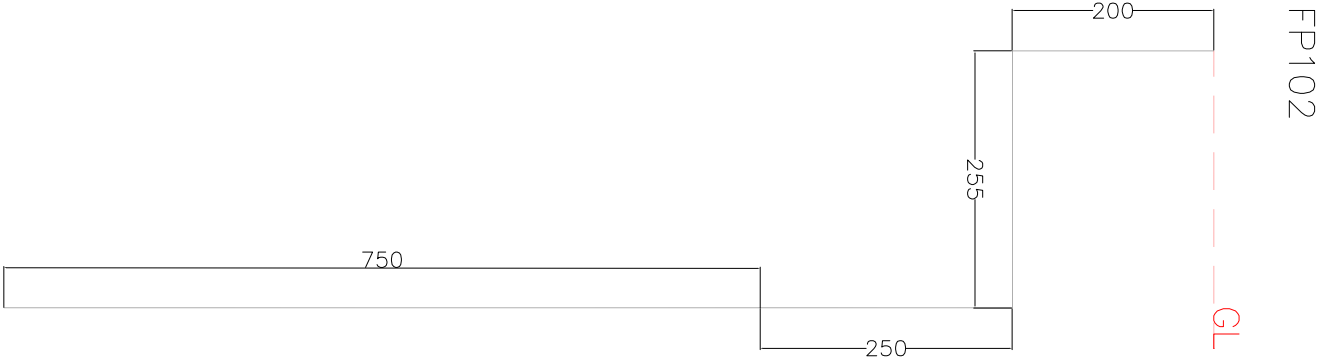
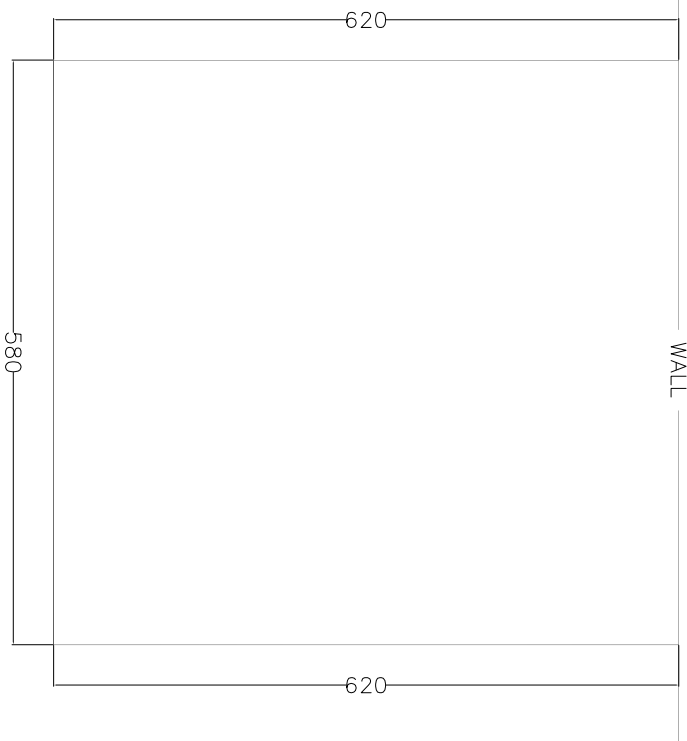
44934p1r0-008  
Foundation Pit Detail  
(FP102)

FP102

0.00 – 0.20m: Tarmac (MADE GROUND)  
0.20 – 1.20m: Fine to medium black, gravelly sand with cobbles. Gravel is fine to coarse, angular to sub-angular of brick, concrete, ash, clinker, metal, glass & plastic. Cobbles are angular to sub-angular of brick.

Only one hand excavated foundation inspection pit was able to be advanced to depth which was located outside on the southern facing wall of the existing building. The remaining
