Ref: 21-1146-RS  
Date: 27<sup>th</sup> February 2023

## **Remediation Statement Land at Ashton Old Road, Manchester**

ERGO has been commissioned by MADP on behalf of Mr F Mahmood to produce a Remediation Statement to detail the works required to remediate identified contamination and subsequently validate the required mitigation measures.

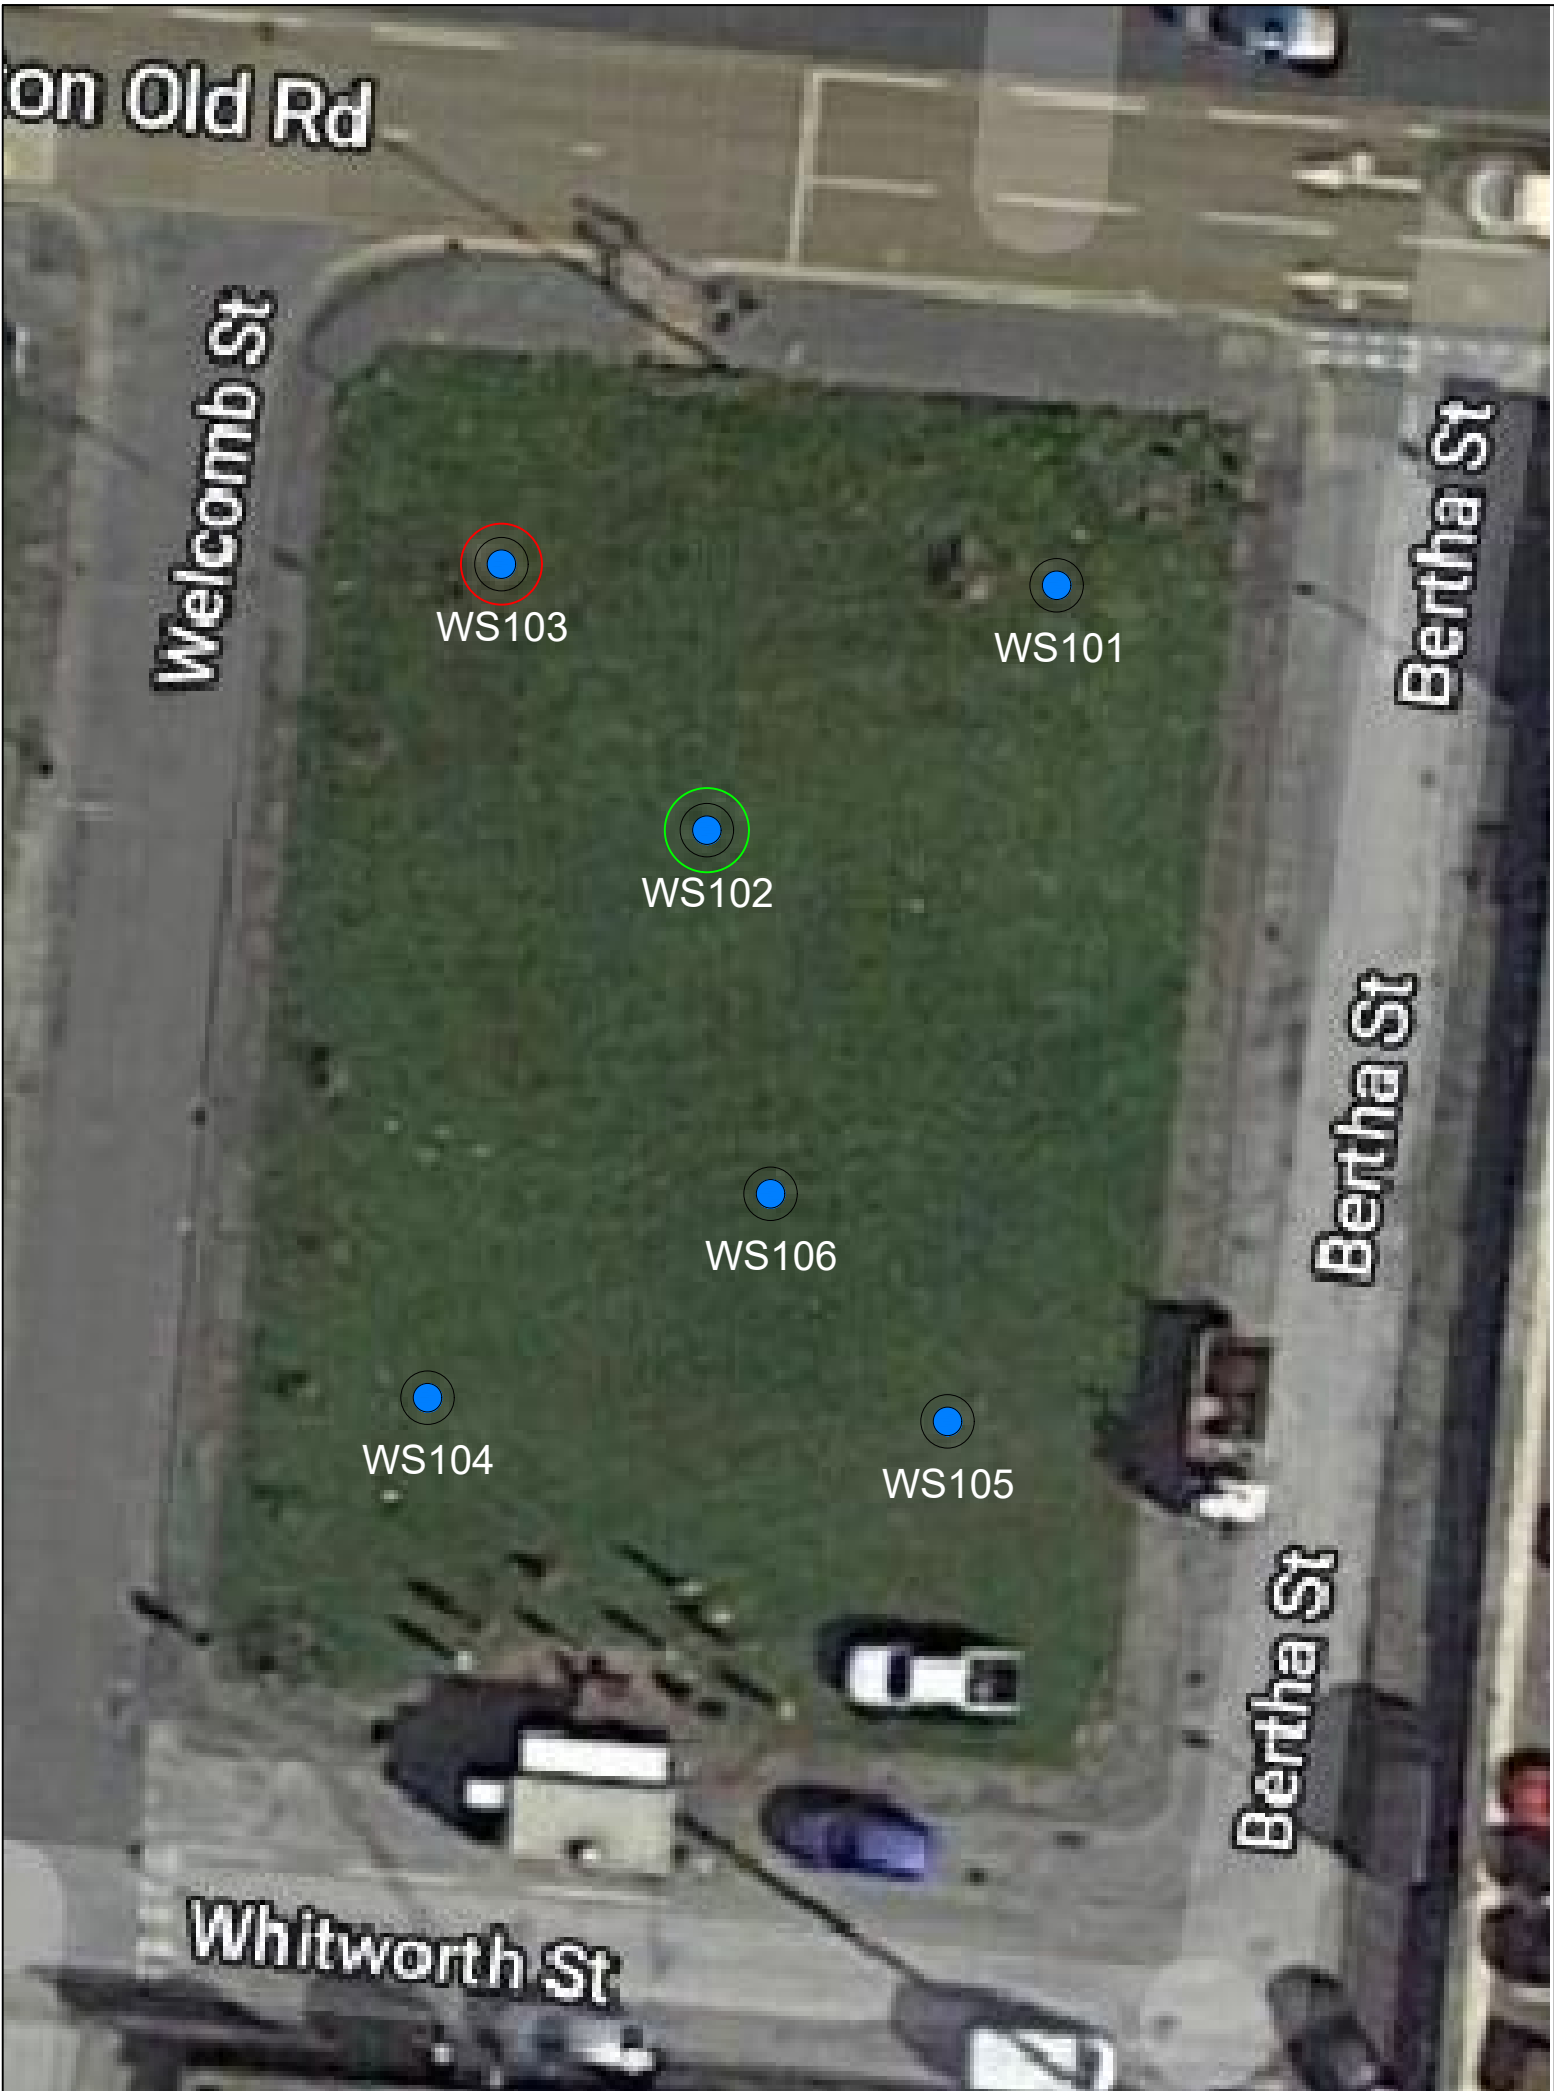
| | | | 004 | NTS | |

- Approximate Window Sample Probehole Location
- Identified Elevated PAH
- Identified Asbestos

| Ashton Old Road, Manchester | | | Contamination Location Plan | | |

A Tier I Human Health Risk Assessment identified the presence of elevated Benzo(a)Pyrene, Benzo(b)Fluoranthene, Dibenzo(a,h)Anthracene within WS102 at 0.50mbgl and asbestos in the form of chrysotile asbestos cement within WS103 at 0.50mbgl.

ERGO Drawing 21-1146-004 Contamination Location Plan
