262 Ryebank Road,  
Chorlton, Manchester

Ecology and Biodiversity Net Gain Assessment

1<sup>st</sup> August 2024

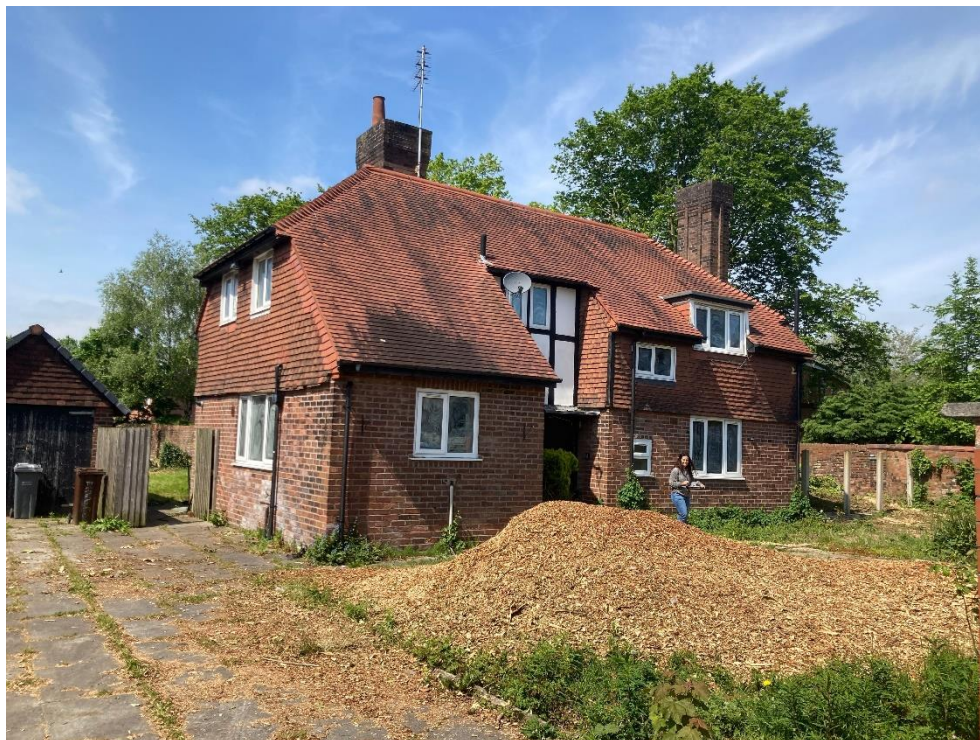
*Photograph 1- East Face of the Building*

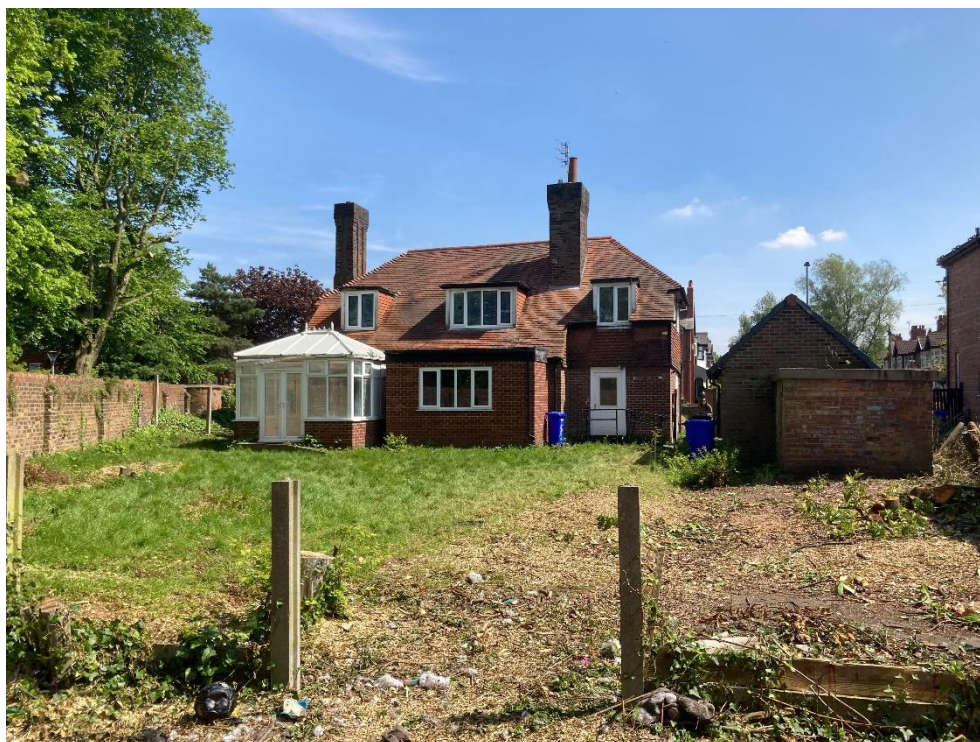
*Photograph 2- West face of the Building*

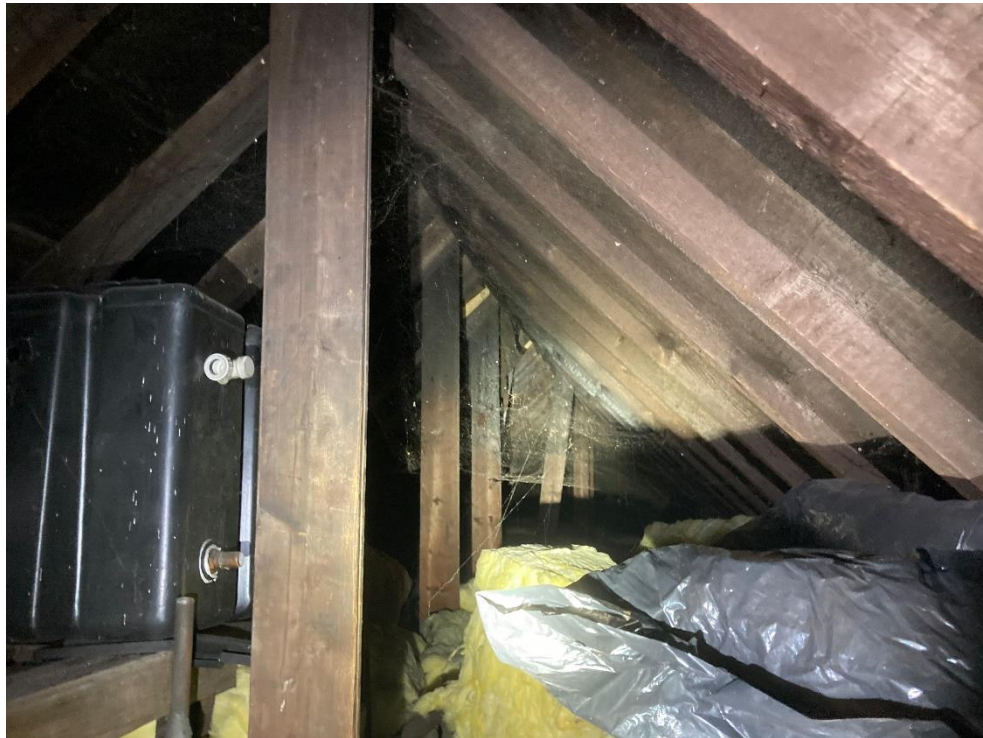
Internally, the upper floor rooms extend partially into the roof void space, therefore there is a narrow loft space running above the upper floor rooms. The ground and first floor rooms are considered to be unsuitable for roosting bats. The loft space is approximately 1.5 m in height and is approximately 10 m long x 1.5 m in width. The internal face of the roof is lined with bitumen hessian felt and the loft space is lined with rockwool insulation. There is a water tank within the loft space and so the void is relatively cluttered. The loft space is heavily cobwebbed including cobwebbing spanning the internal void space.

No obvious potential bat access points or bat droppings were found within loft space. Mouse droppings are present.

*Photograph 3- Loft space interior*

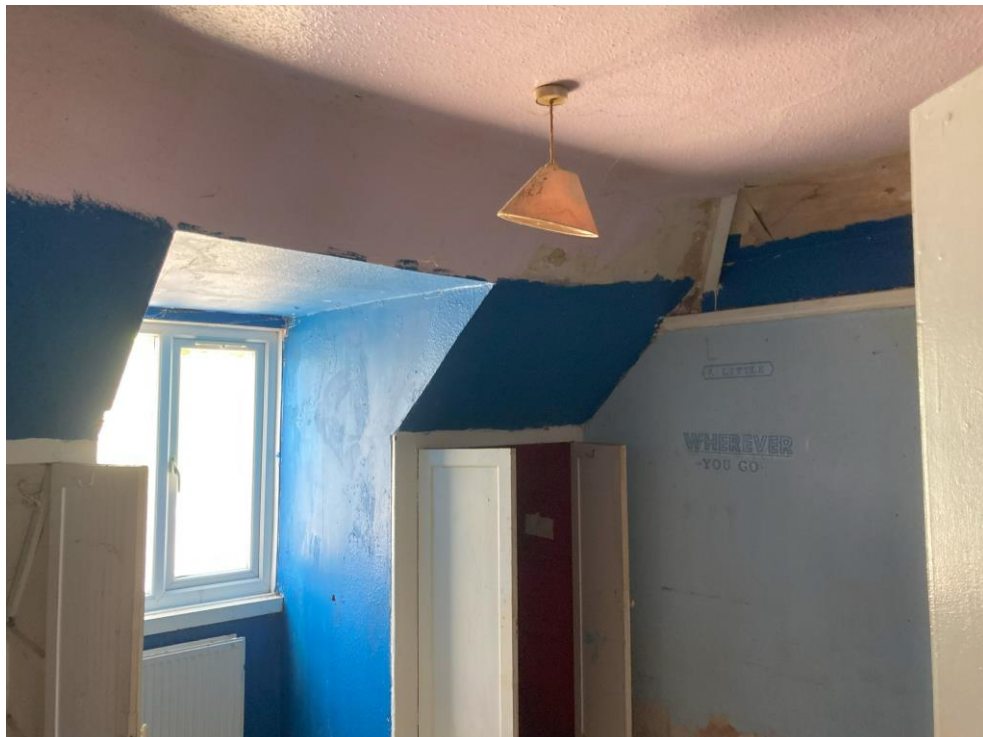
*Photograph 4- Interior of the Building.*

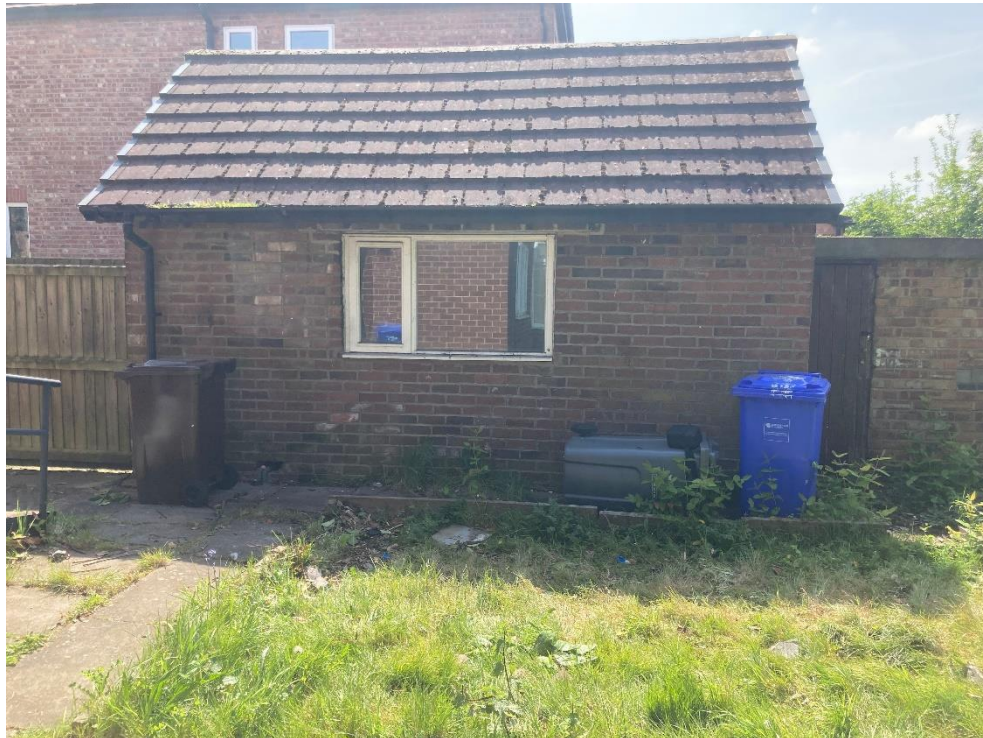
Adjacent to the house there is a small, detached garage with a pitched, gable ended roof clad in interlocking concrete tiles. The verges of the garage are sealed in plastic verge capping. The South face of the garage is clad in hanging tiles. These appear to be mostly intact with some minor crevices. The garage has a glazed window and has a small loft space which is approximately 50 cm in height. The loft space is heavily cobwebbed and the internal face of the roof is lined with bitumen hessian felt.

The garage building was assessed as offering a '**negligible**' bat roosting potential.

*Photograph 5- Small garage at Target Note 4*

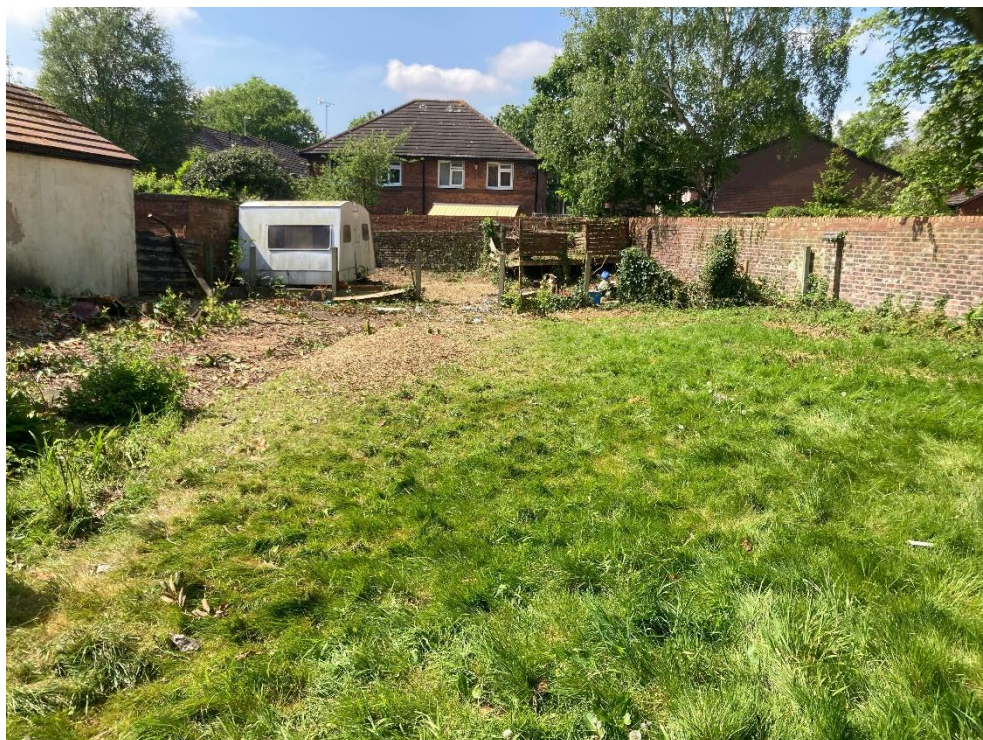
In summary, the building is set within a vegetated garden which appears to have gone largely unmanaged in the recent past. There are areas of lawn to the front and rear of the house with fringes of ruderal vegetation around the edges of the site. This ruderal vegetation includes patches of bramble, hedge bindweed, wood avens and ivy.

*Photograph 6- Rear garden*

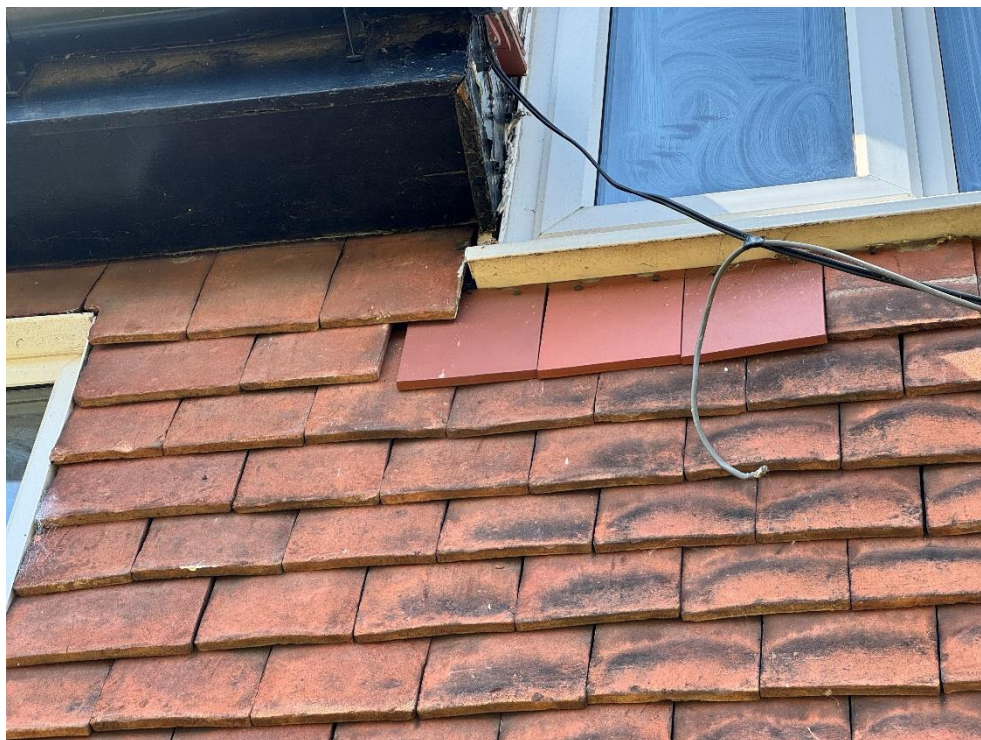
The main house is largely in good condition. The brickwork is well pointed; the roof tiles are largely intact; and the hip and ridge tiles appear to be mostly well mortared. However, there are several potential features offering suitable bat roosting habitat. These include areas of missing and raised hanging tile (Target Note 1, 4, 5 & 8 on Figure 3 in the Appendix), gaps between overlapping tiles at the half gables located at the front face of the building (Target Note 3), gaps between the hanging tiles and the roof structure (Target Note 2), missing roof rosemary tiles (Target Note 6), and raised ridge tiles (Target Note 7).

*Photograph 7 - Potential feature (Target Note 1)*

In order to further assess the identified potential bat roosting features, it is recommended that at a further two dusk/dawn bat activity surveys are carried out during the peak active bat survey season (between May and September with at least one survey completed between late May and the end of August).

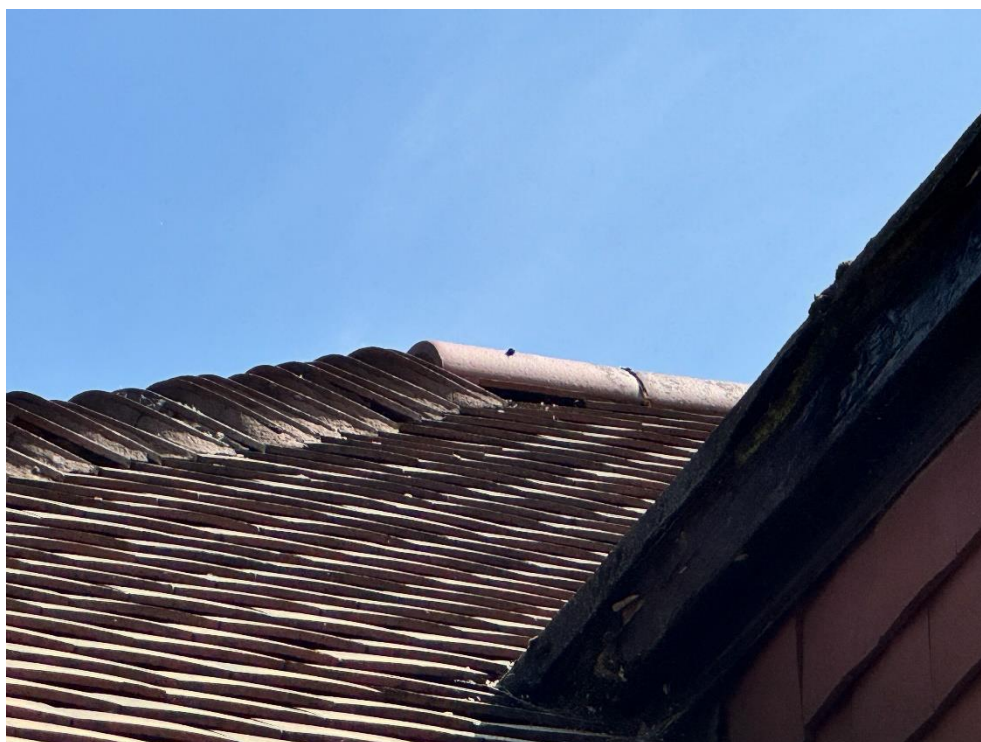
*Photograph 8 - Raised ridge tile (Target Note 7)*

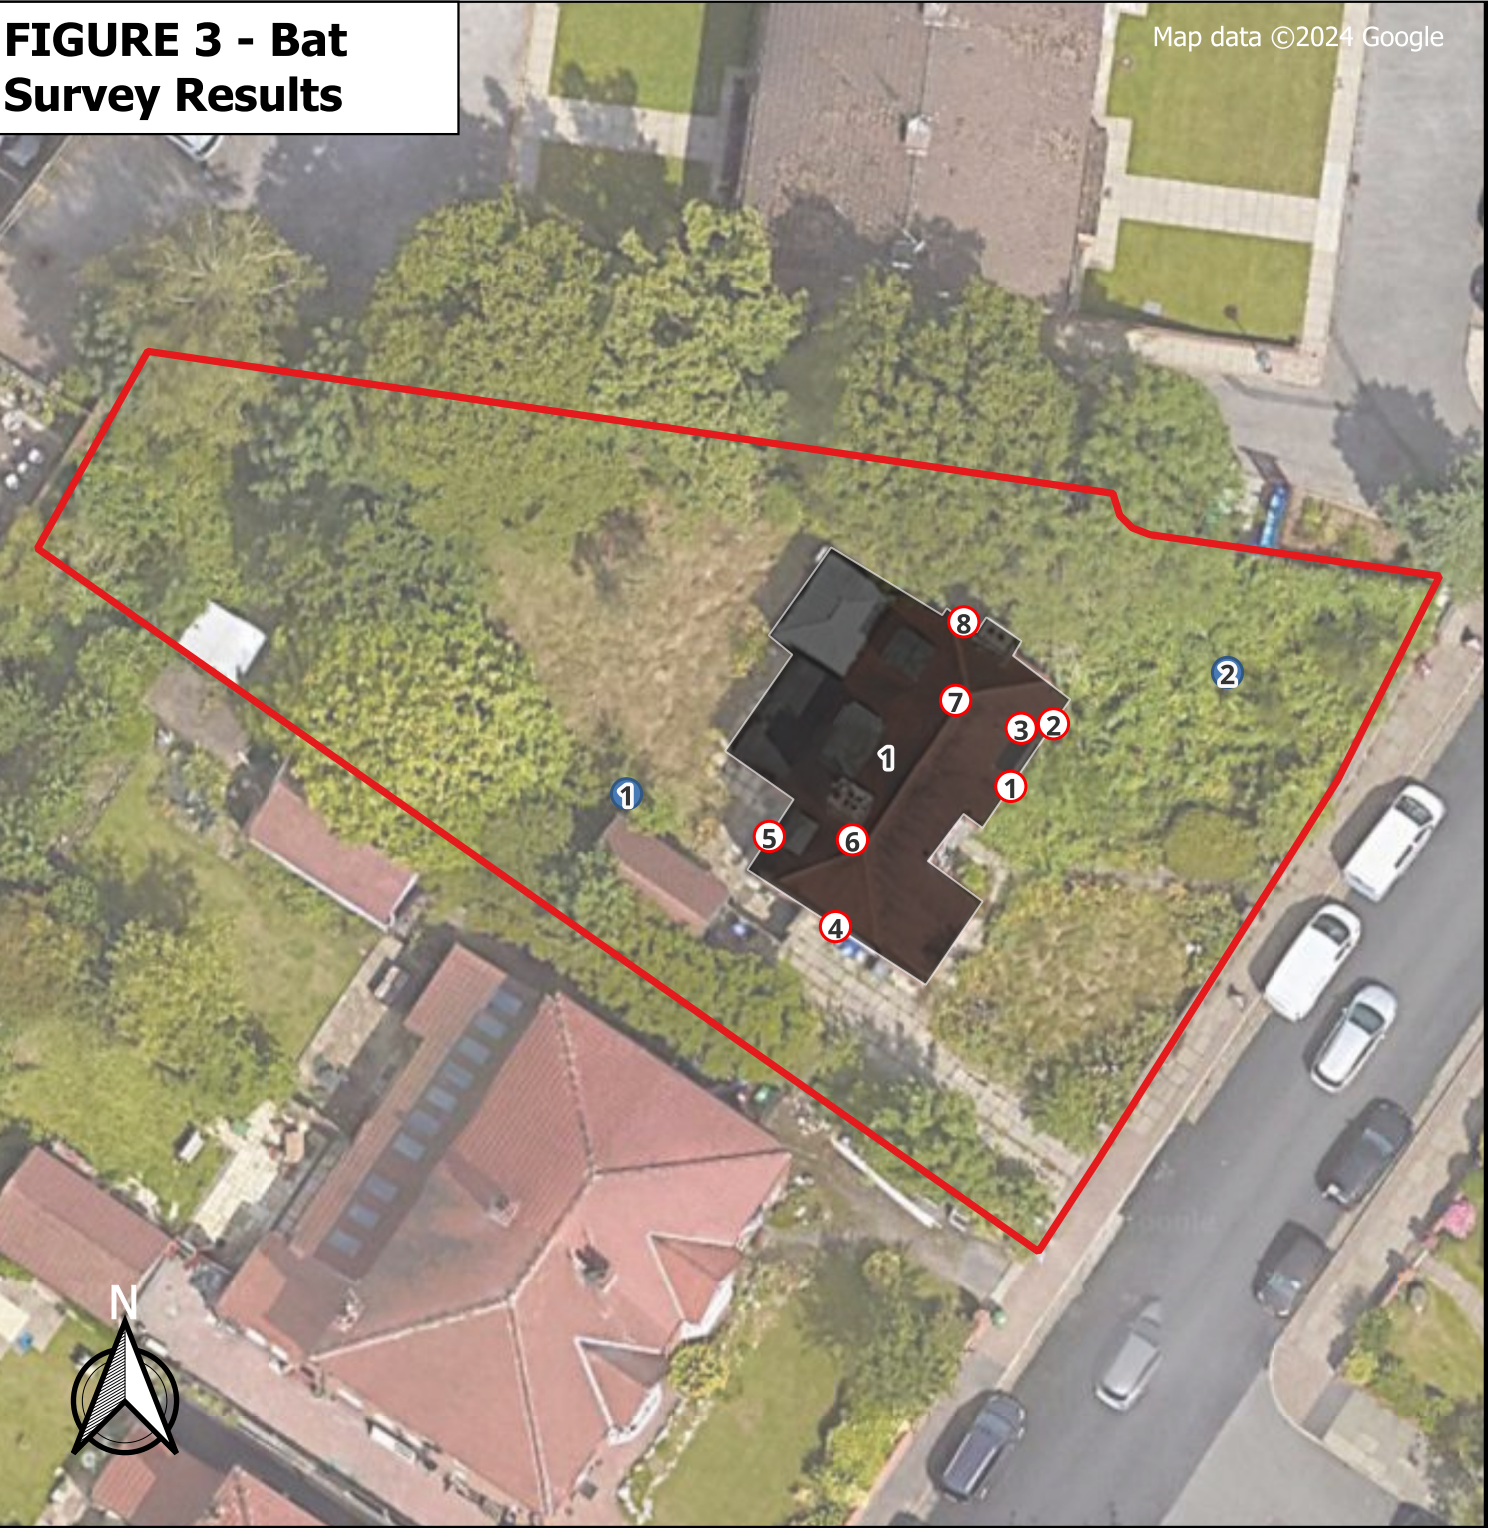
**FIGURE 3 - Bat  
Survey Results**

Taking account of the location of the building and the potential bat roosting features identified, the building was assessed as offering a **'moderate'** bat roosting potential.

The surveys would aim to confirm the presence or otherwise of any bat roosts associated with the building. Recommended surveyor locations are shown on Figure 1.
