**QUEEN'S PARK CONSERVATION  
STUDIOS, HARPURHEY, MANCHESTER**

**BAT DAYTIME SURVEY**

**MARCH 2022**

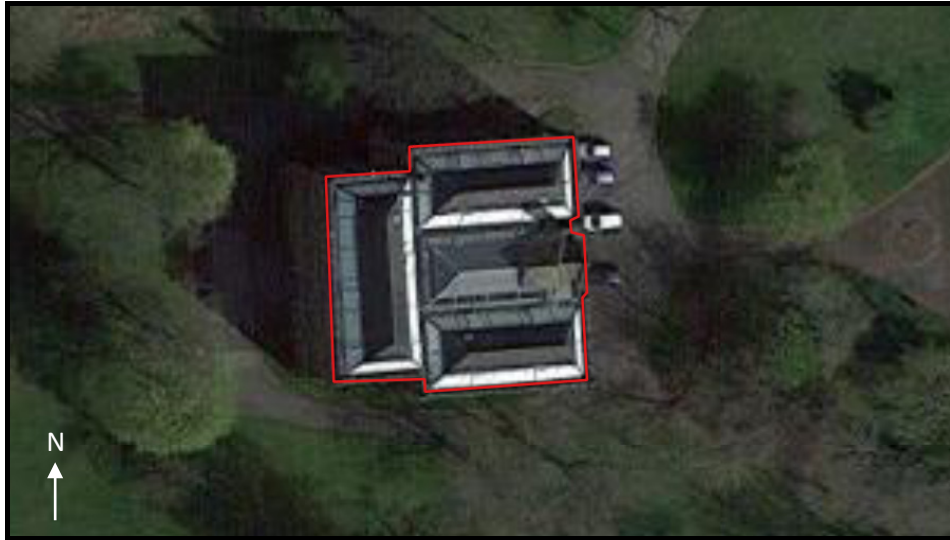
*Figure 1. Aerial Building Plan*

- 1.4 The ordnance survey grid reference for the site is SD 85433 00897.
- 1.5 The survey area comprised the Queens Park Conservation Studios building only, the footprint of which totals approximately 200 square meters, and is hereafter referred to as the 'site' (refer to Figure 1). The building was formerly used as an art gallery and museum, but is currently used as a storage repository.

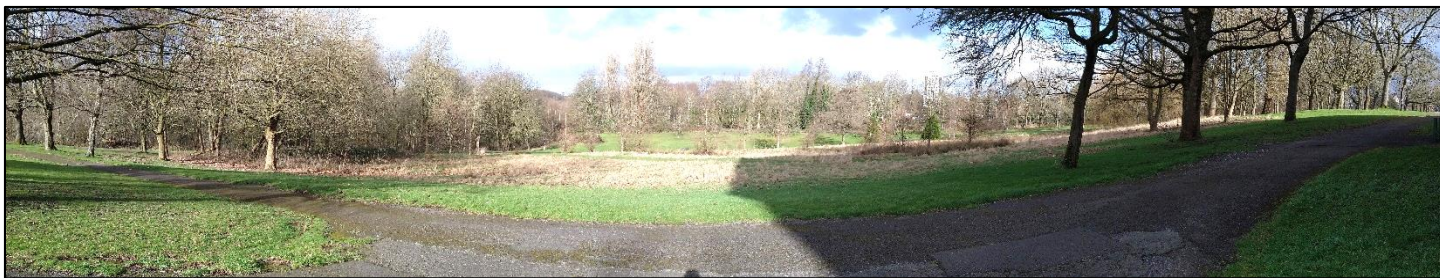
**Plate 1: Panoramic view to the north of the building, showing parkland setting with woodland and areas of rough grassland.**

- 5.2 The immediate surrounding area comprised Queen's Park, with a variety of associated parkland habitats including areas of woodland, mature trees, rough grassland, amenity grassland and scrub (Refer to Plates 1 and 2).

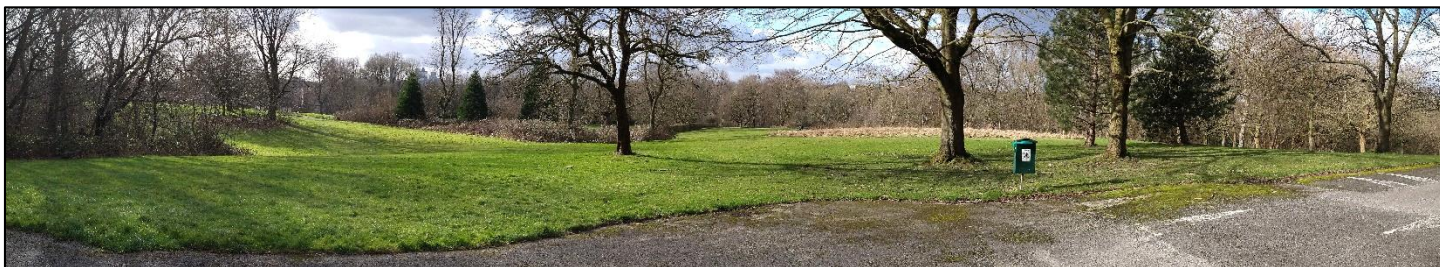
**Plate 2: Panoramic view to the south of the building, with areas of woodland and scrub visible.**

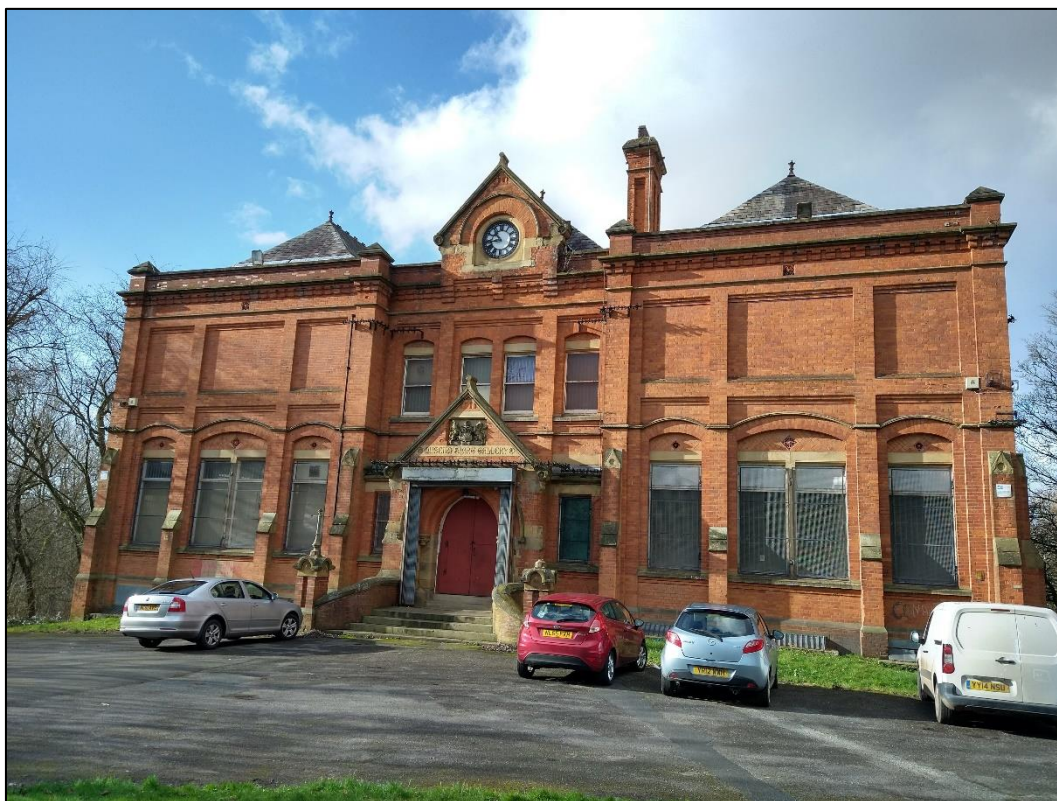
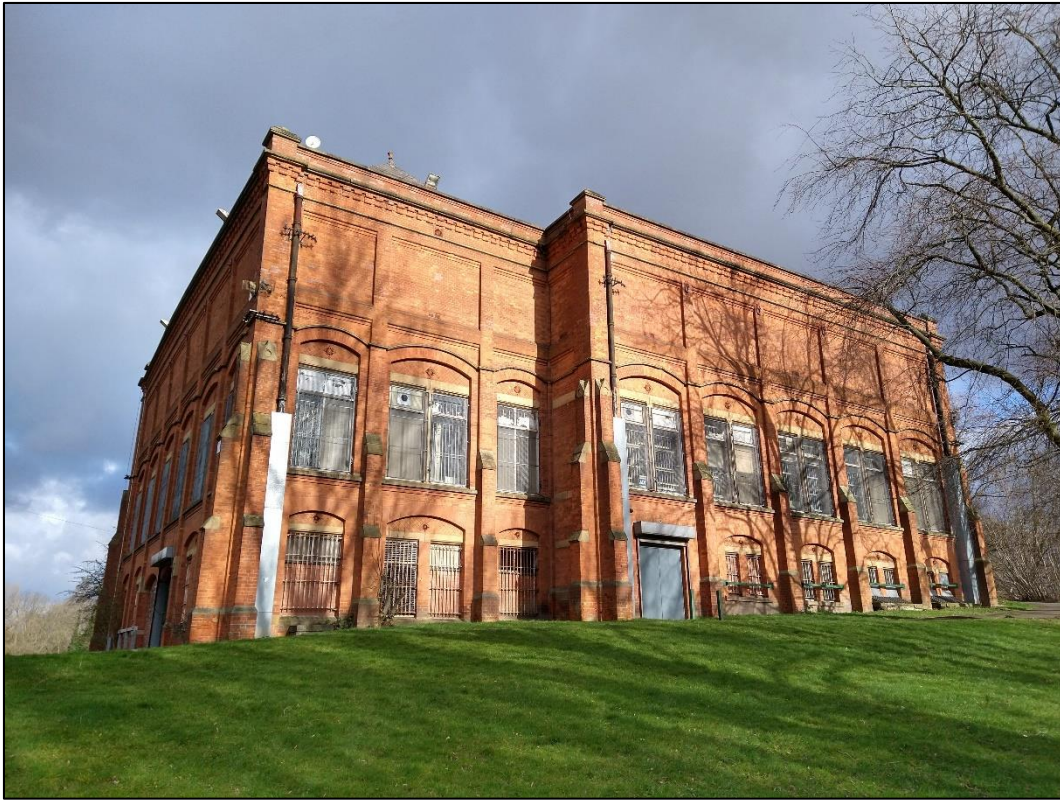
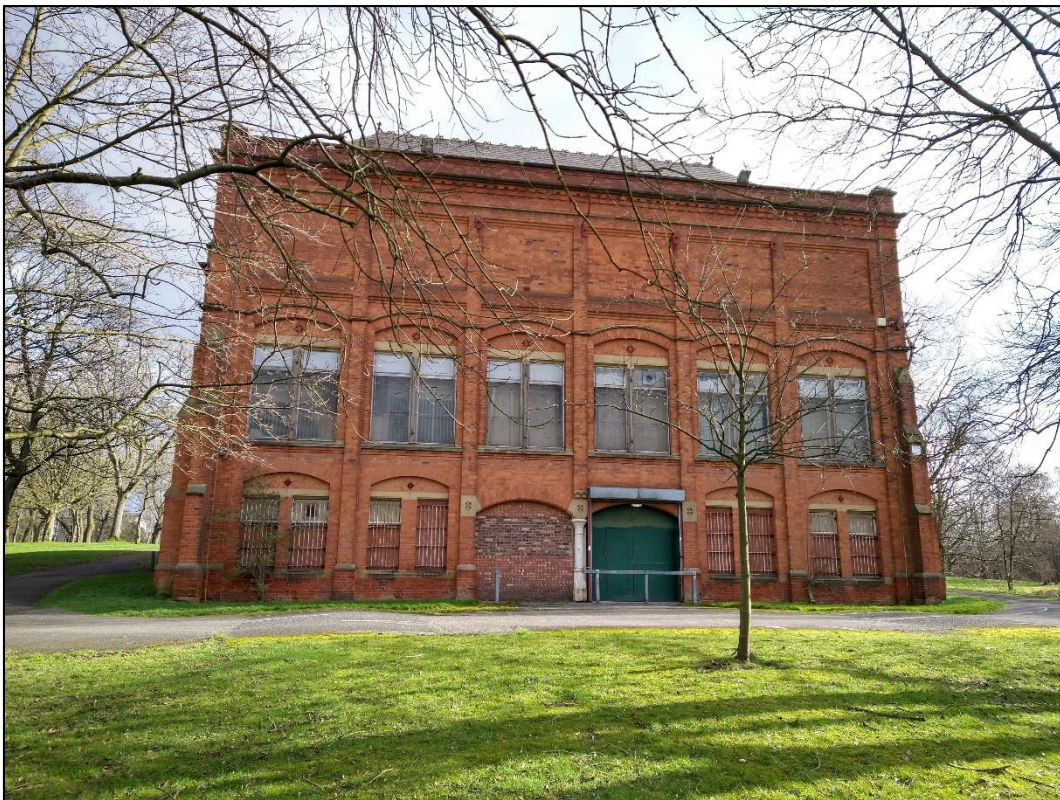
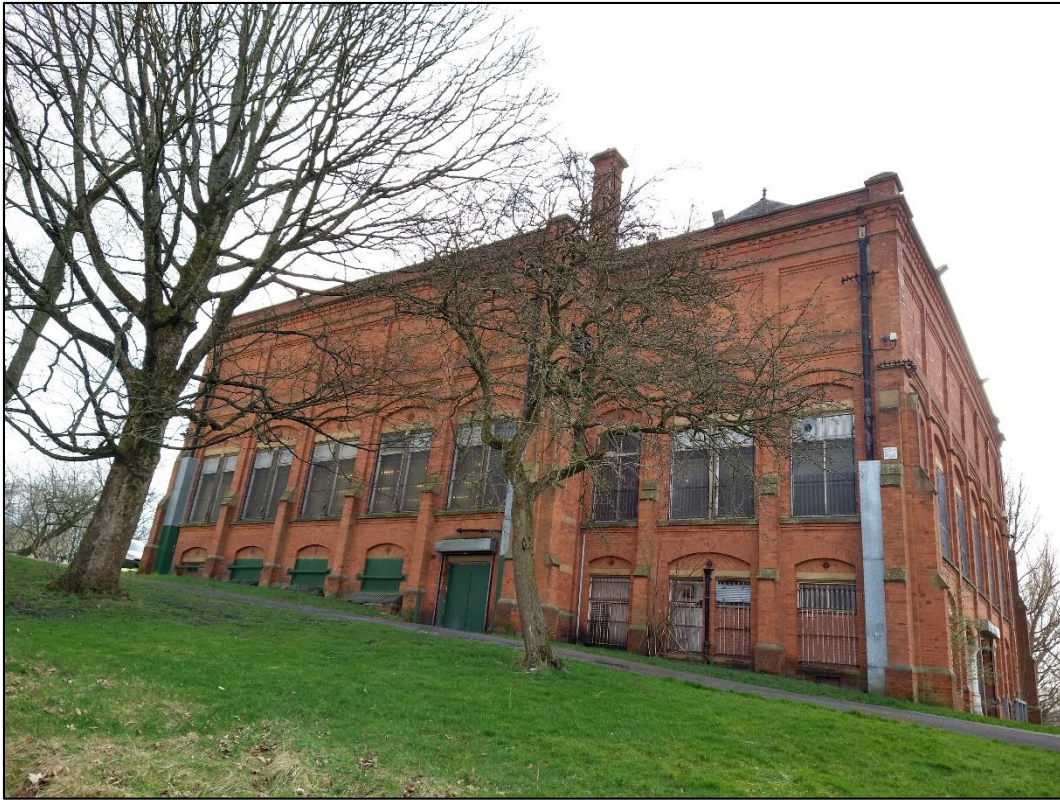
**Plate 3: East façade of building.**

**Plate 4: South façade of building.**

**Plate 5: West façade of building, showing loading entrance into the cellar.**

**Plate 6: Northern façade of building, showing semi-sunken basement level and sloping footprint.**

- 5.5 The single building on site comprised a large three-storey brick structure (including a basement), built in 1884 as a museum and art gallery (Plates 3-6). The walls were considered likely to be solid brick given the period of construction, with decorative arches and decorative rectangular brick framing throughout all building façades. The brickwork was in good condition throughout the building.

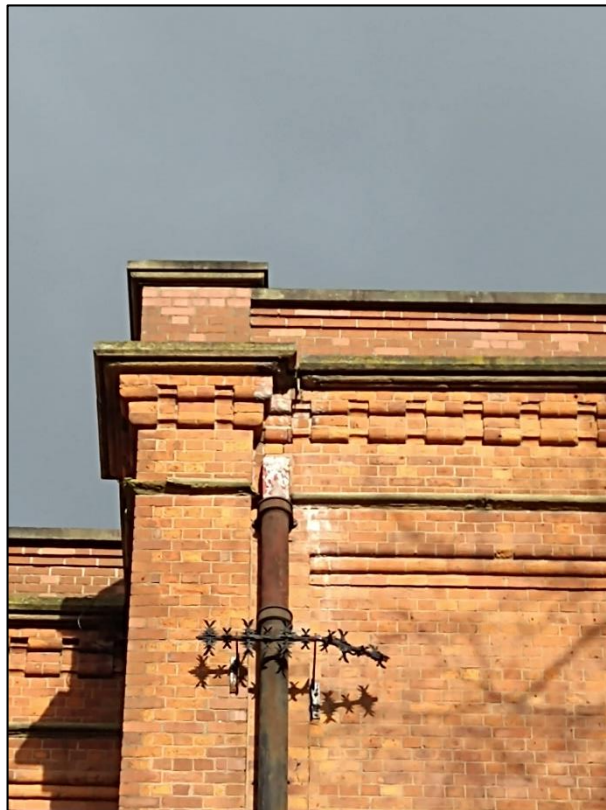
**Plate 7: Example of gap in stonework above drainpipe, located on the southern façade.**

- 5.6 Stonework lintels were present above the timber-framed windows, decorative stonework corning was present in a line below the roofline and stonework corning was present on the top of the roof parapet. Small gaps were observed between the stonework below the parapet on several areas of the building (Plate 7). Coping stones were also present on the corners of the parapet and further decorative stonework was present atop buttressing at ground floor level.

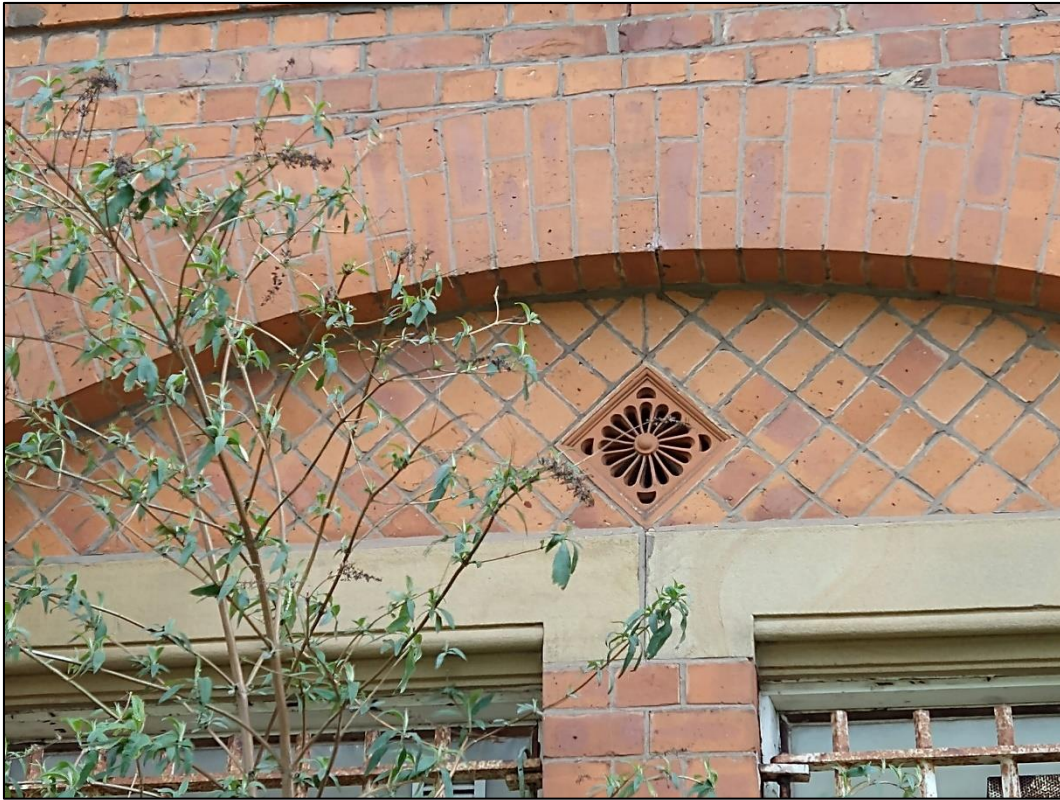
**Plate 8: Example of decorative air vent, which were located throughout the building on multiple levels. Gaps in the vent cover were large enough for entry by bats, and a sizeable cavity was present behind each vent.**

- 5.7 Decorative terracotta vent covers were present throughout the building exterior on all levels, though the majority were present on the basement and ground floor exteriors (Plate 8). Gaps in the vent covers were reasonably large as to allow bats access to the cavity behind the vent cover. A broken vent cover on the western façade was noted to contain an old bird nest (Plate 9), and the absence of the cover revealed a large cavity, which is assumed to be present behind all vent covers.

- 6.2 The building was found to contain multiple suitable features for roosting bats within the exterior of the building including within external decorative vents on all façades, beneath roof and ridge tiles and in gaps between stonework coping, cornicing and decorations. Additionally, gaps under roof and ridge tiles may provide access to internal roof voids, several of which could not be inspected due to lack of access during the survey.

- 7.1 The building was found to have **Moderate** suitability for roosting bats during the summer months, and the majority of features identified are to either be disturbed, blocked or destroyed during the proposed renovation works, which would have the potential to impact on bats, if present.

- 7.2 Therefore, in accordance with The Bat Conservation Trust Good Practice Guidelines (2016) for buildings with Moderate bat roost potential; at least one dusk emergence and one dawn re-entry survey are recommended, in order to confirm presence or likely absence of roosting bats.

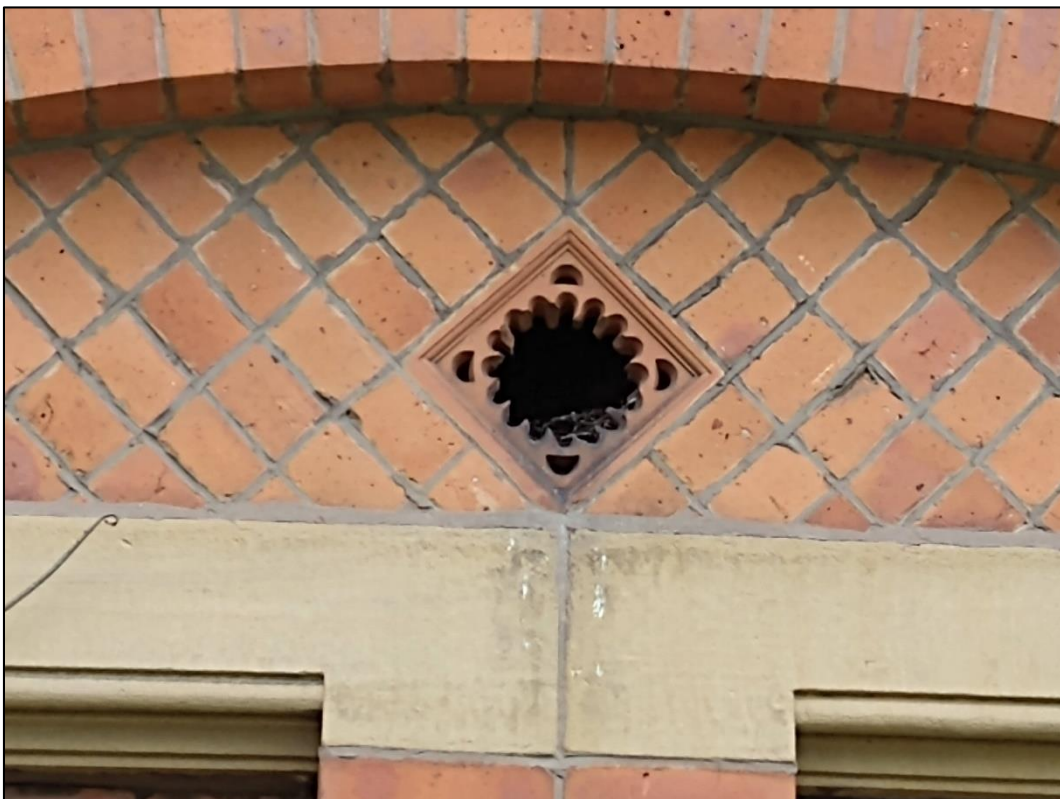
**Plate 9: Decorative air vent with broken spokes. An old birds nest is observable within the hole.**

- 6.5 Evidence of historical bird nesting was found with a broken decorative vent cover on the western building façade, and another broken vent on the same façade may present a suitable nesting location for birds. Additionally, a blue tit was observed to be frequenting an area at the top of a drainpipe on the south-east corner of the building, indicating possible scouting of a suitable nesting location. The broken vent cover and drainpipe tops are therefore likely to present suitable opportunities for nesting birds, along with the roof which may present nesting opportunities for bird species such as feral pigeon.

- 7.7 The building also has the potential to be used by nesting birds, particularly within broken decorative vents, at the top of drainpipes and on the roof.

- 7.8 It is therefore recommended that the renovation works to the roof and exterior of the building be conducted between September and February (i.e. outside of the 'core' nesting bird season, which generally encompasses March to August inclusive). If this is not possible and works are required to be conducted during the 'core' bird nesting season, CES should be contacted and a nesting bird survey be conducted prior to any potentially disturbing works taking place. In the event that nesting birds are found to be present, an appropriate mitigation strategy should be formulated and implemented.

- 7.10 In order to compensate for the loss of nesting features within the building, it is recommended that four house sparrow nest boxes be incorporated into the scheme; house sparrow being a Red list species of Conservation Concern (Stanbury et al, 2021), that tolerate nesting within close proximity to humans. Given that the building

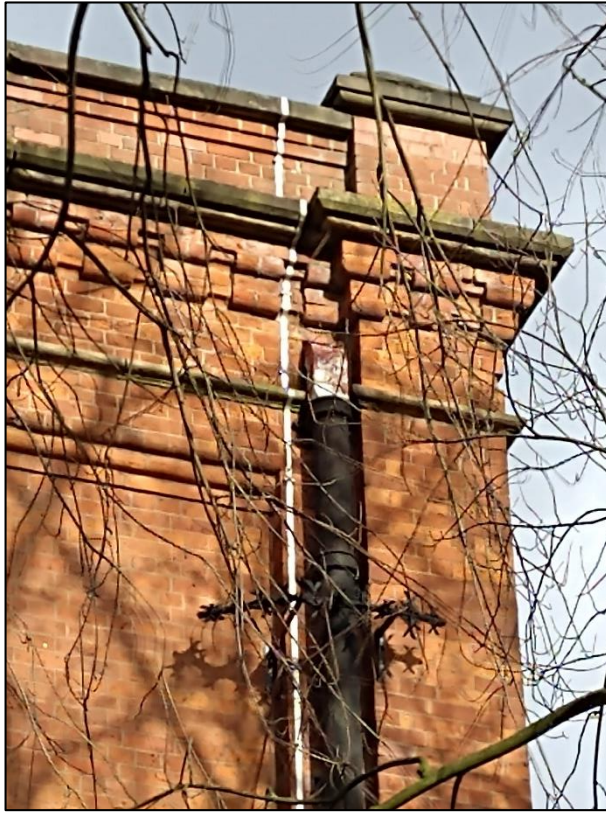
**Plate 10: Location of possible bird nest in a gap by the top of a drainpipe, on the south-east elevation.**

observed making frequent visits to the top of one of the drainpipes on the south-east corner of the building (Plate 10), suggesting that it was either in use as a nest or was being scouted as a possible nest site.

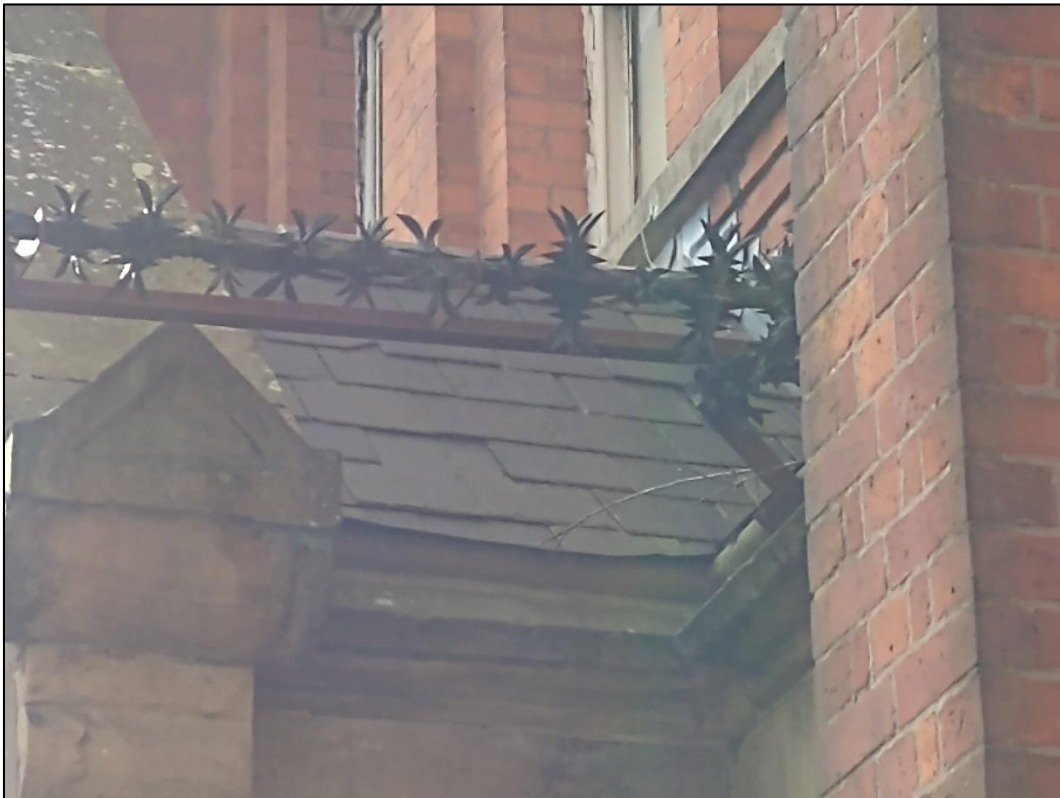
**Plate 11: Gaps beneath slate tiles, present on the eastern porch of the building.**

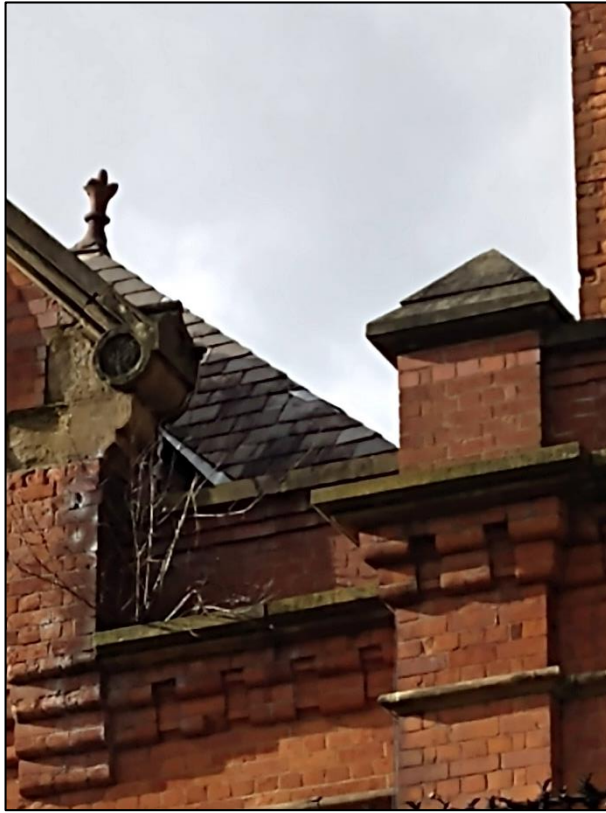
**Plate 12: Lifted slate tiles on a hip, forming the section of roof above the clock tower. Small gaps in the lower stonework layer are also visible.**

- 5.13 The clock tower possessed a different roof structure to the rest of the building, comprising of a ridged structure that connected to the central section, with slate roof tiles and decorative brickwork ridge tiles. The roof was lined with bitumen felt, and supported by timber beams (Plates 16 and 17). The bitumen felt was in good condition and well-sealed against the roof tiles. Two skylights in the north and south rooflines and the semi-translucent clock face meant that the space was well-lit. The southern skylight also allowed access to the roof (Plate 18), but this could not be accessed during the survey as the key was unavailable. The clock tower also allowed access to the roof void above part of the central section via a ladder. This section

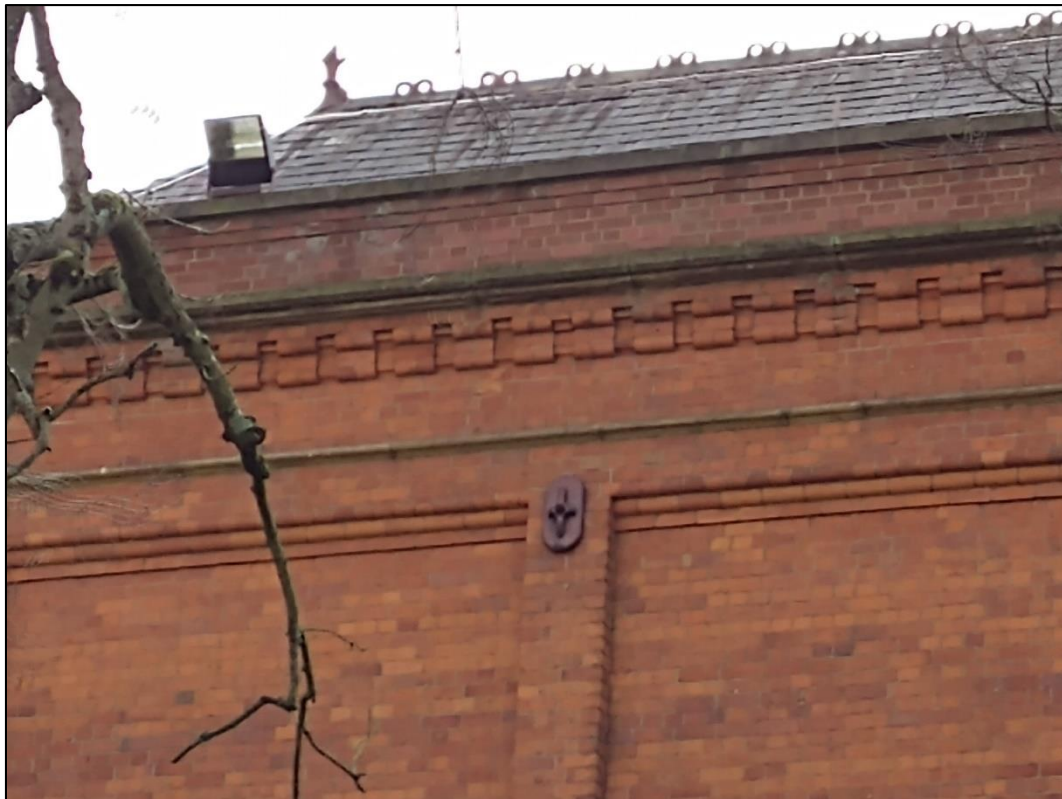
**Plate 13: Zoomed view of slate roof showing small gaps beneath slate tiles and beneath ridge tiles.**

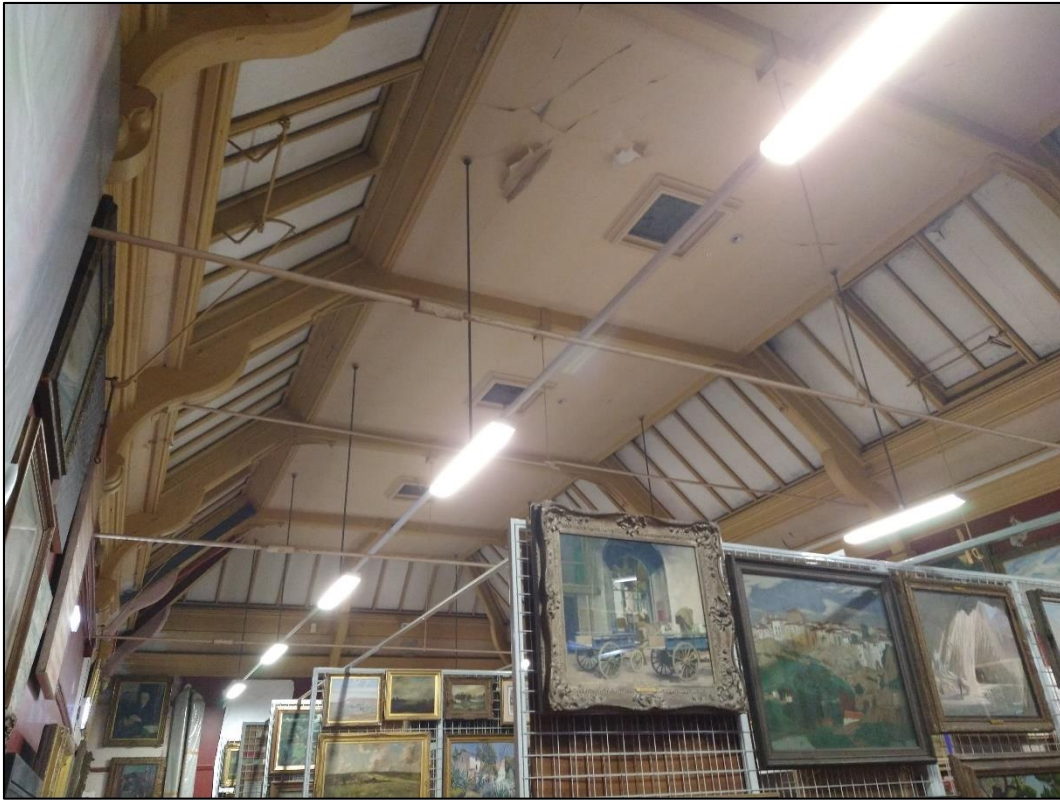
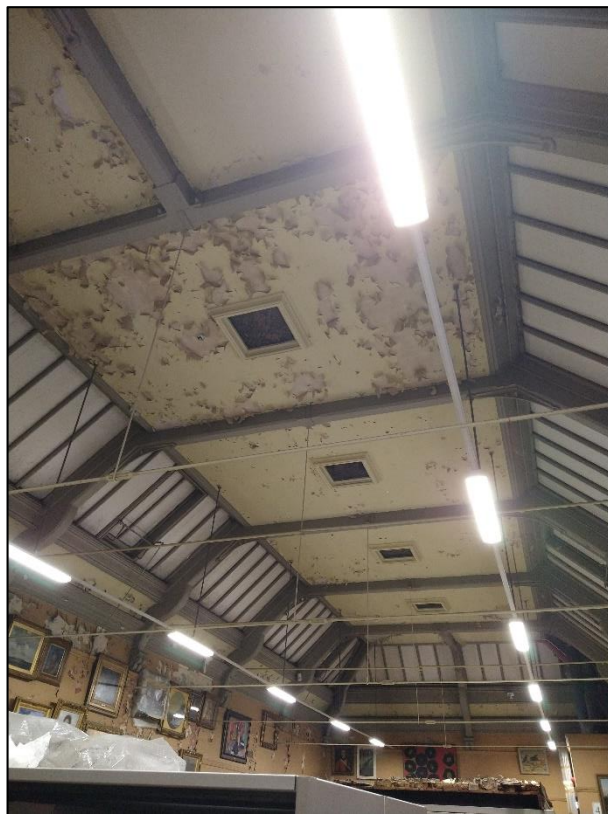
**Plate 14: Example of Internal roof structure, showing the south wing, with an inaccessible internal roof void, with metal shuttered skylights around the edges.**

**Plate 15: Example of internal roof structure, with inaccessible roof void and metal shuttered skylights, within the west wing.**

- 5.12 A similar roof structure was present in the north, west and south wings – with a 'floating' ridged and hipped tiled roof and glass skylights around the base. The roof also possessed decorative brickwork ridge and end tiles (which may have also been present on the central section, but could not be observed due to the limited viewpoints available). Though generally in a good state of repair, small gaps were occasionally visible underneath shifted roof tiles, under ridge tiles and beneath hip tiles on several roof sections (Plate 13). While these gaps form small features by themselves, there is a possibility that they may also allow access to internal roof voids. Unlike the central section, the skylights in the north, west and south sections were covered with what appeared to be plastic and metal sheeting on the roof exterior, so natural light was not available to these areas. These sections also possessed a loft void below the 'floating' tilework section, but the voids could not be accessed due to a lack of access hatches, their height and presence of shelves of densely stored valuable artwork within the rooms below (Plates 14 and 15).

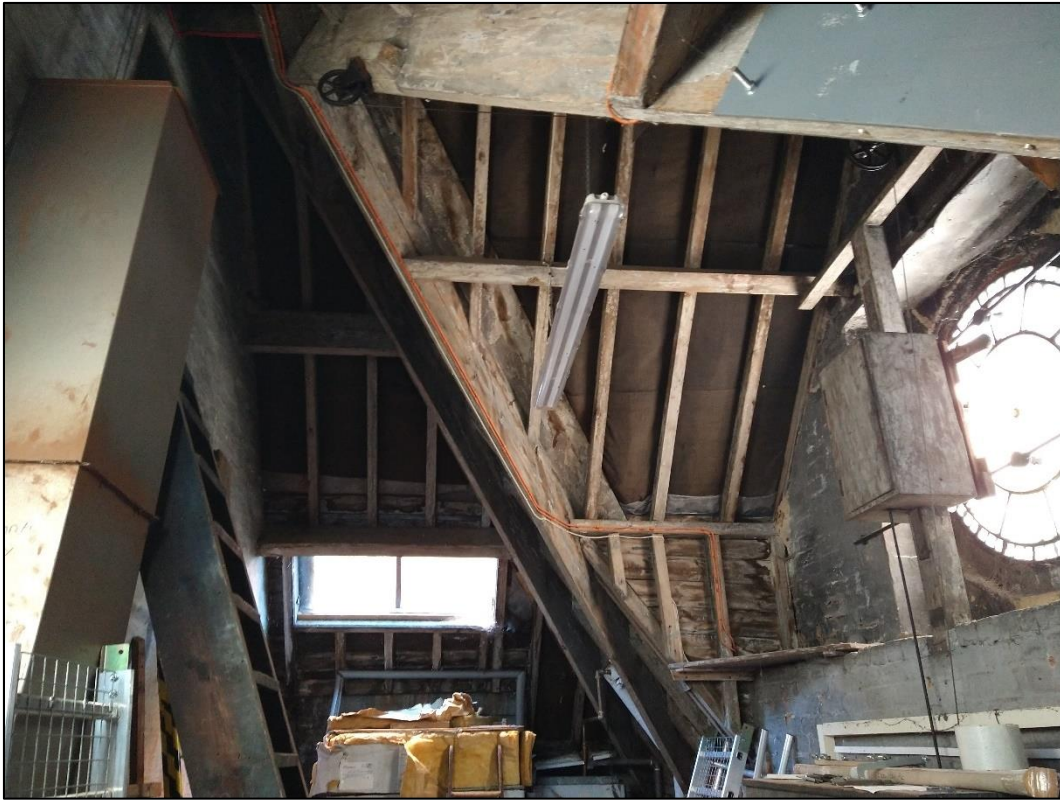
**Plate 16: Interior of the clock tower, showing intact bitumen roofing felt beneath tiles, and multiple windows and the clock face creating a well-lit space.**

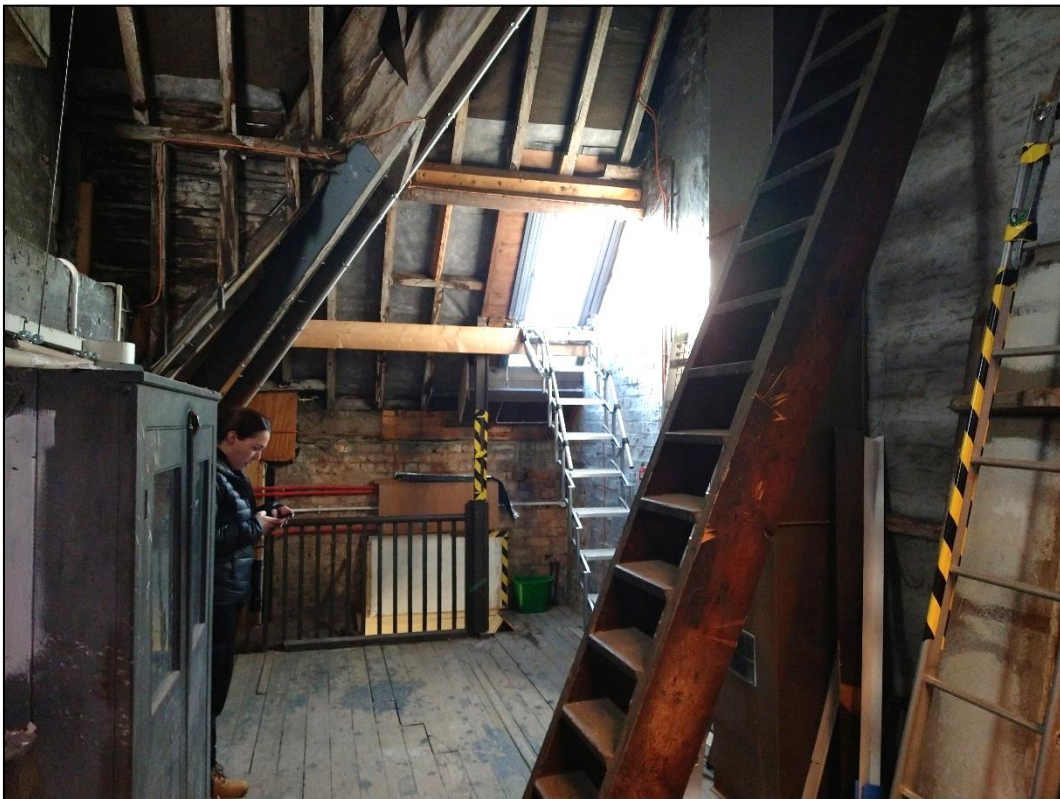
**Plate 17: Alternative view of interior of the clock tower, showing wooden access stairs to the roof void above the main hall to the right, and metal stairs to the roof access straight ahead.**

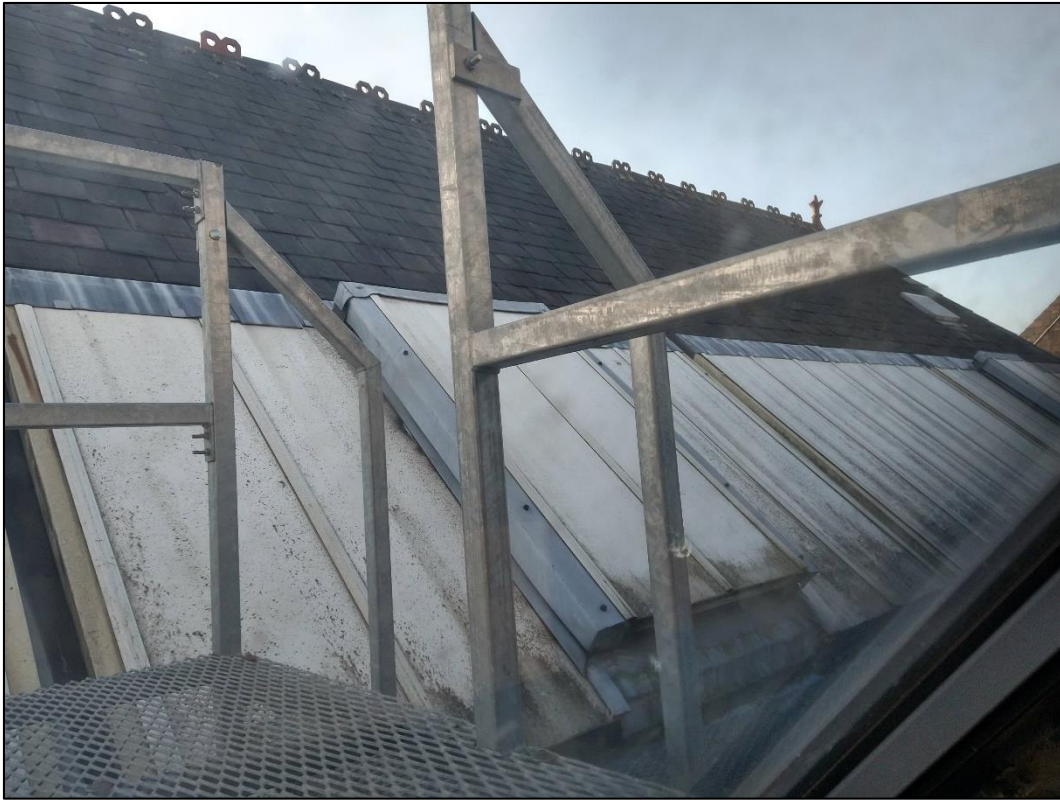
**Plate 18: View through the roof access hatch, showing metal covered skylights with lead flashing on the interior of the southern ridge line. The roof could not be accessed during the survey.**

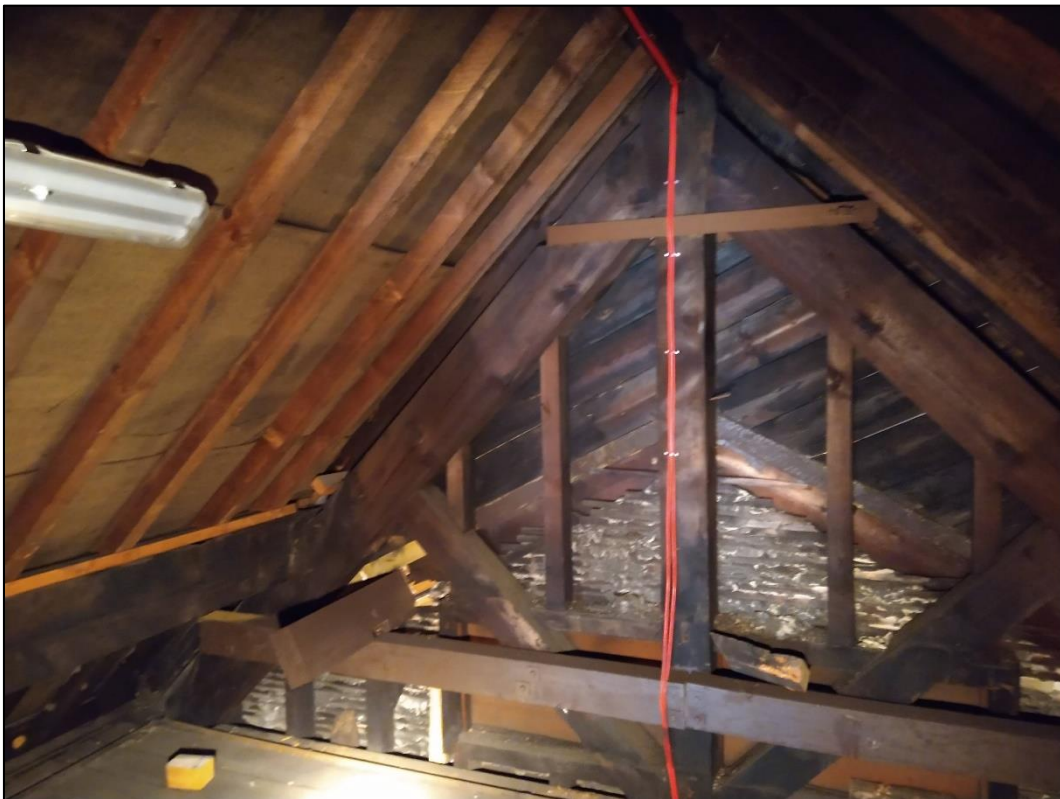
**Plate 19: Interior of the central internal loft void, above the main hall, which was lined with plywood and well-sealed.**

was well sealed, with a bitumen felt roof lining and a timber internal structure that had been coated with what appeared to be pitch or other wood preserver (Plate 19). A single chimney was present on the western edge of the building adjacent to the clock tower, which was of brickwork construction with a stonework crown, and was in good condition.

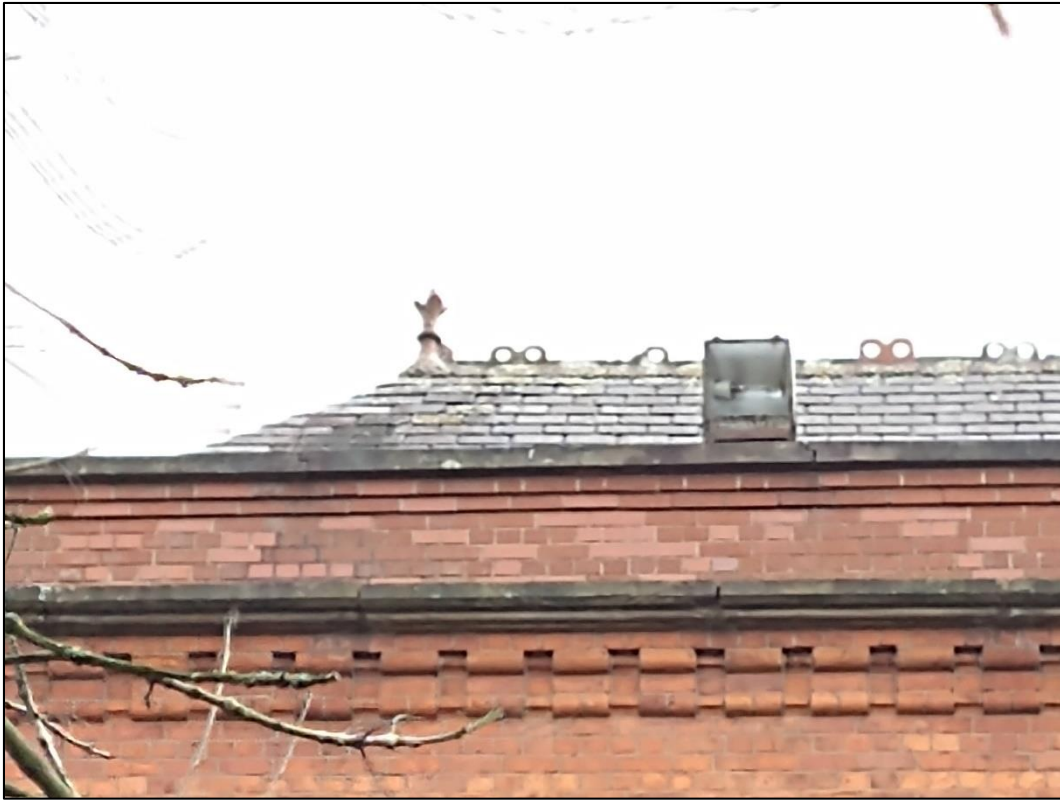
- 5.14 The roof possessed a brickwork parapet which encircled the building, with stonework corning atop the parapet. Security floodlights were present on all building façades, which were fixed to the parapet (Plate 20). The client informed us that the lights were not in use at present, as they promoted antisocial behaviour by drawing attention to the building, and therefore the building remains dark at night, which is conducive to occupation by roosting bats.

**Plate 20: Example of security floodlight, located on the roof parapet.**

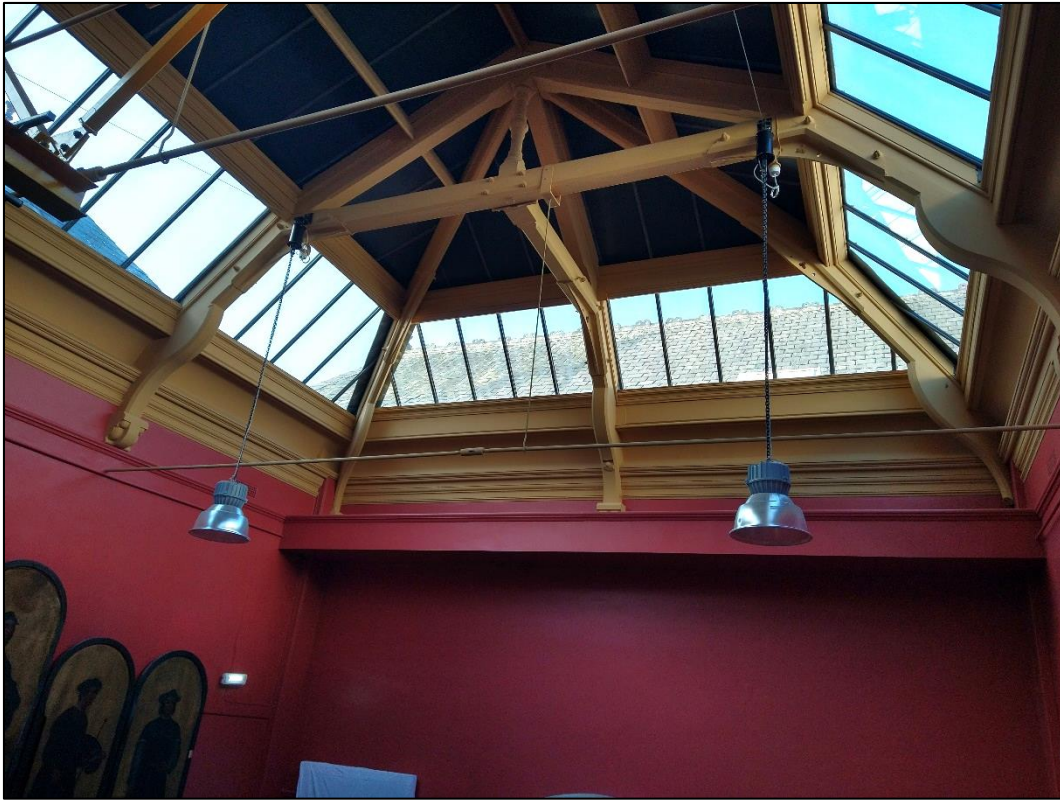
**Plate 22: Main hallway within the building, with internal roof ridges visible through the glass roof.**

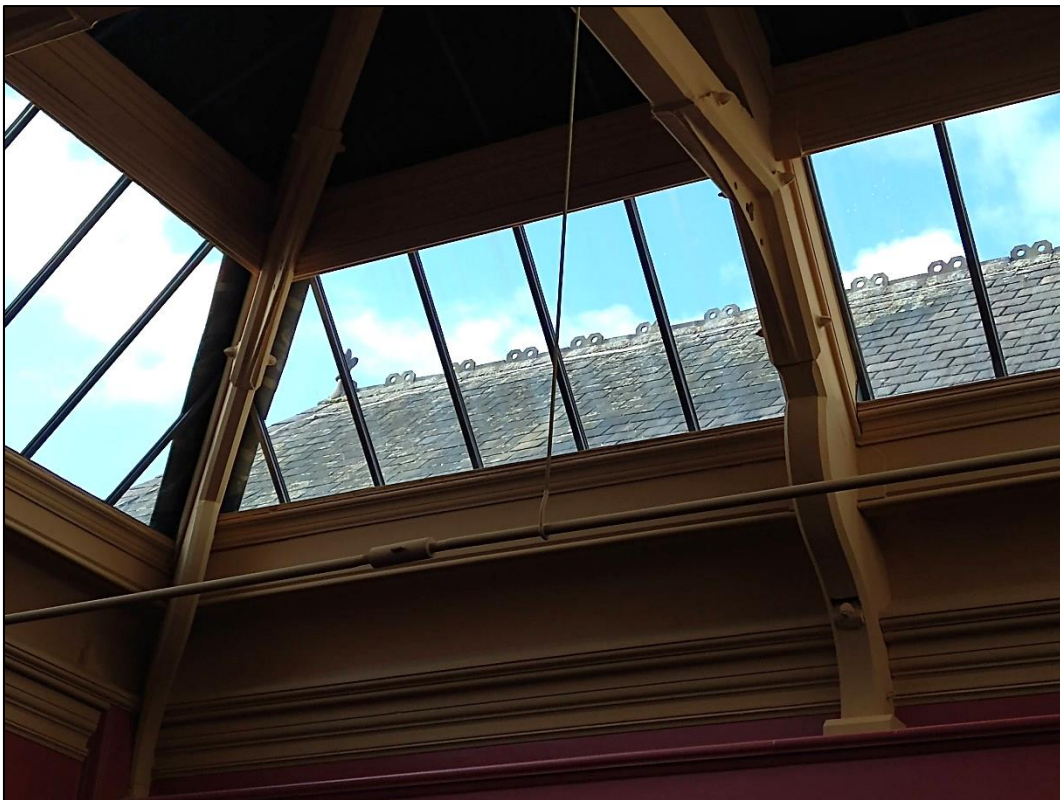
**Plate 23: View through internal glass roof structure, toward internal ridgeline, with tiles well-fitting and in generally good condition.**

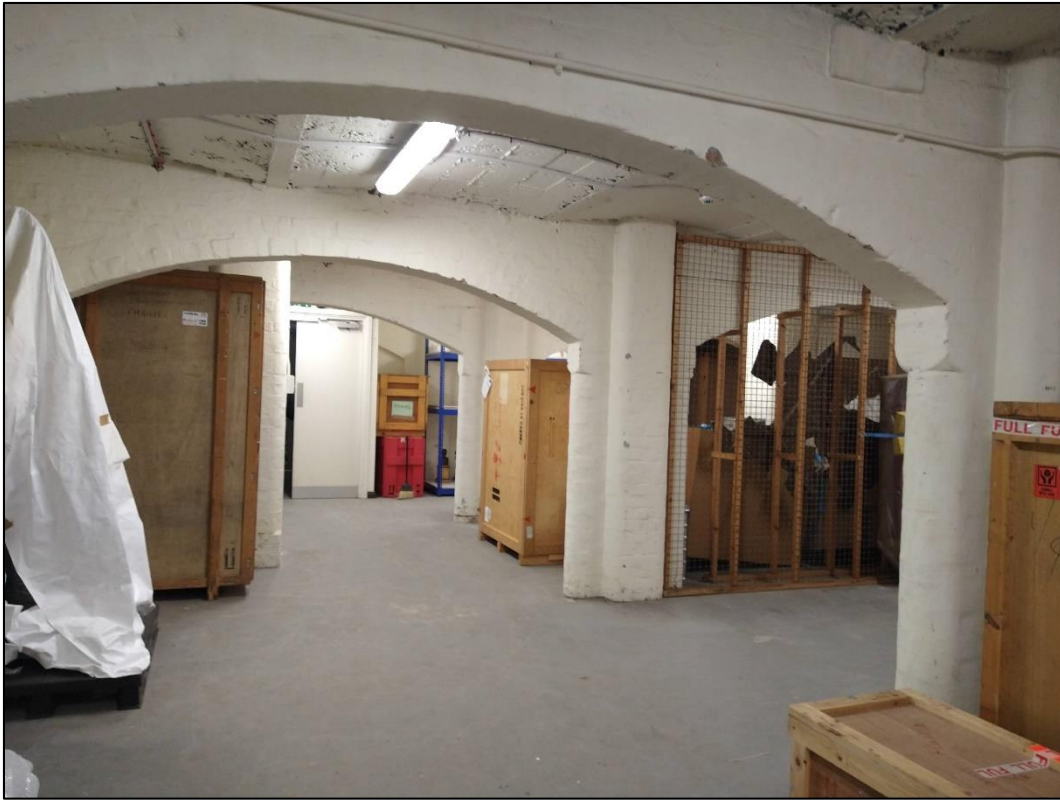
**Plate 24: Example of internal basement space, below the main hall of the building, which was well-lit, well-sealed and in frequent use.**

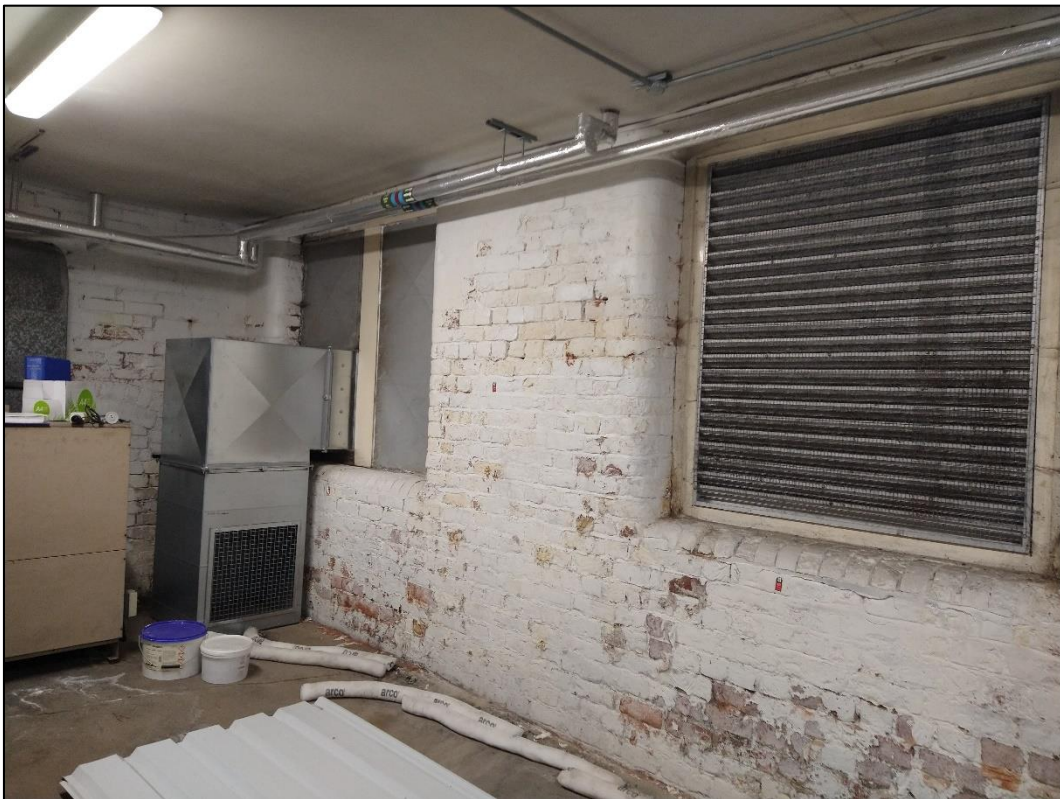
**Plate 25: View of shutters present within the plant roof, which were well sealed and in good condition, with no gaps large enough for bats to gain entry.**

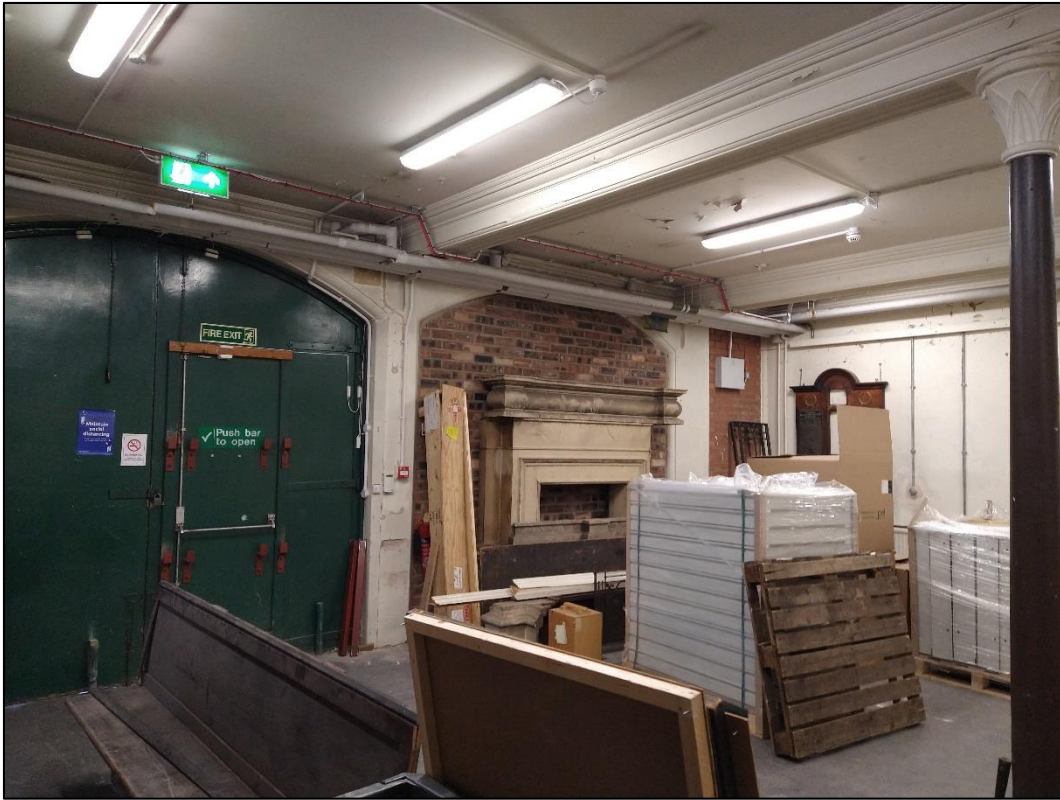
**Plate 26: Example of internal basement space, showing the large loading bay doors on the western side of the building, which were well sealed around the frame.**
