**QUEEN'S PARK CONSERVATION  
STUDIOS, HARPURHEY, MANCHESTER**

**BAT DAYTIME SURVEY**

**MARCH 2022**

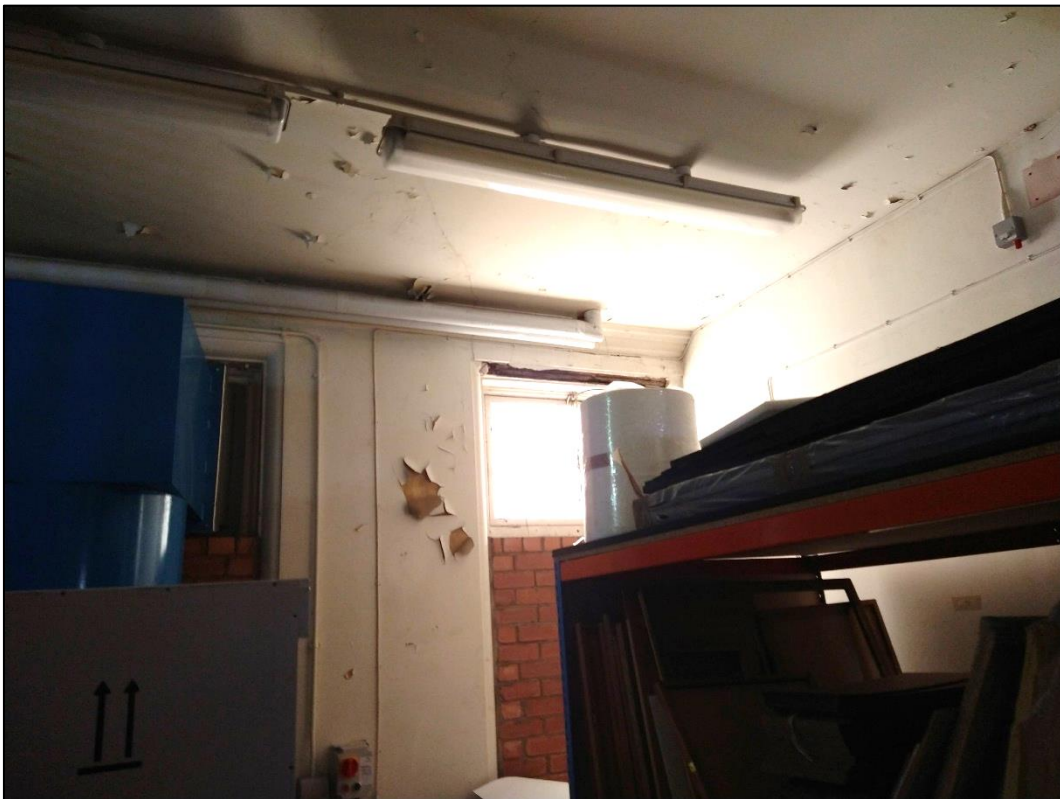
**Plate 27: Example of internal basement space, which was well-lit by windows, well-sealed, and appeared to be in frequent use.**
