## **Hough Hall, Hough Hall Road, Moston.**

### **Heritage Statement**

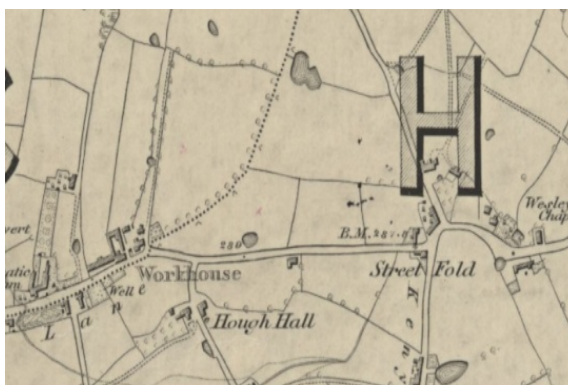
Fig . 1848 OS Map. Not to scale.  
Crown Copyright 2022.

2.2 There is very little map information to refer to. Yates map 1786 does not include the Hall. Moston Lane and Kenyon Lane are shown, as is Street Fold at their meeting to the east. Nearby Moston Hall (to the east) and Lightburn Hall (later Lightbowne and south east) are included. Does this give an indication of the importance of Hough Hall? The 1848 OS map (Fig. ) shows Hough Hall, and a lunatic asylum and workhouse to the north on Moston Lane with Street Fold again prominent. There is another large building shown opposite the Hall to the east on what later becomes Hough Hall Road together with a smaller building on a north/south axis to the south. All around is open land. By 1893 (Fig. ) the Hall is in an open site with farmland to the south and what appears to be marshy ground or a pond. By this time there has been considerable development to the east, west and north of the Hall mainly in the form of terraced housing. At that time the building opposite and to the south of the Hall still exist. Notable buildings constructed since 1848 are the primary school on Moston Lane and the Simpson Memorial building. The 1922 map shows the Hall in reduced grounds, but also that parts of early Street Fold to the east might still remain. By 1989 the Hall site is referred to a depot with new buildings added. The building opposite the Hall is there and named as Hough House.

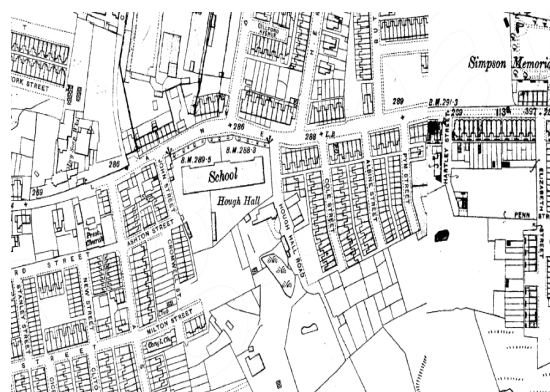
1893 OS Map. Not to Scale.  
Crown copyright 2022.
