## Phase III Remediation & Validation Strategy Proposals

Devonshire Street,  
Ardwick

Client: Jigsaw Homes Group

Reference: 33494-SUT-ZZ-00-RP-G-7301

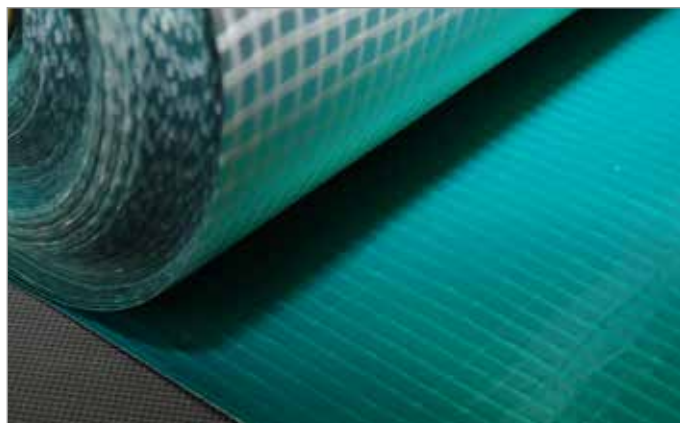
Protech GM Super incorporates a reinforced grid to ensure that maximum protection is achieved when installed to manufacturers' instructions.

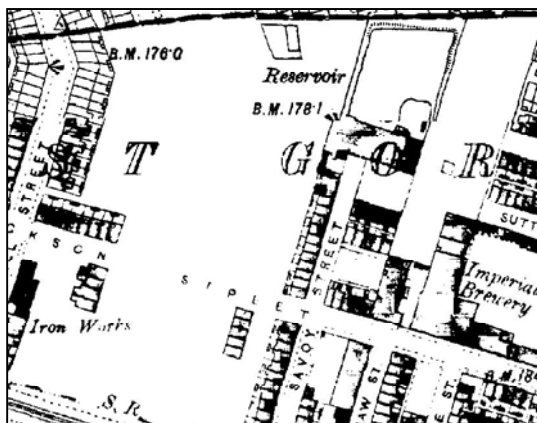
*Digital historical mapping allows the history of land to be traced.*

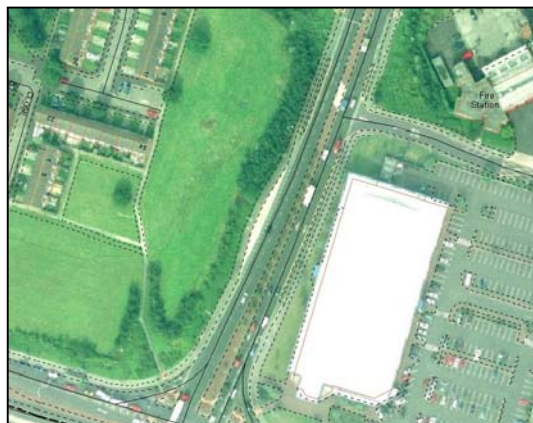
*Recent aerial photography is used in conjunction with Ordnance Survey mapping to determine the current use of the land.*

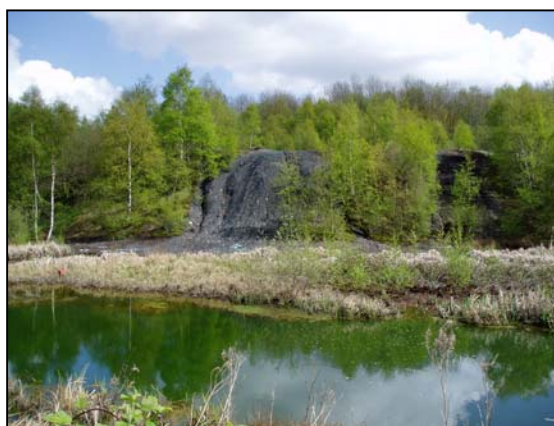
*Open land in Harpurhey used historically as a tip for industrial wastes.*

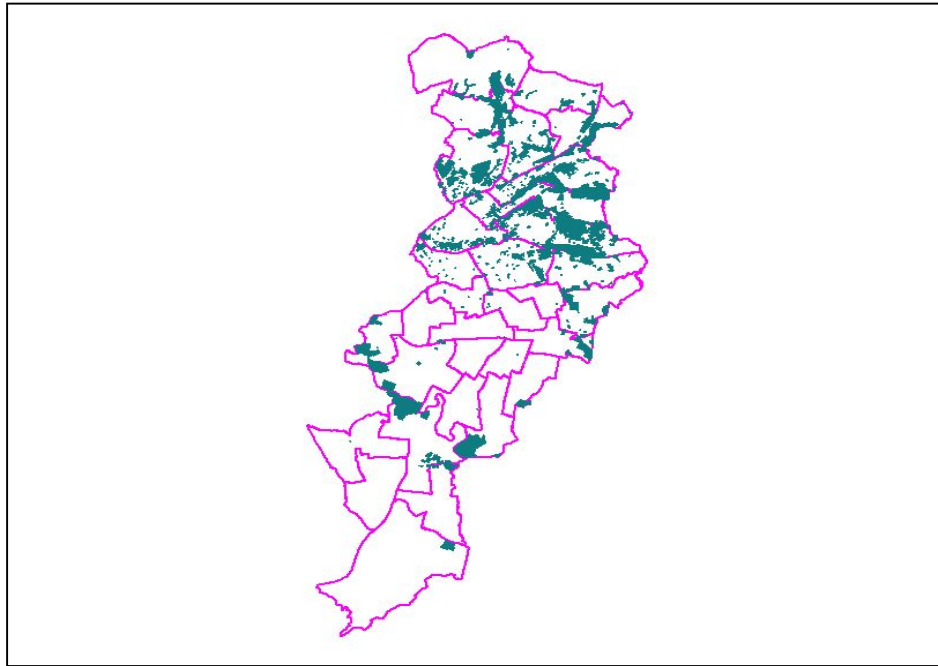
*Areas of the City with the greatest concentrations of historical industry and landfilling.*

An overview study has been completed to identify the parts of the district with the greatest concentrations of historical industry. These are the areas likely to have become the most polluted. This overview will assist strategic planning while the detailed prioritisation of potential contaminated sites is being completed.
