## Verification Report – Phase 1 Development

Lowry Park  
Grimshaw Lane  
Manchester  
M40 2HJ

May 2024

602192.0000.0000

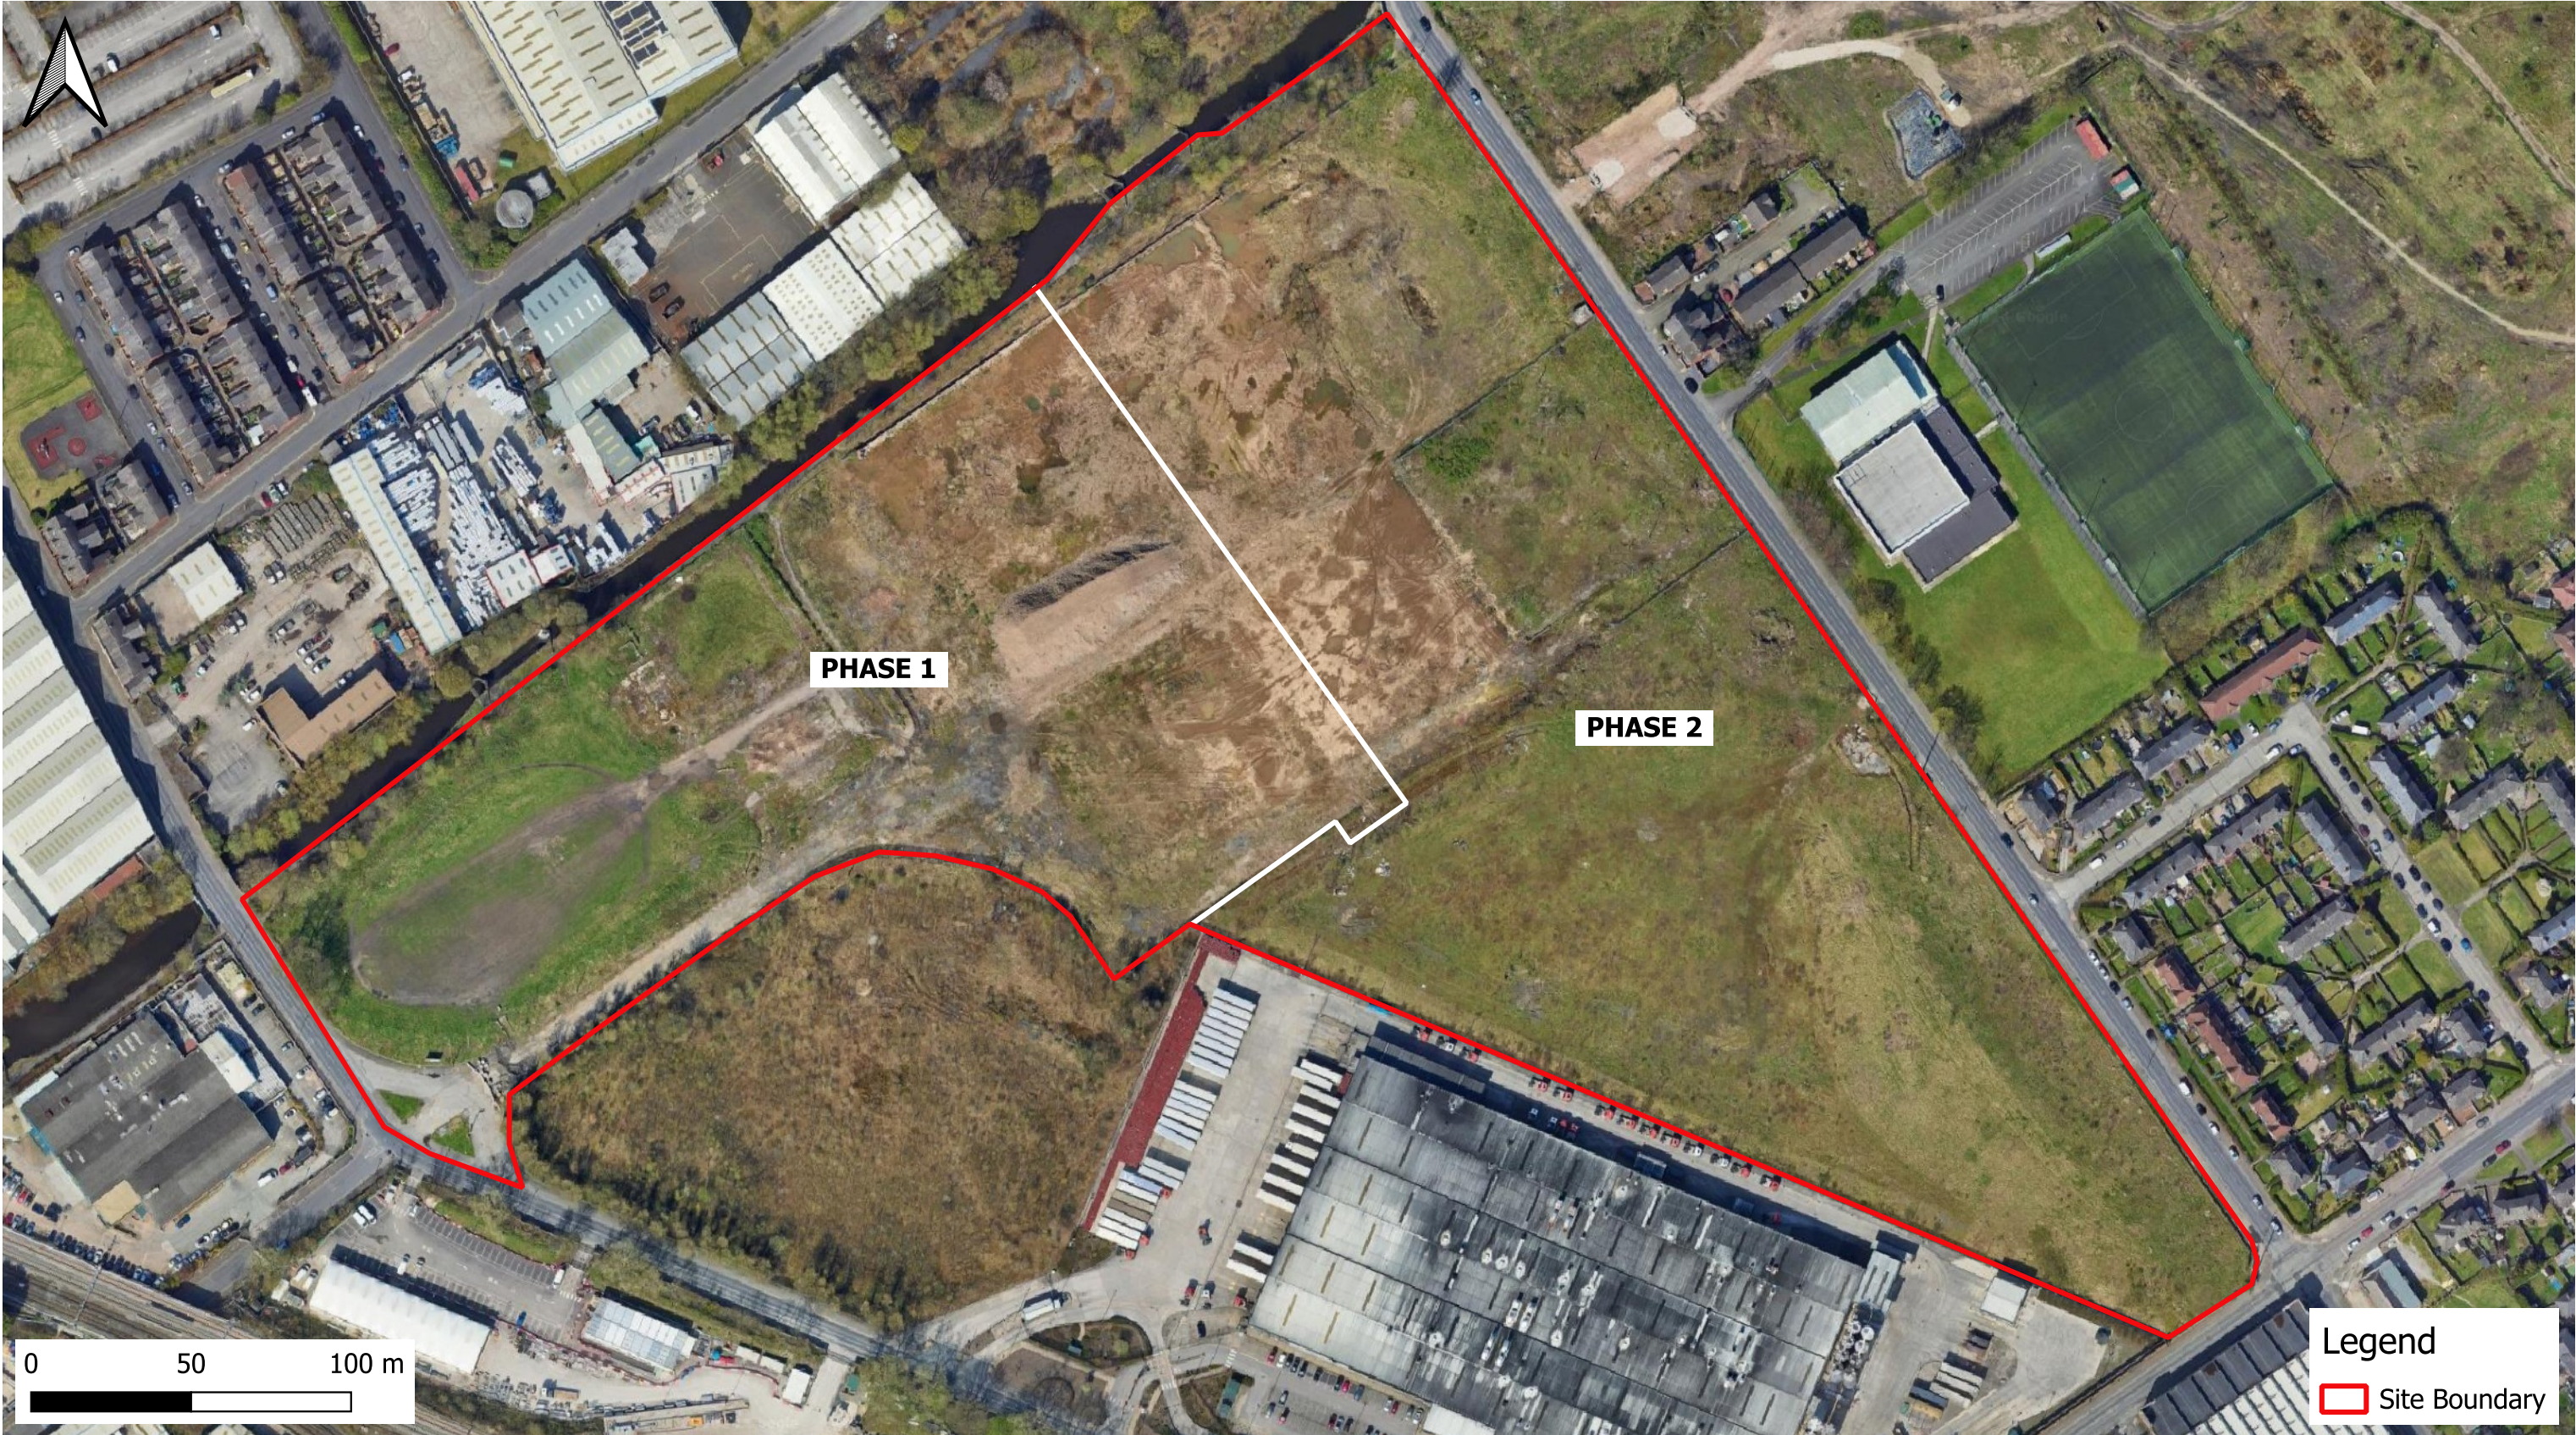
| NOTES | COPYRIGHT NOTES<br><br>Google Imagery January 2024 | | REVISIONS | | | | <div><div></div><div>Arkwright House<br/>Manchester<br/>M3 2LF</div></div> | | TITLE<br>SITE LAYOUT PLAN | |

The remediation strategy considers the Site as a whole, but this report covers only the works undertaken as part of phase one of the development. A Site Layout Plan showing the phases of development is presented as Figure 2 in Annex A. A proposed development plan for the Phase One Development is presented as Figure 3 in Annex A.

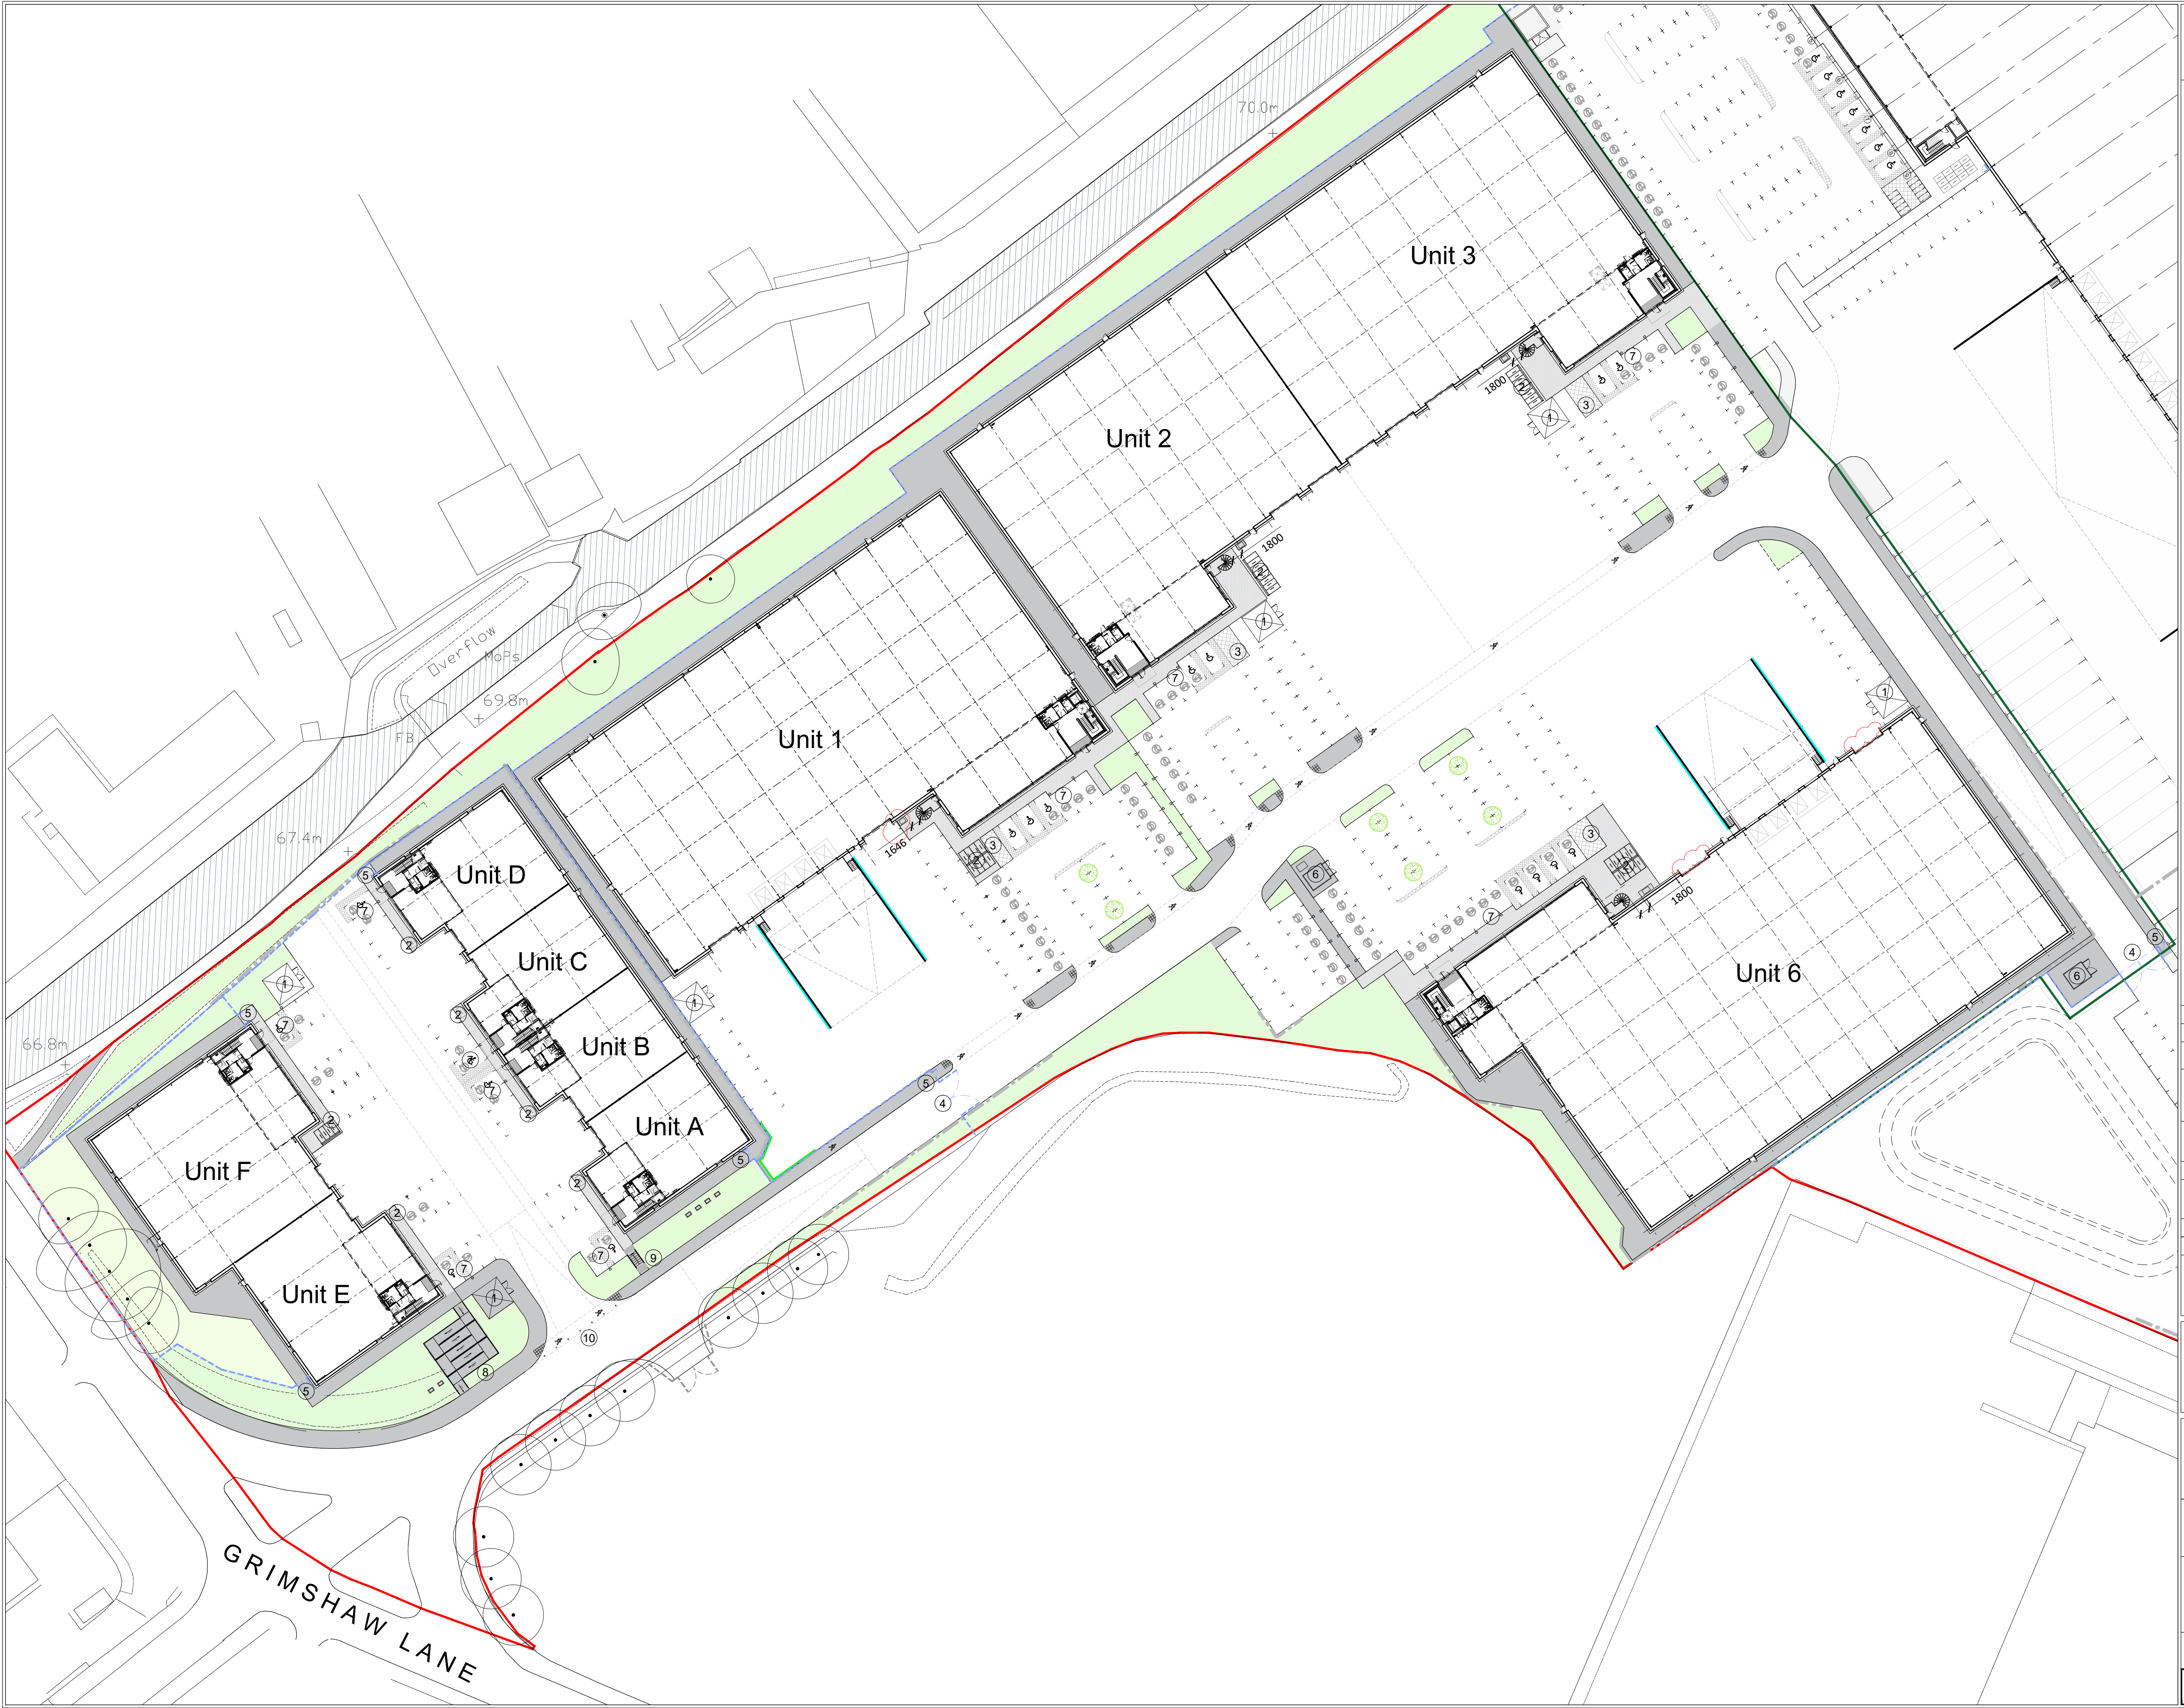
9762-PTA-SW-XX-DR-C- 8021

The cut and fill drawing provided by the Principal Contractor is presented within Annex B (drawing no. 9762-PTA-SW-XX-DR-C-8021) for information. As shown within the drawing, there was a net import of 10,994m<sup>3</sup> imported to meet development requirements. These materials comprised 6F2 recycled aggregate supplied by Murray RIX from Wharf Street, Dukinfield, and 6F5 crushed sandstone from Scout Moor Quarry. Grading and moisture certificates provided by the contractor have been provided within Annex E.

The cut and fill drawings show that 10,994m<sup>3</sup> of 6F2 and 6F5 material was imported for engineering purposes. Grading certificates have been provided for those materials. No further sampling and analysis was performed on these materials. However, it is noted that the materials were sourced from an aggregate supplier and comprised virgin aggregate and recycled aggregated products produced under environmental permits.

- No allowance is made in these calculations for bulking of excavated material, since the bulking factors will vary depending upon whether the material is to be exported from site, or re-used on site as loosely compacted or engineered fill. Bulking factors will also vary depending upon the type of material. The Contractor should state the bulking factors assumed within their analysis.

- No allowance has been made in this appraisal for excavations required to construct foundations, drainage runs, attenuation/infiltration tanks, manholes, lift pits, service trenches, etc.
