# CHAIN ROAD BLACKLEY

## PHASE 1: PRELIMINARY RISK ASSESSMENT

**Job Number:** LKC 21 1026

| <b>LK Consult</b><br><b>Document Verification</b> | | | |
|---|---|---|---|
| <b>Report Title</b> | Phase 1: Preliminary Risk Assessment | | |

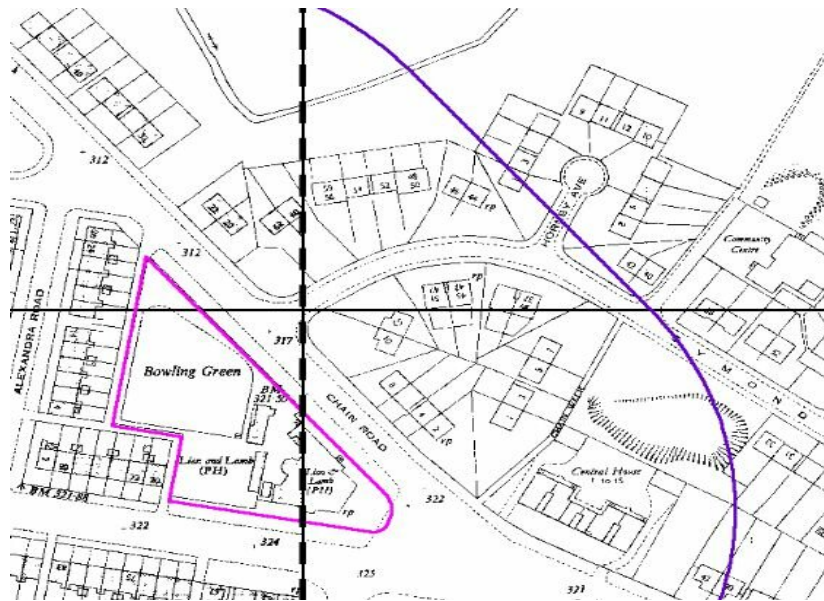
Plate 2-1: Extract from 1952 mapping.

The 1952 mapping showing site features and surrounding cutting, refuse heap and watercourse is shown on Plate 2-1.

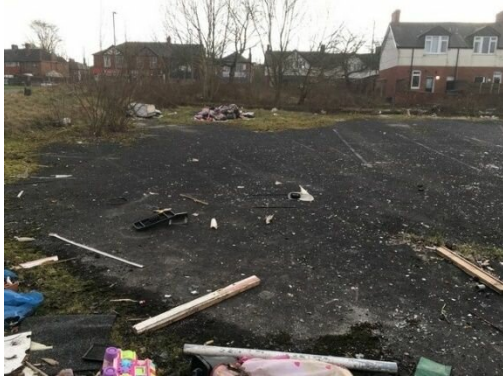
| <p><b>Photograph 1:</b> View of NW site from E entrance from Chain Road.</p> | <p><b>Photograph 2:</b> View of NW site from E entrance showing brick wall and small cement block.</p> |

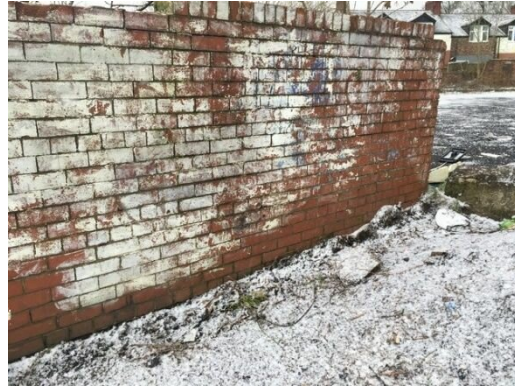
- At the entrance off Chain Road, small cement blocks have been positioned (covered in fly tipping) to prevent people driving on. A brick wall is also present at the entrance (Plate 4-1, Photographs 1-2).
- A large amount of fly tipping has occurred here across this area. The contents appear to be household waste (Plate 4-1, Photograph 3).
- Adjacent north and east are side alleys for the neighbouring estate. A water main runs along these side alleys (Plate 4-1, Photographs 5 and 6).
- The tarmac is in moderate condition with tree roots disrupting it and general wear and tear.
- The area is bordered by a combination of mature trees (west) and wooden fencing (north east), and brick walls (south) (Plate 4-1 Photographs 2, 4, 6).

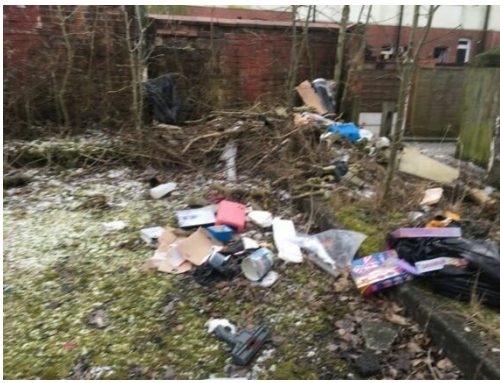
| <p><b>Photograph 3:</b> Fly tipping present around the edge of the NW site.</p> | <p><b>Photograph 4:</b> View of the level up from the NW area of the site to the SW.</p> |

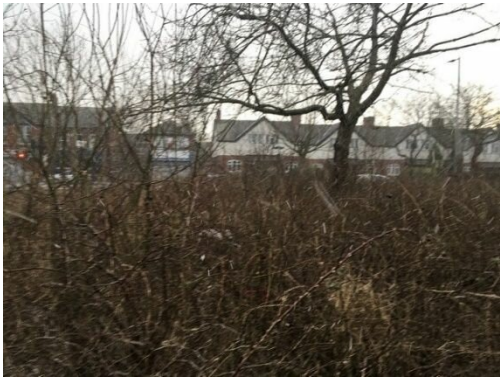
| <p><b>Photograph 5:</b> Photograph of the SW area of the site from the E - too overgrown to gain access in.</p> | <p><b>Photograph 6:</b> Brick wall on the south border of the NW site, into an alley for the adjacent houses. Water manhole cover present.</p> |

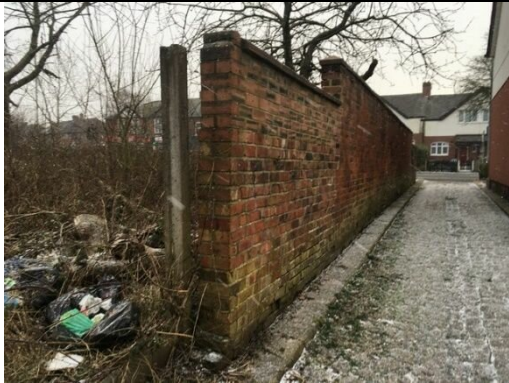
| <p><b>Photograph 7:</b> Brick wall on the western border of the SW site.</p> | <p><b>Photograph 8:</b> Unofficial footpath from the NW site to the SE.</p> |

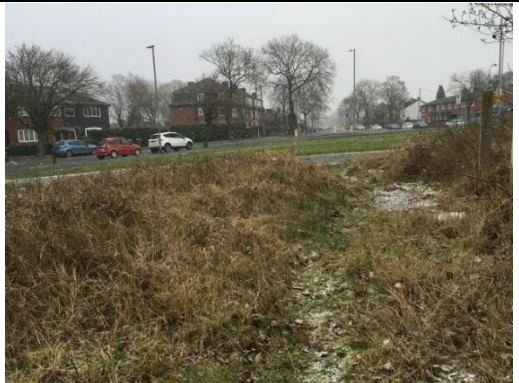
- Primarily composing well-kept grass, no fly tipping is present here. A tarmacadam path runs along the west border, north to south and an unofficial footpath is also present (Plate 4-1, Photograph 7-8).
- Sandstone flags are present in the south area of this site (Plate 4-1, Photograph 11).
- This site is the same level as the SW area but relatively higher than the NW car park.
- Tarmacadam borders the grass, looking in a moderate condition. Many services are also present in the north and east borders, including gas pipes (in the east) and water manhole covers (north).
- A broadband / telecoms distribution box is also adjacent north of this area (Plate 4-1, Photograph 12).

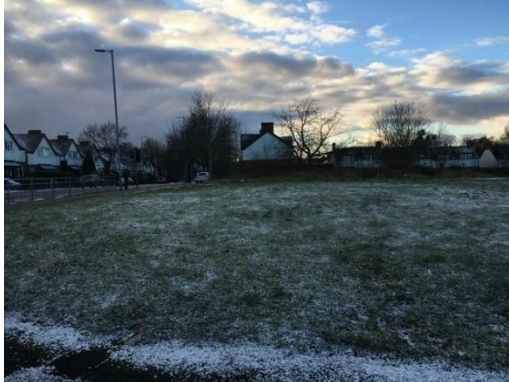
| <p><b>Photograph 9:</b> SE area looking from the east.</p> | <p><b>Photograph 10:</b> SE area looking northwest from the east, scars showing evidence of services.</p> |

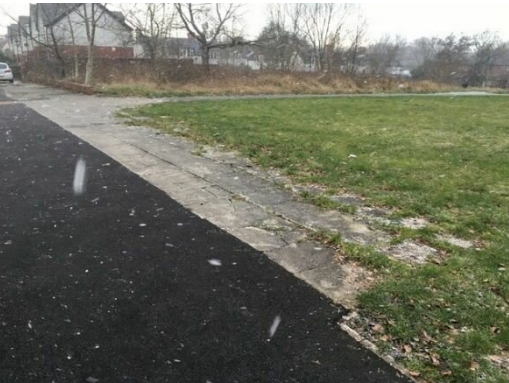
| <p><b>Photograph 11:</b> Sandstone flags present in the south of the SE site.</p> | <p><b>Photograph 12:</b> Telecoms / broadband distribution box in the north of the site – more scars indicating services on site.</p> |

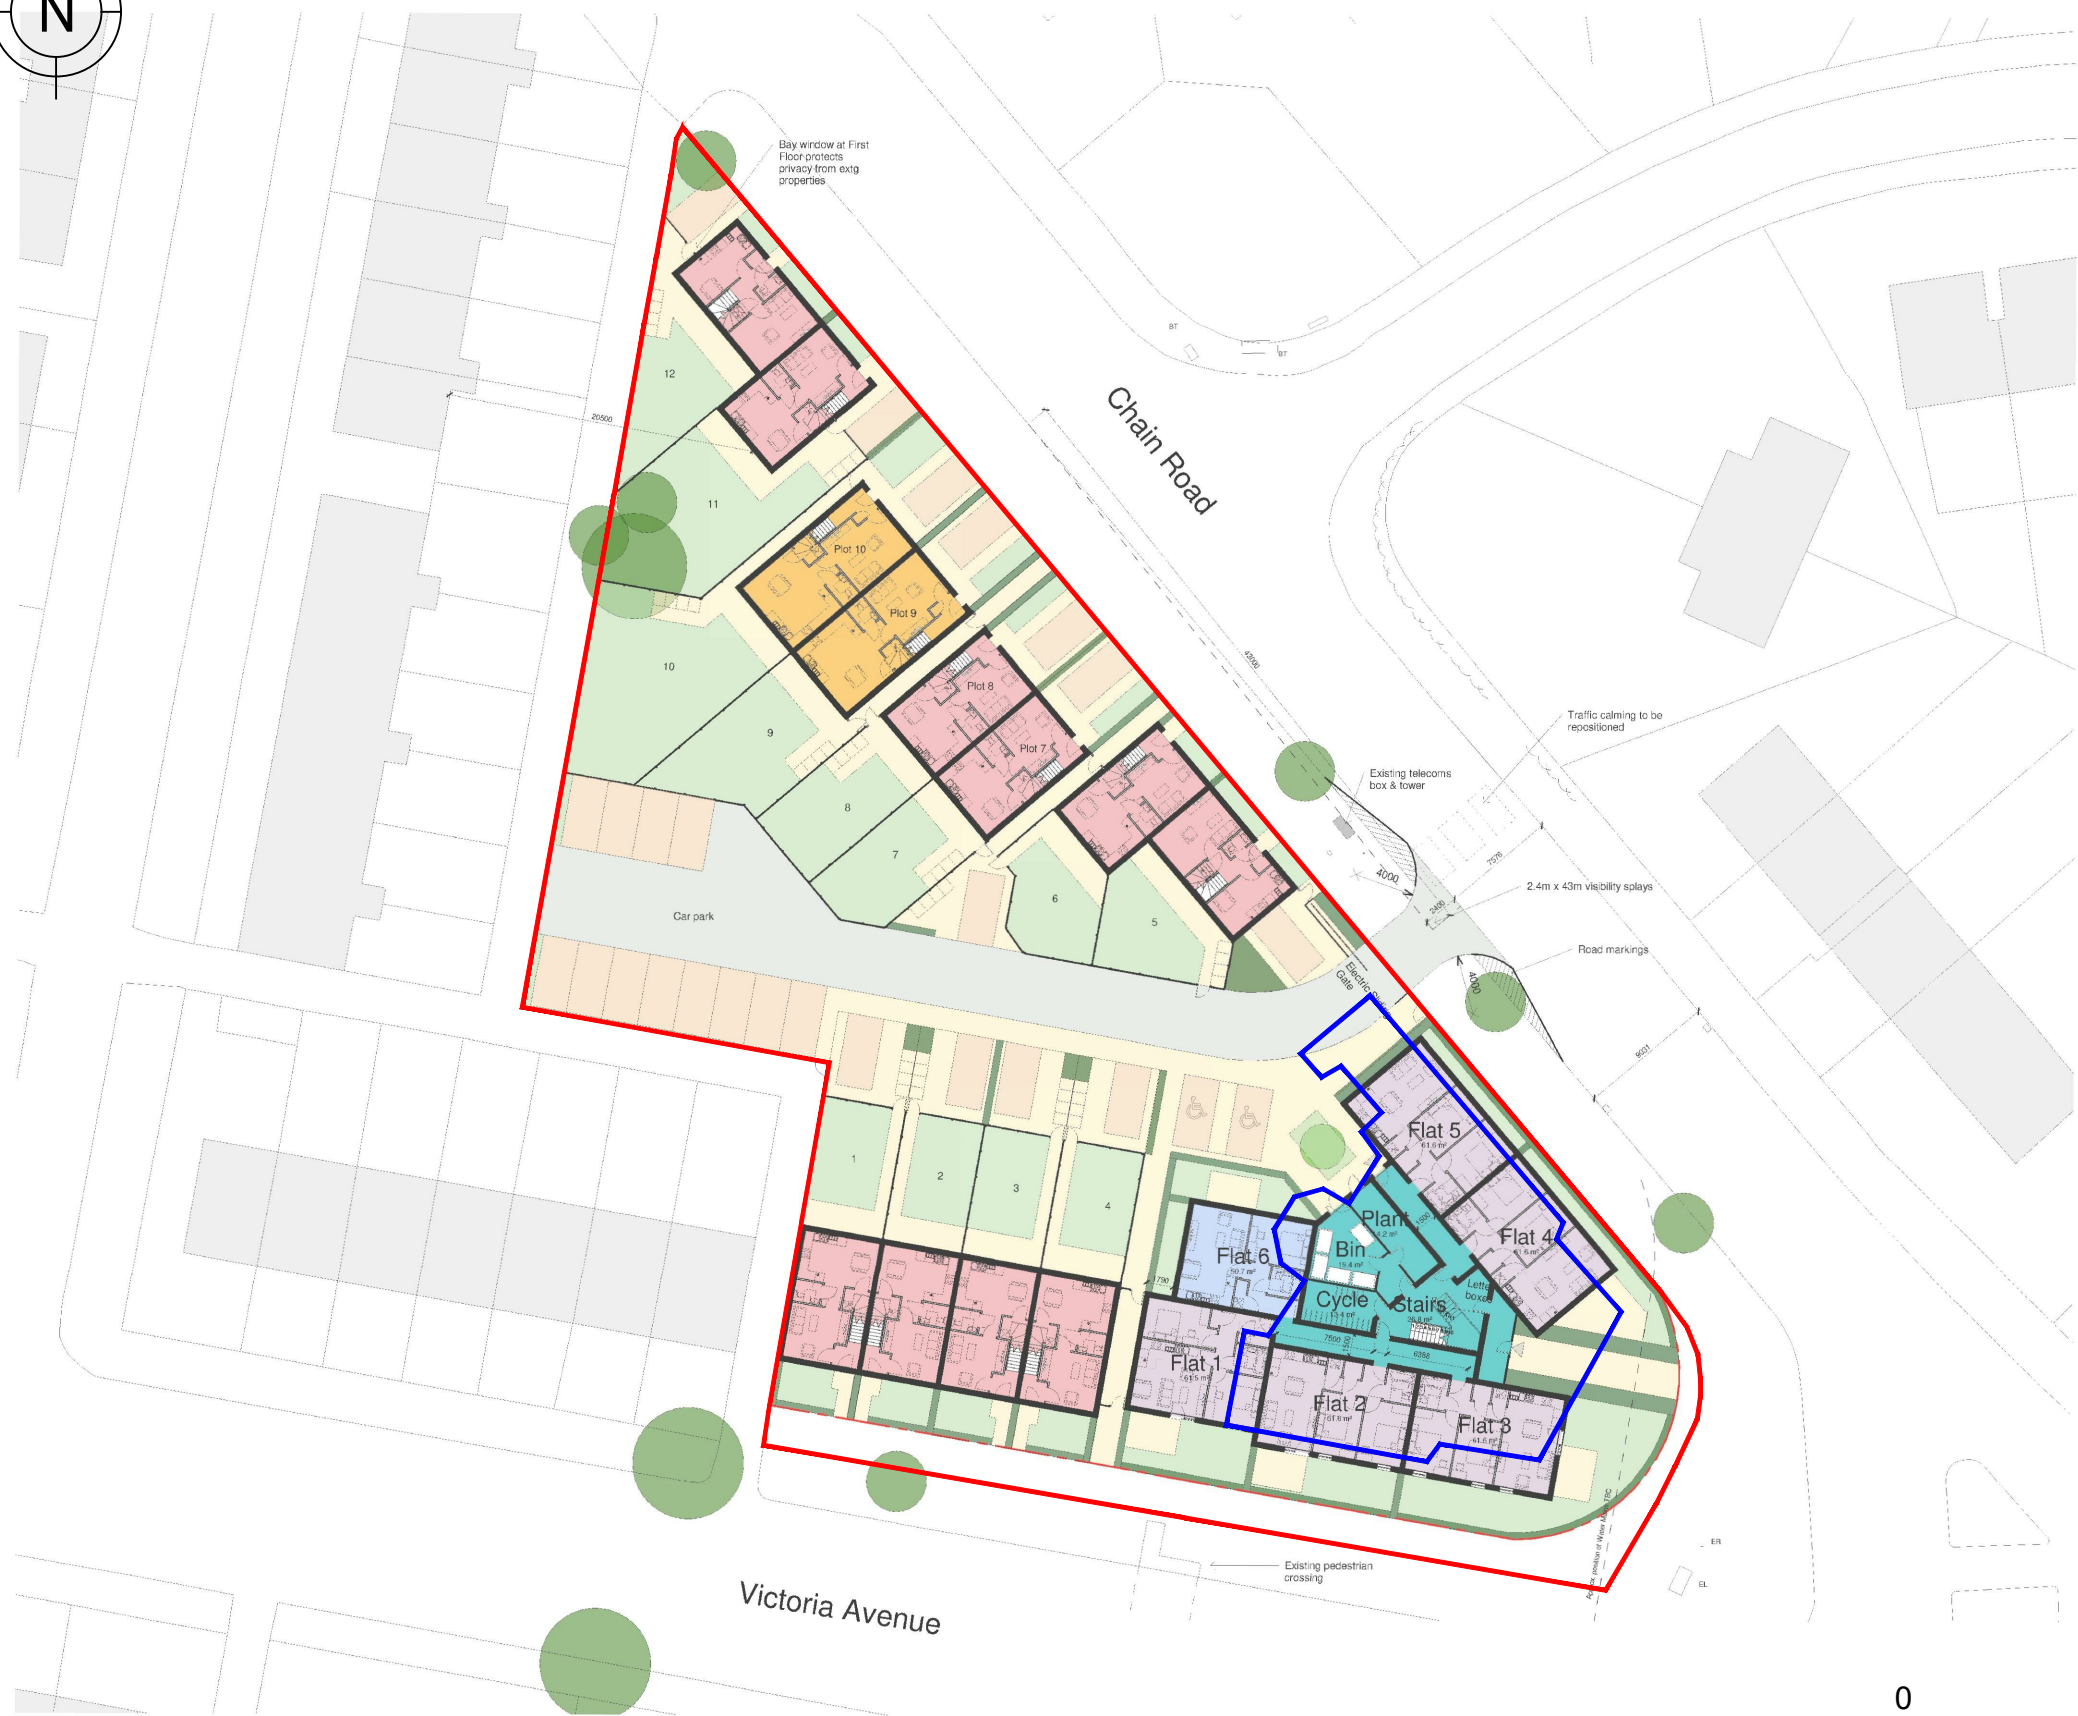
Extract from: Bowker Sadler Architecture  
Drawing Ref: Proposed Site Plan, No.0100, Rev:A (26/05/2021)

| <b>Proposed Development</b> | Residential housing with gardens / soft landscaping.<br>12no. residential houses (semi-detached and terraced) with front and rear gardens and an apartment building with associated soft landscaping.<br>Also includes associated infrastructure including road network. |
