## Remediation Strategy and Verification Plan

Crabtree Lane, Manchester  
Former Walkers Site  
Crabtree Lane  
Manchester  
M11 4GU

546629.0004.0000

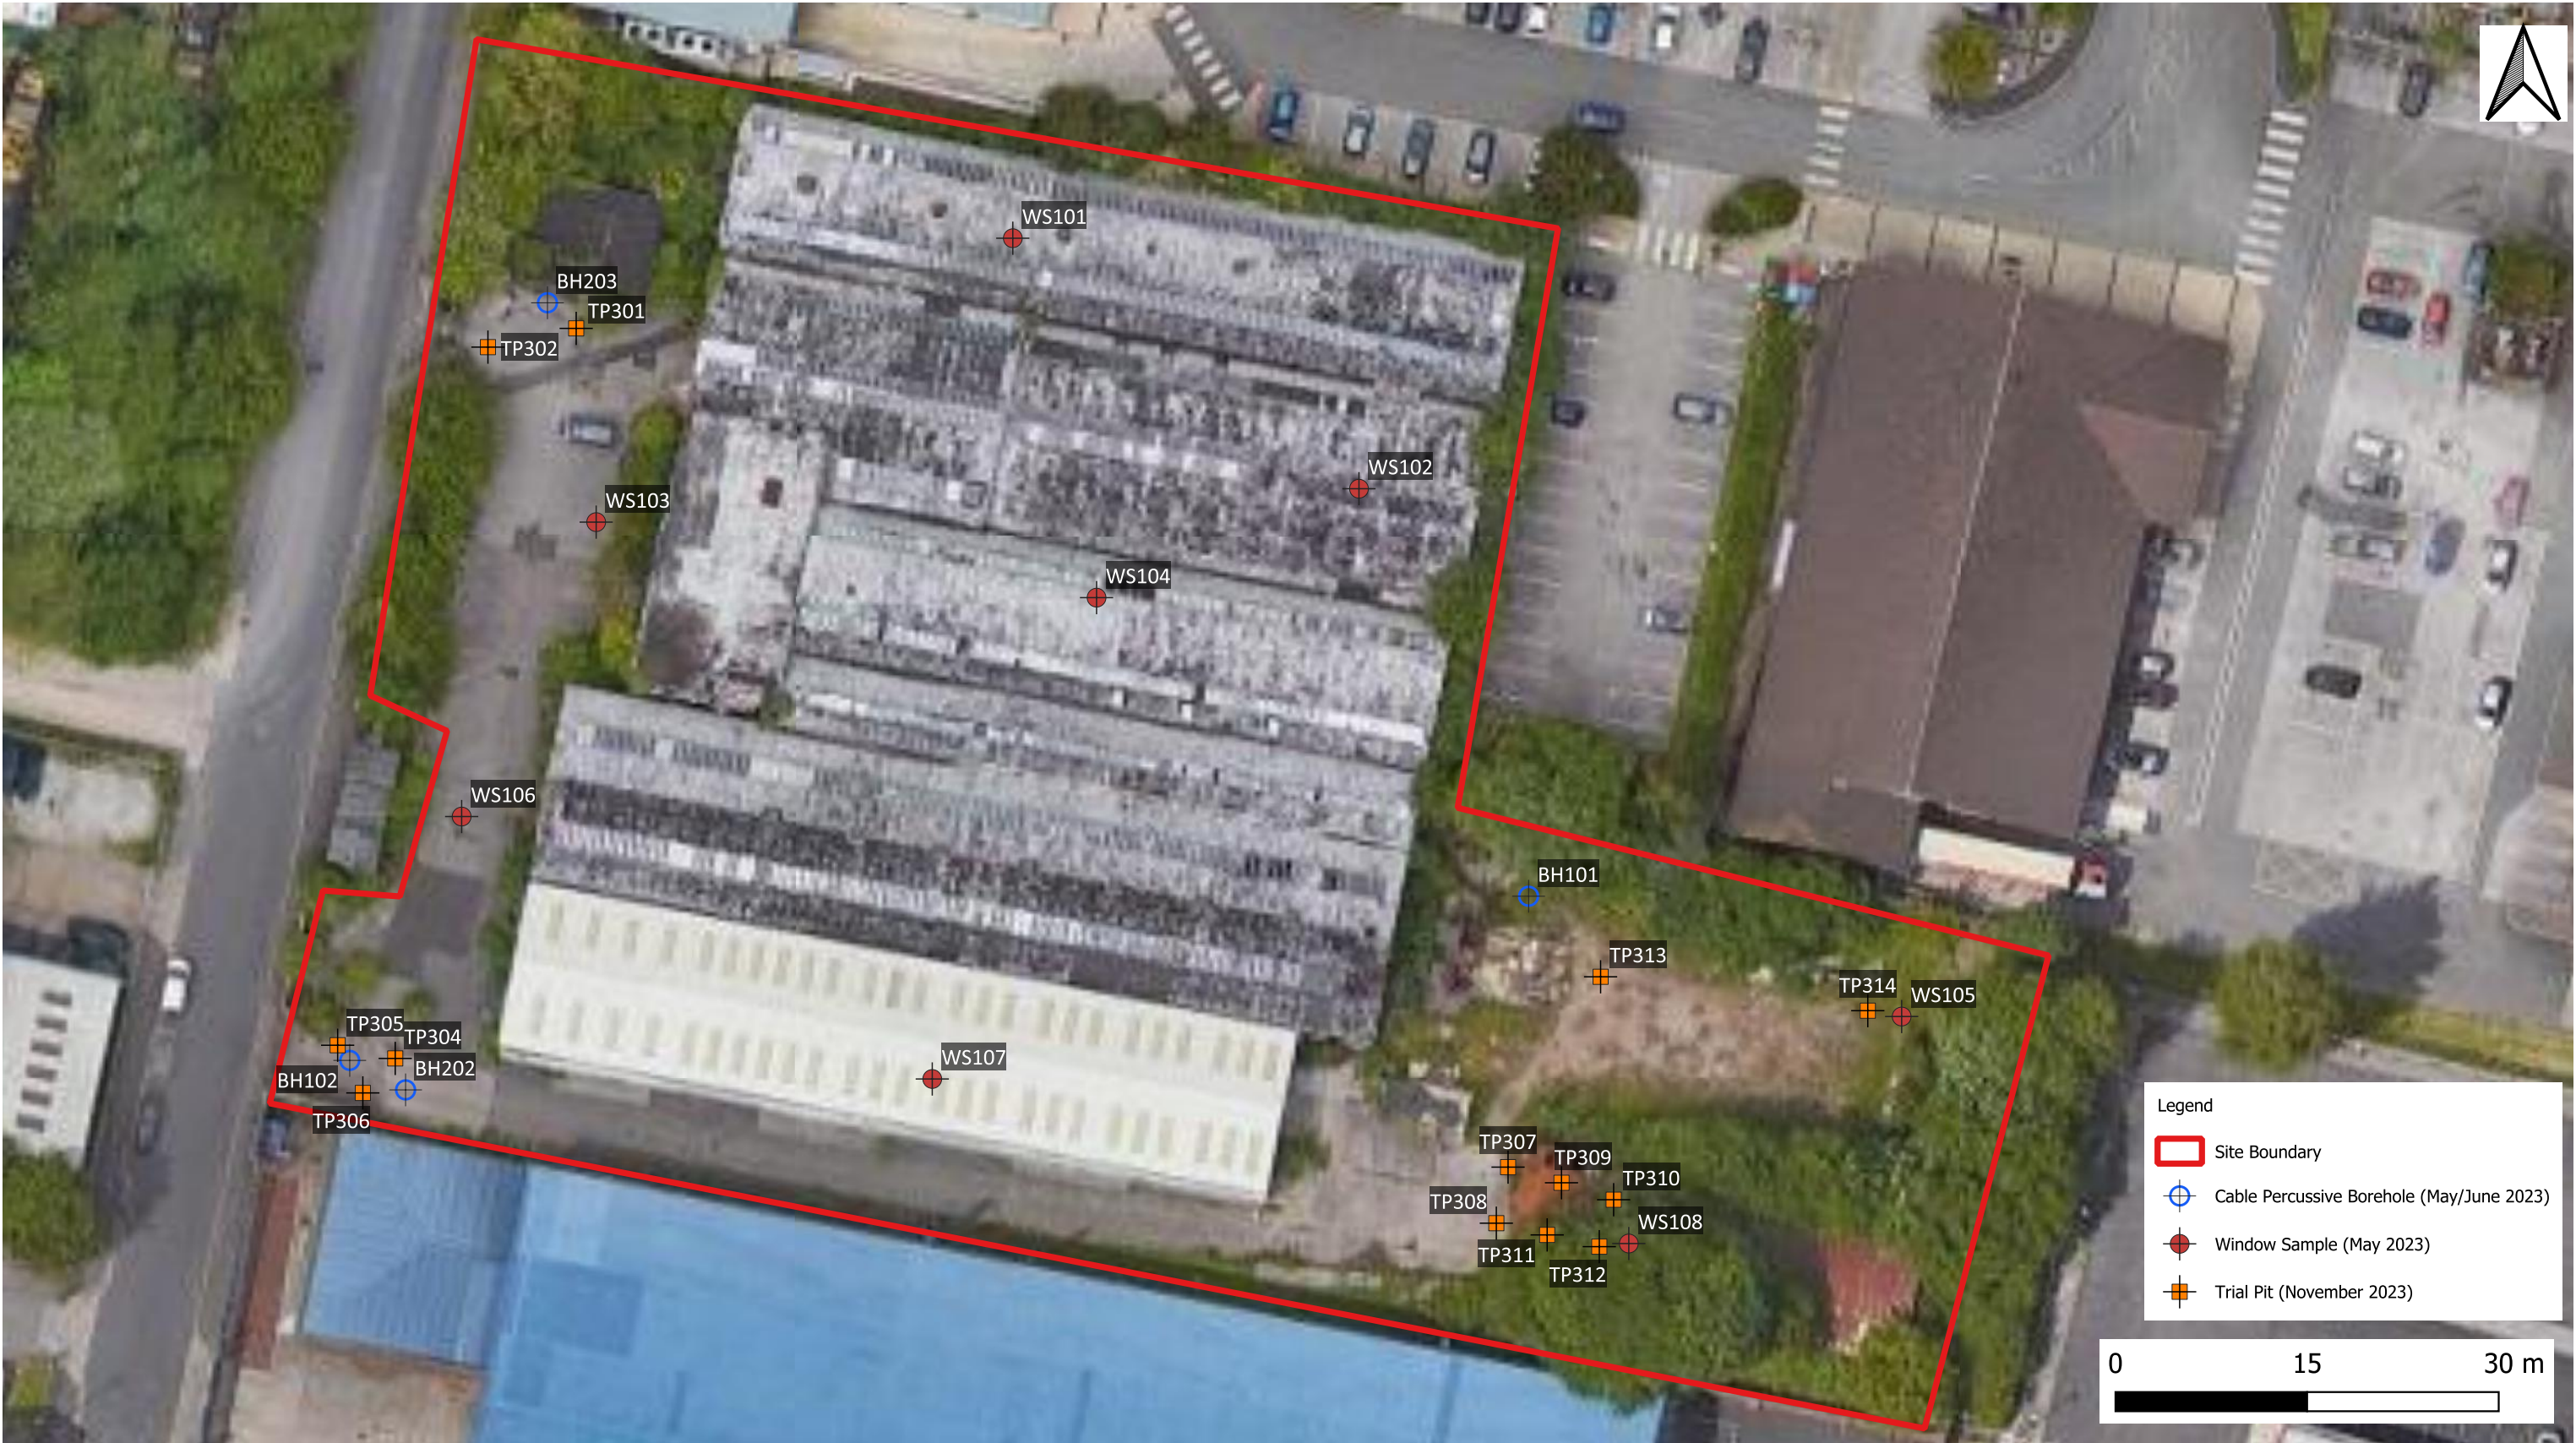
| NOTES | COPYRIGHT NOTES<br><br>Google imagery June 2018 | | | | REVISIONS | | | | <div> Arkwright House<br/>Manchester<br/>M3 2LF</div> | | TITLE<br>EXPLORATORY HOLE LOCATION PLAN | |

TRC have undertaken Phase I and Phase II Geo-environmental and Geotechnical Site Assessments. A summary of the previous assessments are detailed in Table 4. A figure showing the TRC exploratory hole locations is presented as Figure 3 in Annex 1.
