# TREE REPORT SYDNEY AVENUE

Document no: MT2RSYDN-MAN.CP.ZZ.ZZ-JAC-G-RP-FLORA-0001  
Revision no: 1.1

Manchester Airport Ltd

MAG Landside - FI, SA & VCC  
23/04/24

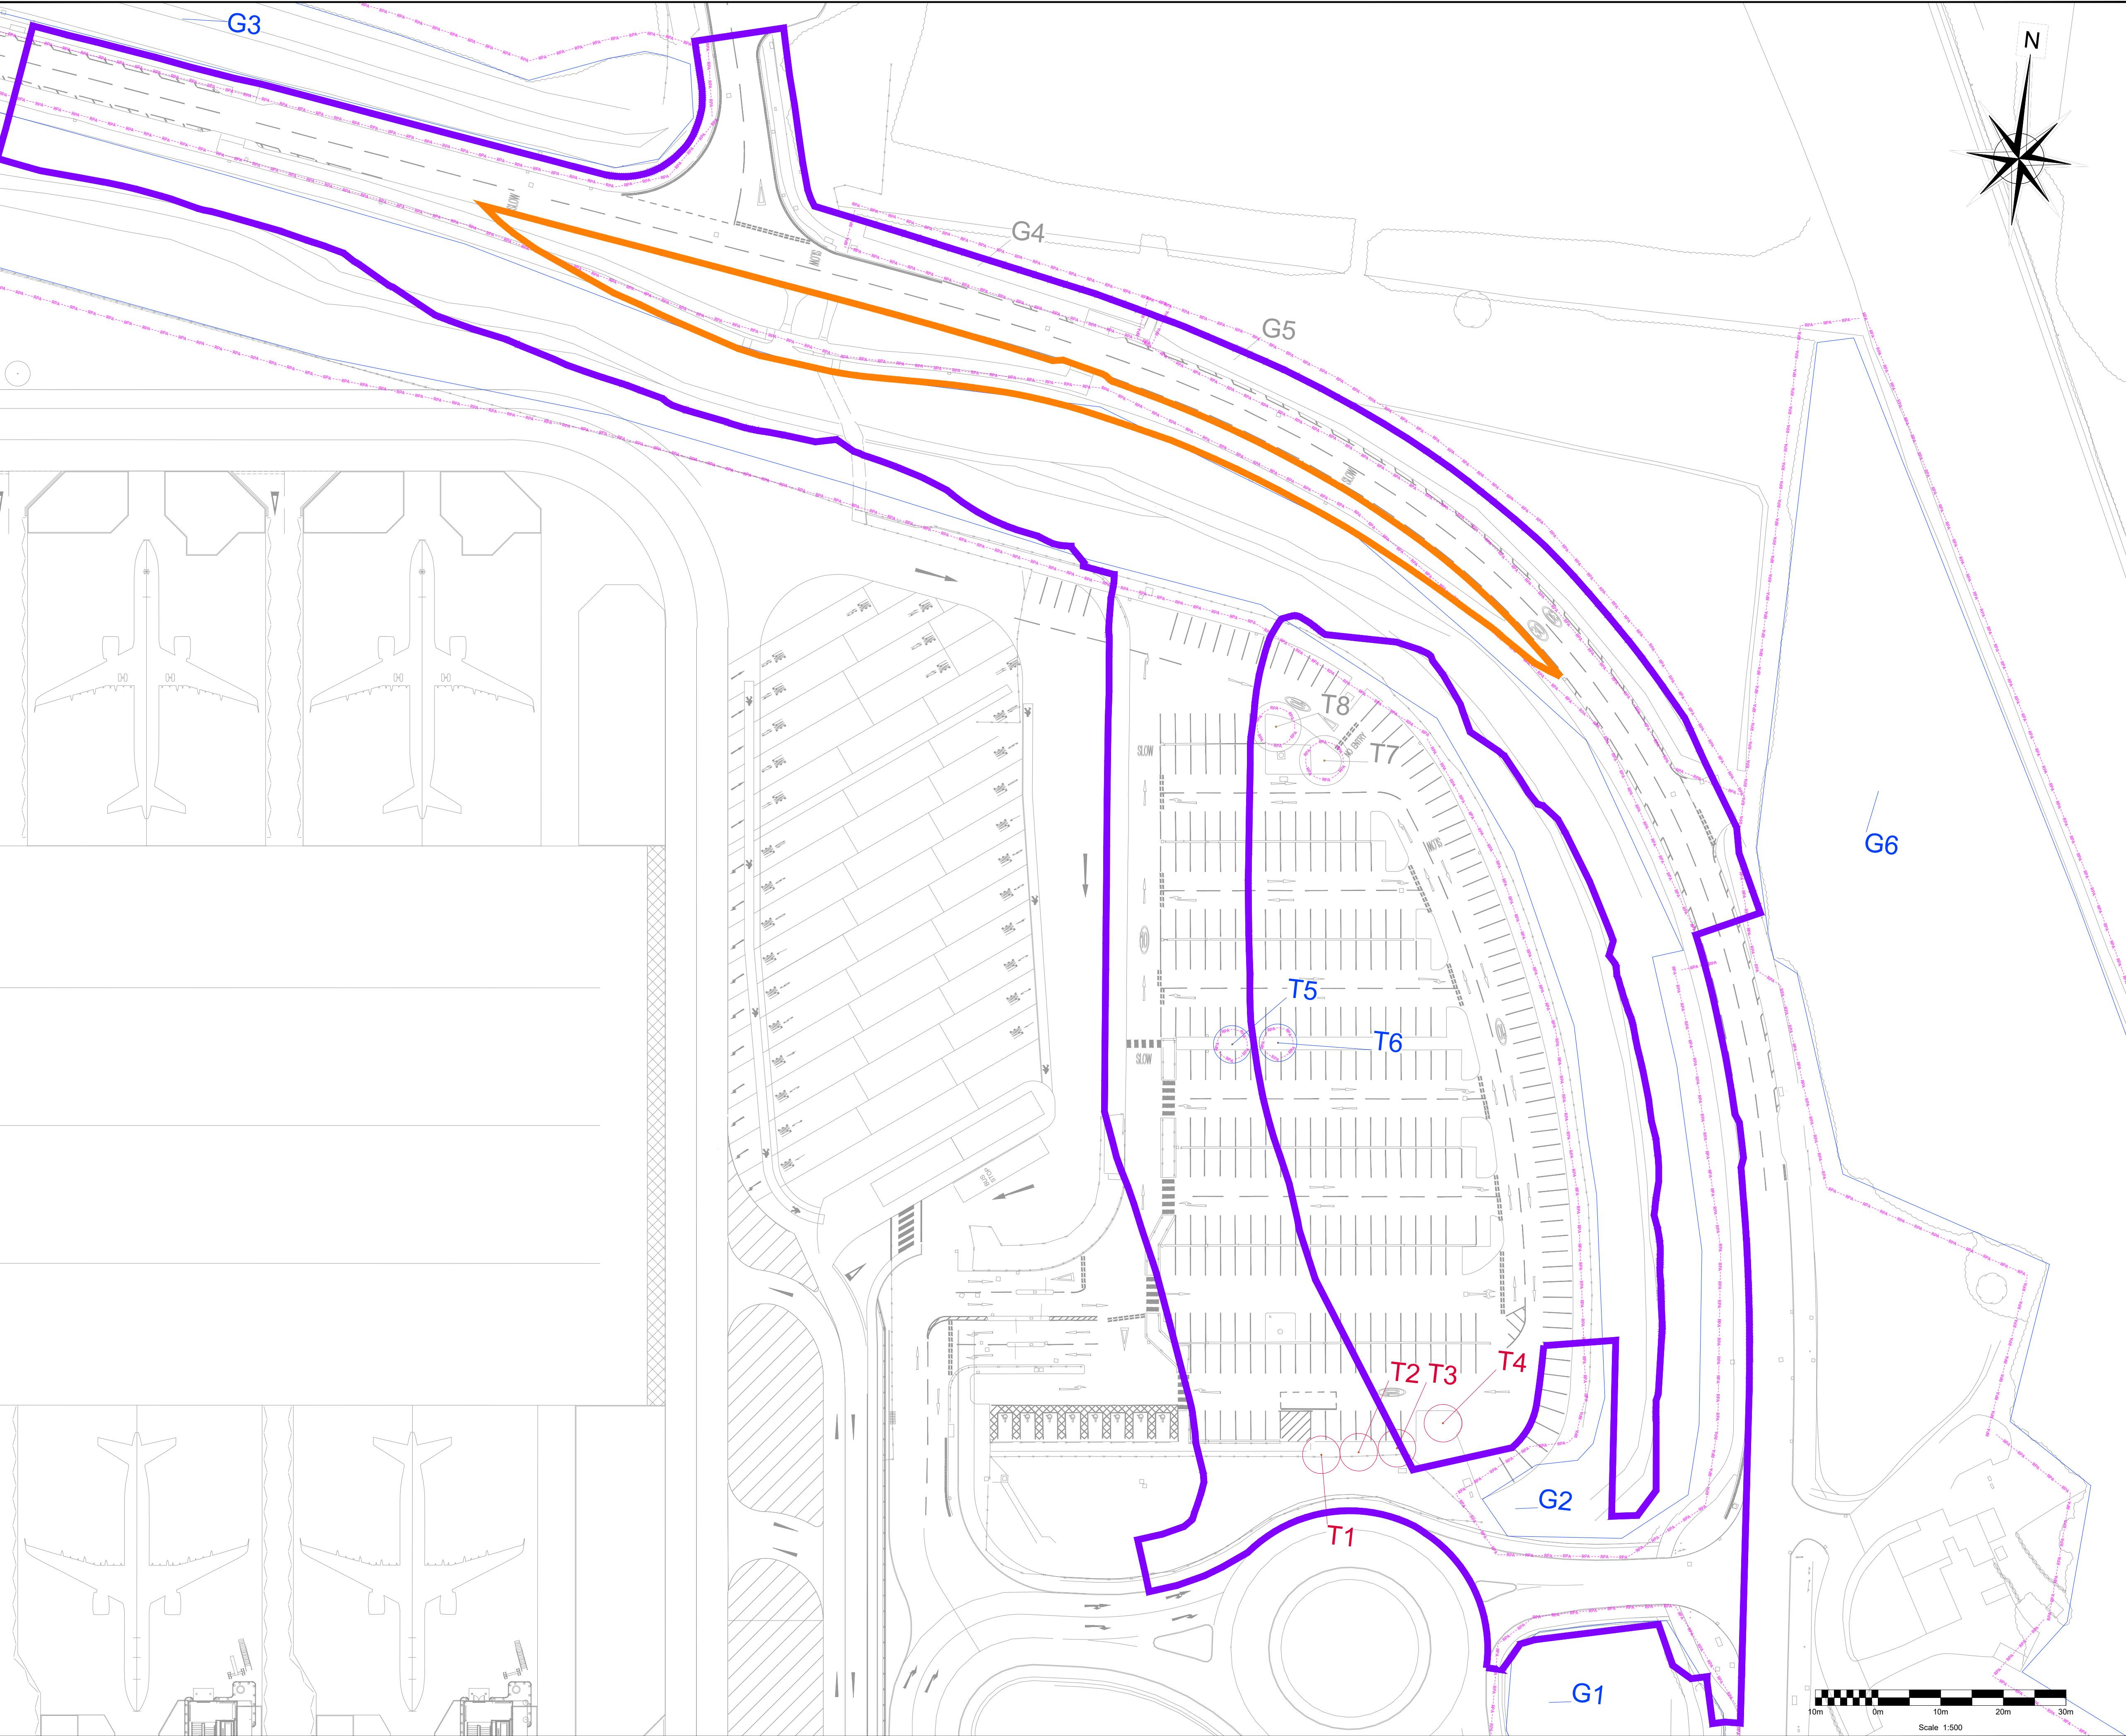
**Appendix F. Tree Constraints Plan**

The Project site boundary (the blue line) is shown in Appendix F (Tree Constraints Plan). Note the survey area may differ from the site boundary.

The tree survey data is shown in Appendix E (Tree Survey Schedule) and was used to produce a Tree Constraints Plan (TCP) in Appendix F, which depicts the existing rooting area and canopy constraints posed by the trees within the Site Boundary.

It is recommended that, in consideration of this AIA and the Tree Constraints Plan (Appendix F) and Tree Removals Plan (Appendix G.), the appointed contractor submit a Site-Specific Arboricultural Method Statement (AMS) as part of the tendering process to detail how they will protect existing trees within temporary working areas, as well as detailing their construction techniques to be used where construction activity is to occur within an RPA. The contractor should only remove trees within the Project Site that are absolutely necessary to facilitate the scheme, as shown on the Tree Removals Plan (Appendix G).

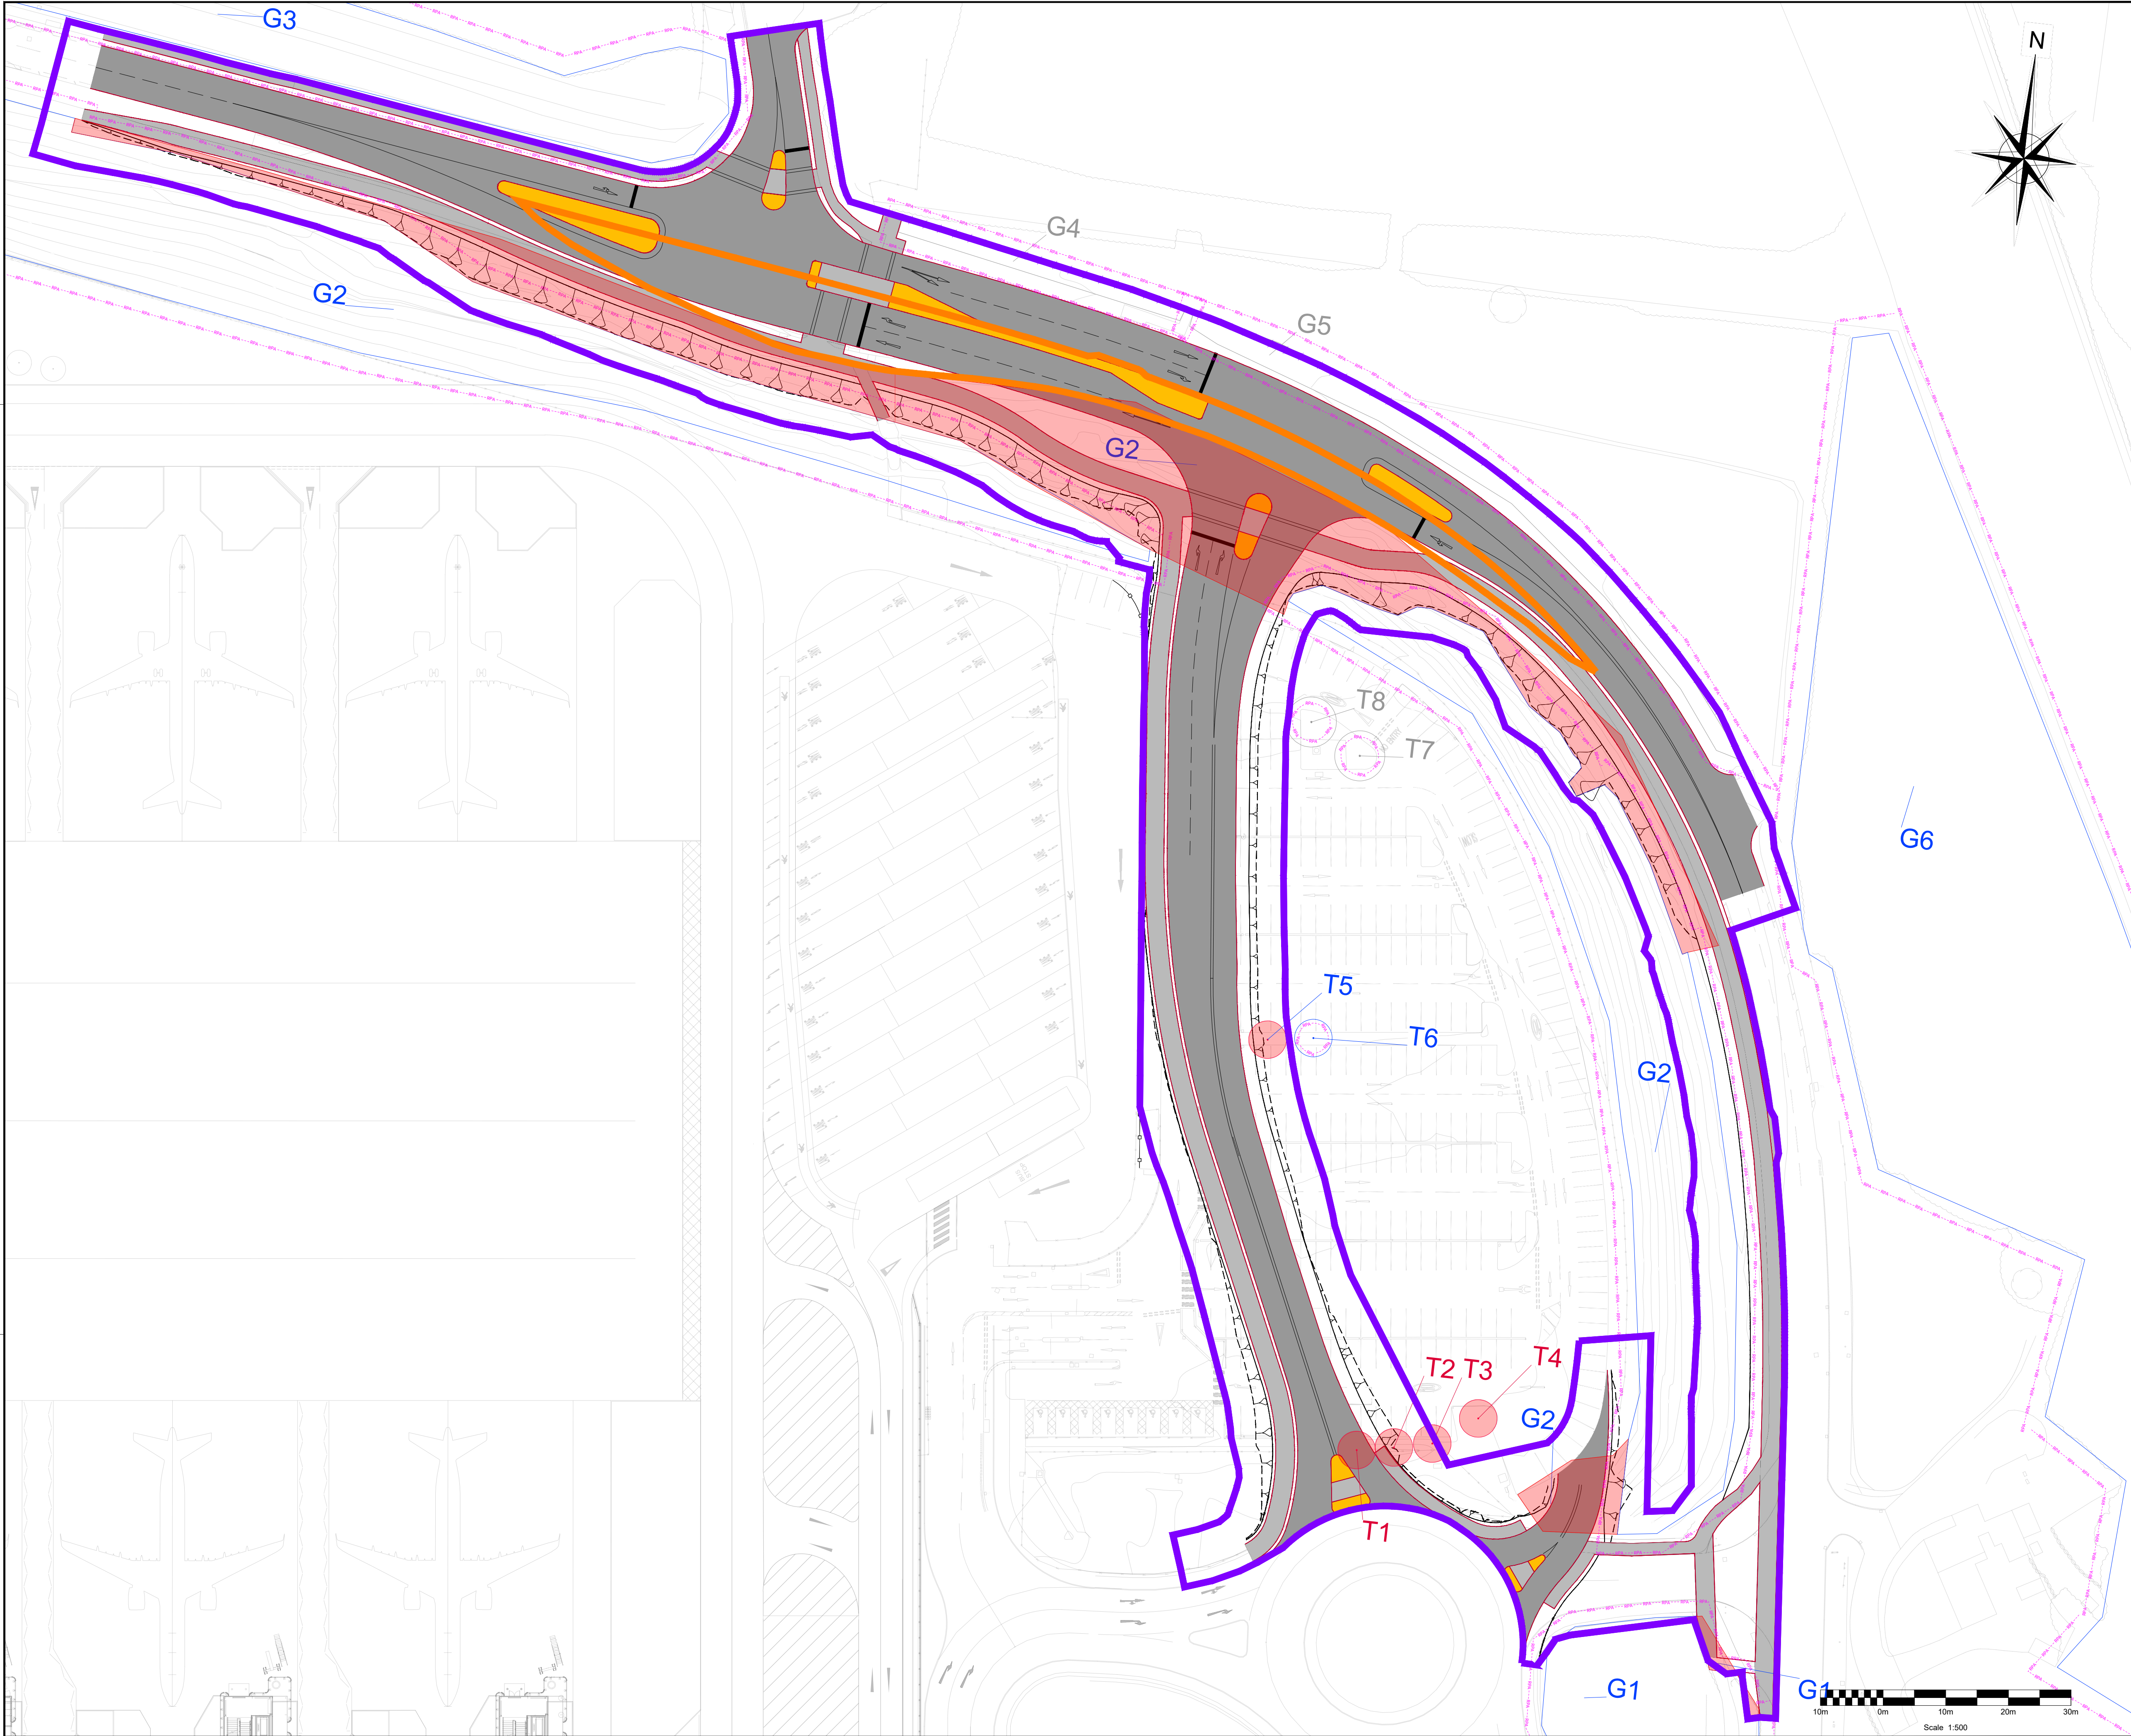
**Appendix G. Tree Removal Plan**

The planning application is limited to seeking planning permission for the creation of a new access from the northern end of the new road to the Thorley Lane carriageway. The extent of the planning application boundary and the extent of the project boundary are shown on the plan in Appendix G.

This report is based upon the most recent revision of the General Arrangement. The scheme is shown on the Tree Removal Plans, Appendix G.
