**EMBASSY VILLAGE (ADDITIONAL)  
EGERTON STREET  
MANCHESTER  
M15 4NU**

**FACTUAL REPORT ON  
GROUND INVESTIGATION**

**Contract: 2230942**

**Date: March 2023**

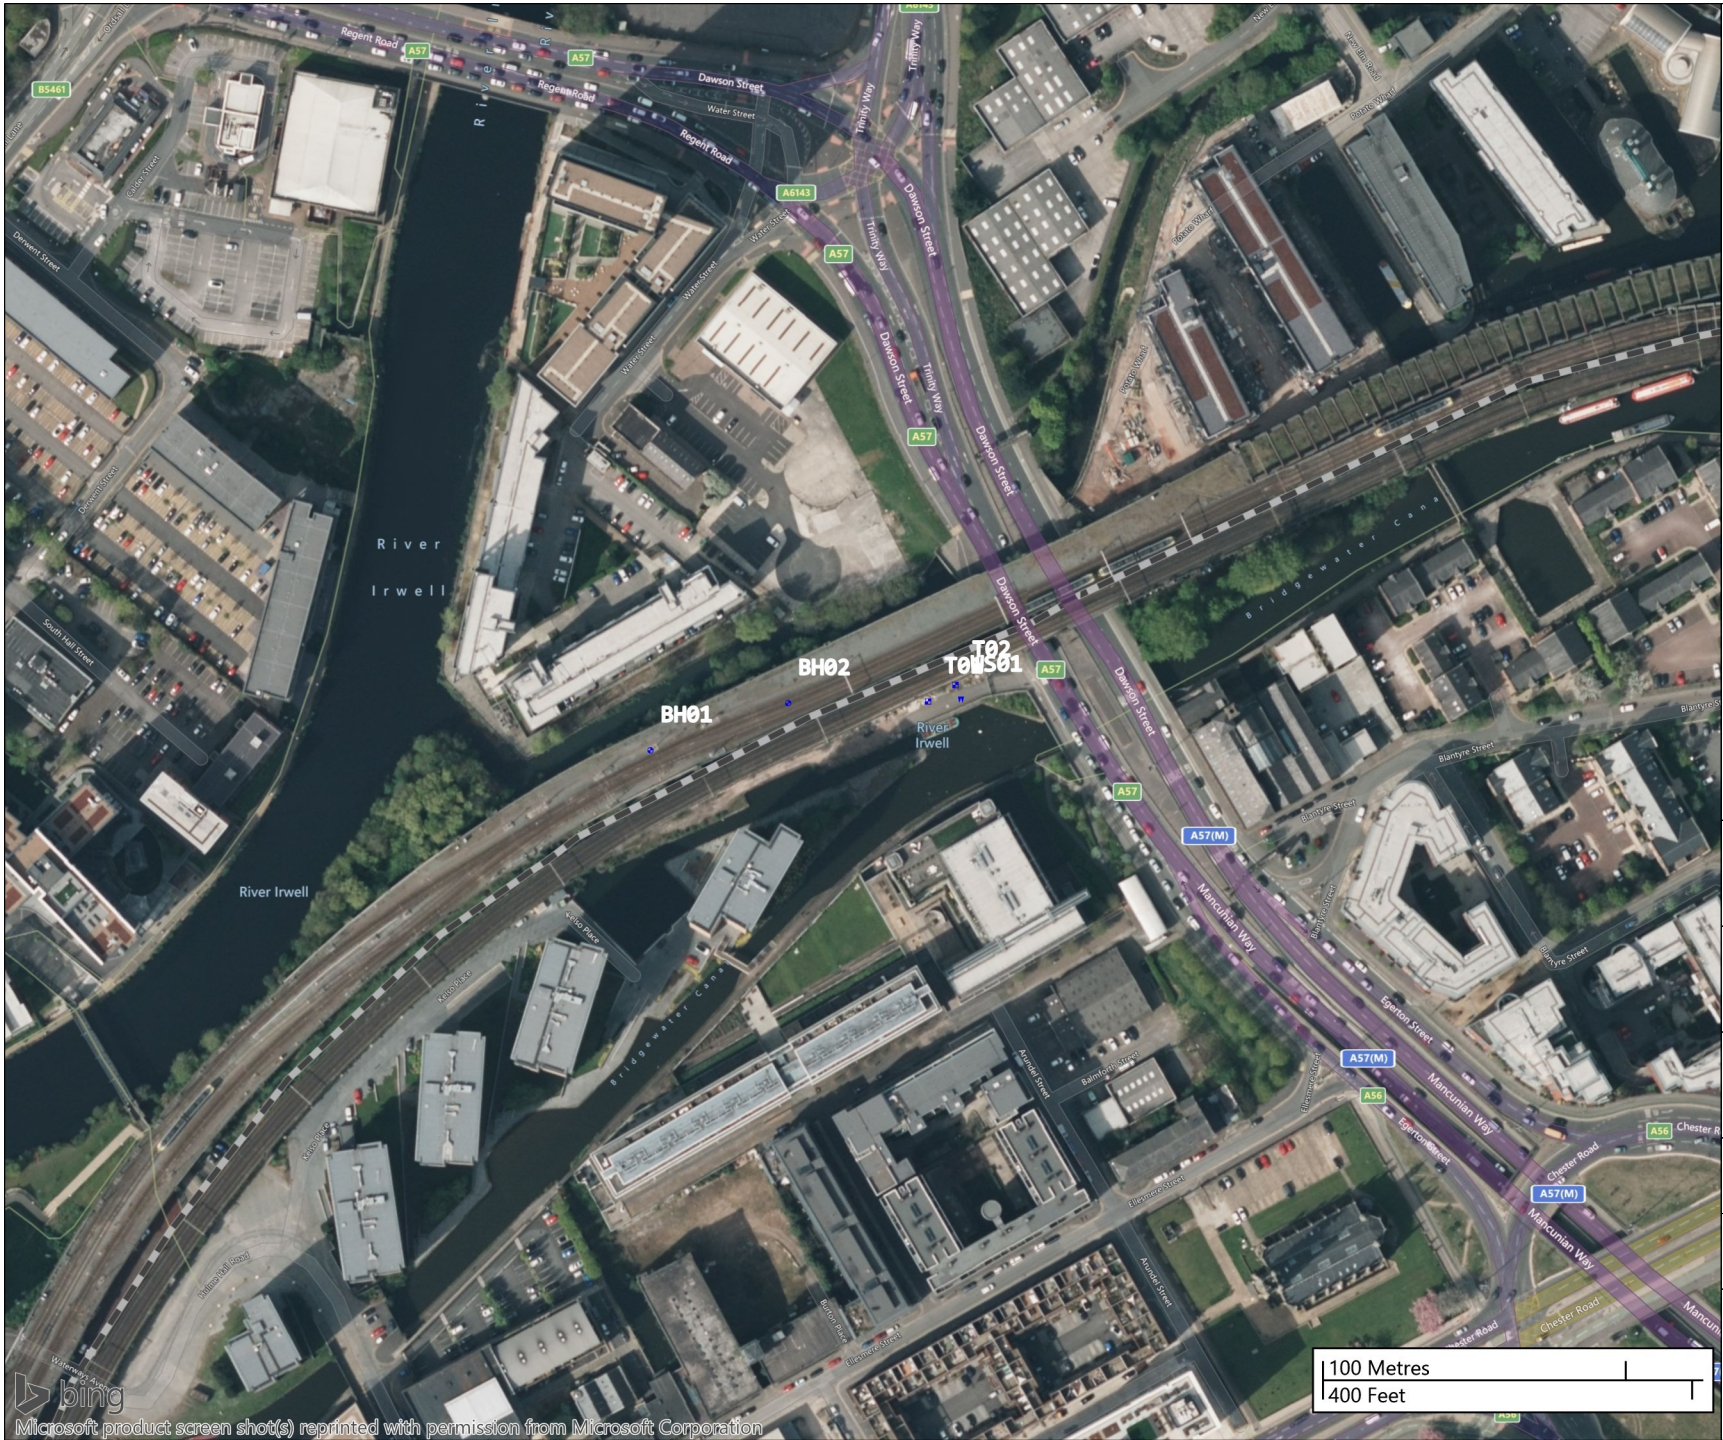
| Fig. A1.2 | (00) |

- 3.5 A site plan showing the positions of the exploratory holes is presented in Appendix 1 as Figure A1.2.
- 3.6 The depths of exploratory holes, descriptions of strata encountered and comments on groundwater conditions are presented on the records in Appendix 2.

| Exploratory Hole Location Plan | |

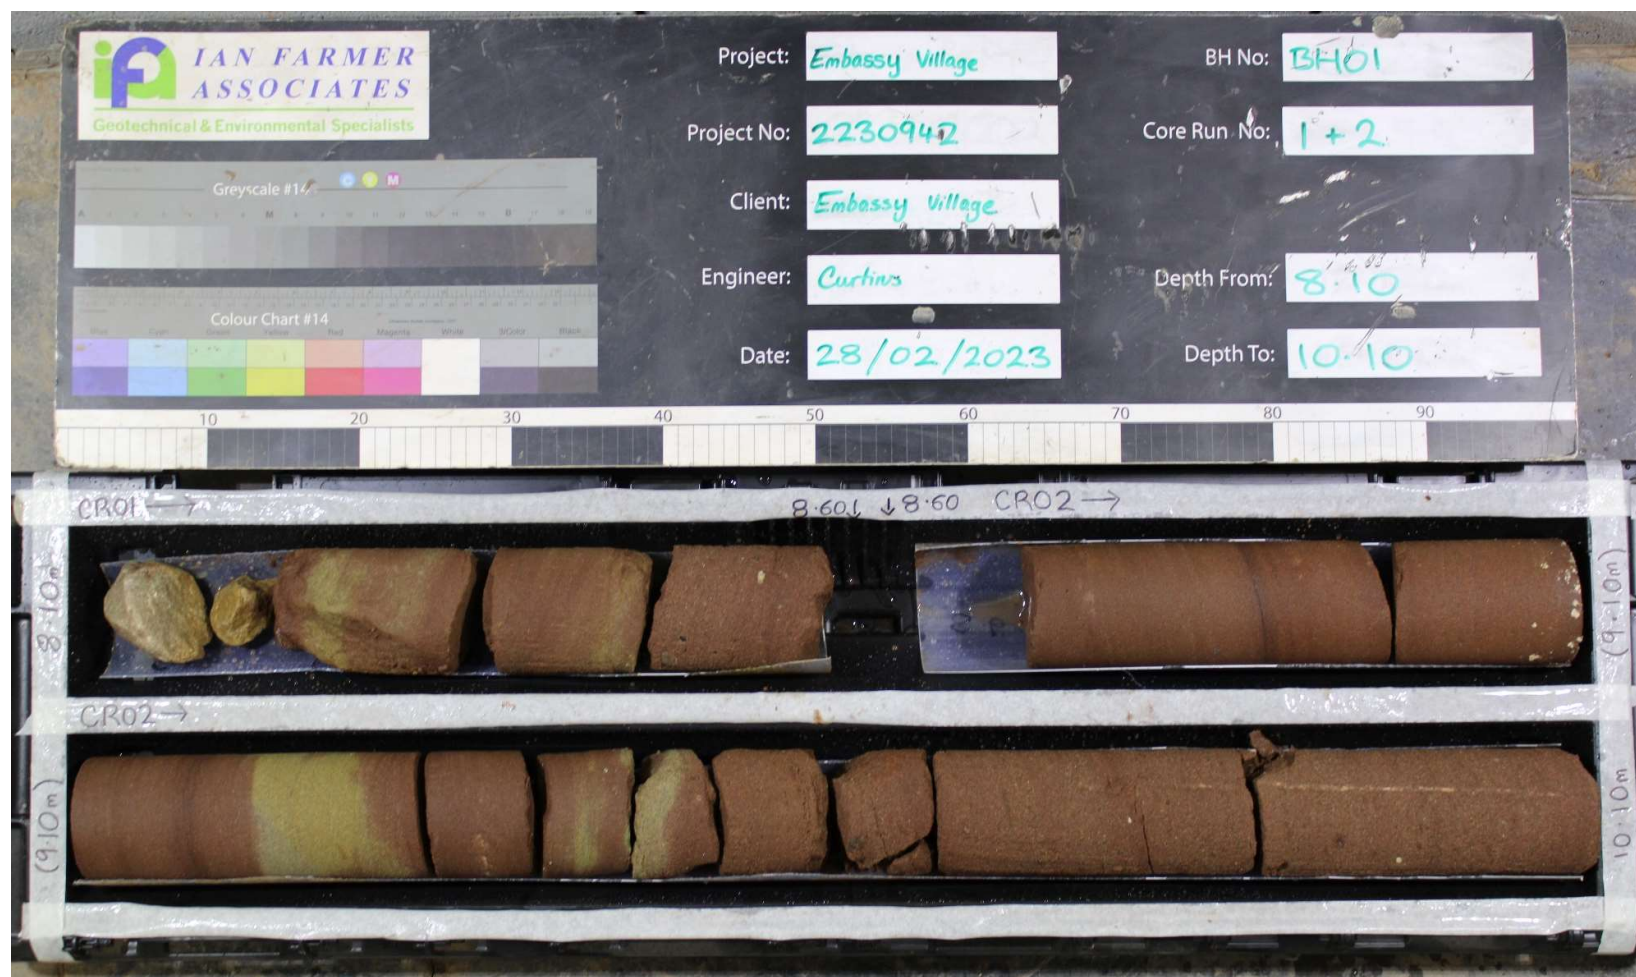
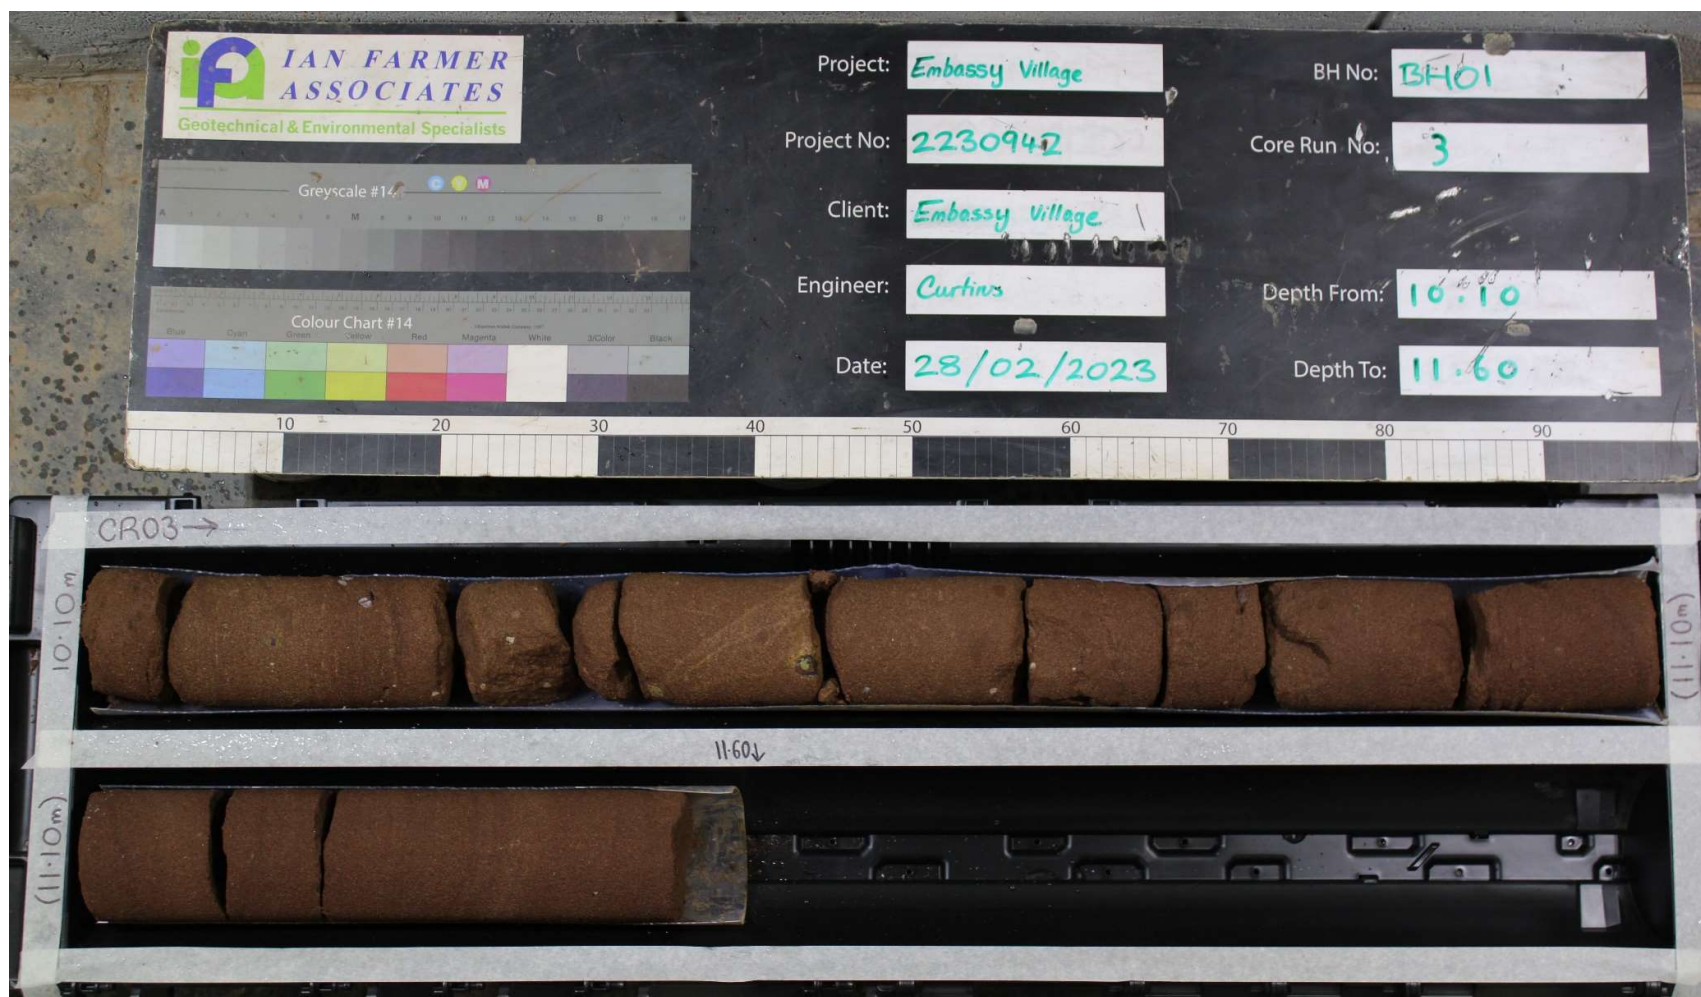
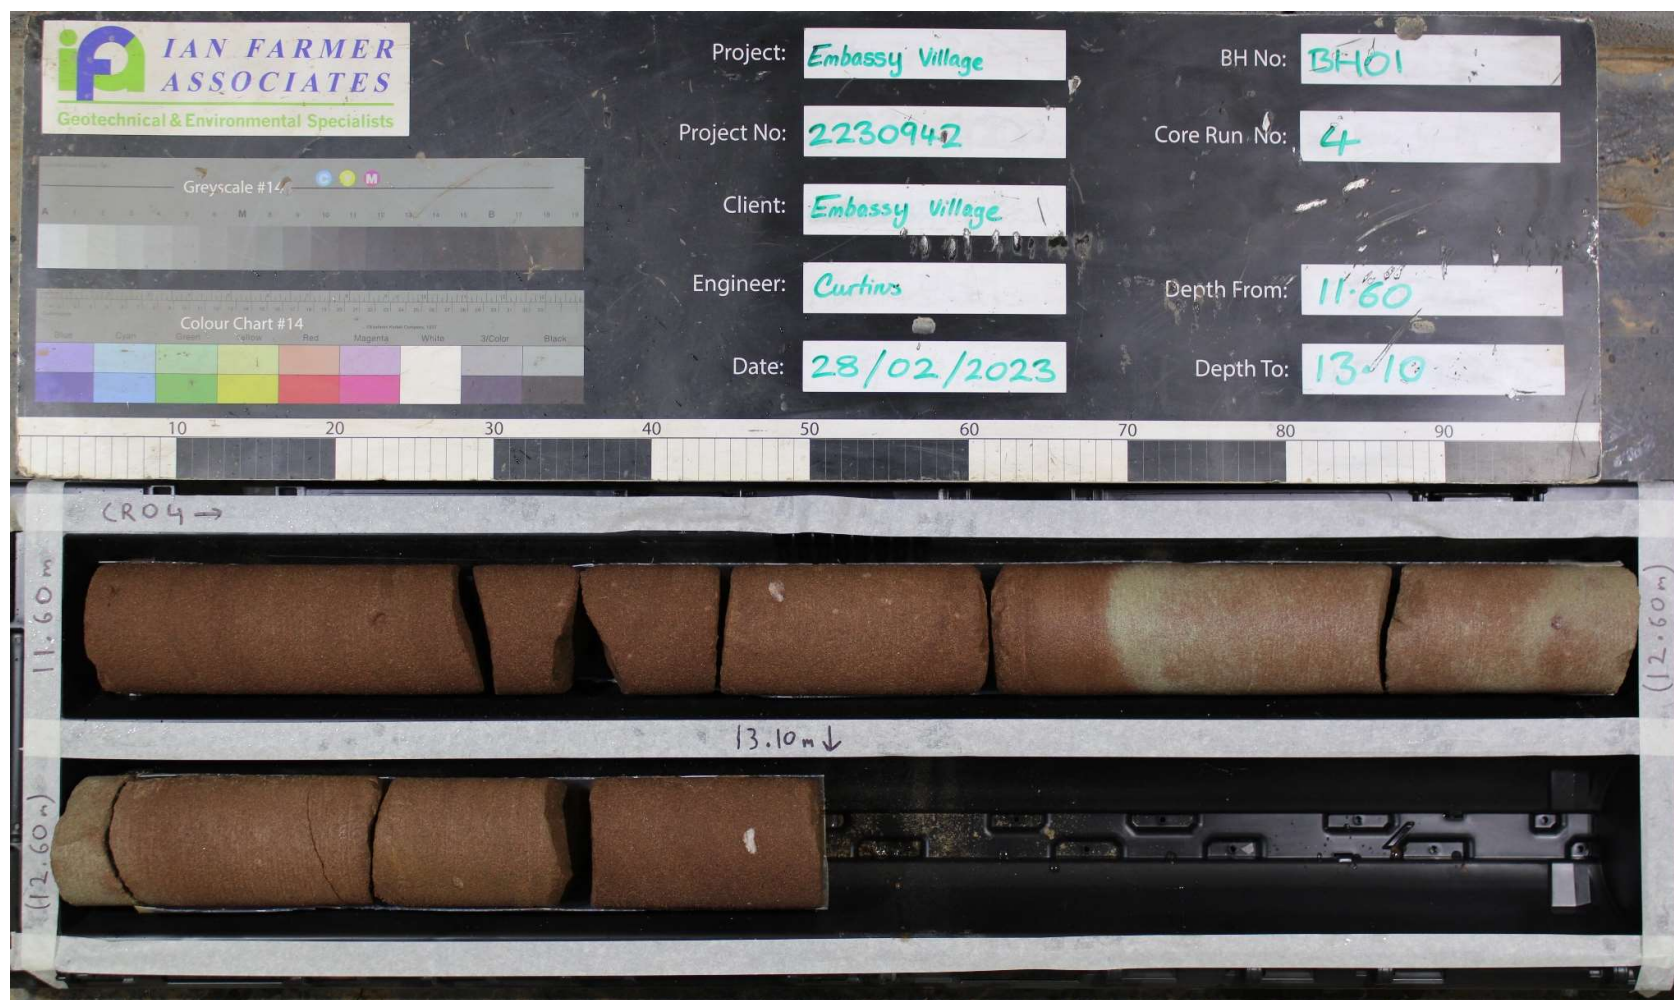
## Core Photographs BH01

| 10.10 - 11.60 | 93<br>84<br>70 | 3 | | | 10.33 | Moderately weak, reddish brown, fine and medium grained SANDSTONE with occasional greenish grey discolouration spots and surface stained yellowish brown, approximately 1mm.<br><i>Between 9.50m and 9.70m: occasional partings, 0-15 degrees, very closely spaced, planar.</i> | | 11 | | | | | | | |
| 11.60 - 13.10 | 100<br>95<br>77 | 0 | | | (2.17) | Weak, reddish brown, medium grained SANDSTONE with rare pebbles, subangular to rounded including mudstone. Discontinuities are 5 degrees, planar, smooth, clean.<br>Weak, reddish brown, medium grained SANDSTONE with occasional subangular to subrounded gravel including mudstone and rare discolouration spots, greenish grey, 4-6mm. Discontinuities are 1) 0-12 degrees, very closely to closely spaced, planar smooth to rough, clean. 2) 0-5 degrees, closely to medium spaced, undulating with reddish brown silt coating. 3) 1No. fracture, 87 degrees, planar, smooth clean.<br><i>Below 10.90m: moderately weak. Between 11.84m and 13.10m: Discontinuities are 1) 18 -20 degrees, closely to medium spaced, planar smooth, clean. 2) 0-5 degrees, closely to medium spaced, undulating with reddish brown silt coating.</i> | 12 | | | | | | | | |
| | | | | | 12.50<br>(0.60) | Moderately weak, reddish brown with grey discolouration, medium grained SANDSTONE with rare subangular to rounded, fine and medium gravel including quartz. Discontinuities are 15-30 degrees, closely spaced, planar, smooth clean. | | 13 | | | | | | | |

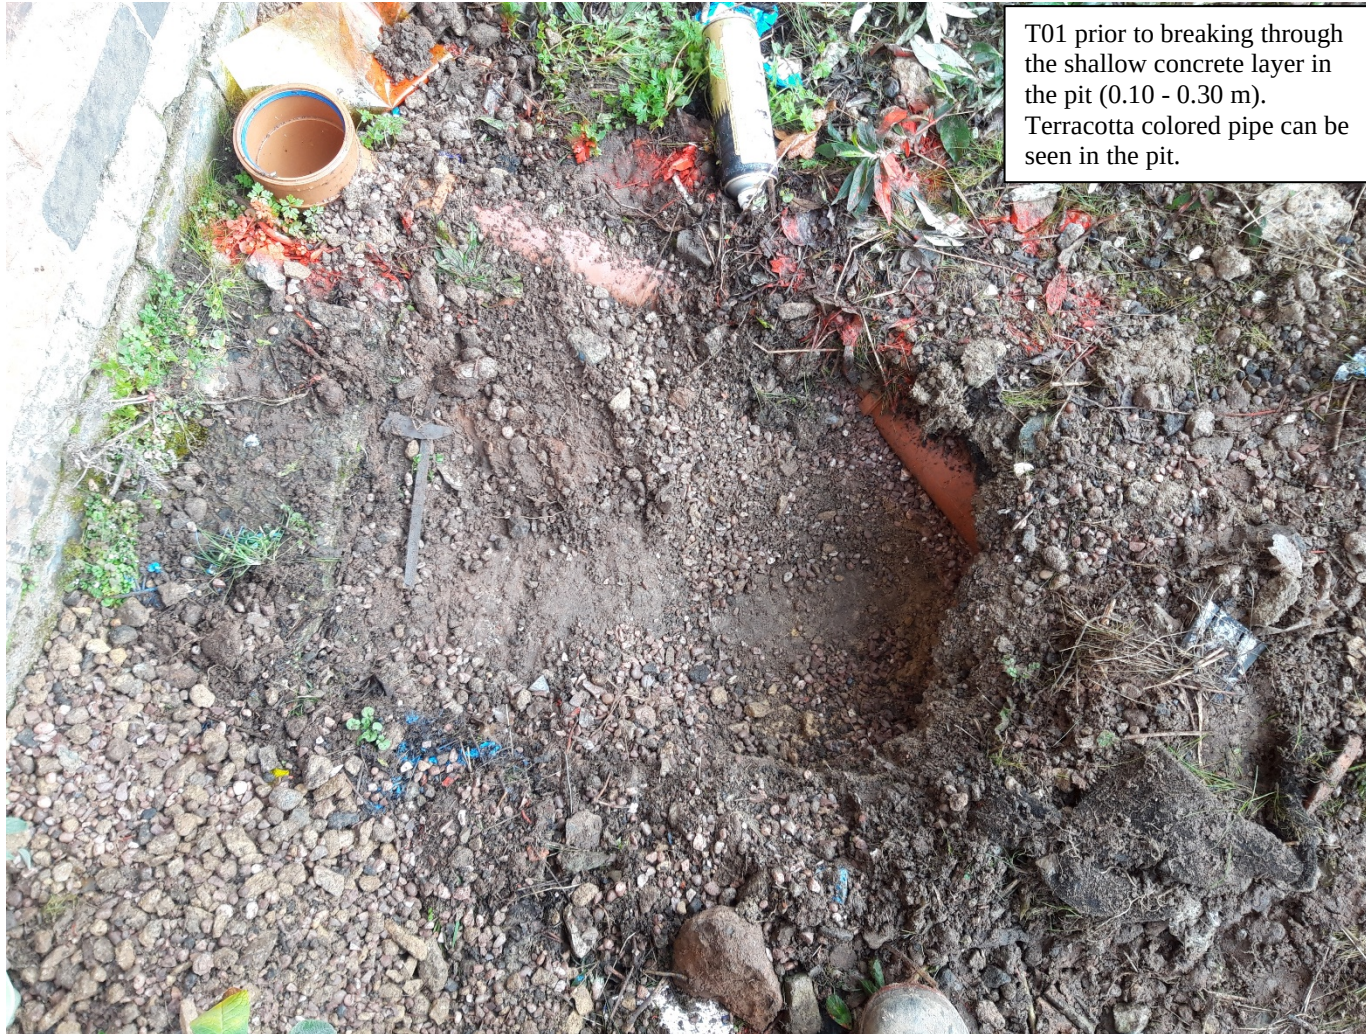
## **Trial Pit Photographs T01**

T01 prior to breaking through the shallow concrete layer in the pit (0.10 - 0.30 m).  
Terracotta colored pipe can be seen in the pit.

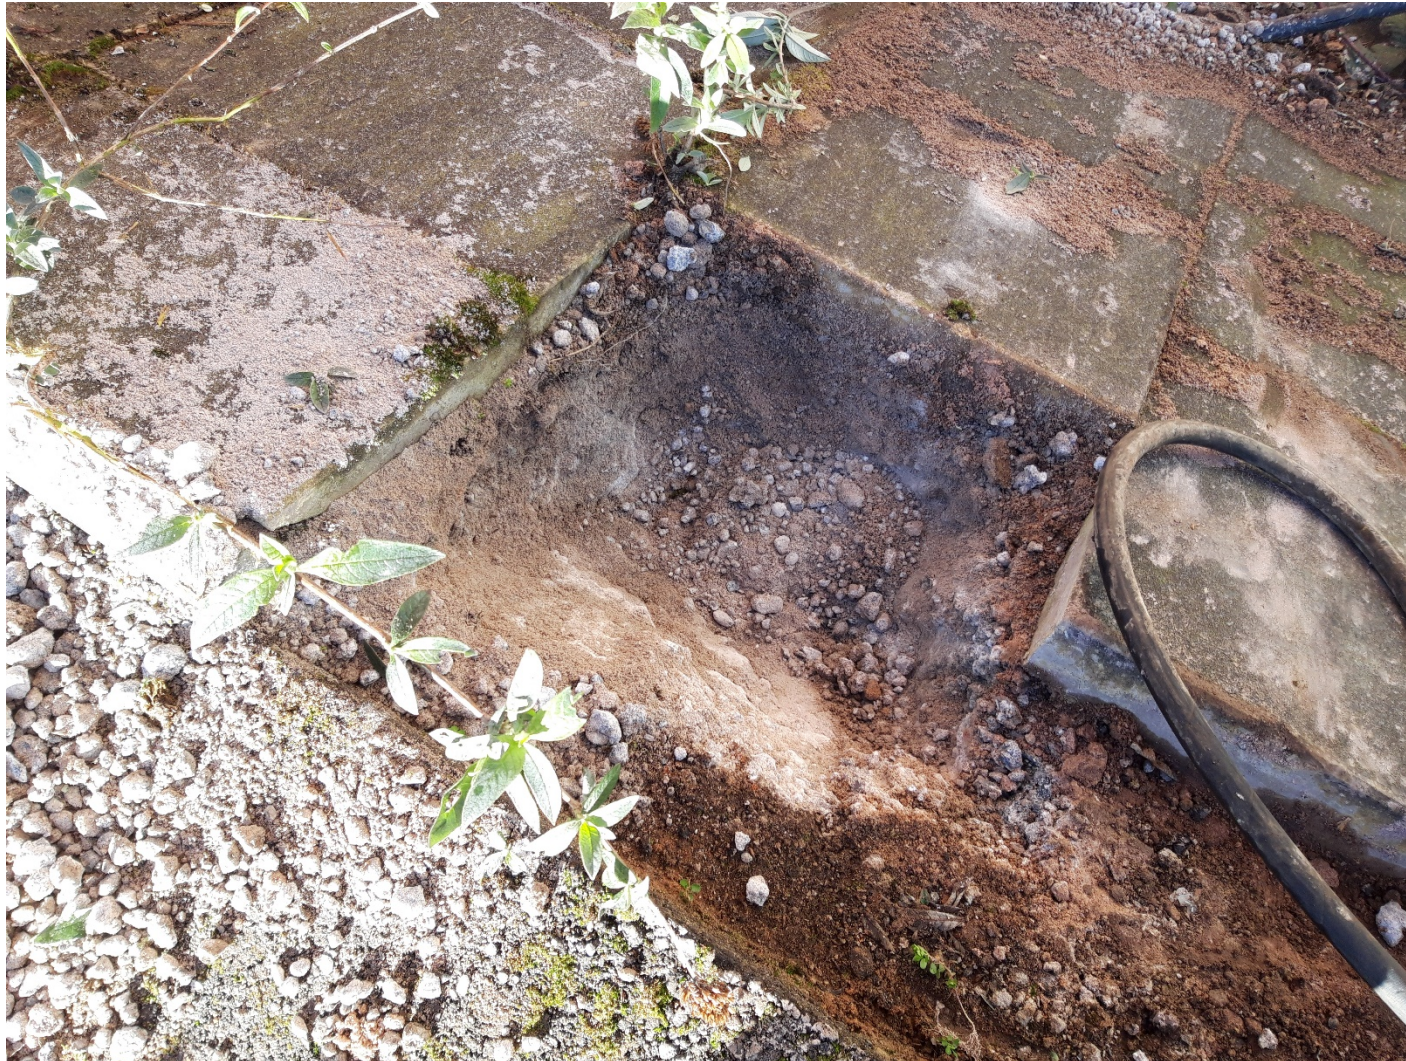
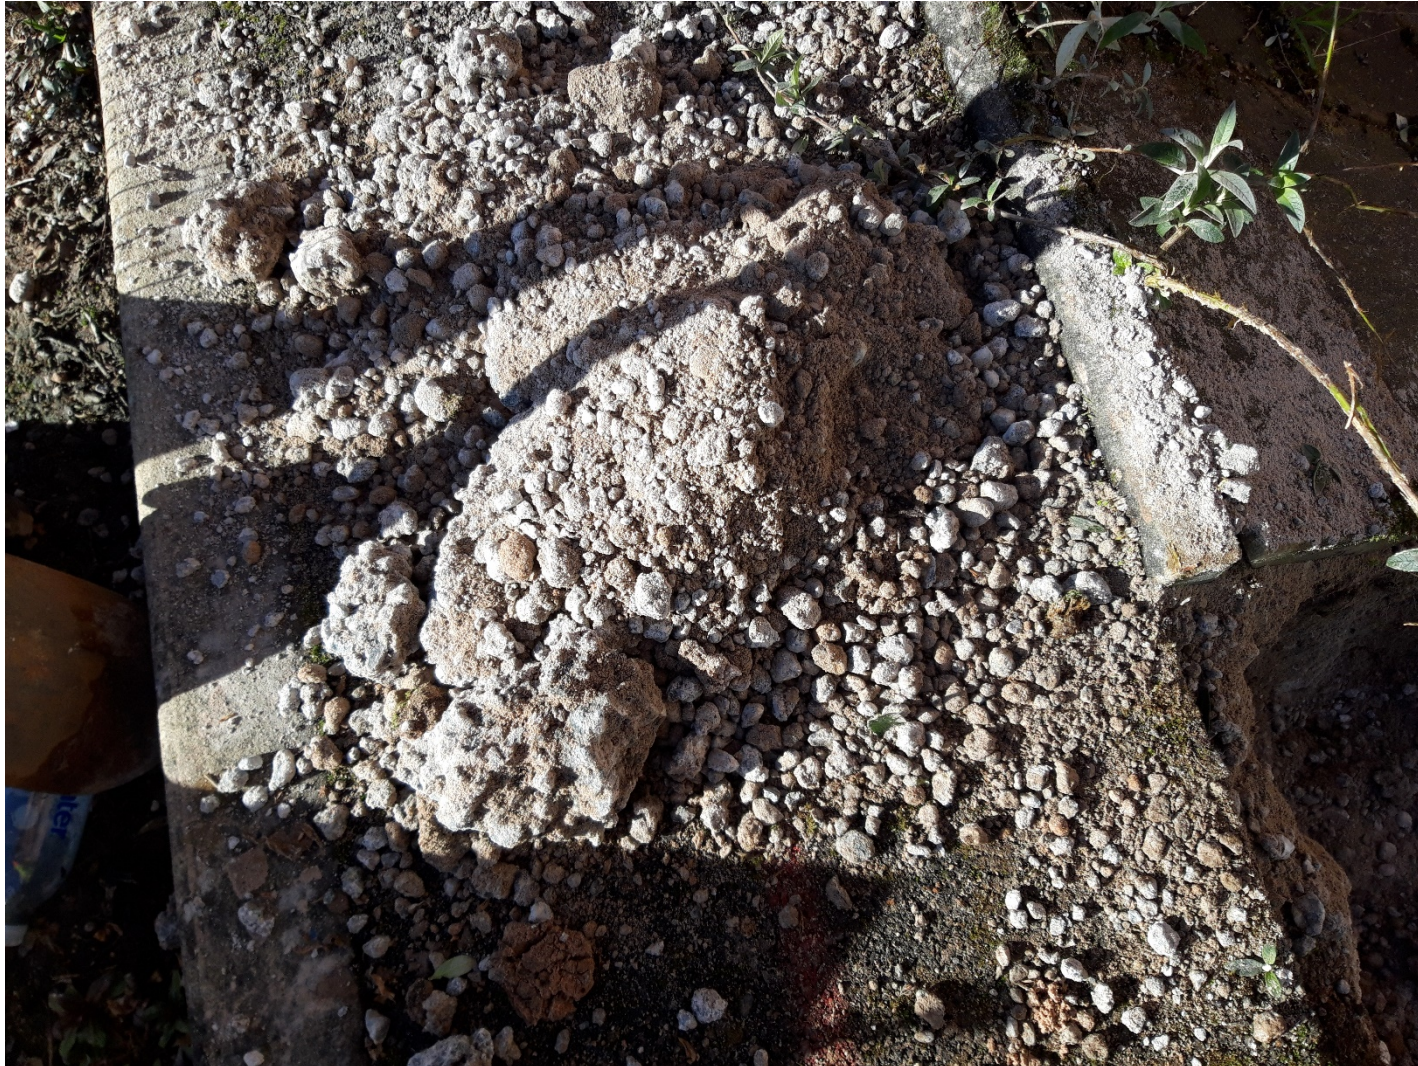
## **Trial Pit Photographs T02**

| | | | | 0.10 | MADE GROUND: Paving slab. | | 1 | | |
| | | | | (0.30) | MADE GROUND: Concrete. | | | | |
| | | | | 0.40 | End of Trial Pit at 0.40m | | | | |
