# Heritage Statement

77-79 Mosley Street  
Manchester  
M2 3FX

Client: Biz Assets Ltd  
Date: May 2023  
Revision: \_C

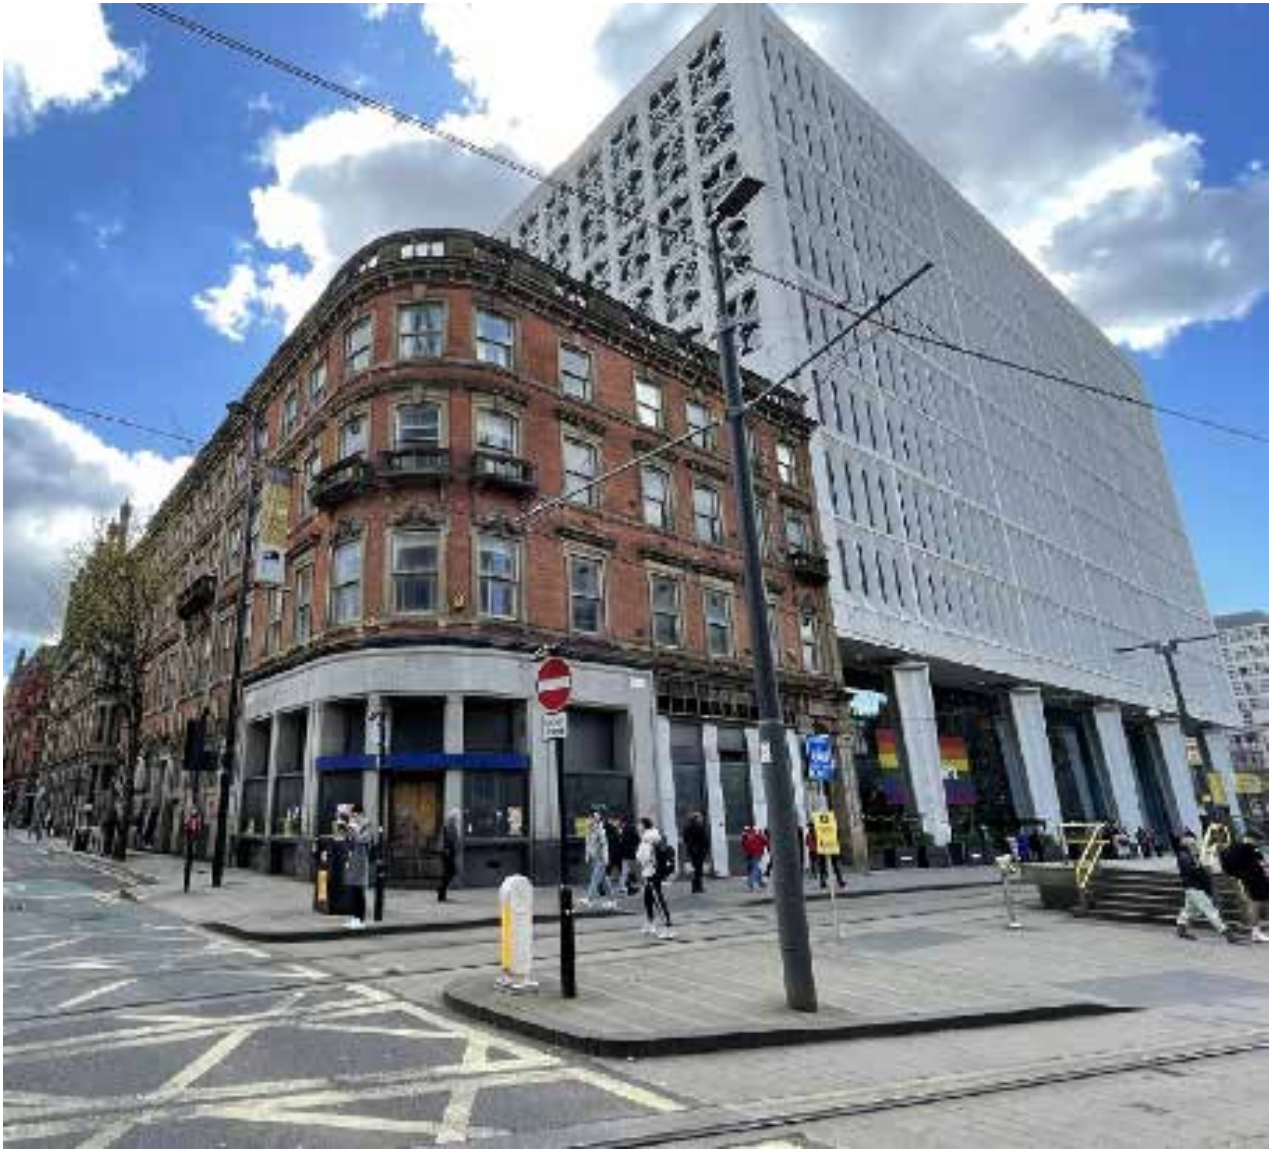
Image 3: Contemporary photograph of 77-79 Mosley Street, with the modern block of 2 St. Peter's Square to the right.

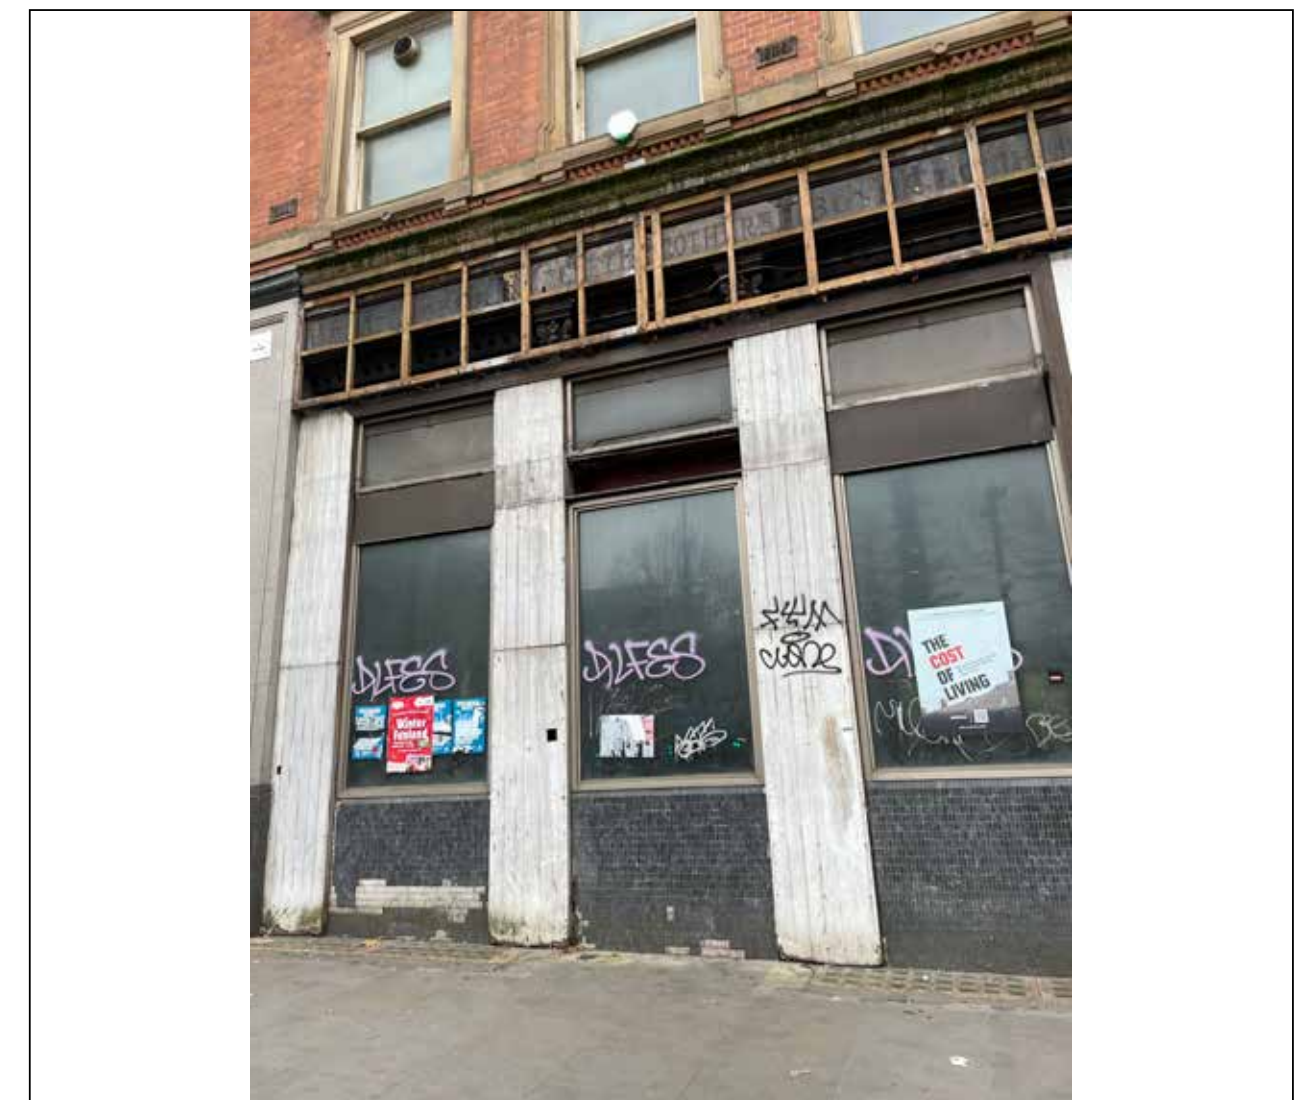
Images 12,13: Top: Detail of modern inserted shop front over historic fabric, Mosley St. Bottom: Back George St. elevation.

Modern shop front at 77a Mosley Street to be removed and historic timber framed frontage behind revealed, retained, and repaired (former Macbeth Tailors). Stone signage within this frontage to be revealed and retained.

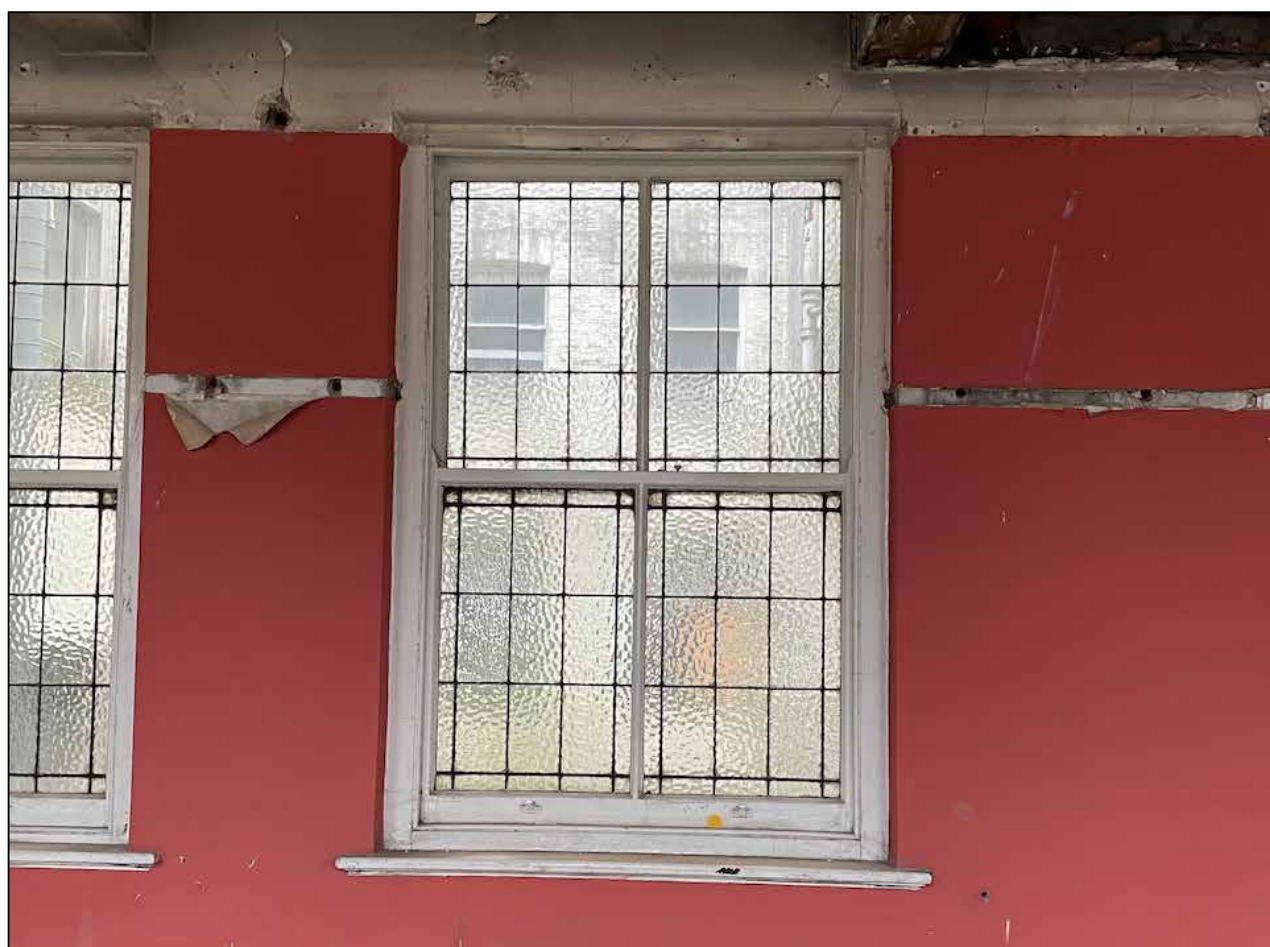
image 14: Photograph showing typical early 20th century leaded windows to lightwell.

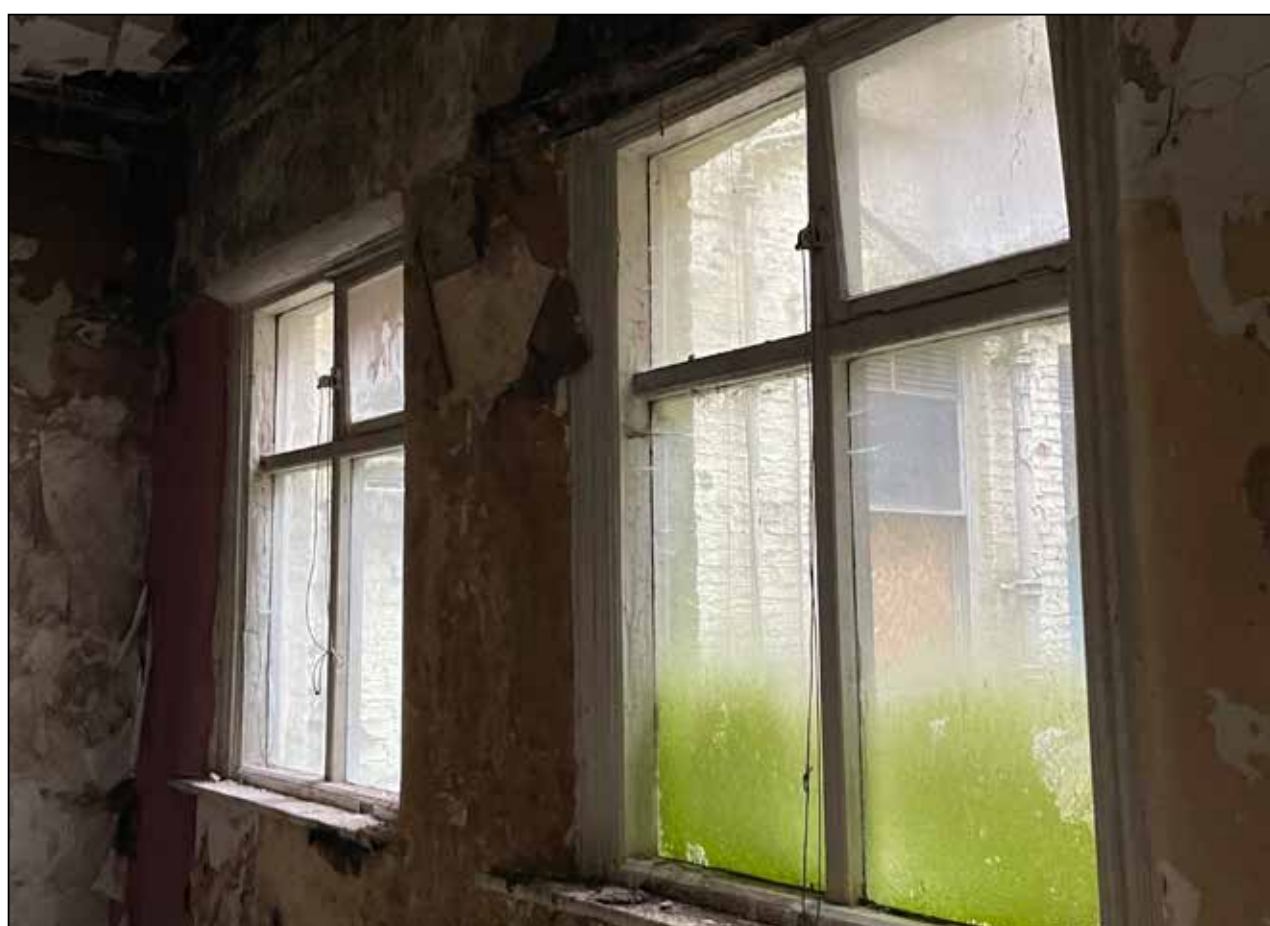
Image 15: Photograph to show later inserted windows to lightwell, upper floor.

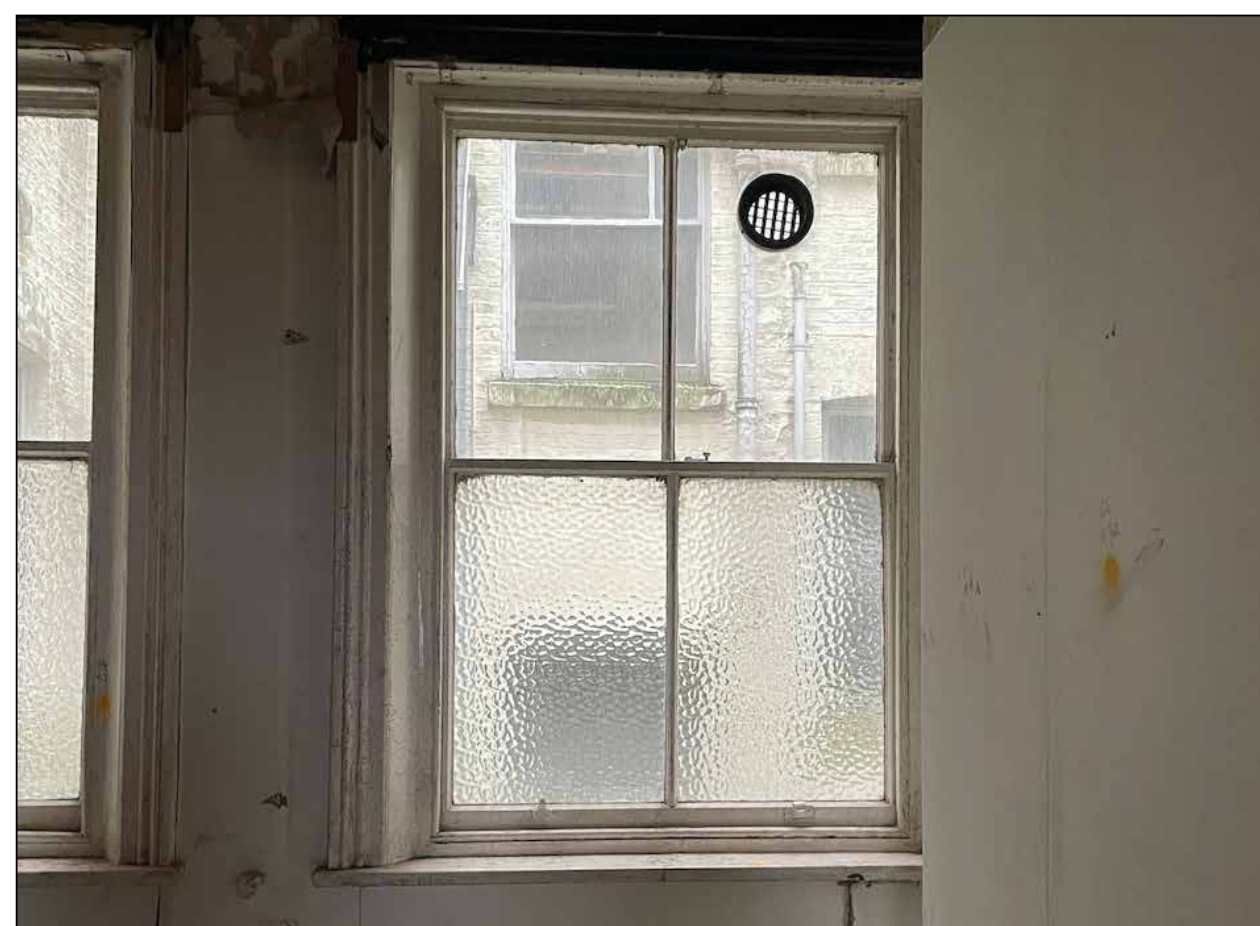
Image 17: Photograph showing example of two over two sliding sash windows to lightwell, with vent hole and obscured glass (later alteration).

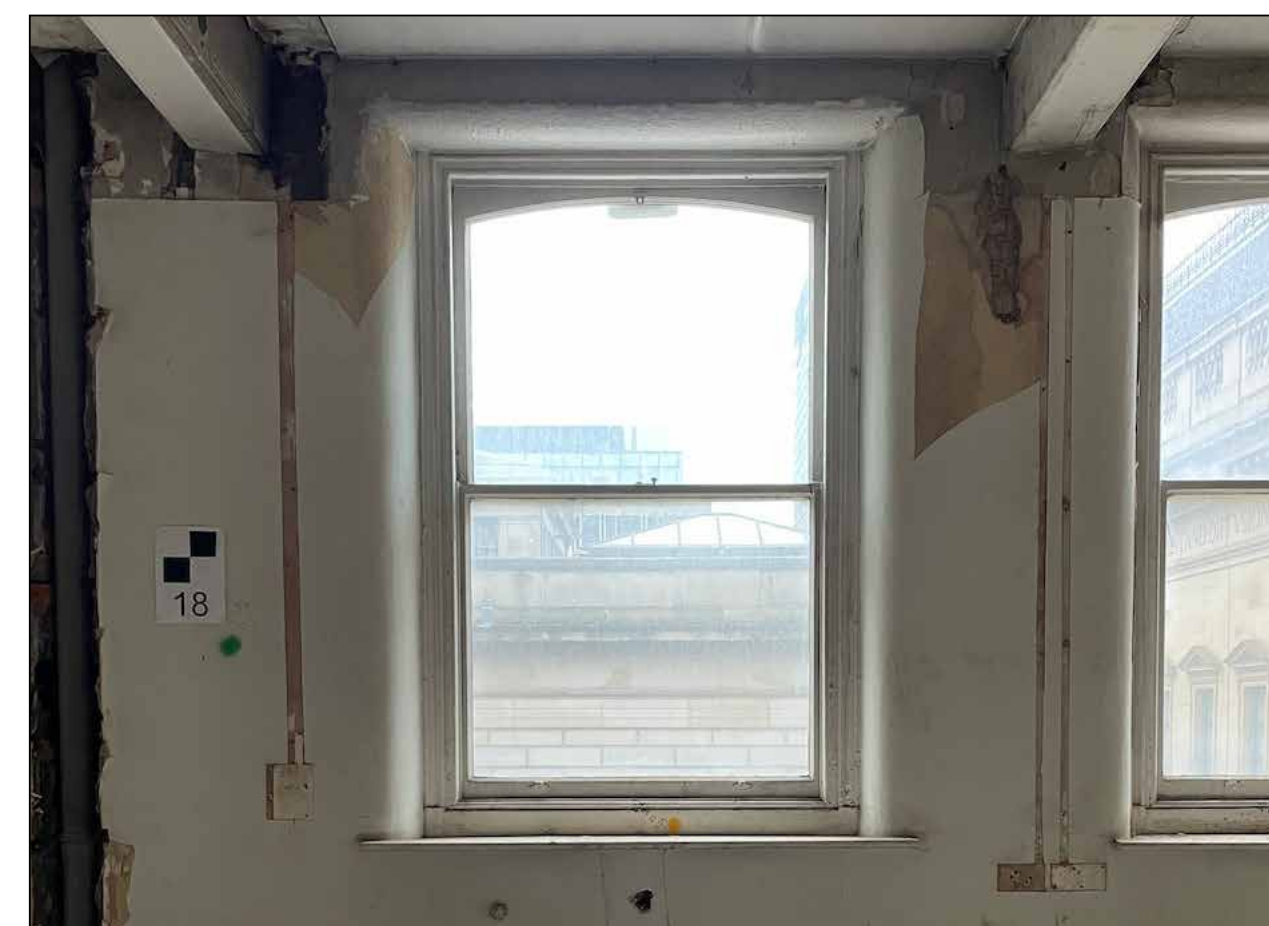
Image 19: Photograph showing typical upper floor one over one sliding sash window to Princess St.

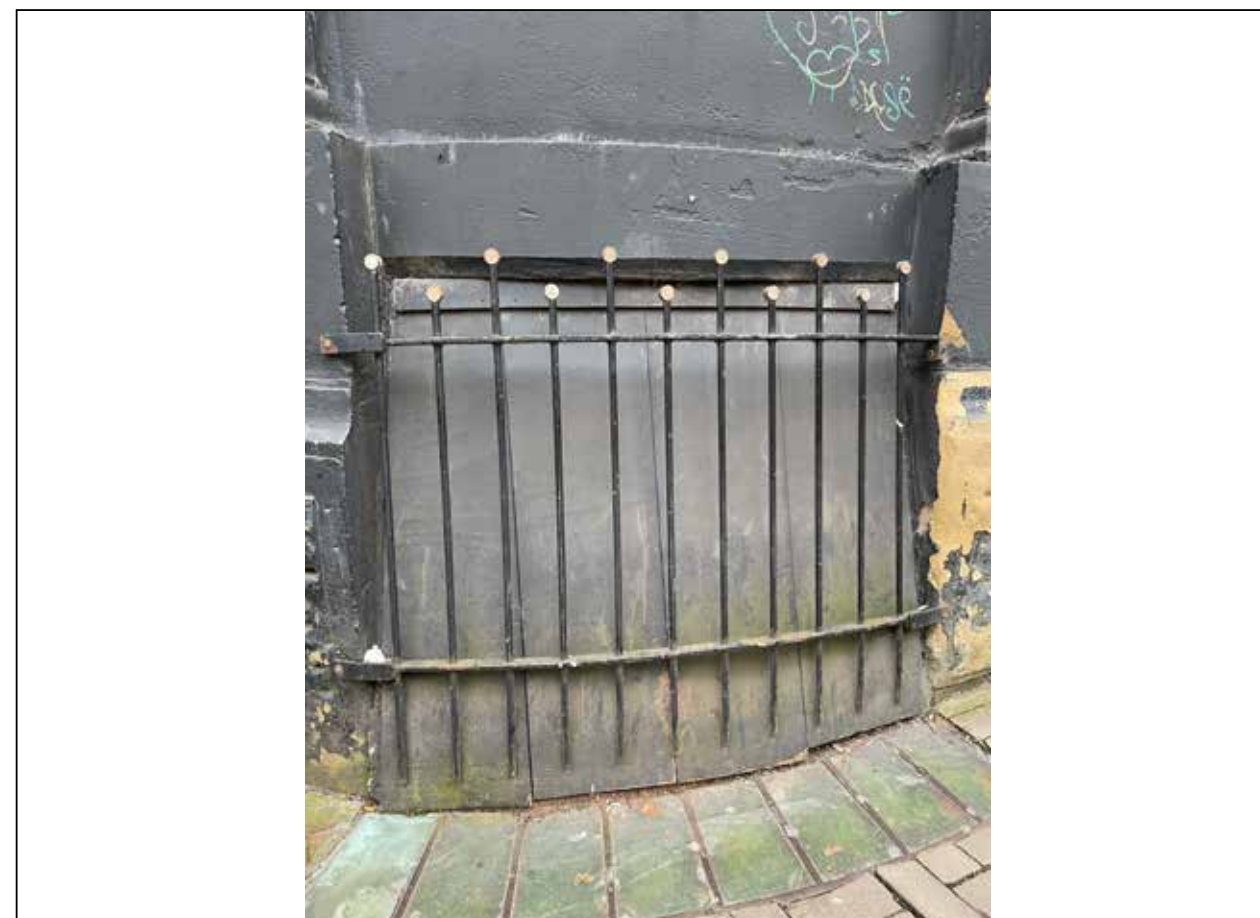
Image 22: Detail of corner of Princess St. showing basement opening and original pavement lights.

Princess Street basement windows to be re-exposed and glass reinstated or repaired where possible.

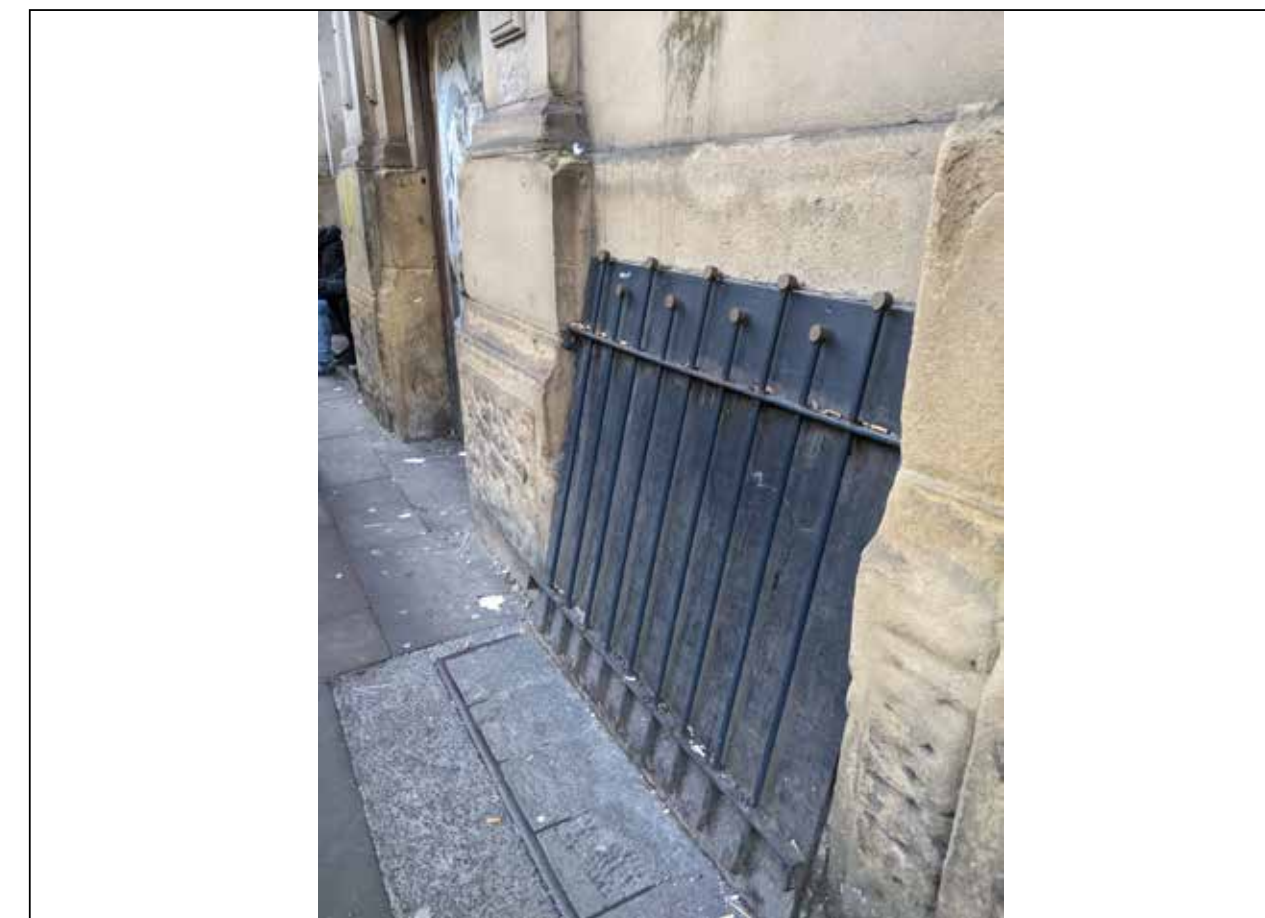
Image 24: Detail of external opening to basement (over-boarded) with railings.

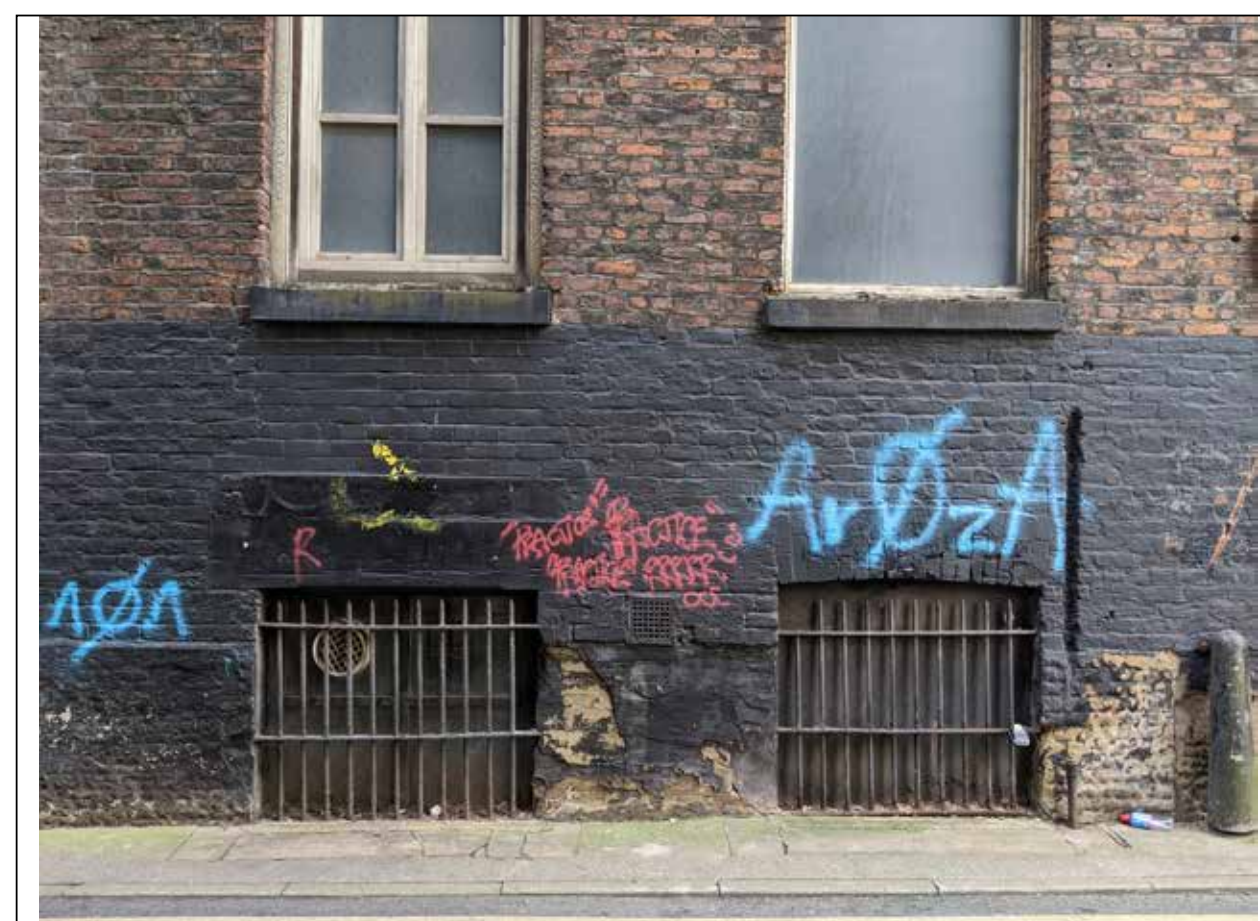
Image 23: Detail on Back George Street elevation showing basement openings and over-painting to brickwork.

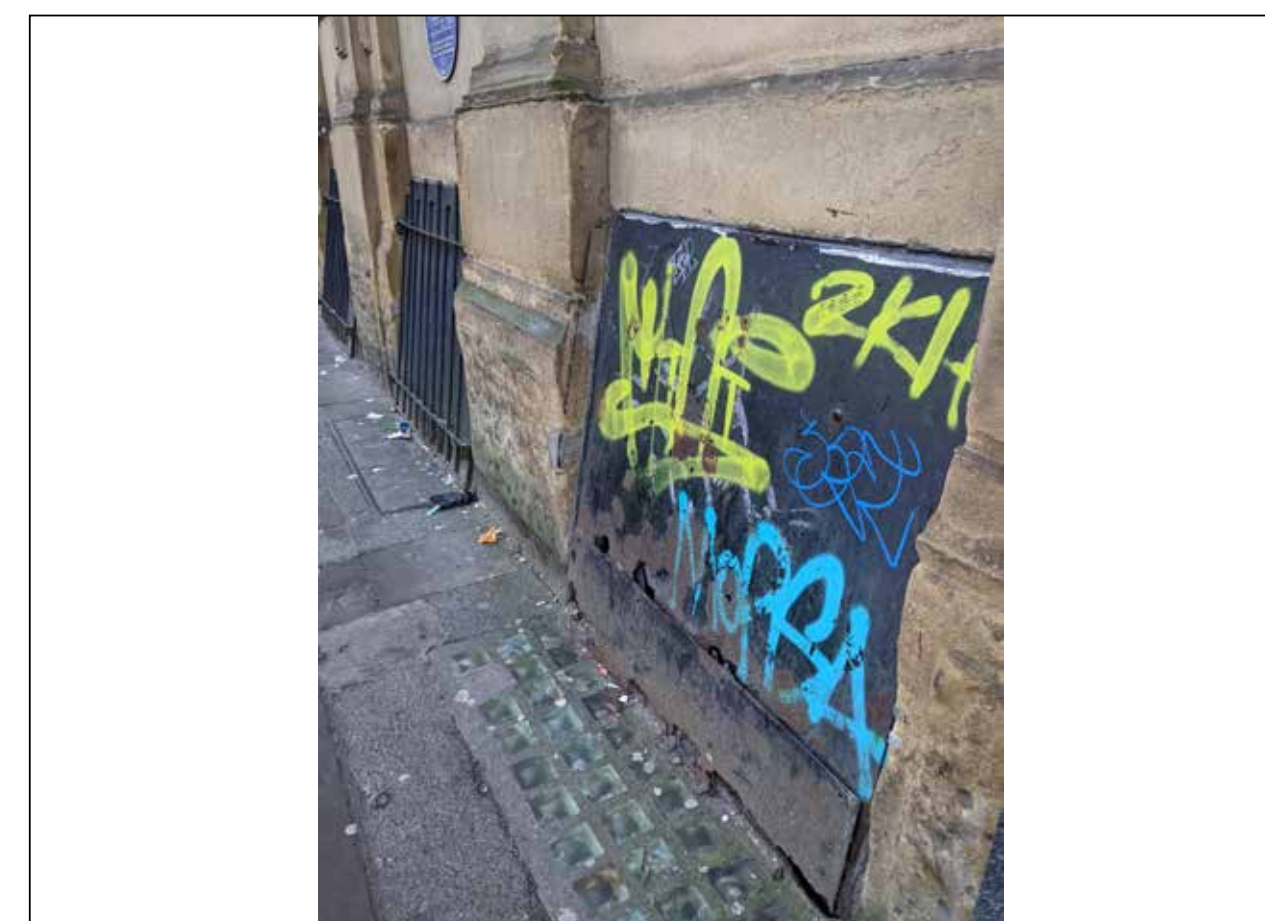
Image 25: Detail of pavement lights to Princess St.

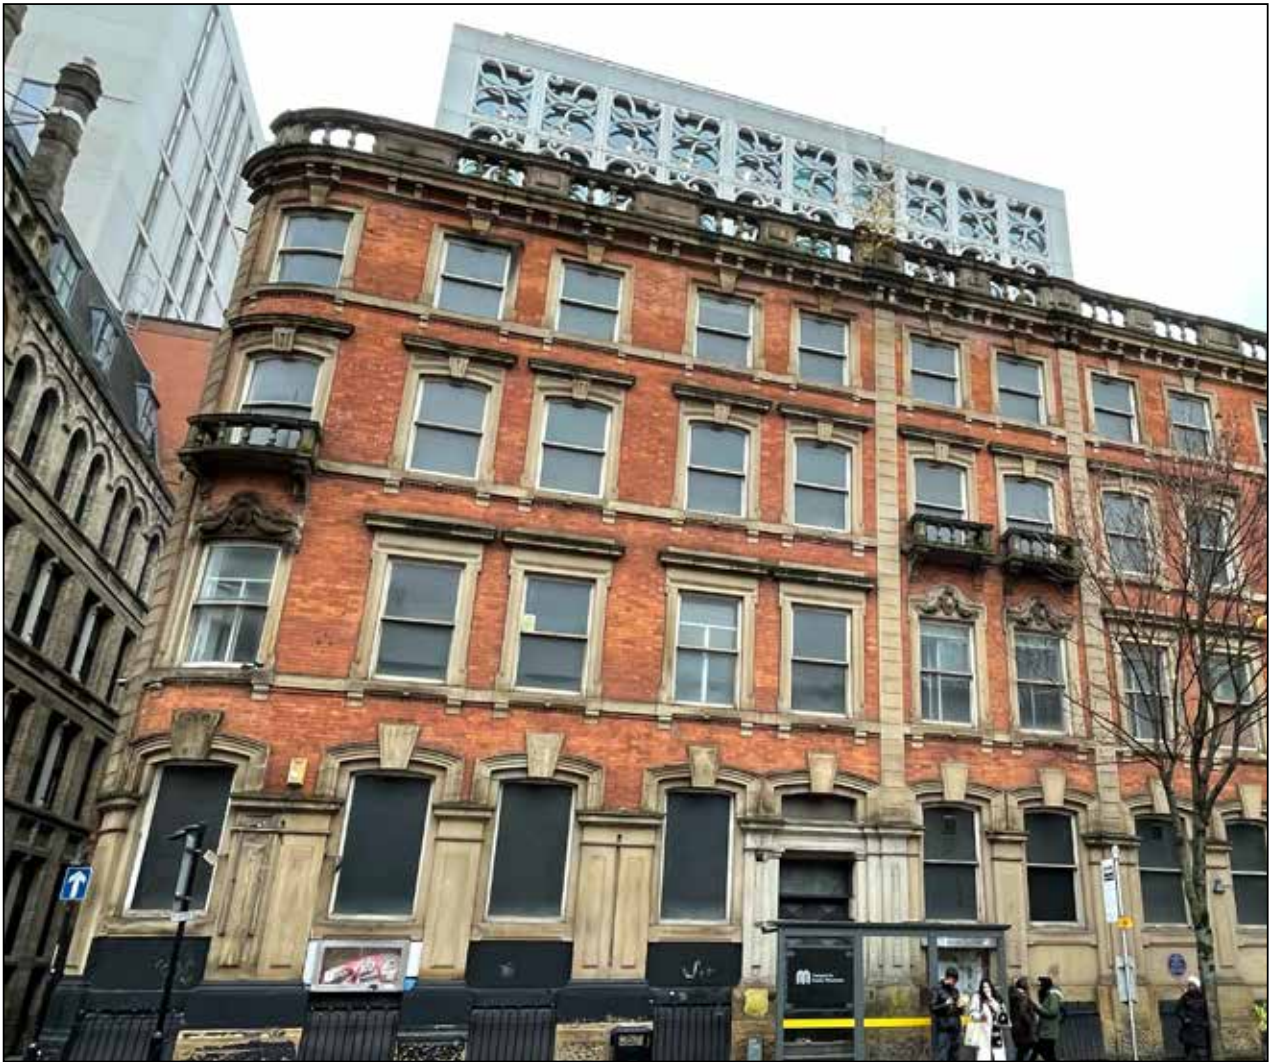
The Princess Street elevation features double doors accessed via steps. There is a decorative door surround, in restrained classical form.

A secondary entrance has been added to this elevation to the right-hand side of the original, accessing the former barbers. This is a later change, is of no heritage significance and detracts from the aesthetic qualities of the elevation.

Image 26: Princess St. elevation with Back George St to left.

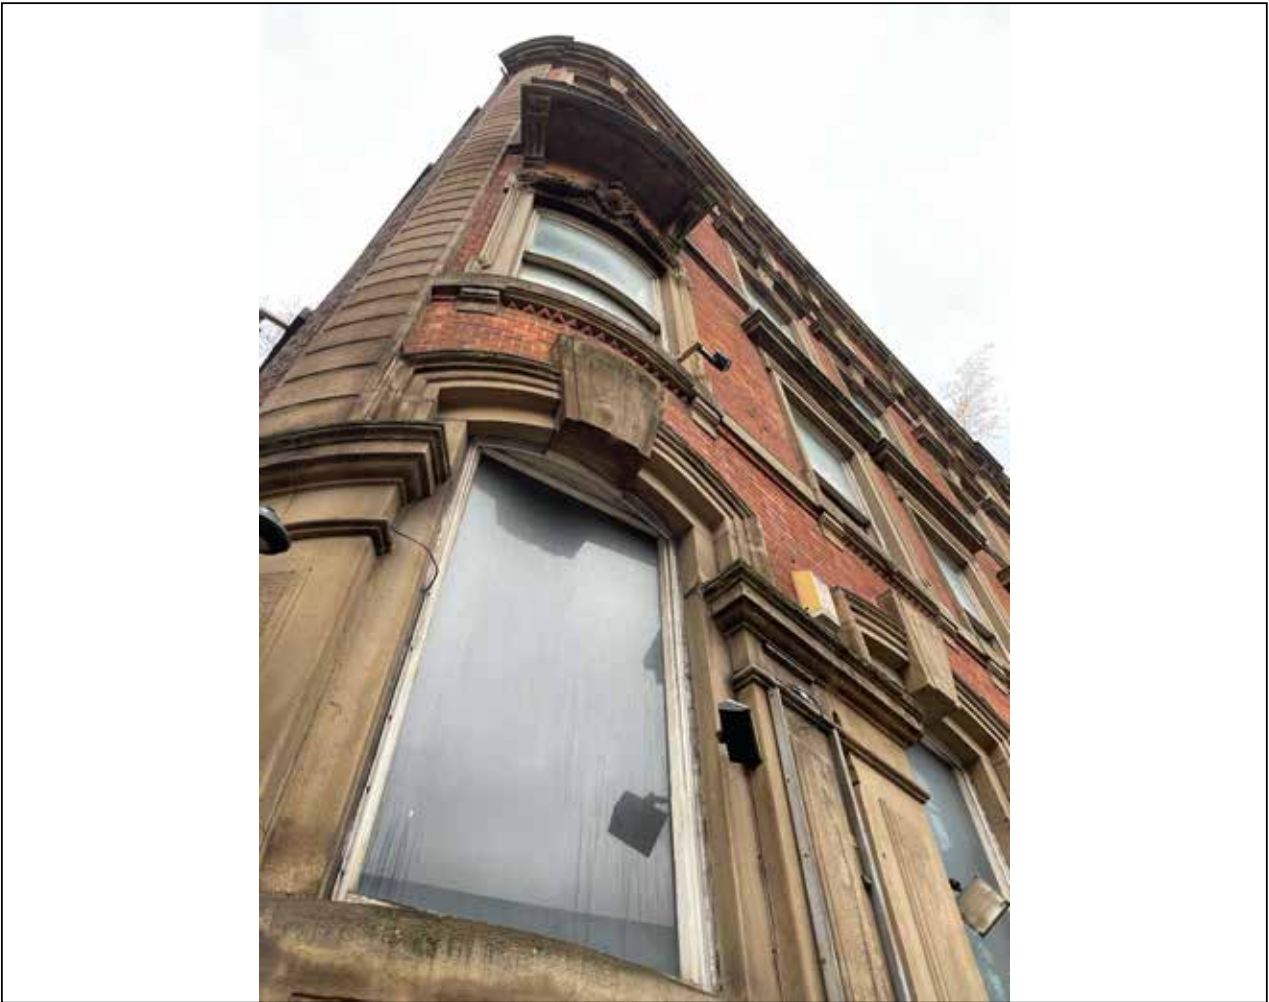
Image 28: Detail of corner of Princess/Back George St. with original rounded windows and later flat replacement versions.

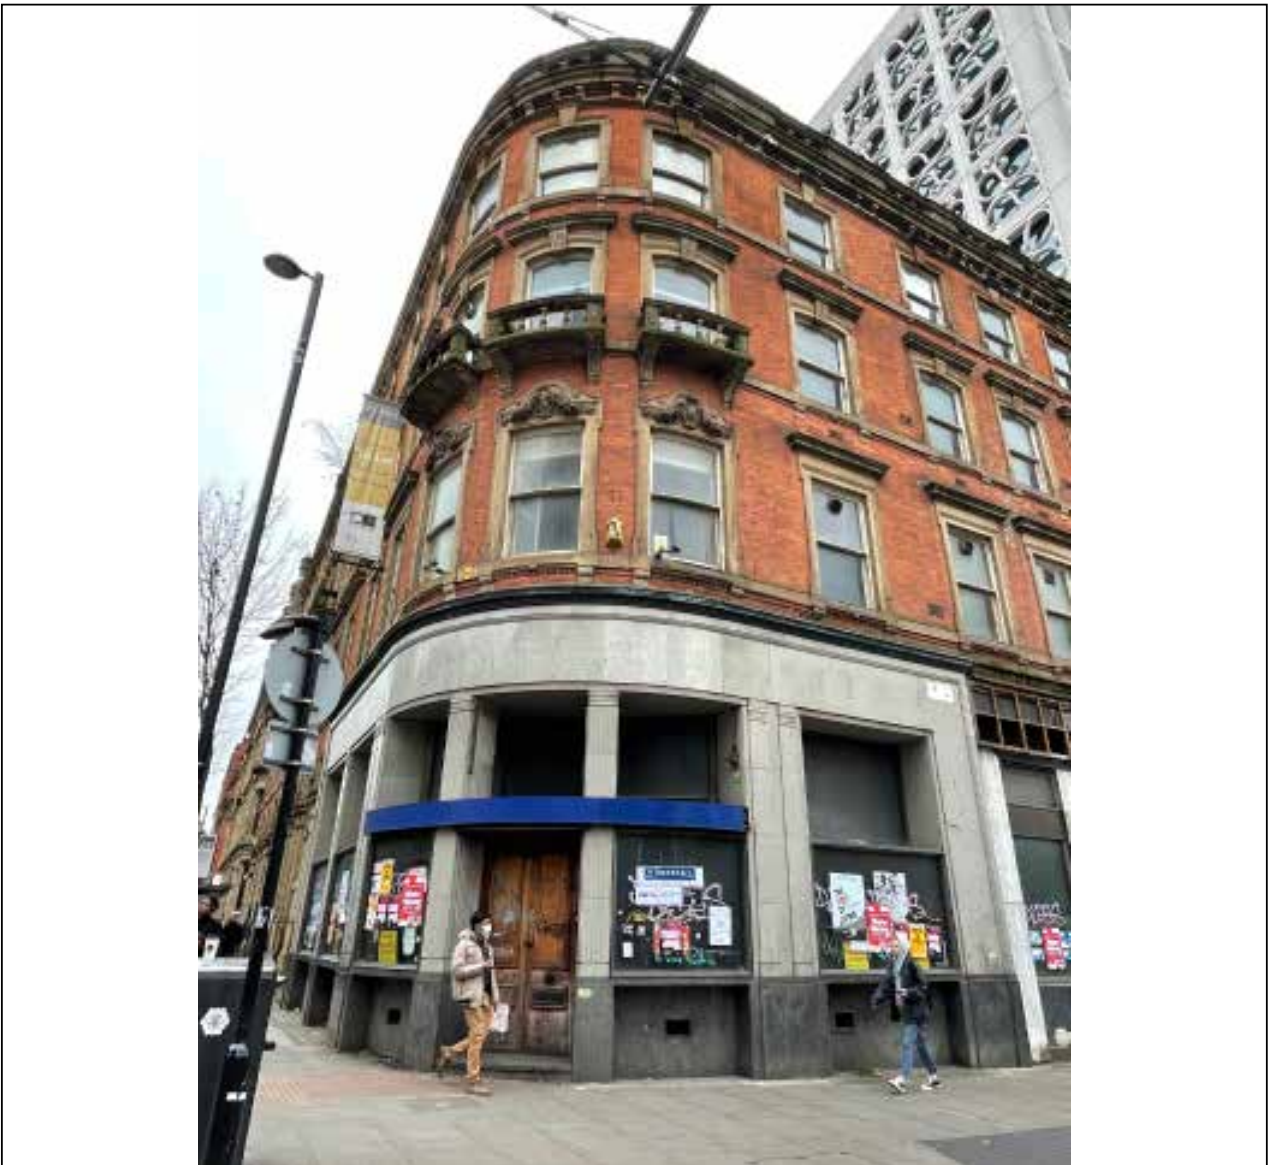
Windows to the former bank are original to the alterations and housed within metal frames. These have heritage value as part of the overall 1950s scheme. Windows to 77a, former shop unit, are later replacement and of no heritage value.

Image 29: Detail of mid-1950s frontage to former building society.

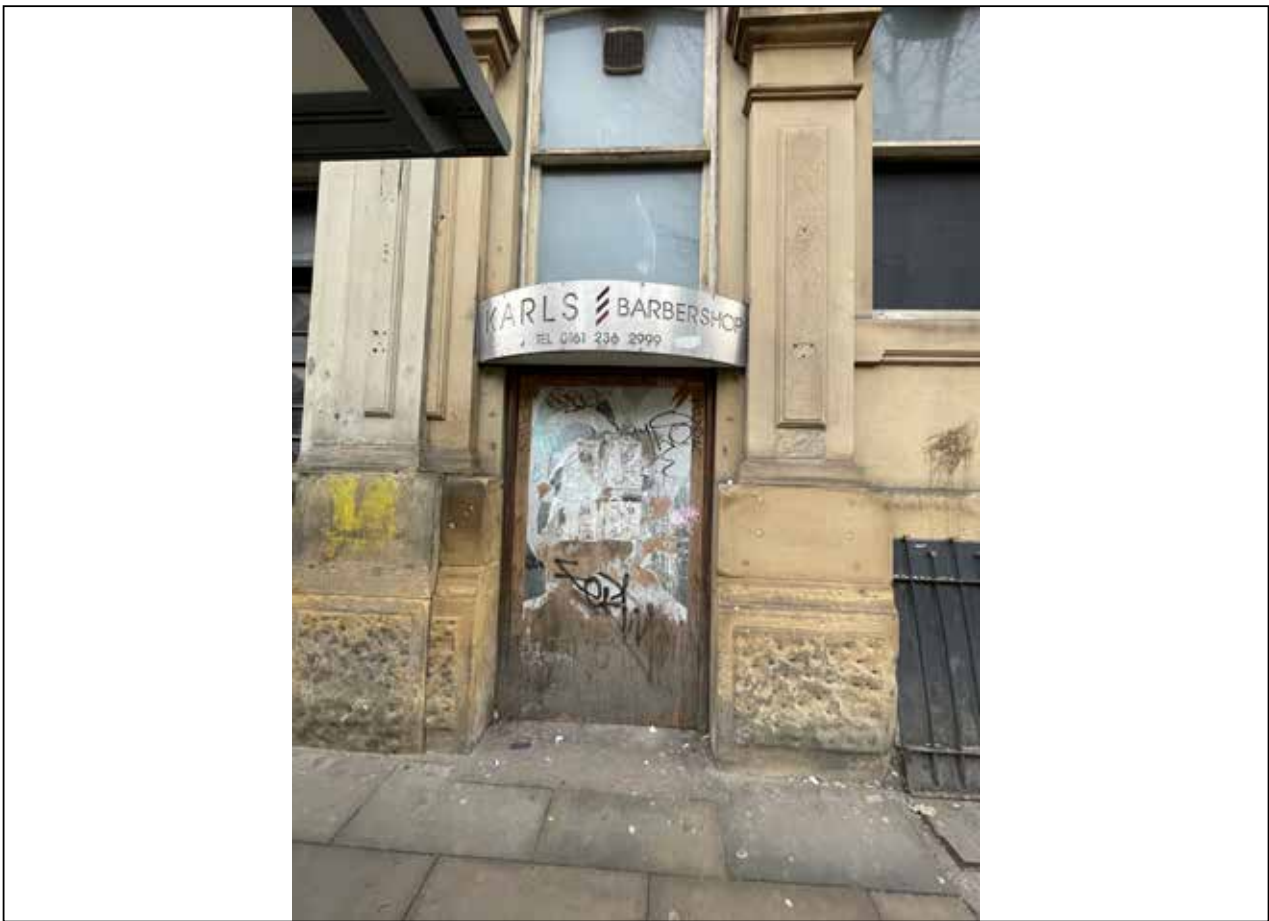
Image 30: Detail of later inserted doorway on Princess St. elevation.

Later entrance to basement barbers on Princess Street to be retained and door replaced with high quality replacement in suitable style.

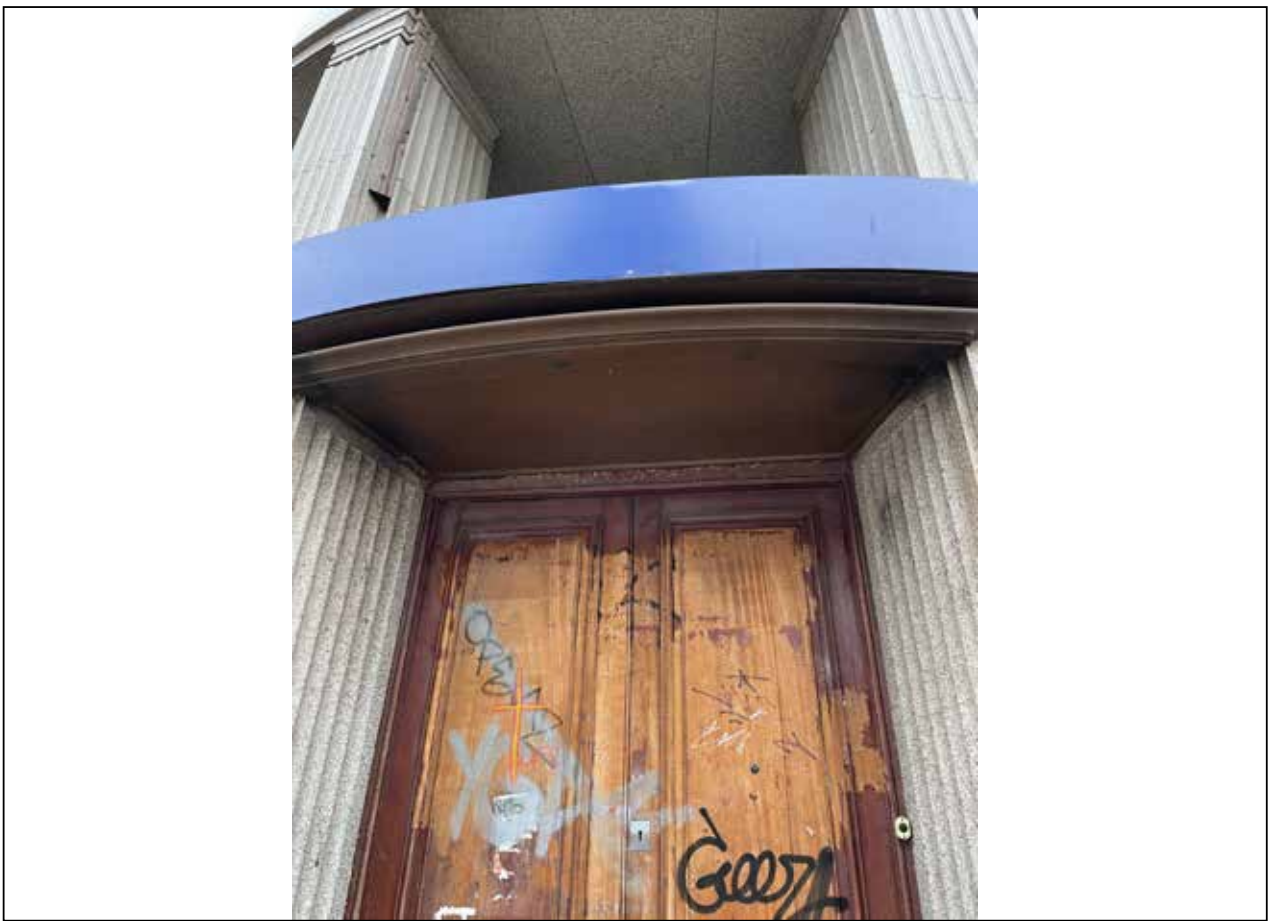
Image 32: Detail of former building society entrance, 77 Mosley St. with signage band.

Existing low step to former bank at no. 77 to be removed and replaced with new ramp in granite (colour to match existing) to allow for level access.

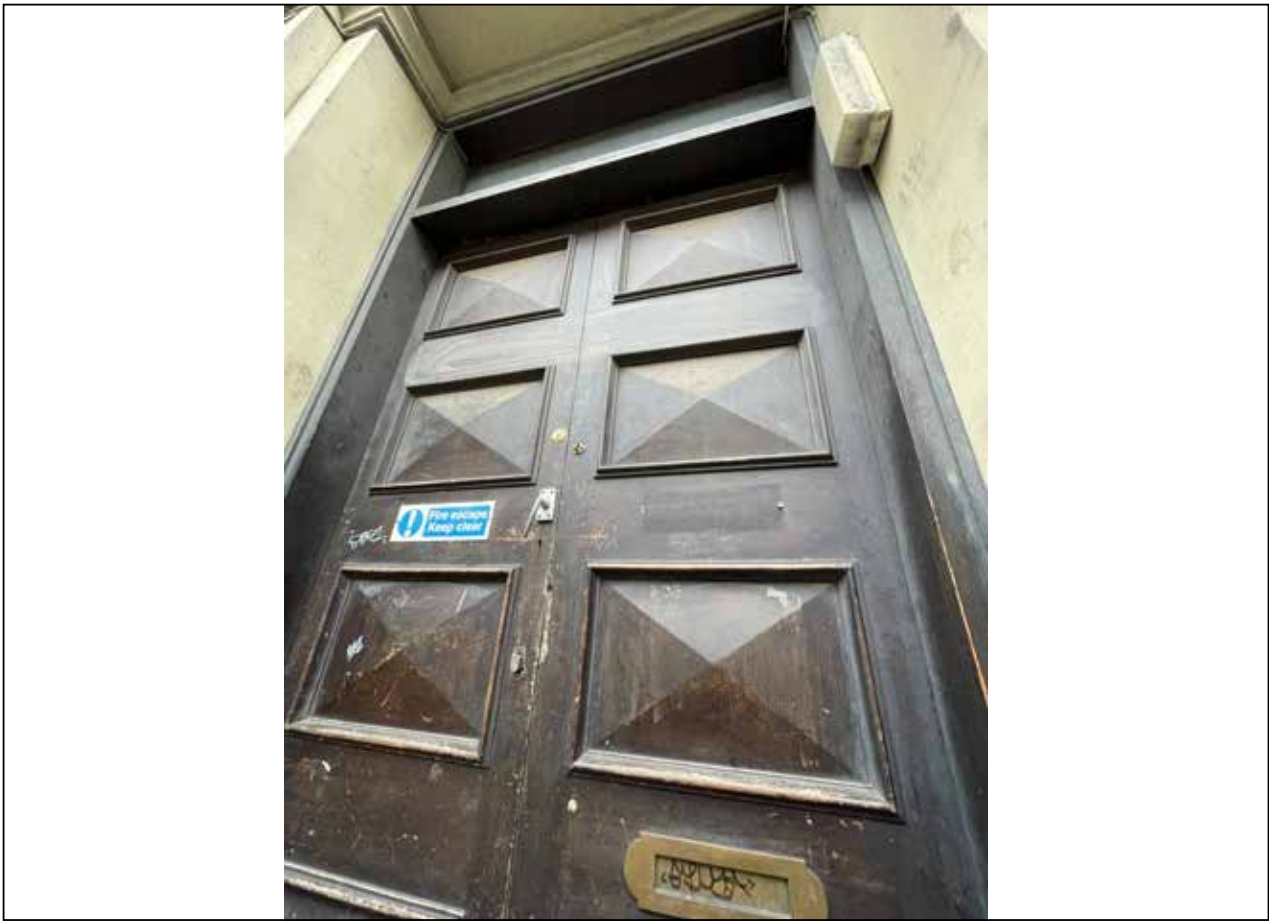
Image 31: Detail of entrance doorway to Princess St. elevation.

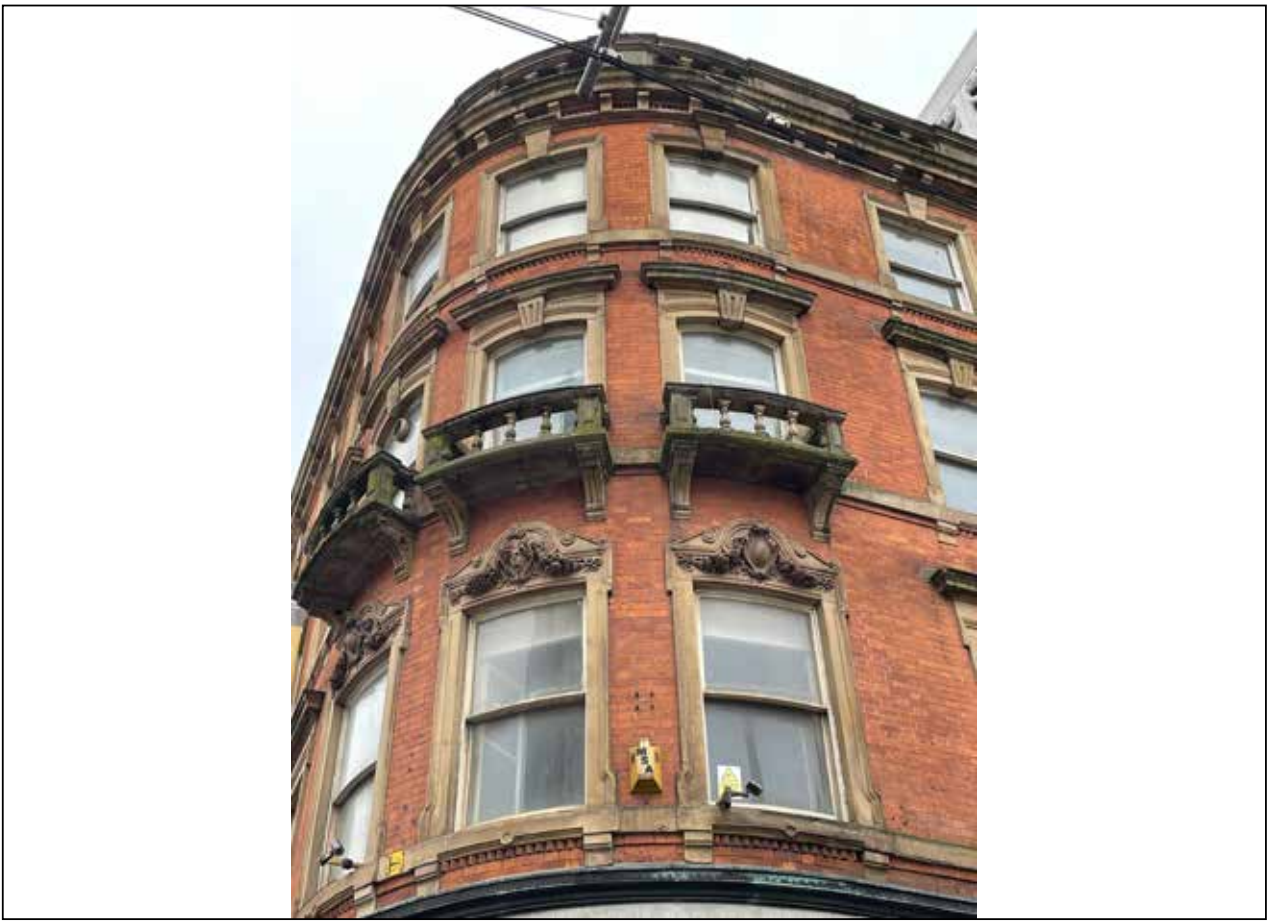
to the rear, all sitting upon a rusticated stone plinth. The contrasting treatment of formal principal elevations and more functional rear façades is of significance. The end bays feature carved stone swag decoration to the first floor and balconies are present at second floor to end bays, central 2 bays to Princess Street and across the rounded corner. These details, along with high-level balustraded parapet, form attractive, well-proportioned elevations with decoration conveying a sense of the commercial wealth in 19th century Manchester.

Image 35: Detail of stone decoration and brick elevations to curved Mosley St. corner, showing balconies, windows, and roof level detail.

Princess Street and Mosley Street elevations to have like for like repairs, where required. Later added paint will be cleaned from low level stone.
