# Heritage Statement

77-79 Mosley Street  
Manchester  
M2 3FX

Client: Biz Assets Ltd  
Date: May 2023  
Revision: \_C

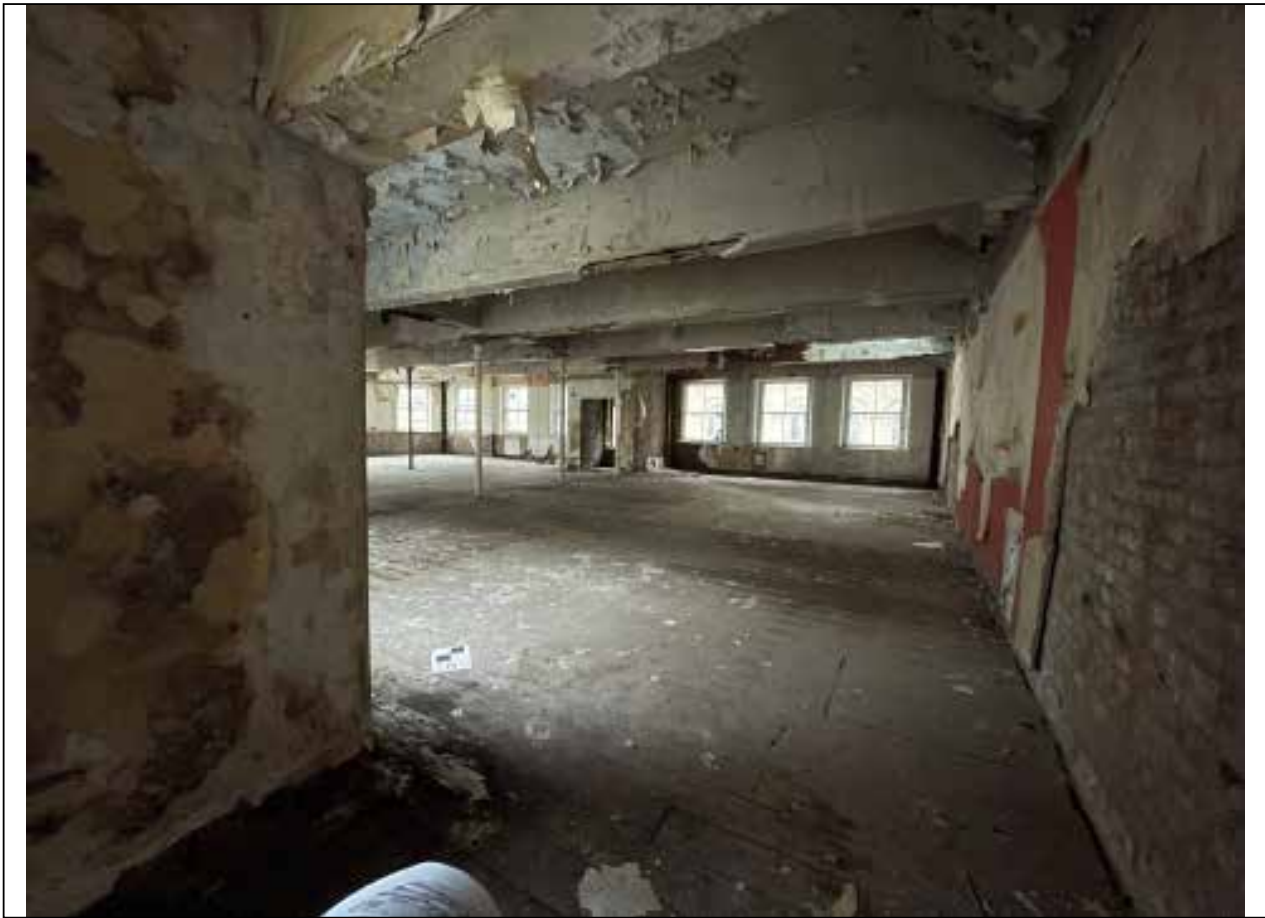
Cast iron columns are present in several areas throughout the floors, and a particularly tight grid pattern is present in the former warehouse. Columns differ in size and form slightly, reflecting former loadings, but are of high heritage significance throughout, as is exposed timber roof structure. Ceilings appear to be lath and plaster and are of high significance for their historic and evidential value. There is a partial fourth floor which contains the lift motor room, accessed via a steep set of timber stairs. It has a

Image 36: View of warehouse side of building with columns and former hoist visible.

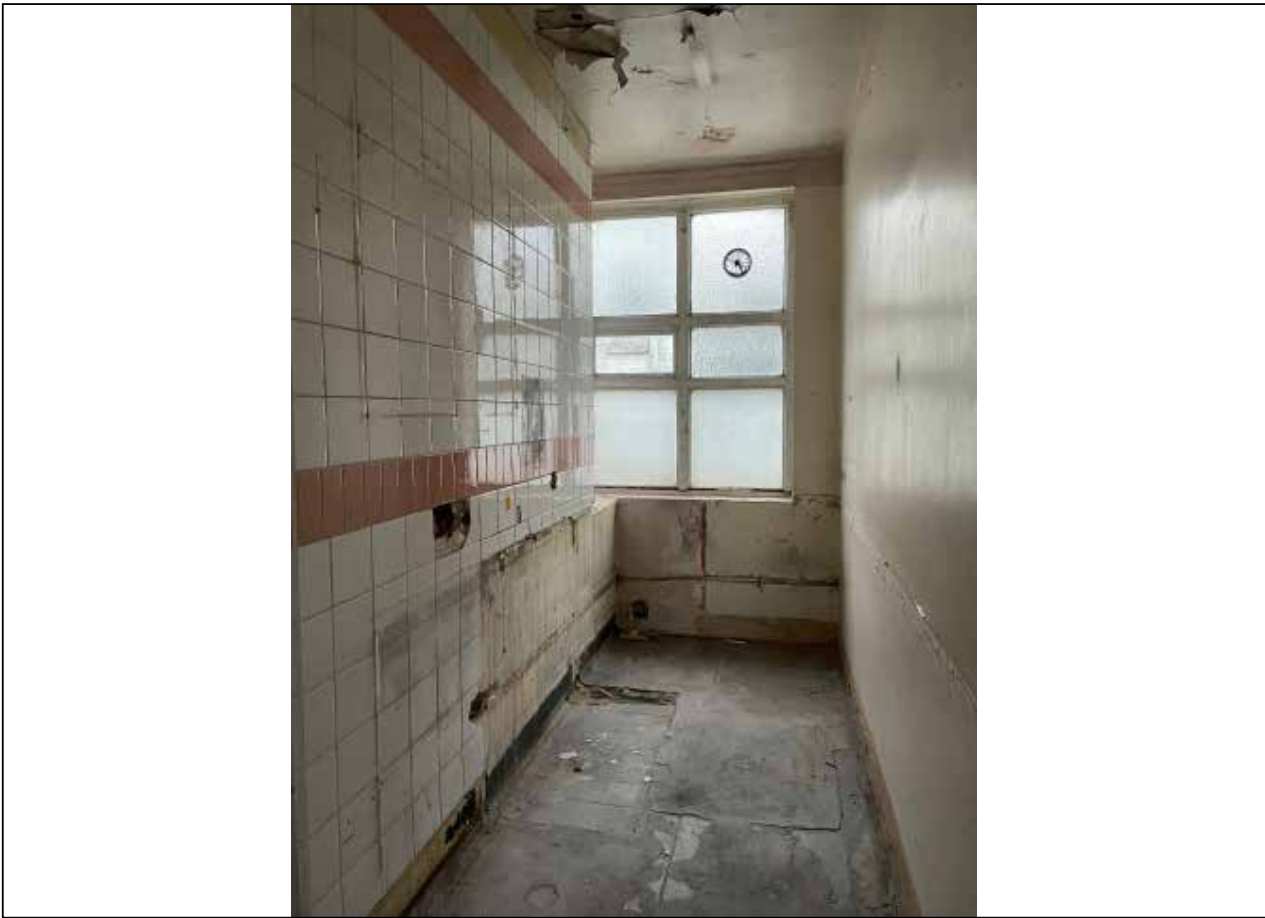
Image 38: An example of modern finishes to typical bathroom/kitchen spaces and altered window to lightwell.

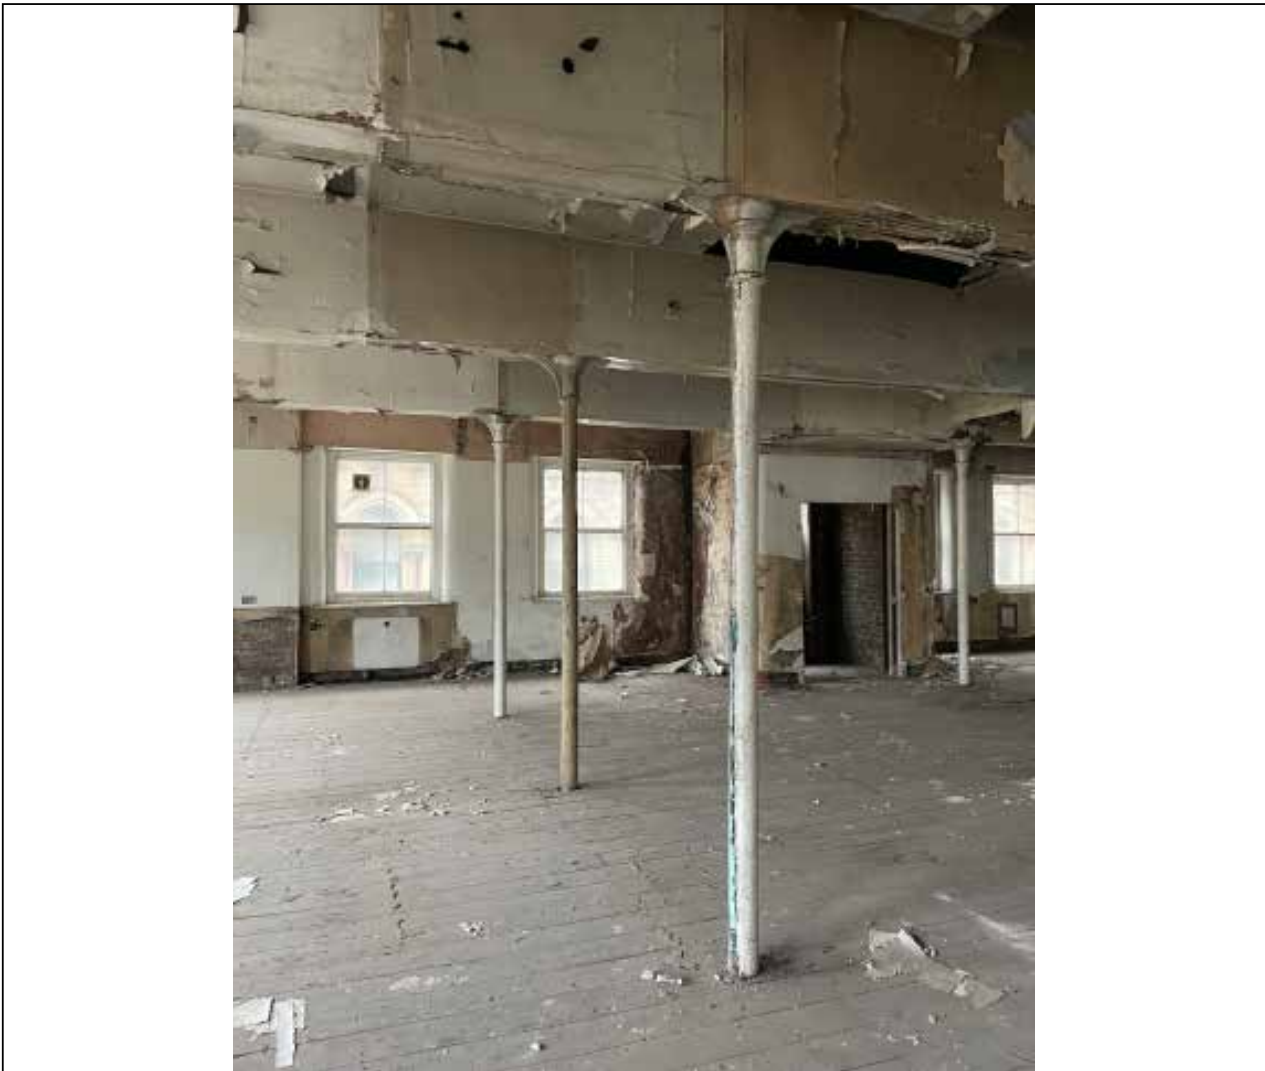
Image 42: View of tight column grid to warehouse space and former hoist to back wall.

The vertical means of moving goods was via the hoist, opening out at upper levels to Back George Street. External doors have been replaced with more modern windows and part infill (no heritage significance). The recessed elevational brickwork to this vertical run is still evident and despite the alterations, the feature is highly significant evidentially and historically. The internal hoist walls have been altered in place, but are present to each floor and are in plastered masonry. Original internal fire doors to hoist are missing. The internal evidence of the hoist is of high significance.

The rear, warehousing, space has few features. Those of value are the columns and the hoist, along with the various internal steps and stairs (to basement and to entrance). The bulkheads over basement steps are plain timber and functional in form with limited heritage significance.

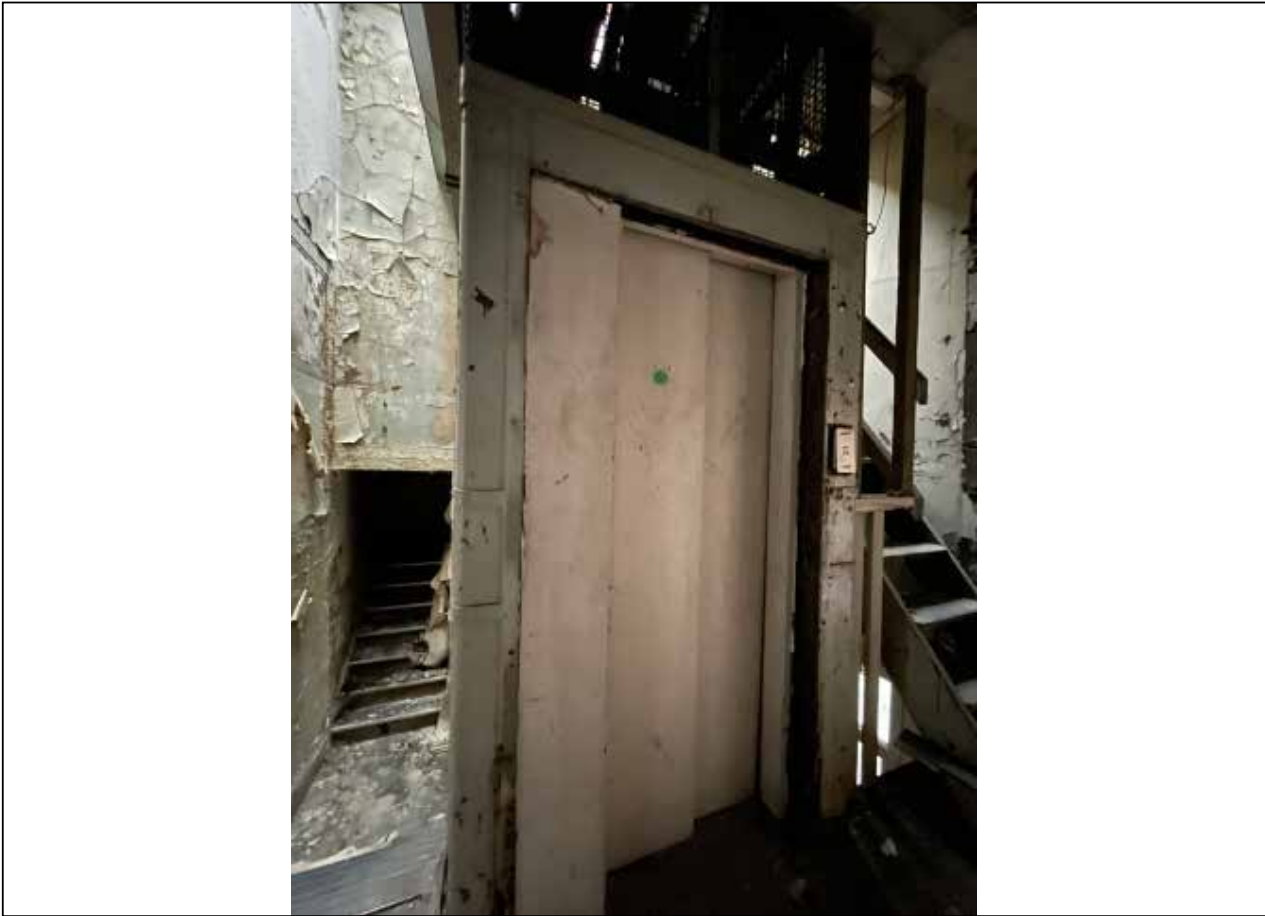
Image 43: Former office access showing existing lift with original staircase running around (altered in places).

**Justification:** The existing non-original lift is insufficient for modern office use and cannot be upgraded. The proposed lifts are necessary if the space is to be put back into long-term office use. Alternative locations for lifts involve a greater degree of damage to historic fabric through loss of floor and structure, and loss of internal floor area. The key

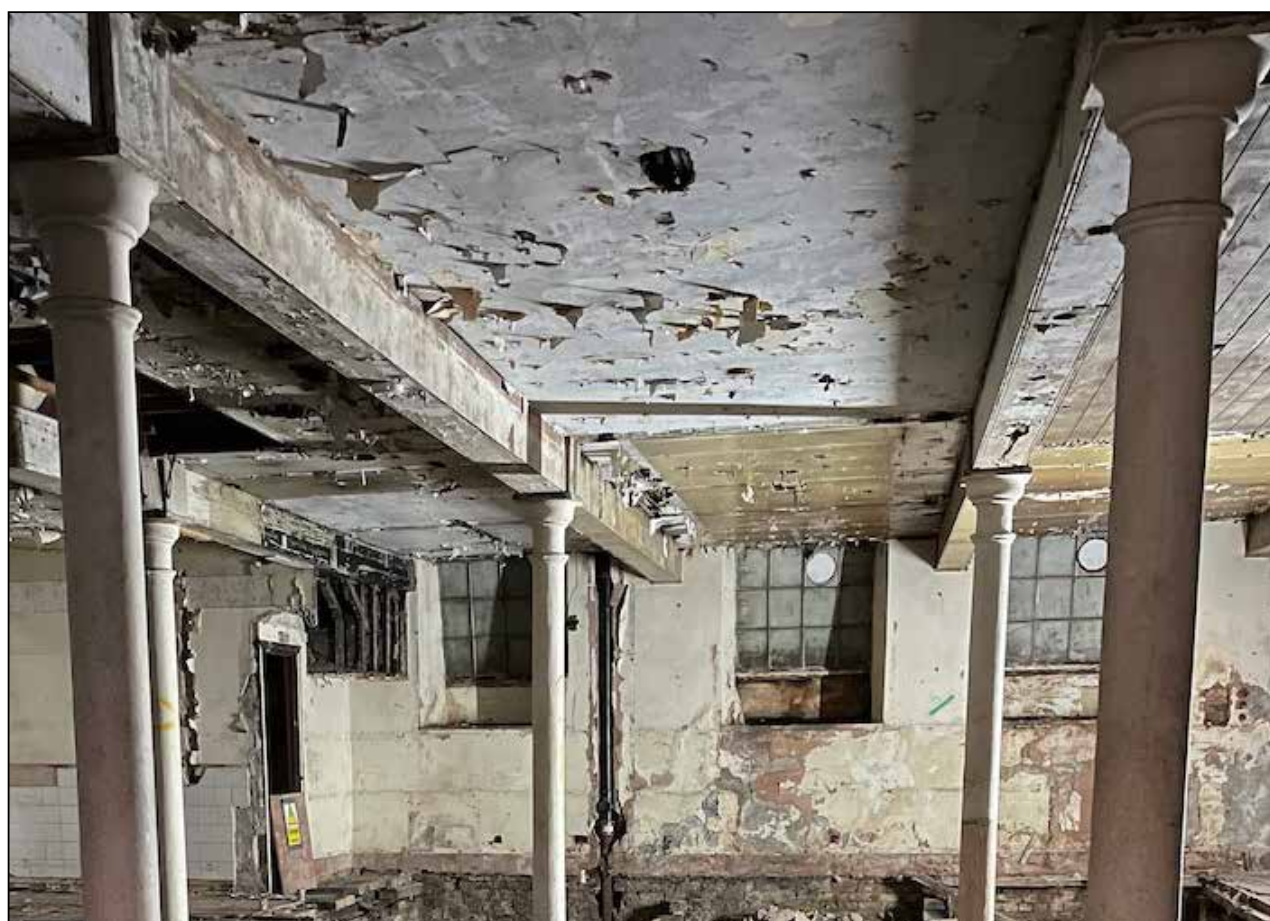
Image 44: Photograph showing basement columns and blocked windows.

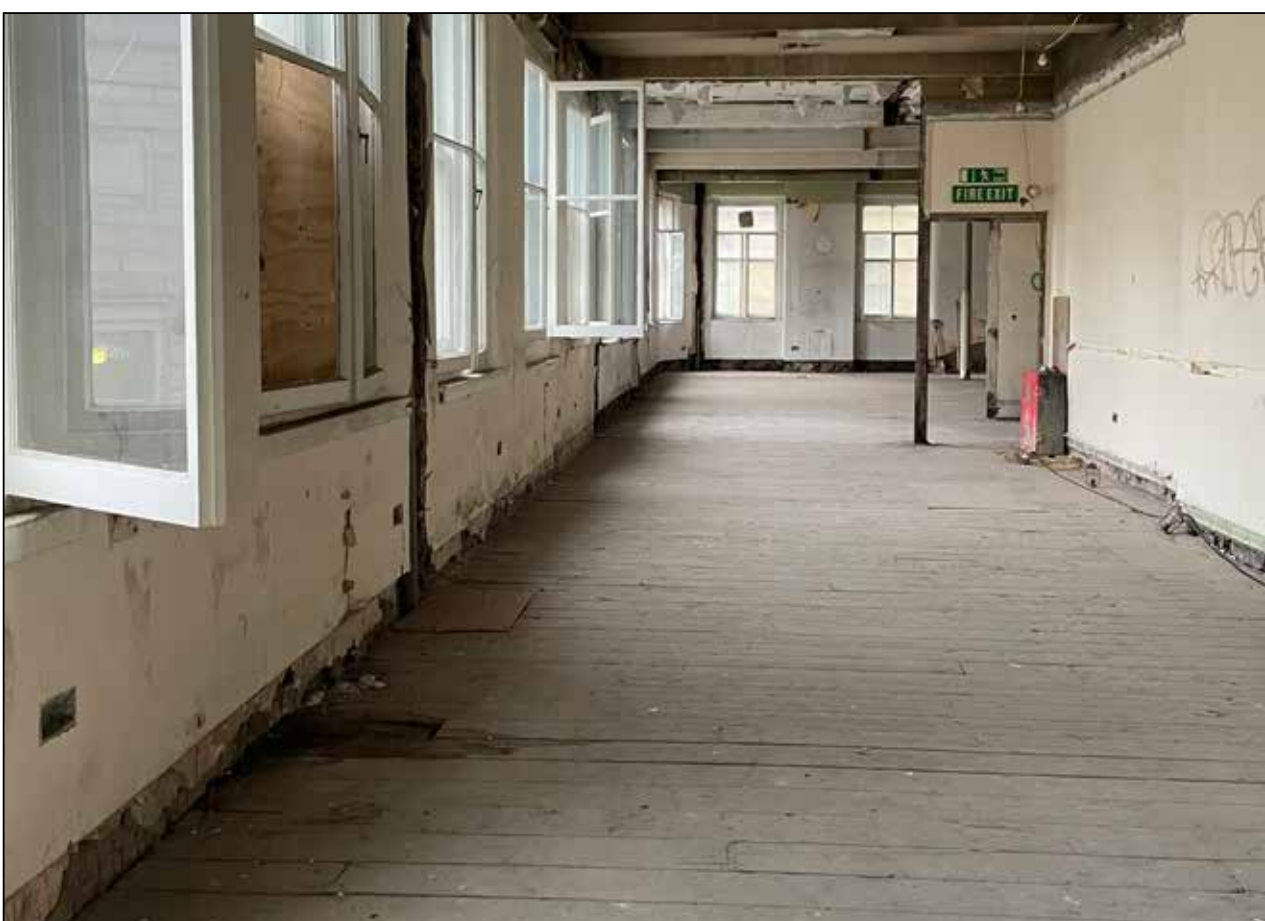
ilmage 46: Photograph showing upper Princess St. section of building with original floorboards.

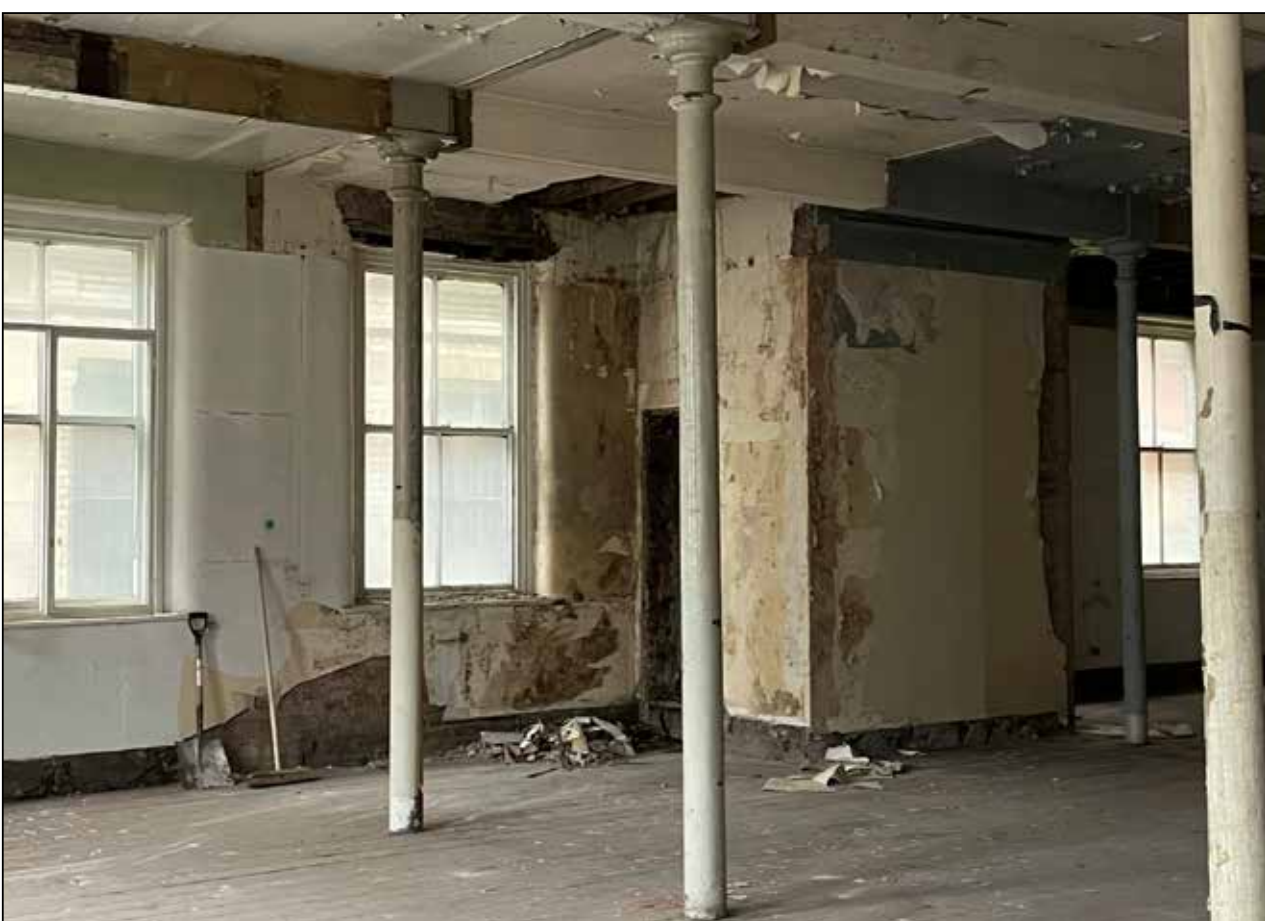
Image 48: Photograph showing housing for former hoist, damaged and with non-original opening inserted.

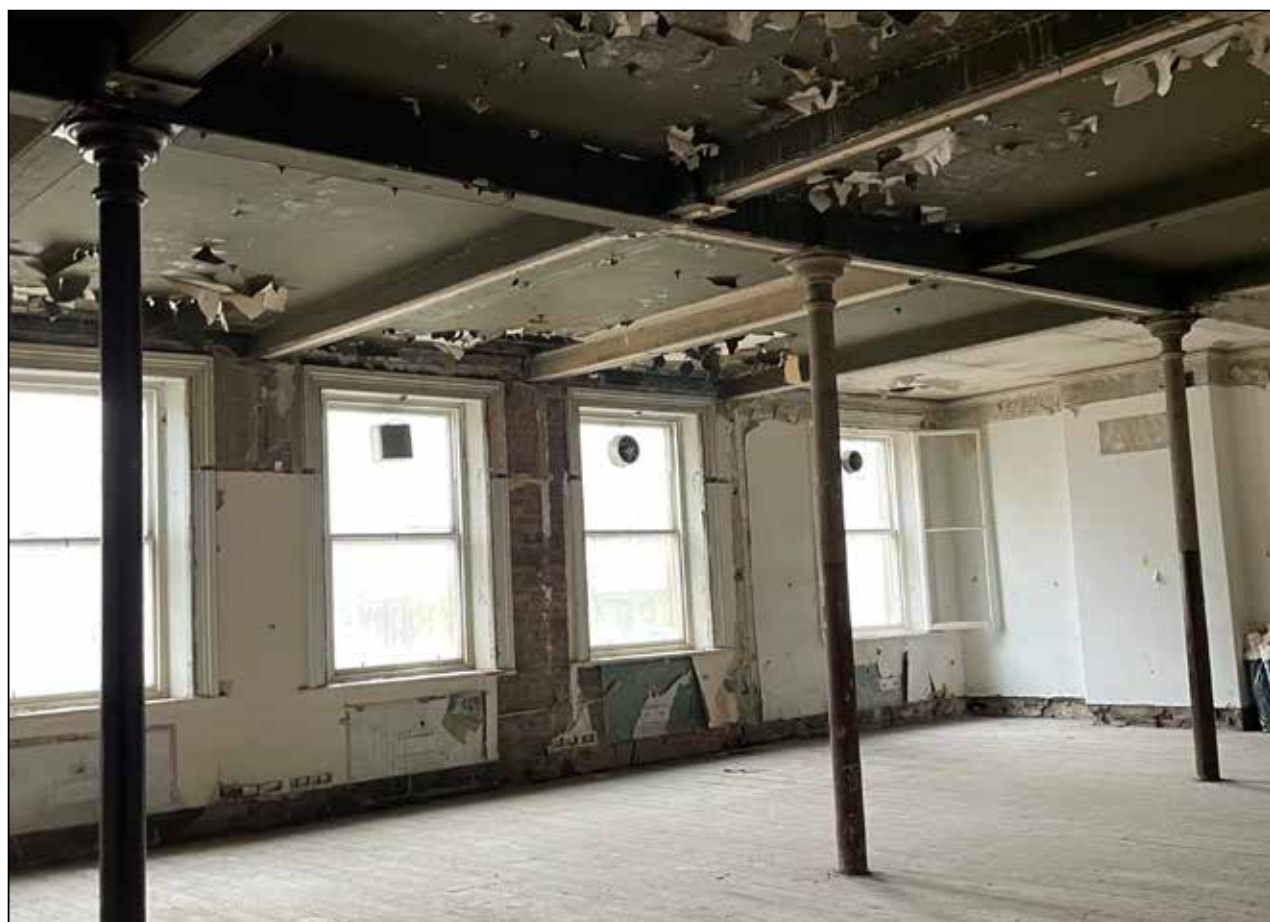
Image 45: First floor windows and columns with exposed heads.

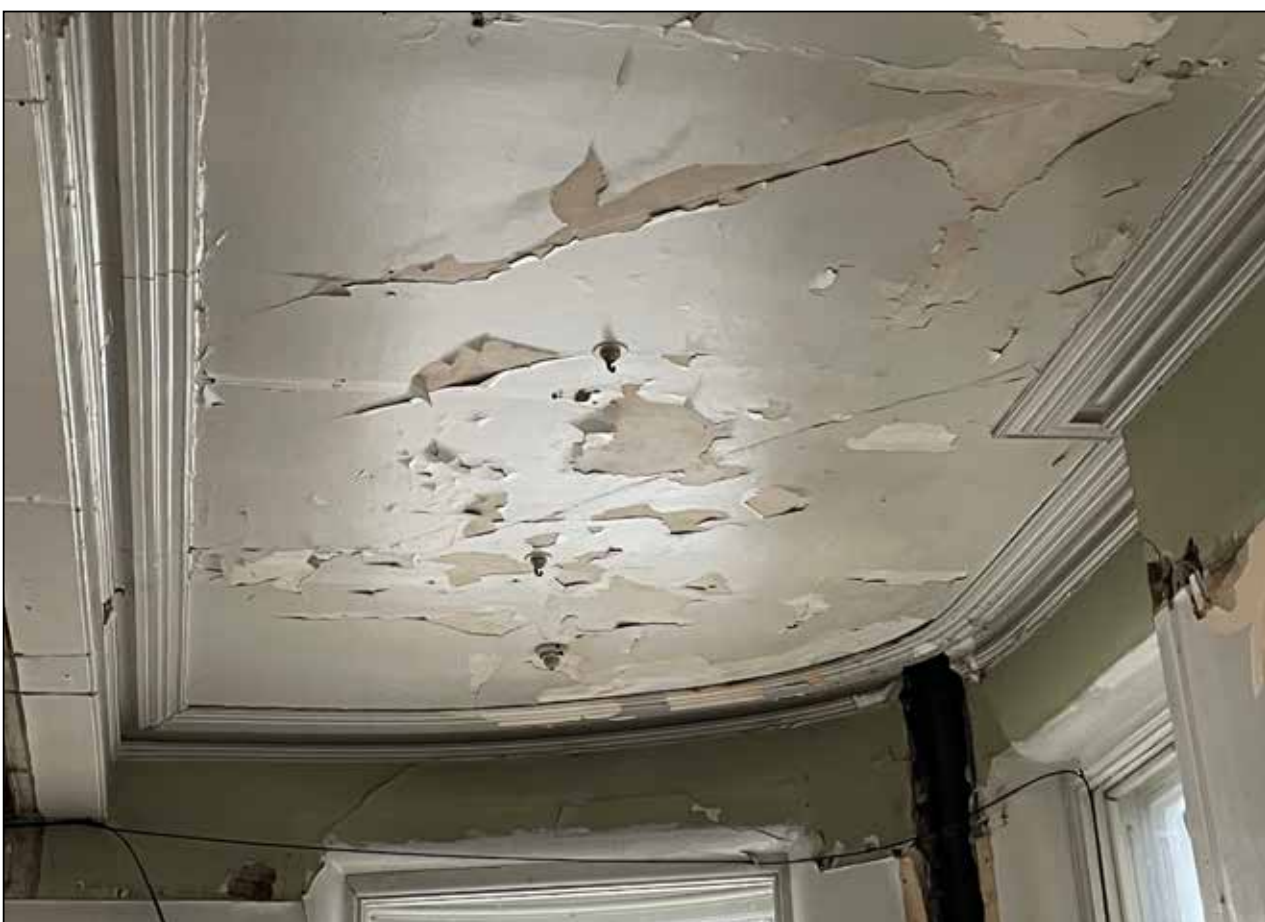
Walls are painted plaster, which is considered typical of this type of warehouse. Where cornicing exists (more extensively to the first floor; around staircases; and within sub-offices) it is of high significance, though it is limited in general extent and has been damaged/lost in places. Fireplace openings remain in places, but surrounds are missing. Floors are timber boards on timber joists. These are original throughout and of high significance as original fabric and evidence of original design. A timber and glass dividing screen is present to third floor office area and is of historical value, though it is uncertain if it is original. Kitchen facilities are modern low-quality additions and have no heritage significance. An arched top doorway at first floor level is non-original and of no heritage value.

Image 47: First floor example of cornicing to ceiling.

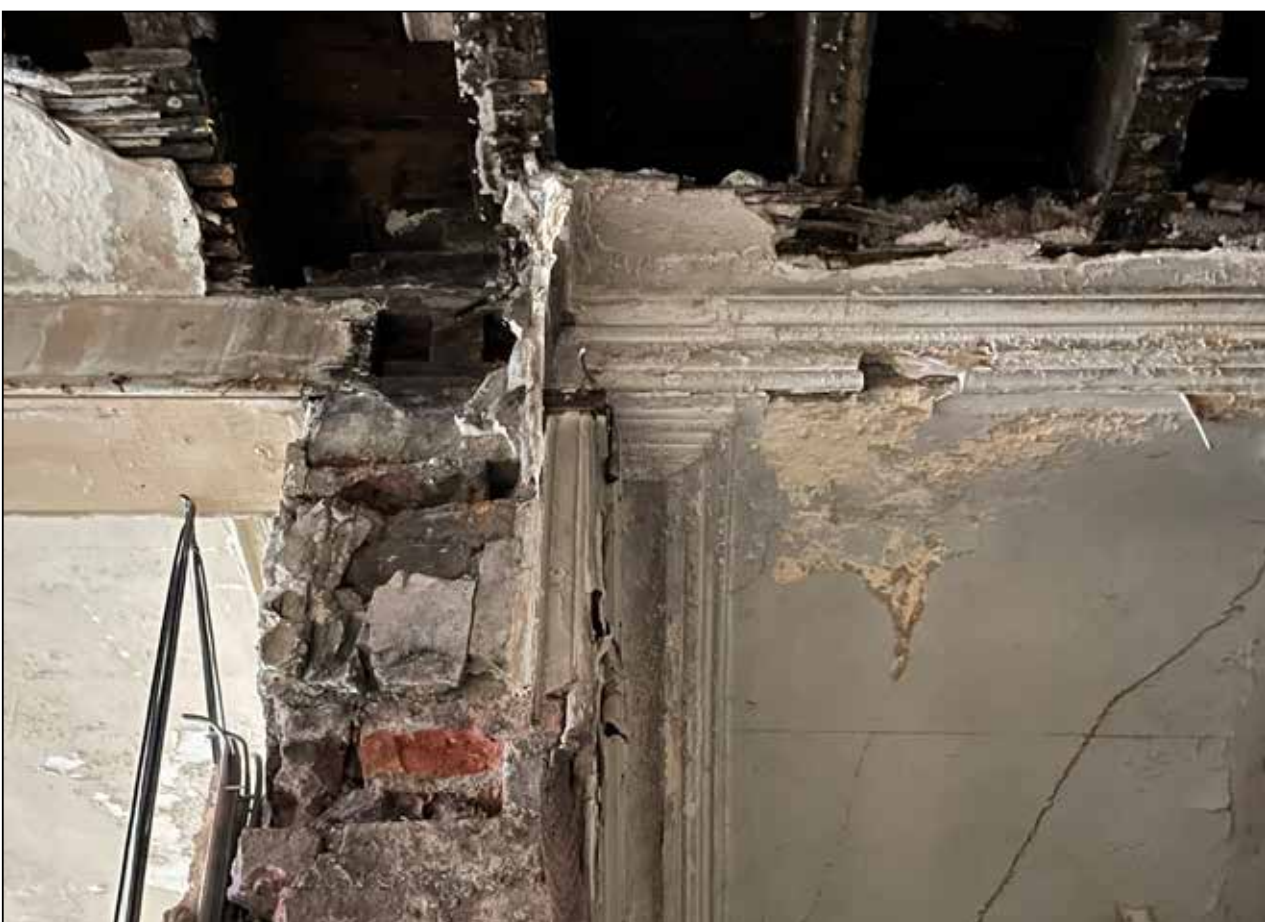
Image 49: First floor, damaged cornicing and evidence of lath and plaster finishes.

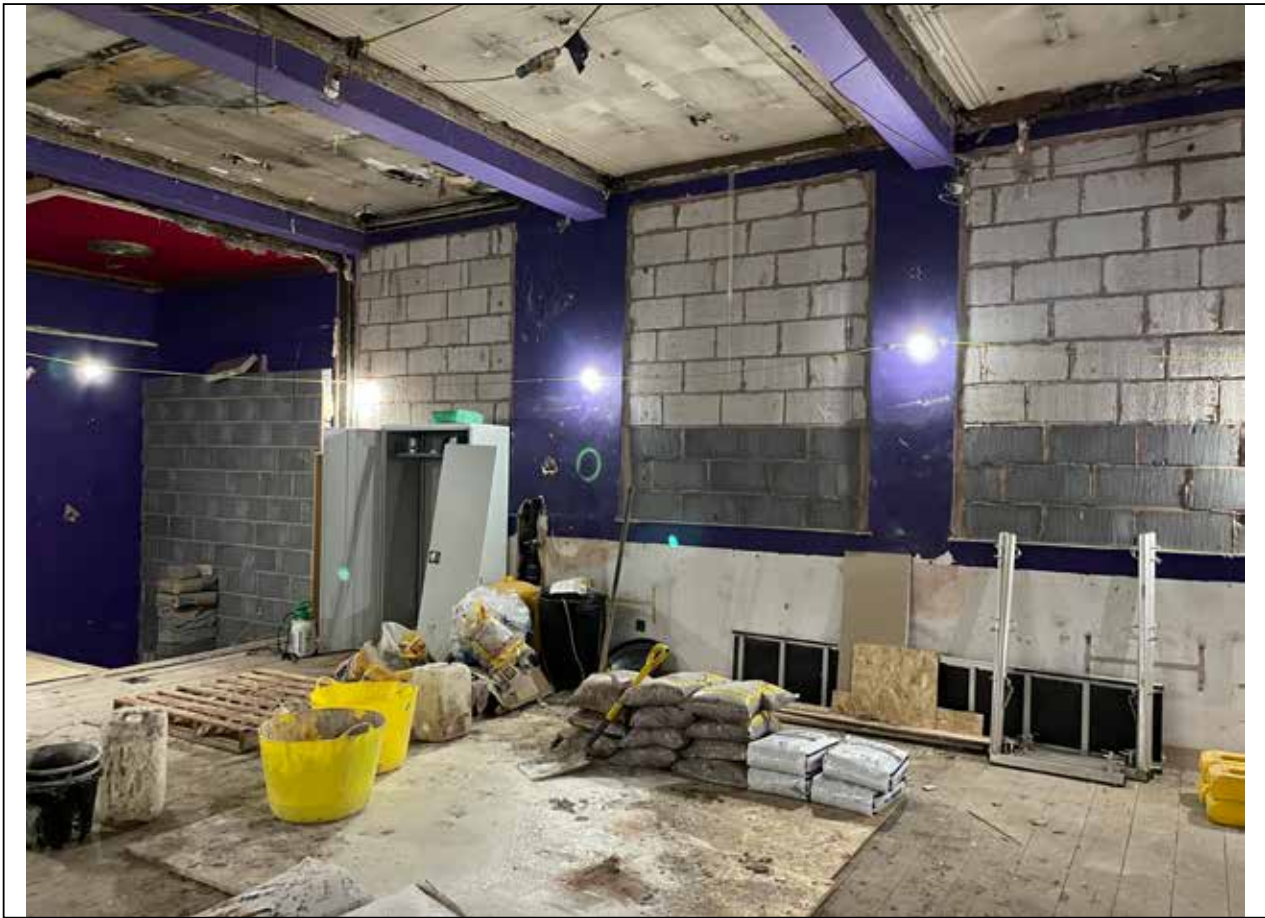
Image 50: Blocked up openings to ground floor unit along Princess St.

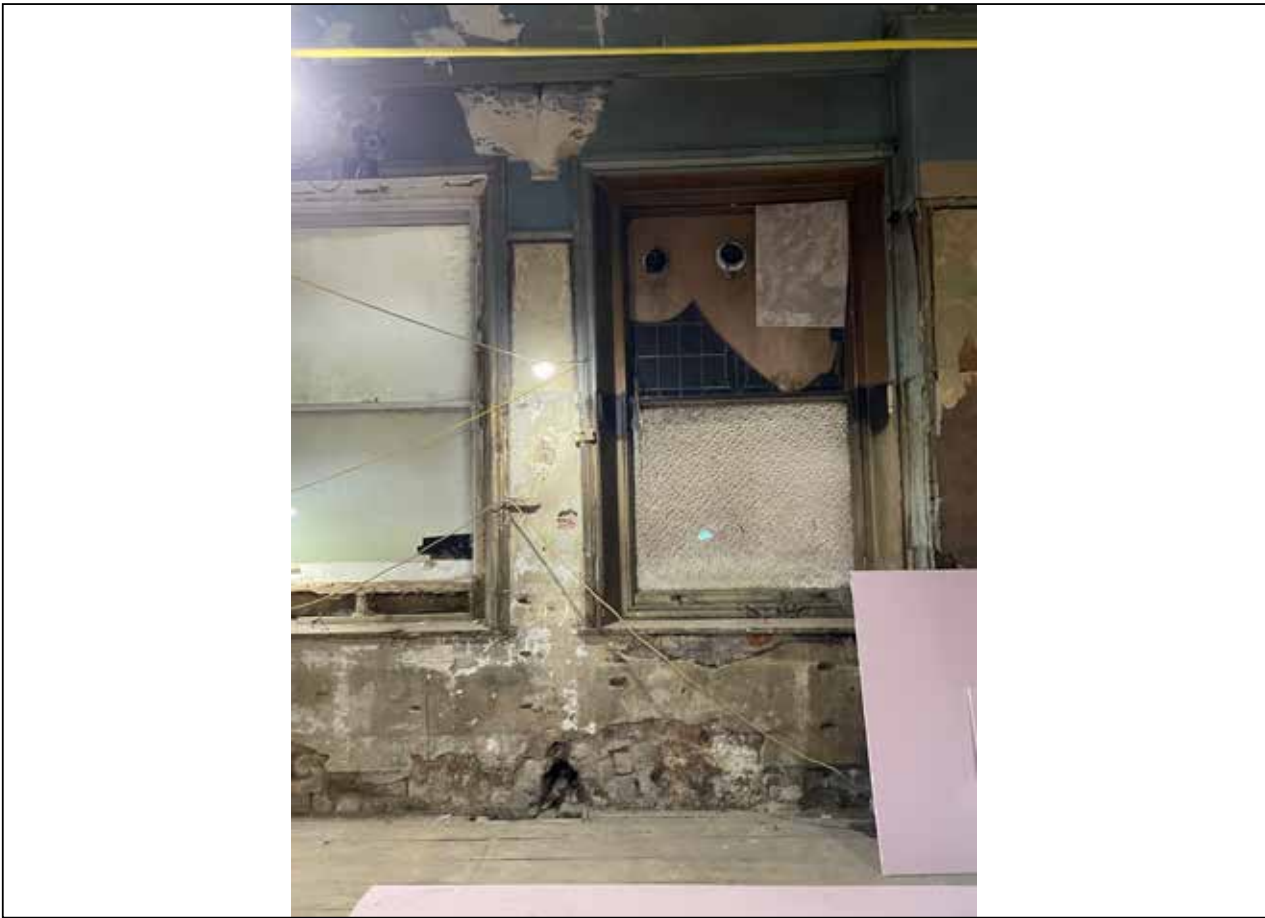
Image 52: Blocked up windows to lightwell on ground floor.

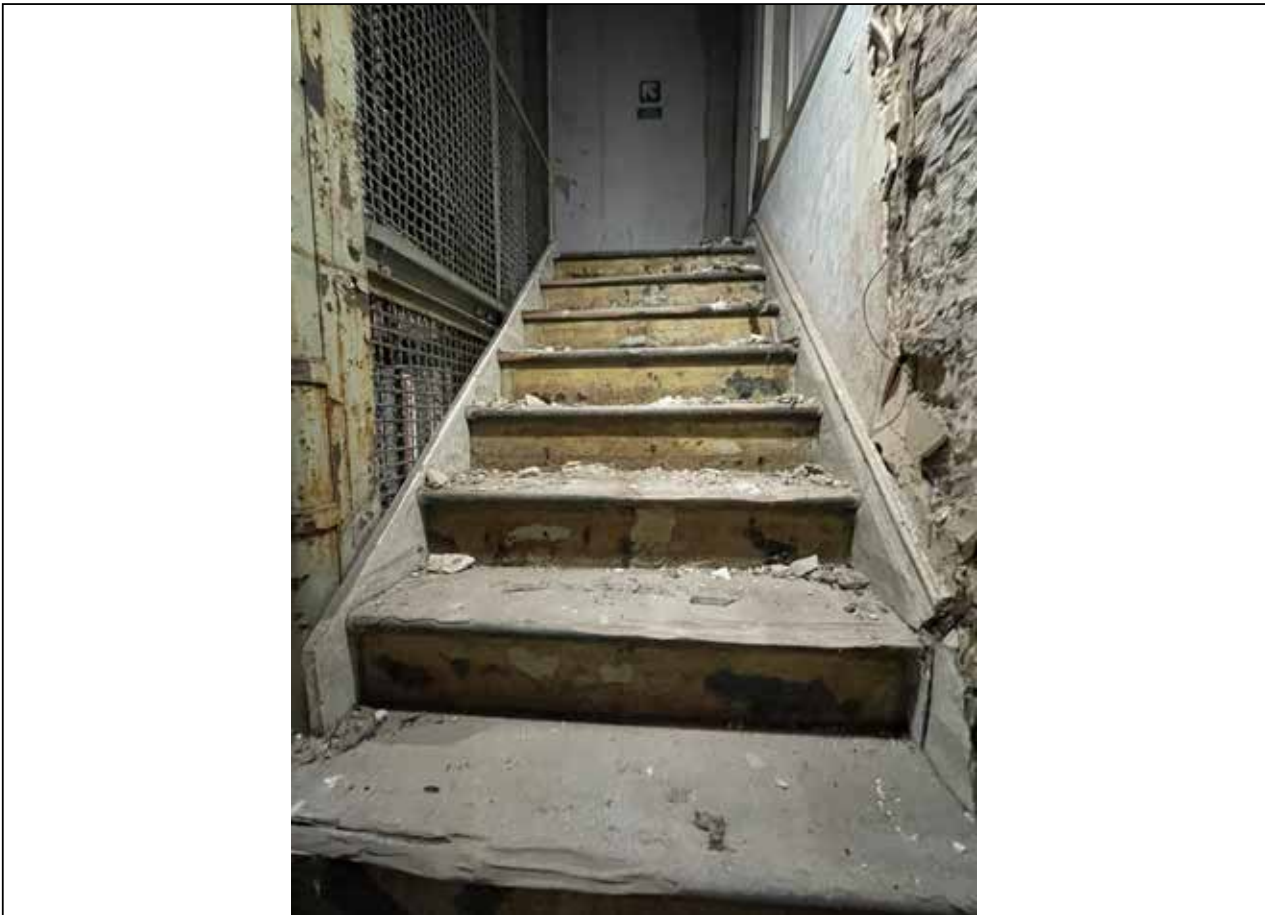
Image 56: Detail of original timber staircase to ground floor, former office side.

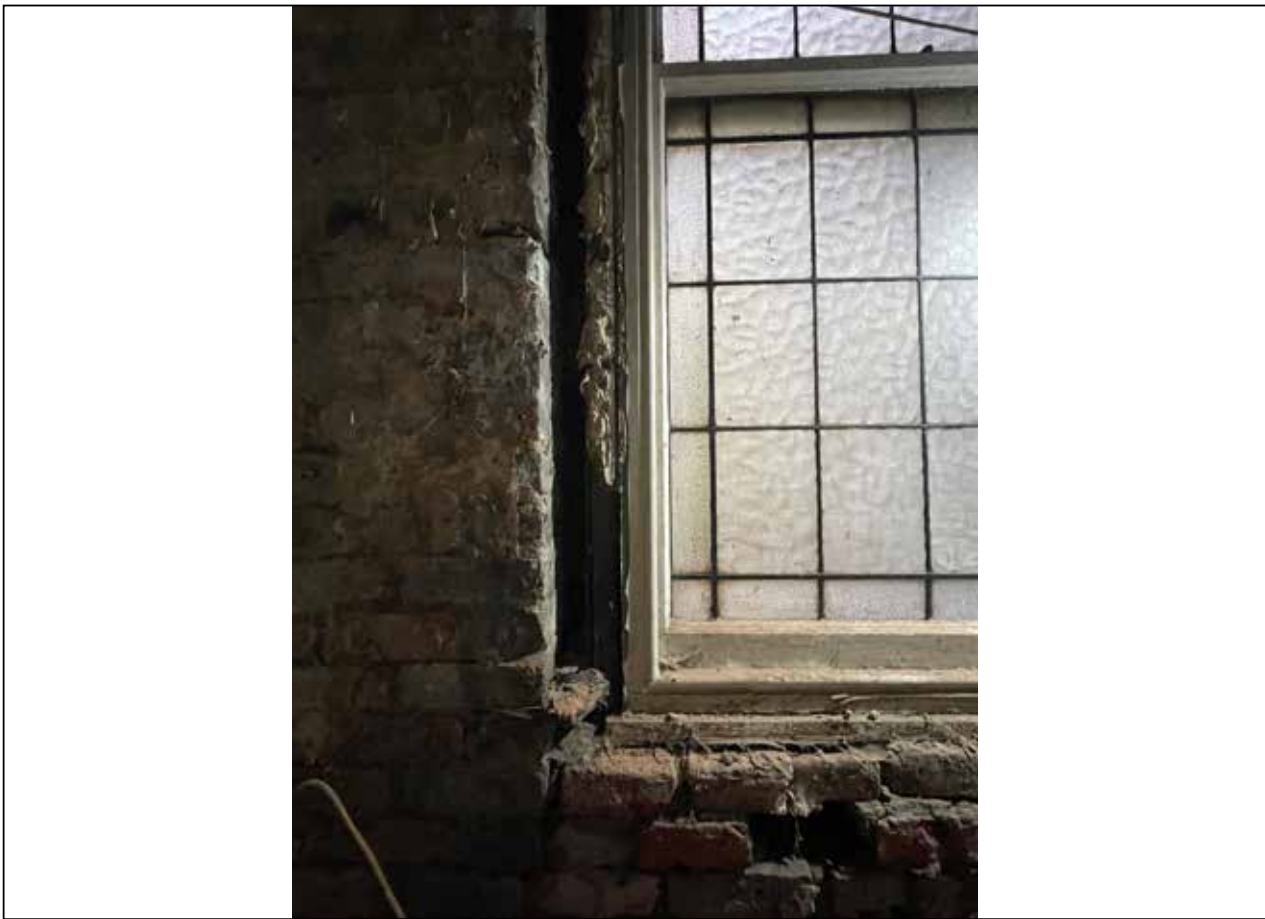
The more decorative stair is that to the warehouse, located next to the lightwell. In the staircase area, windows are replacement leaded sliding sashes, likely to date from the early decades of the 1900s. The staircase is constructed from timber with decorative cast iron spindles, with a limited number of cruder timber replacements. It features an original, long, sweeping handrail of polished timber, has carved stringers and is of high heritage value.

Image 55: Detail of lightwell window with early 20th century glazing, ground floor.

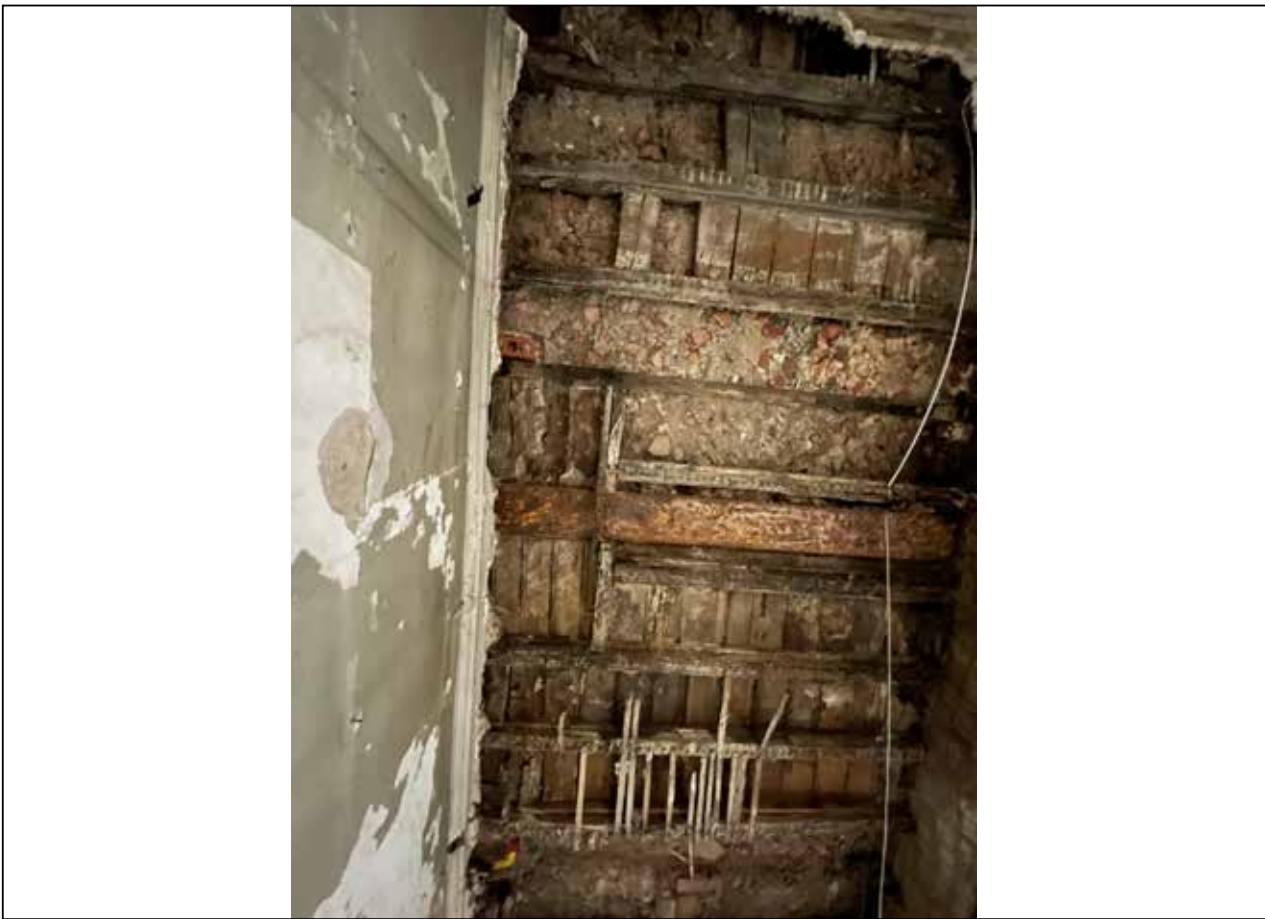
Image 57: Evidence of lath and plaster to ground floor ceiling.

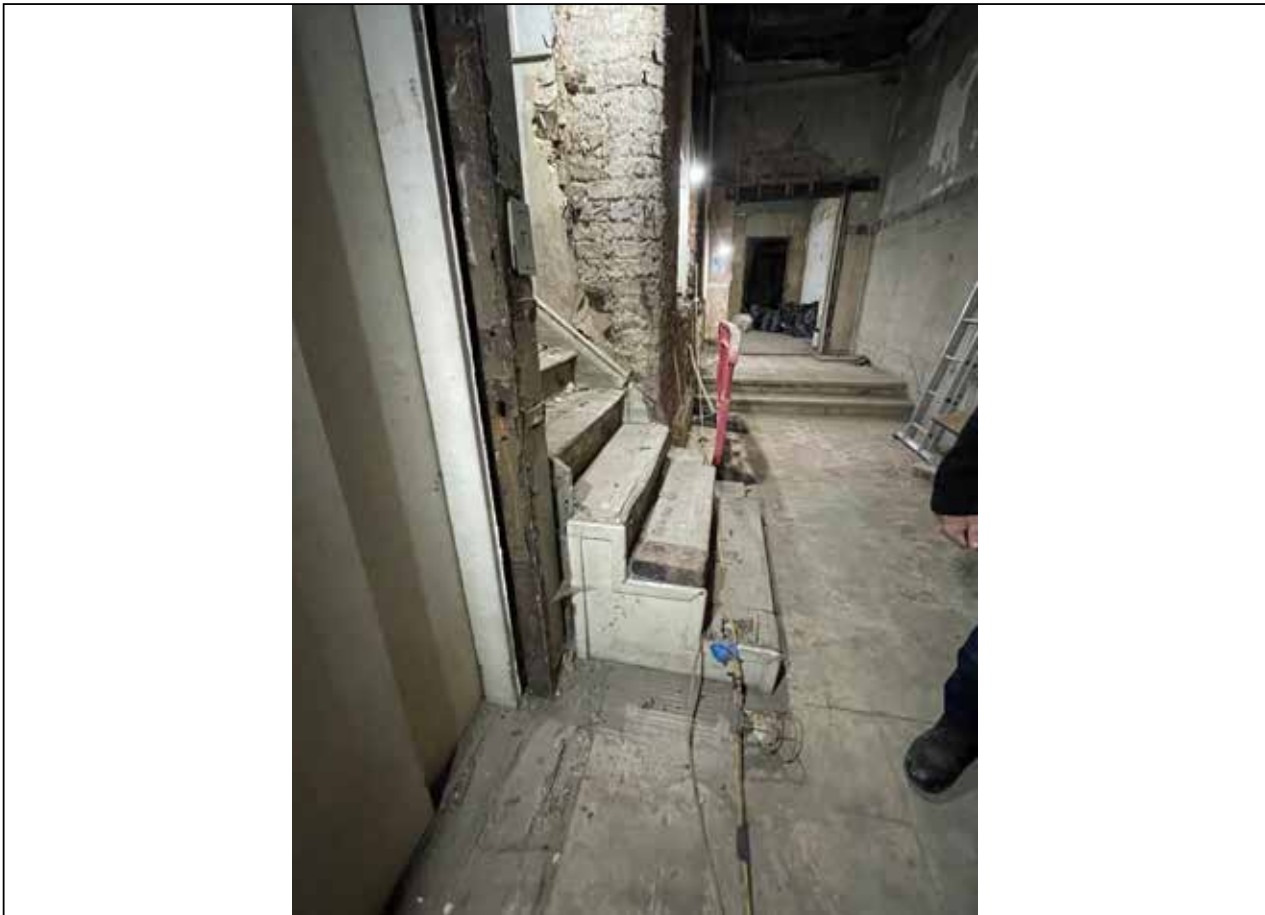
Image 58: Detail of ground floor office stair and further steps (background).

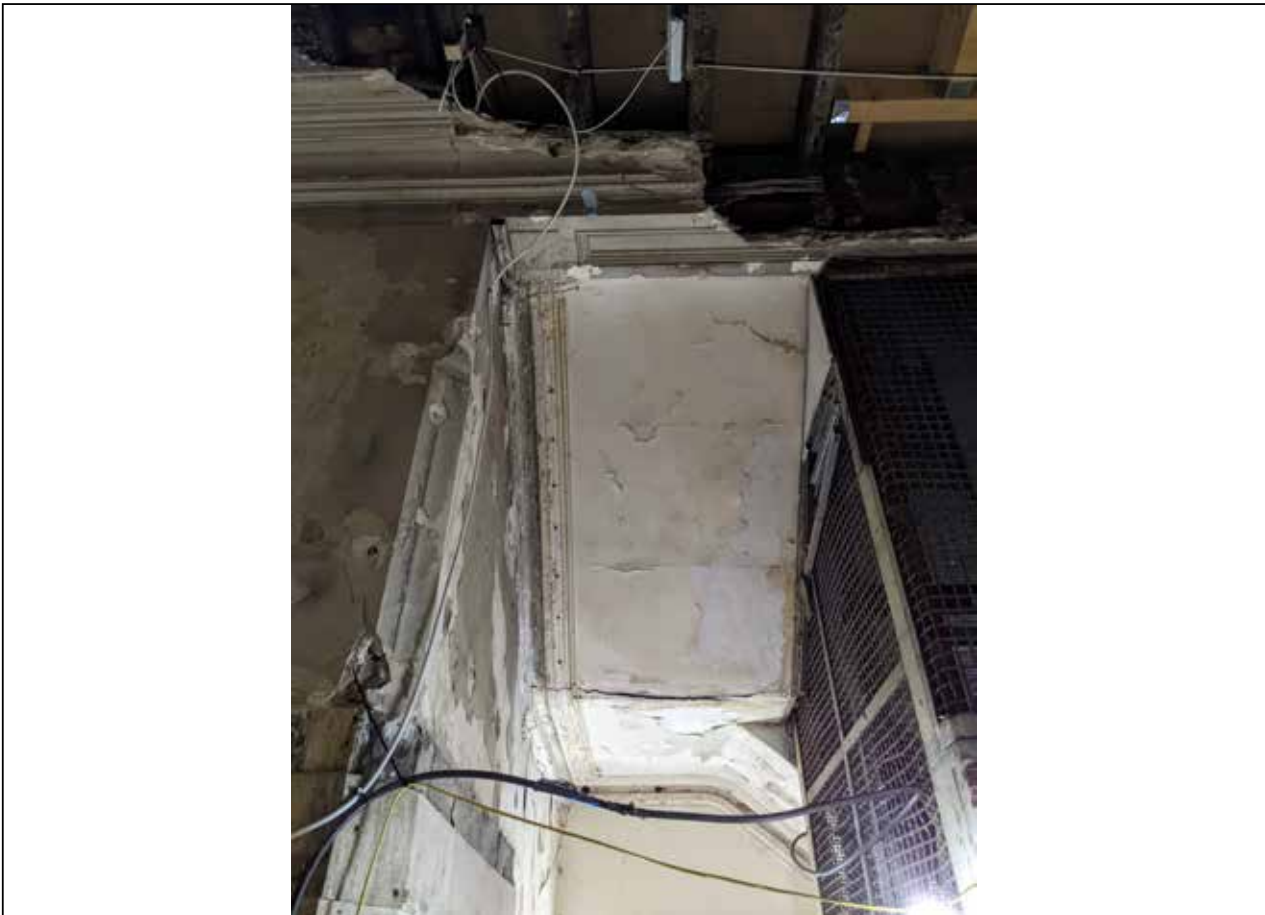
Image 64: Detail of ceiling cornice around lift and office stairs.

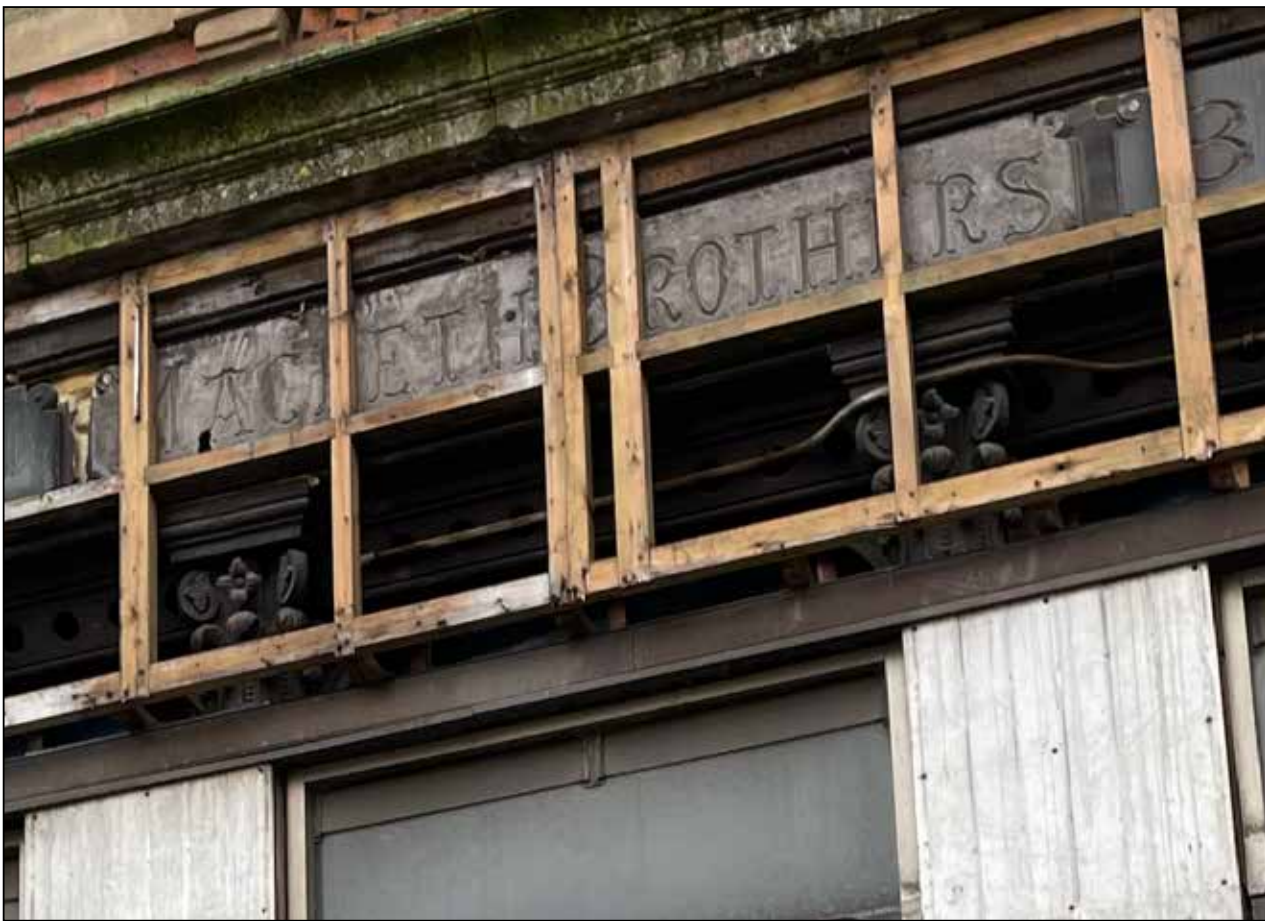
Image 66: Historic shop front to be revealed to former tailors shop on Mosley St.

Modern shop front at 77a Mosley Street to be removed and historic timber framed frontage behind revealed, retained, and repaired (former Macbeth Tailors). Stone signage within this frontage to be revealed and retained.
