# Heritage Statement

77-79 Mosley Street  
Manchester  
M2 3FX

Client: Biz Assets Ltd  
Date: May 2023  
Revision: \_C

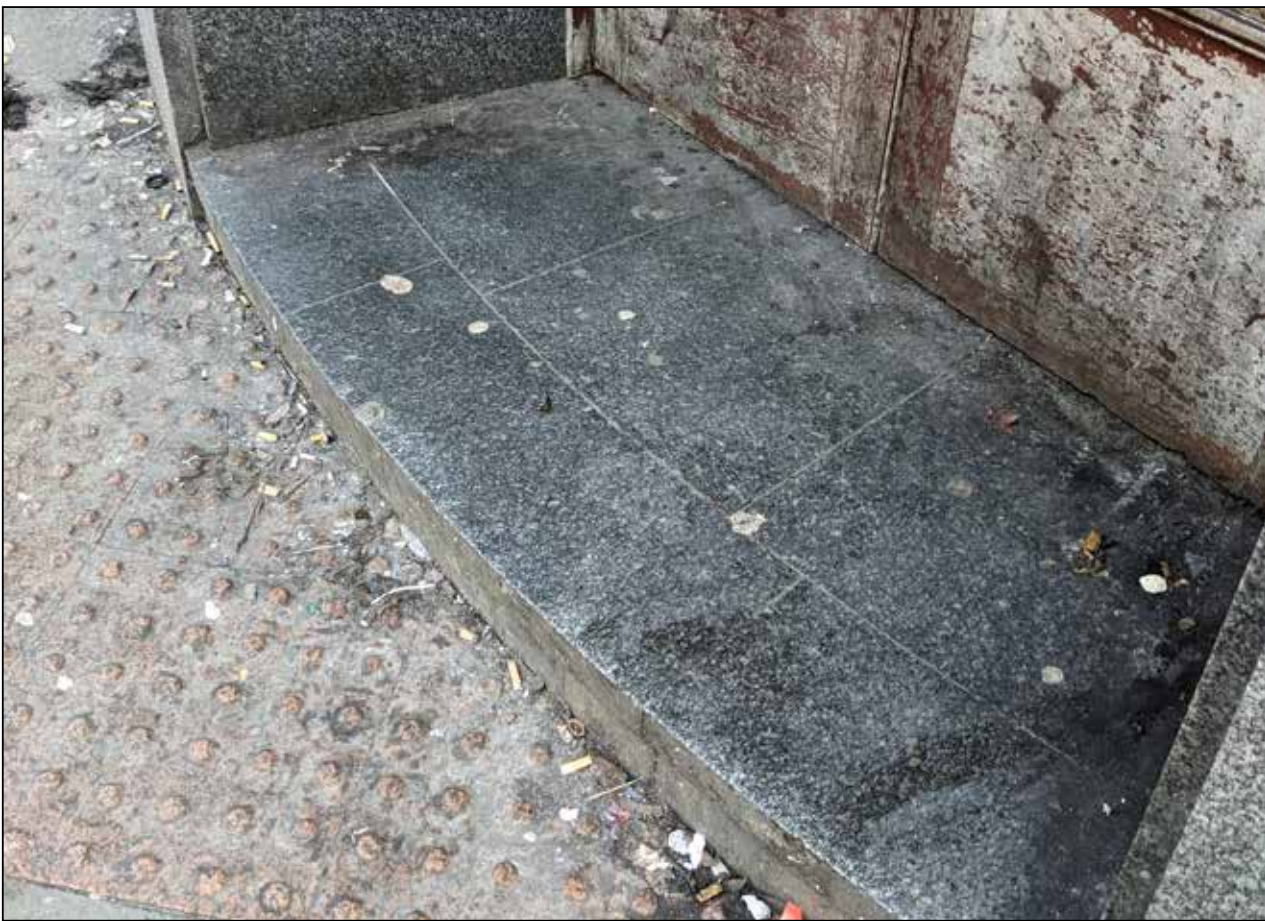
Image 68: Front step to 77 Mosley St. to be replaced with ramp.

Existing low step to former bank at no. 77 to be removed and replaced with new ramp in granite (colour to match existing) to allow for level access.

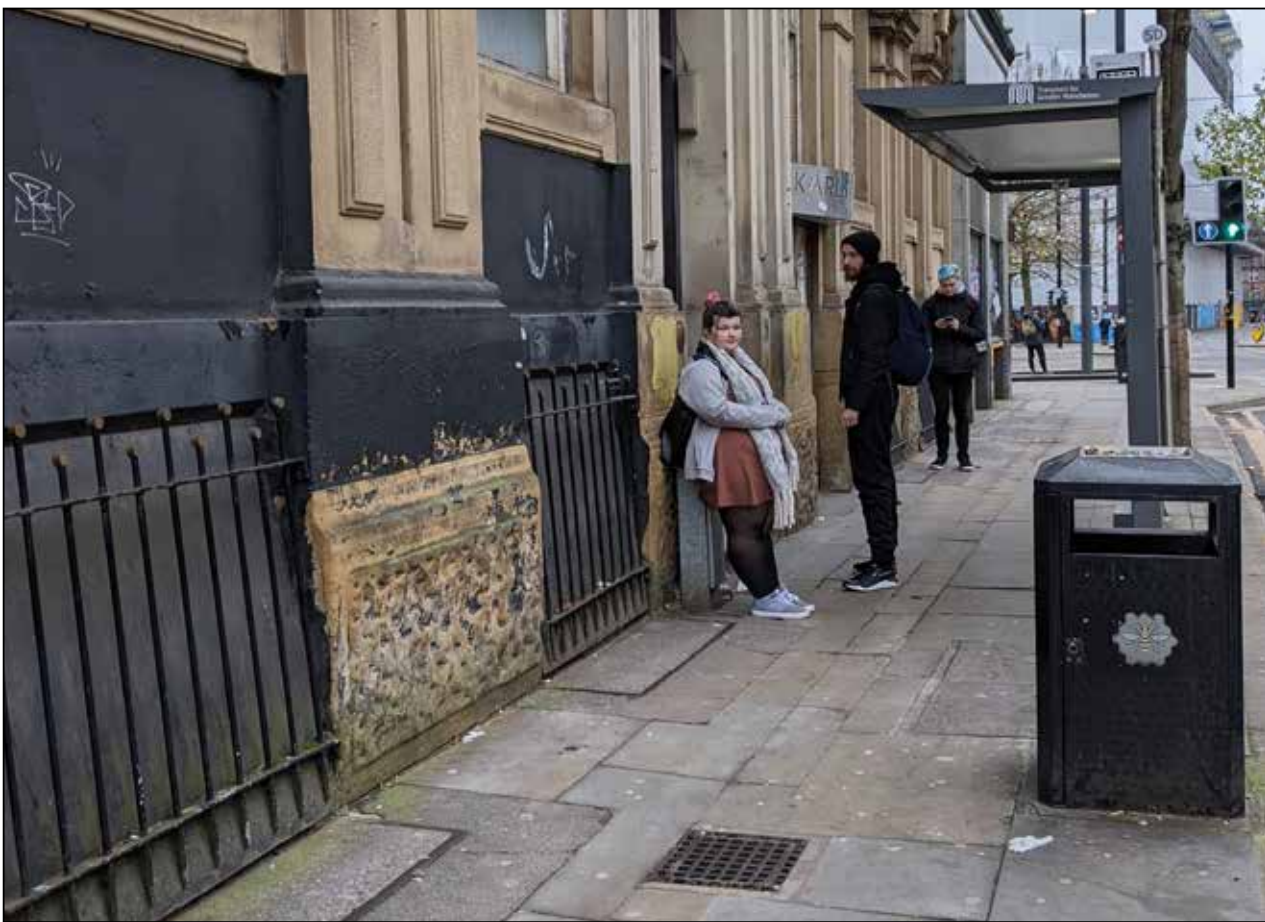
Image 67: Photograph showing existing street scape with boarded windows, over-painted stone and graffiti.

Princess Street and Mosley Street elevations to have like for like repairs, where required. Later added paint will be cleaned from low level stone.

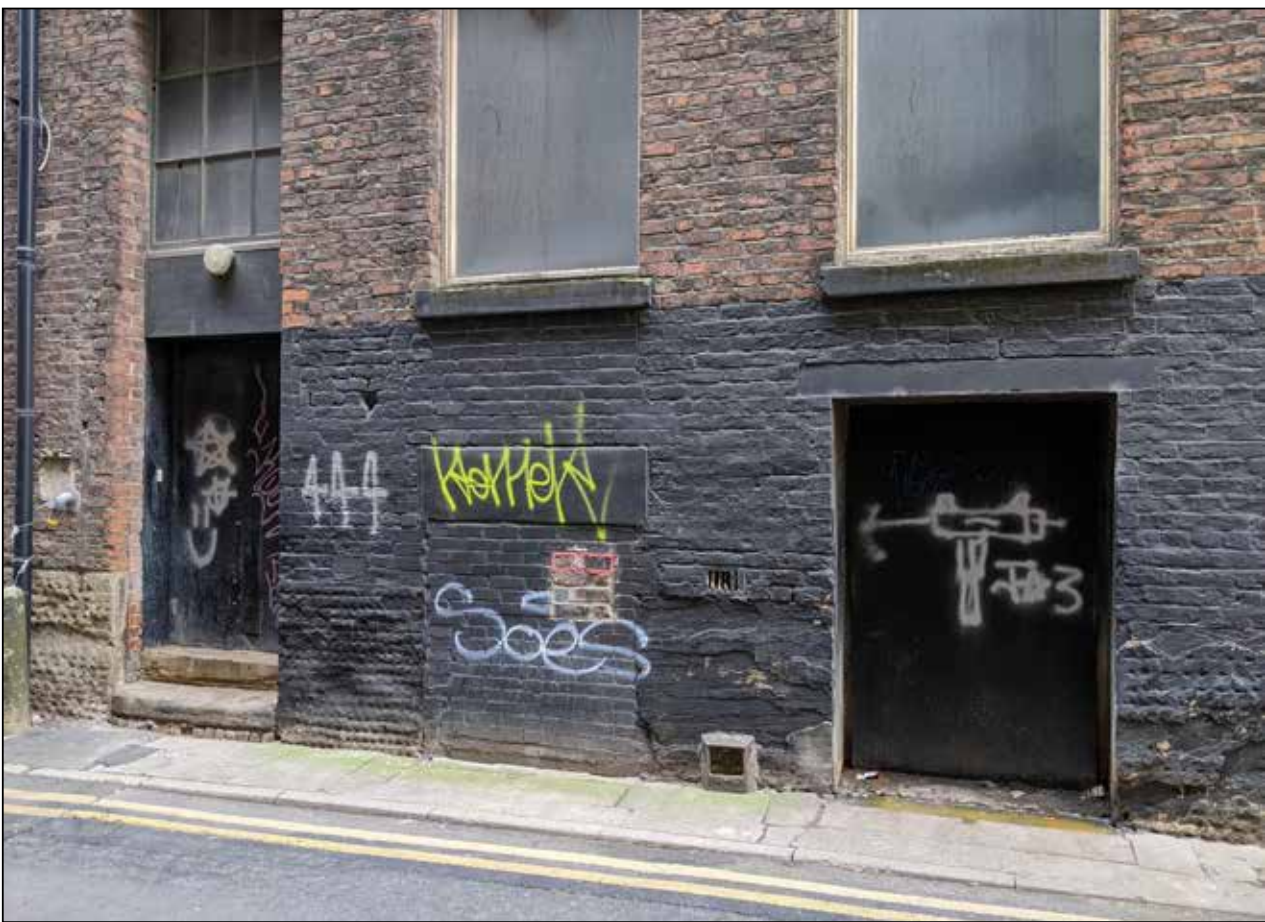
The secondary back elevations to Back George Street are less ornate, built in a functional style almost entirely of red brick with stone sills and low-level rusticated stone, later painted black (paint is a negative addition). There are metal grilles over basement windows which appear original. Numerous alterations and infill on this facade detract from significance.

Image 69: Photograph of Back George St. showing existing street scape.

Poorly matched inserted brickwork to Princess Street end of elevation to be replaced with more appropriate matching.

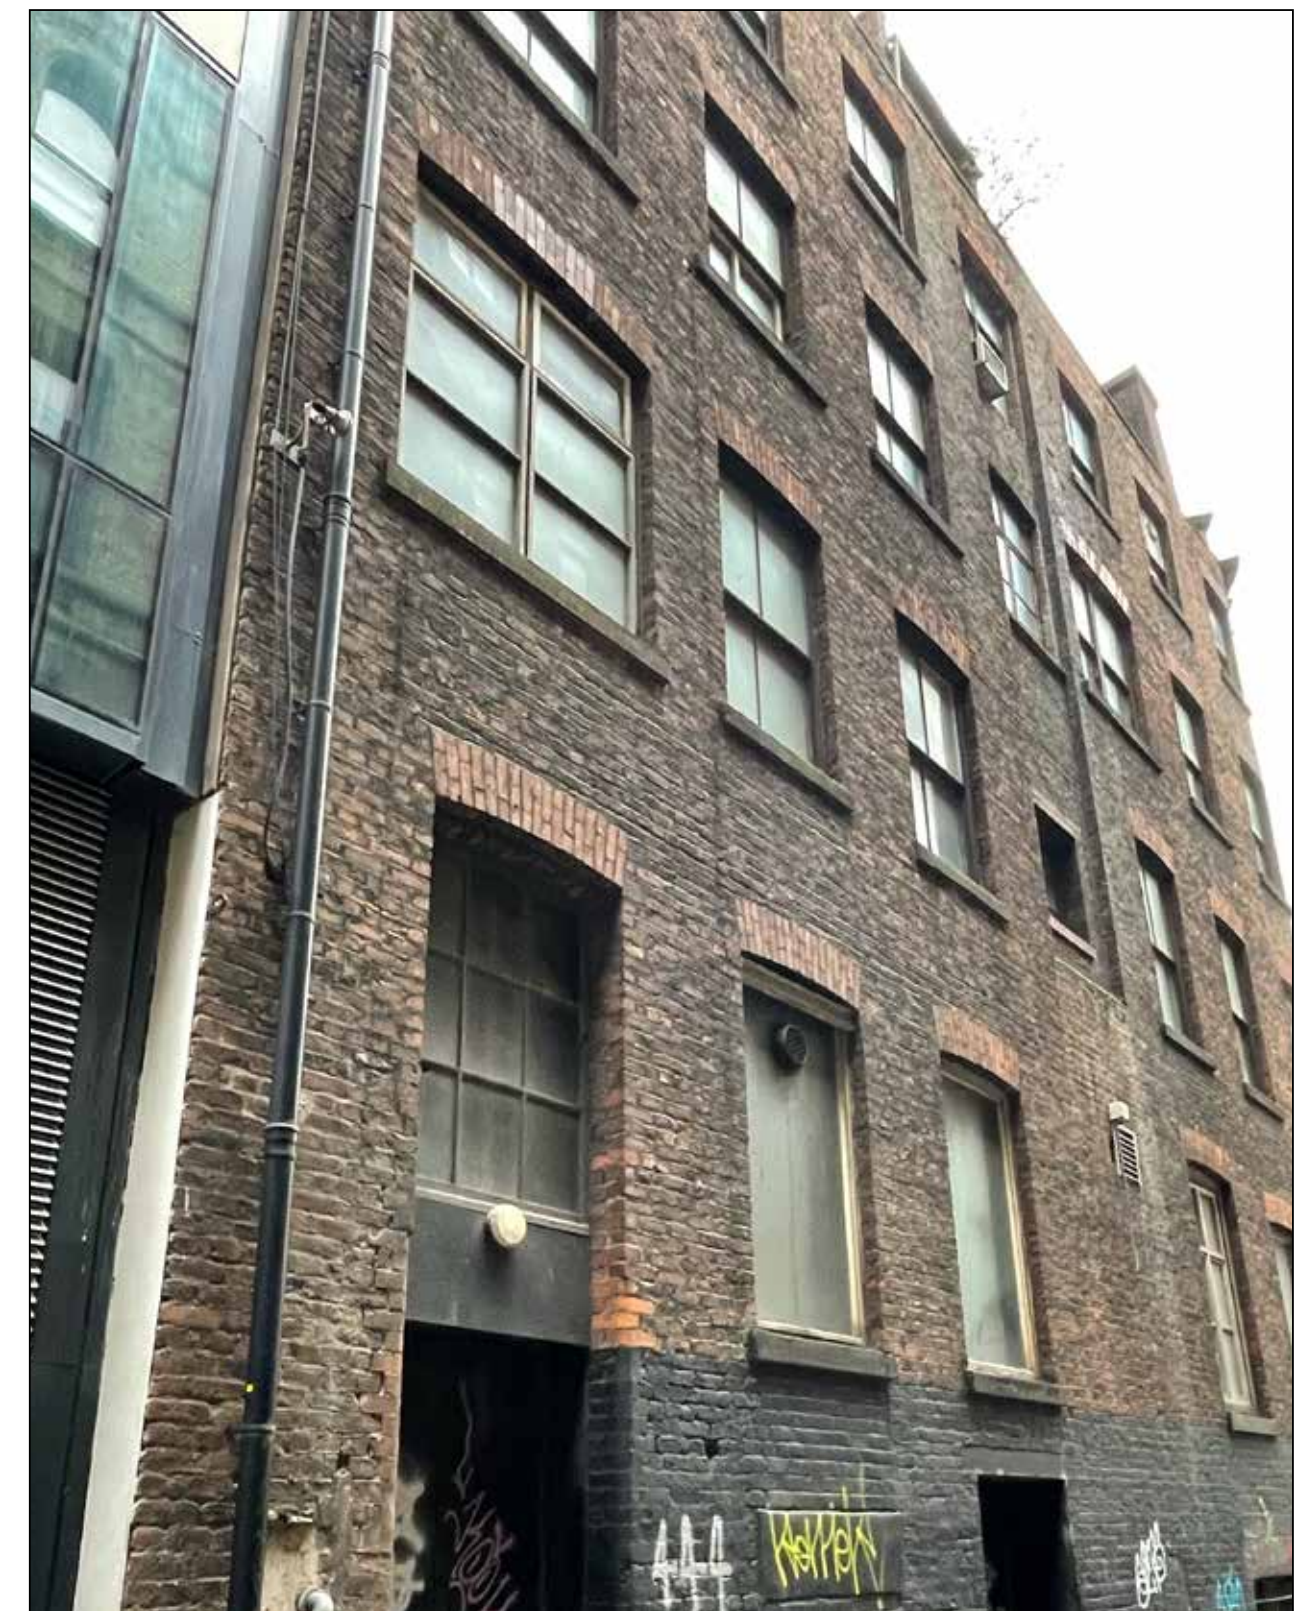
Image 70: Photograph along Back George St.

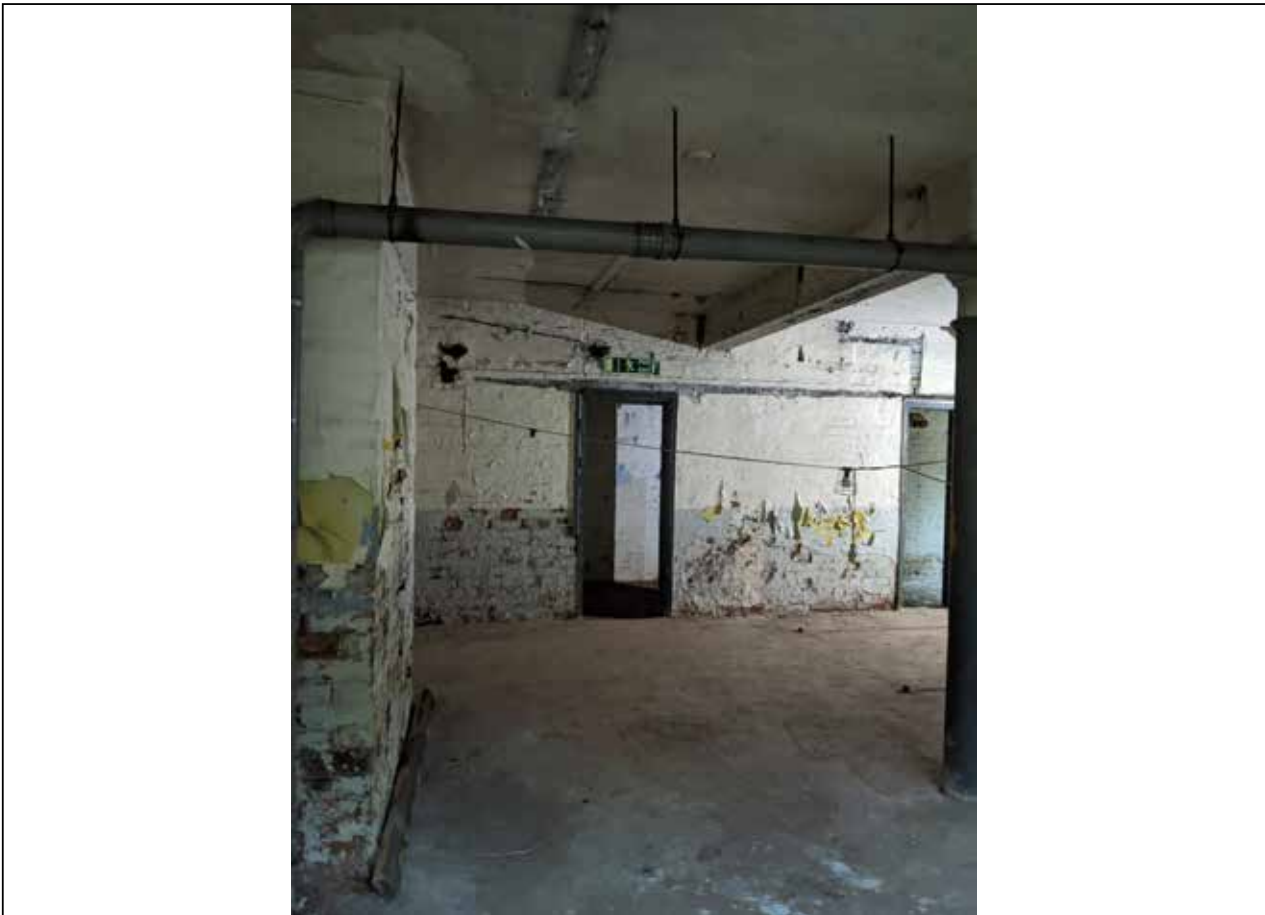
Image 71: Interior view of basement, with chimney breast to left hand side.

Chimney breast to be removed to right-hand side of plan, central room. This is historic fabric, with some significance in terms of plan form, though has no particular features.

**Impact:** Minor, adverse. Removing this feature will have a limited impact upon the significance of the whole.

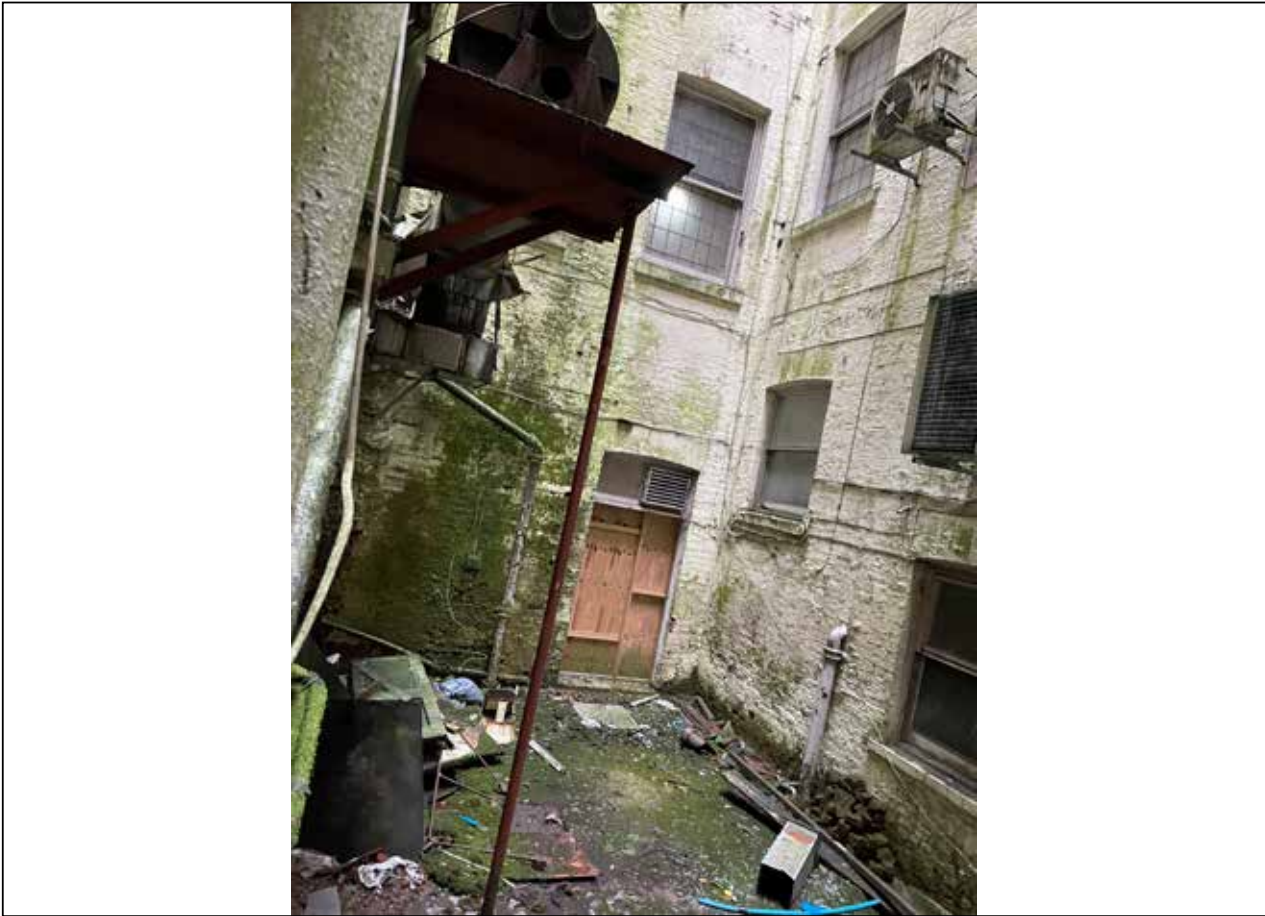
Image 72: Internal view of lightwell.

**Impact:** Moderate, adverse. The nature of the lightwell will be compromised to a limited degree with the insertion of a solid floor. A limited number of windows will be lost by conversion to openings. A portion of windows and wall will be replaced with a larger opening.

Repair and redecoration of internal facing white-painted brickwork to lightwell.  
**Impact:** Minor, positive. The white colour of the bricks is a typical and significant characteristic of the lightwell, as it allowed light to reflect into internal spaces. Restoring it will enhance the feature.

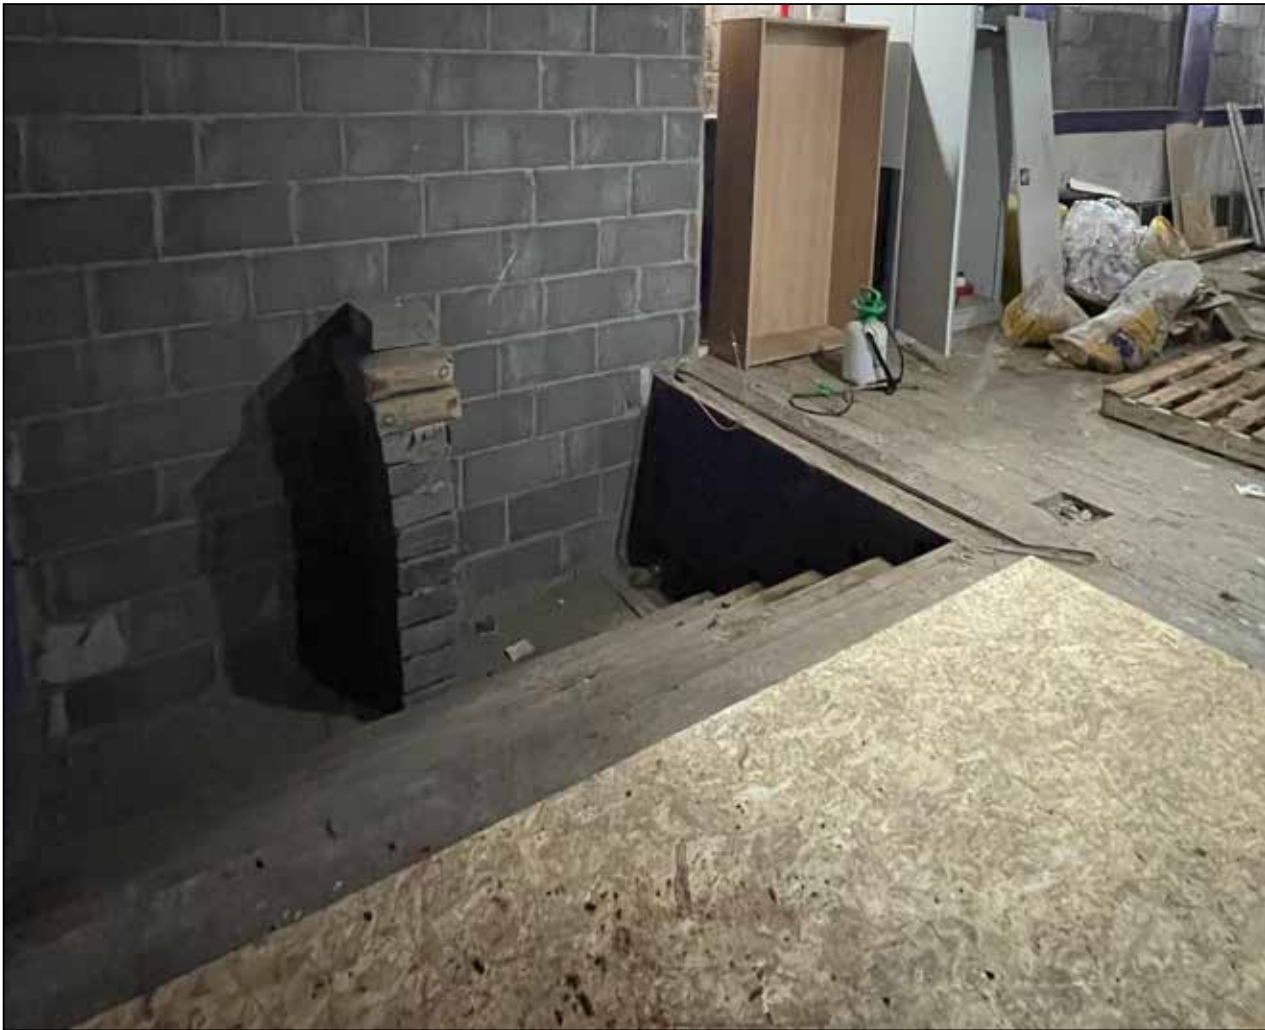
Image 73: Detail of steps to back of Princess St. entrance.

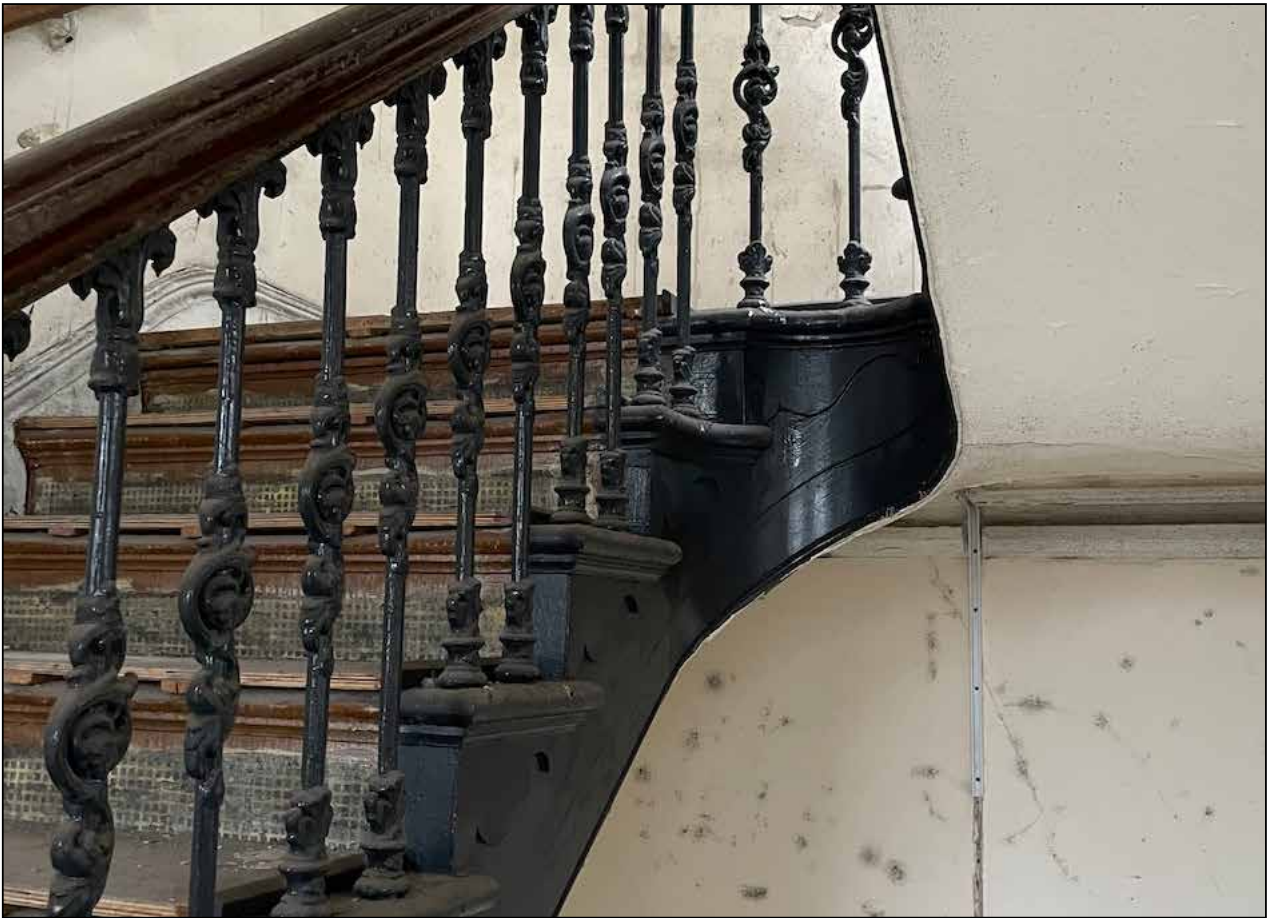
Image 75: Detail of secondary (warehouse) staircase.

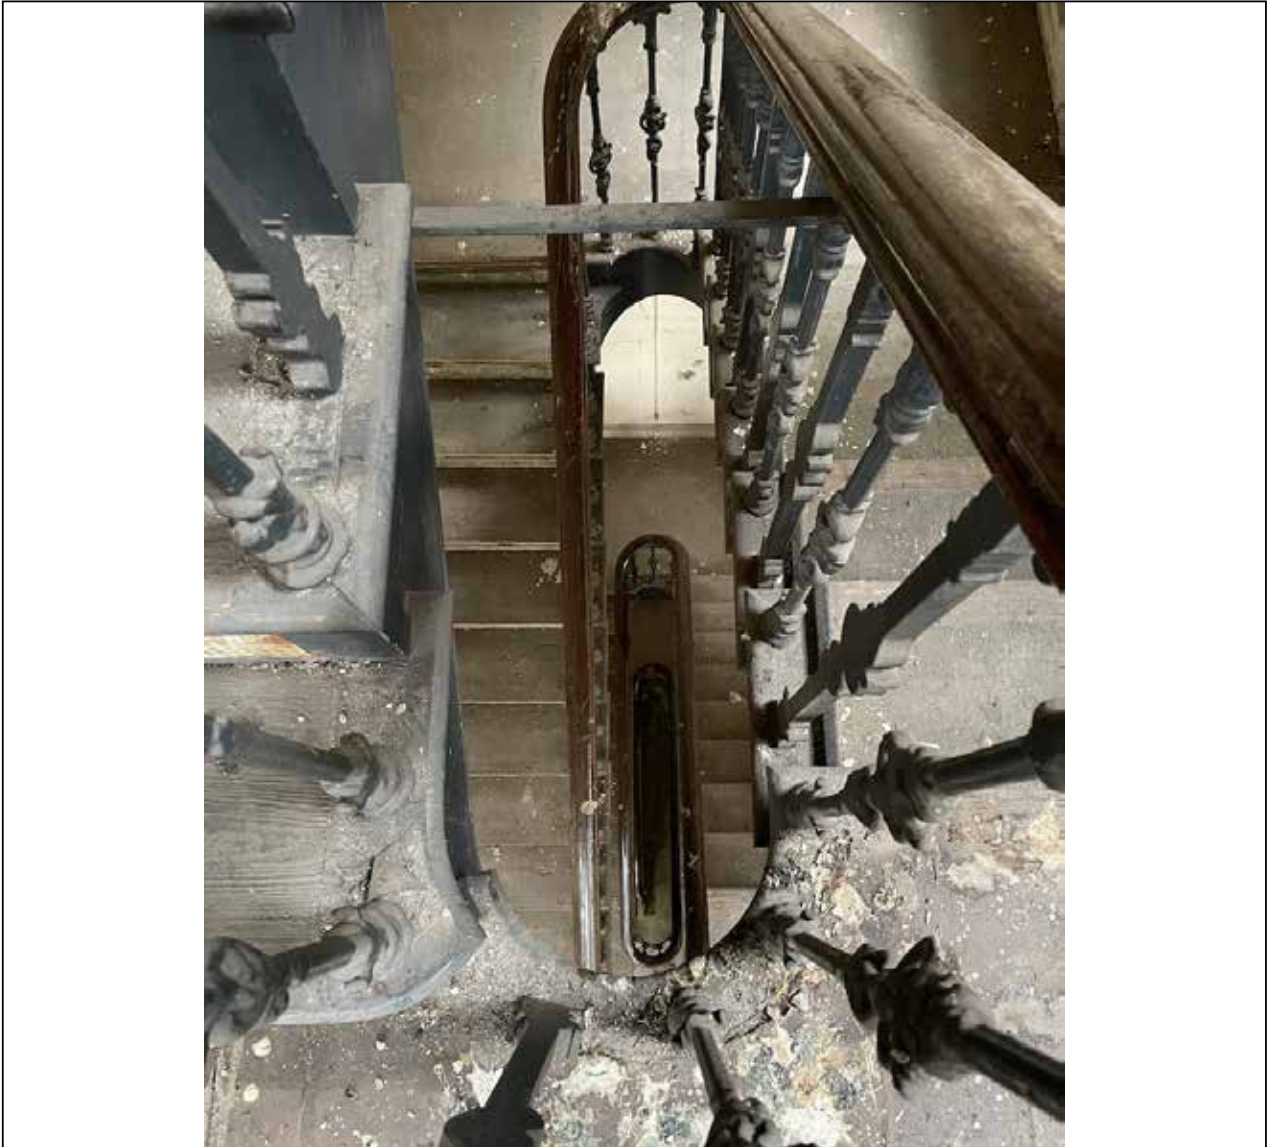
Image 76: Detail of secondary (warehouse) staircase with cast iron balustrade.

The loss of the staircase would cause harm to one area of the interior, but would allow the greater majority of fabric to be retained.

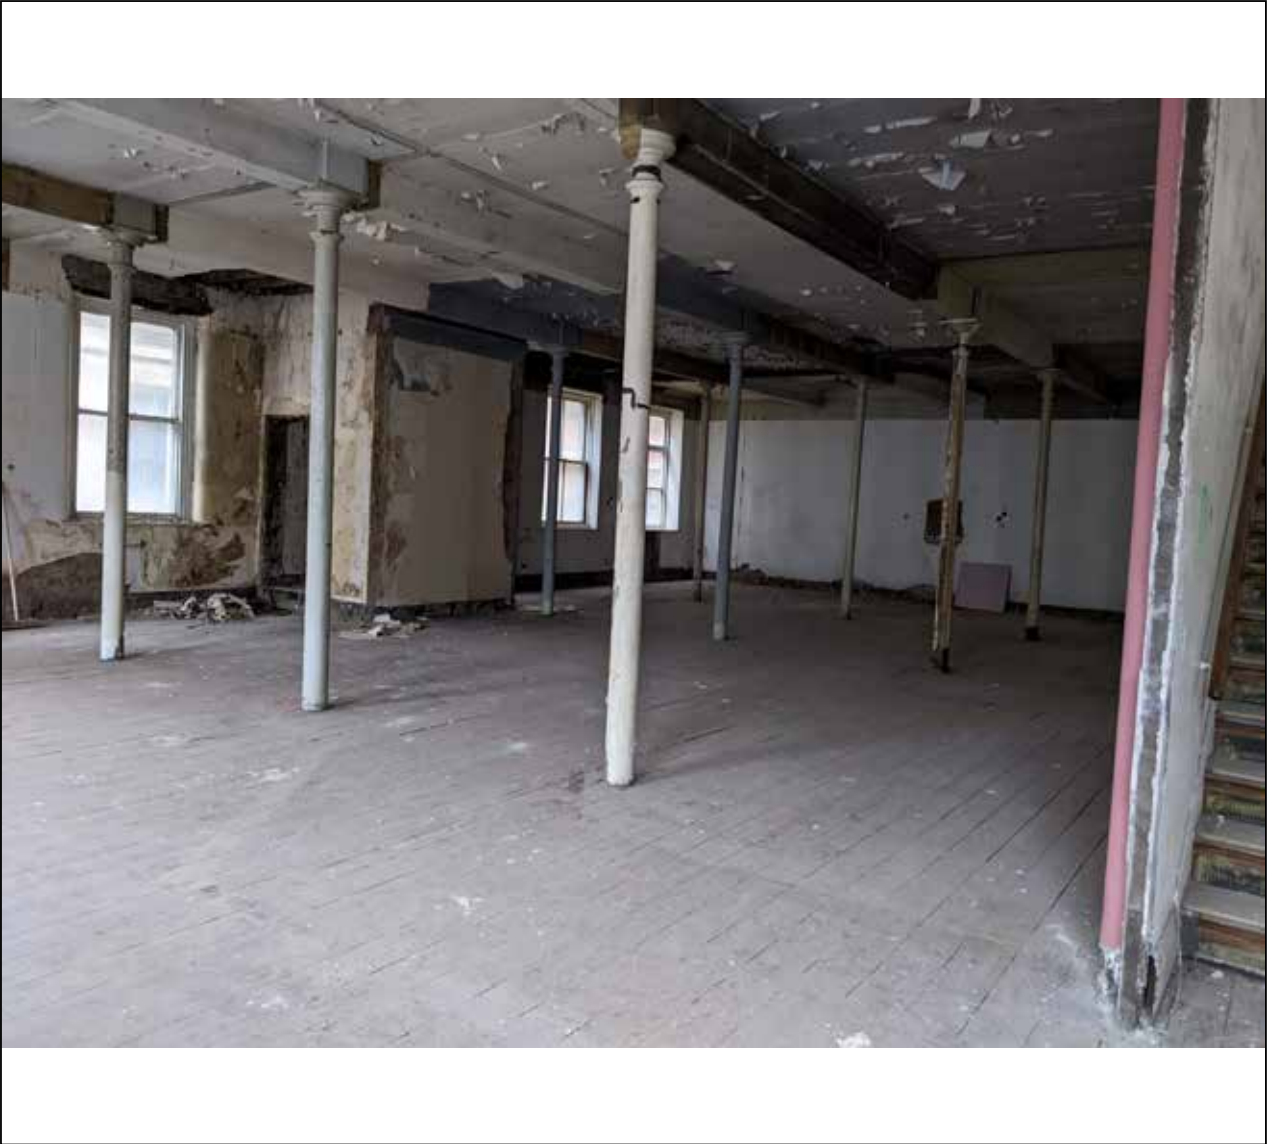
Image 79: Photograph showing internal space to former warehouse. The close knit grid of columns is evident, as is the former hoist which extends into floor space from the Back George St. wall. The warehouse staircase is visible to the right hand side.
