# Transpennine Route Upgrade GI

## BAM Ritchies - W1B - SPO5.3W - MVL1 Drainage Tanker Access Assessment - GRIP 5

Factual Account of Ground Investigation

BAM Ritchies Project Reference: 322Q-26a

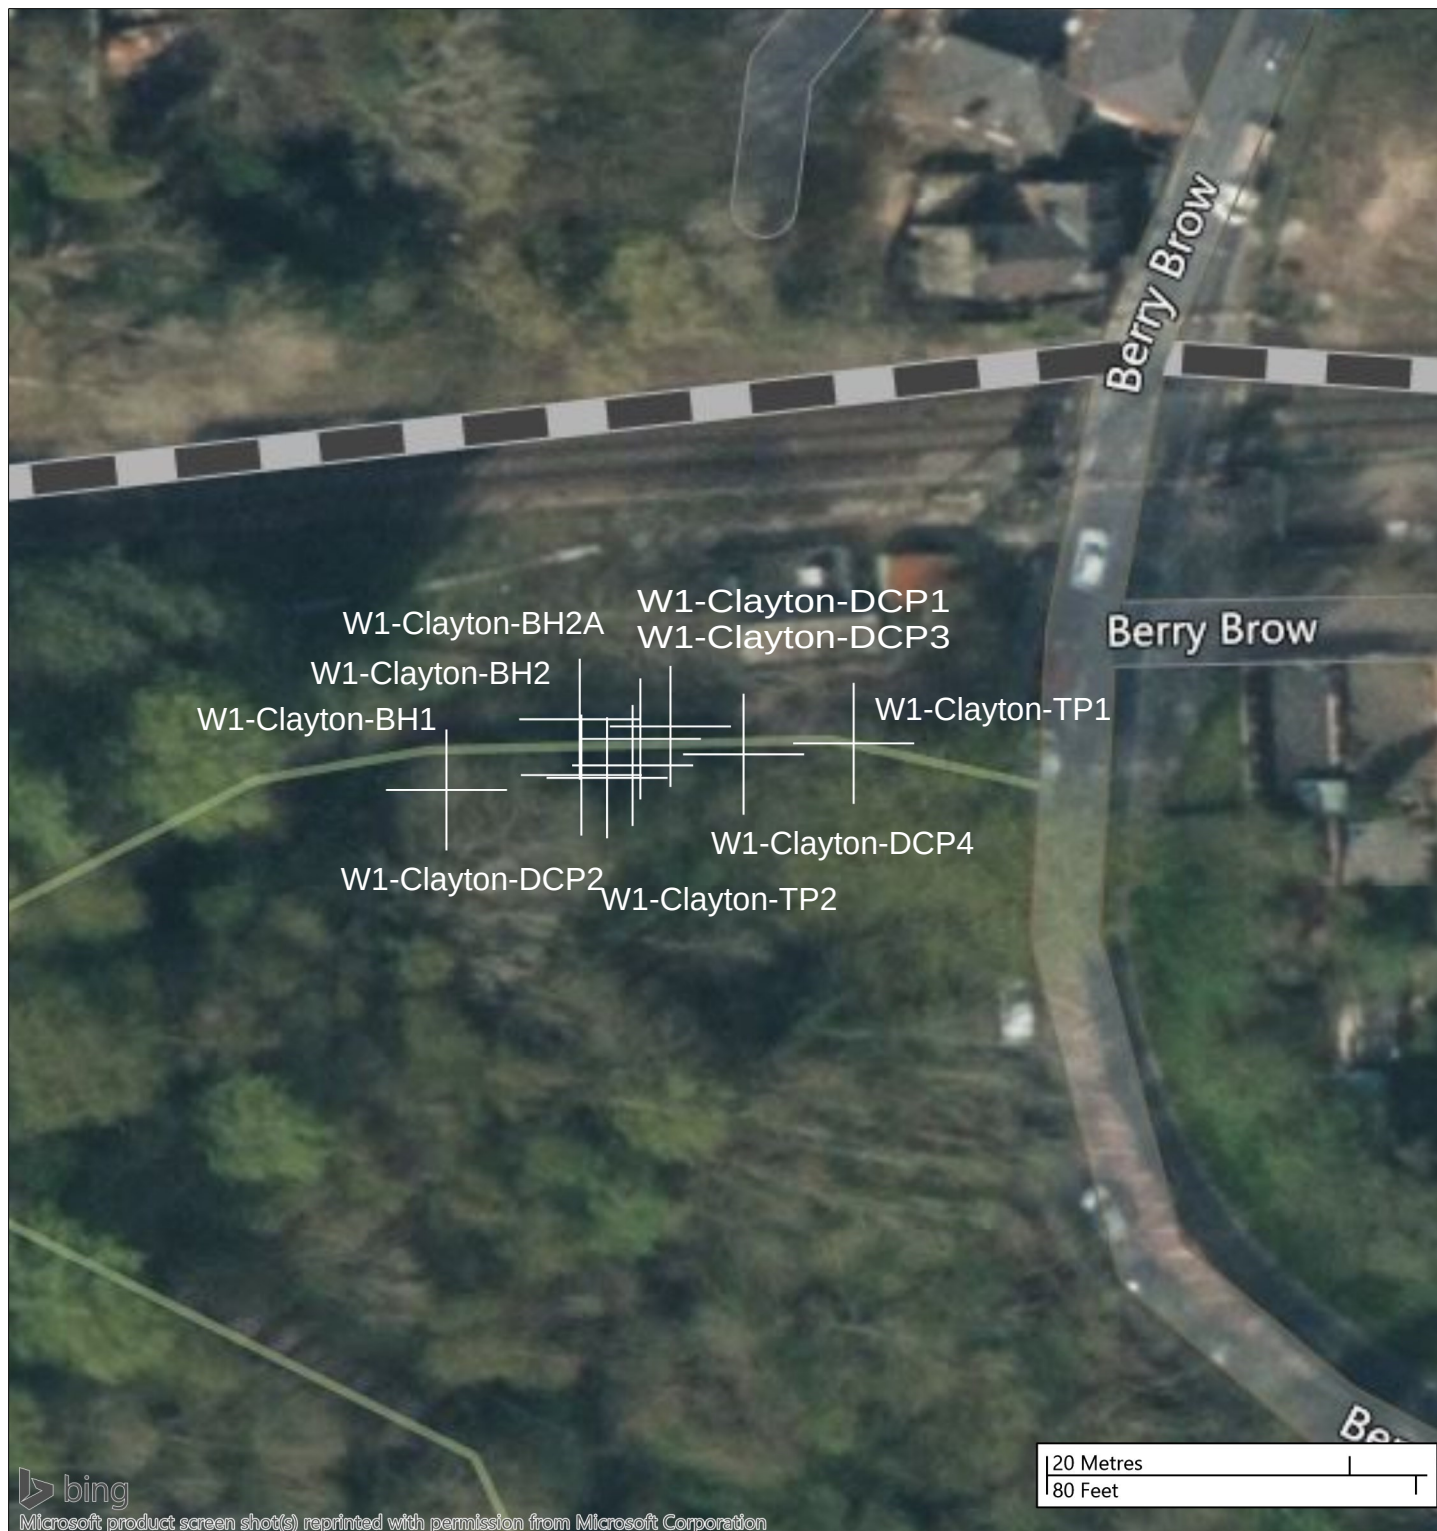
| Legend Key | Remarks | <div data-bbox="1321 1608 1469 1682"> </div> <div data-bbox="1107 1704 1501 1742"> <h3>Exploratory Hole Locations</h3> </div> <div data-bbox="1098 1765 1493 2067"> <p>Project Name: Transpennine Route Upgrade SIGI</p> <p>Project No: 322Q-26a</p> <p>Client: Transpire Alliance</p> <p>Engineer: Transpire Alliance</p> <p>Contractor: BAM Ritchies</p> <p>Date: 22/08/2022</p> <p>Scale: 1:500</p> </div> <div data-bbox="1251 2089 1493 2112"> <p>Figure No: 322Q-26a / xxx</p> </div> <div data-bbox="1238 2130 1501 2145"> <p>BAM R Hole Location Plan A4 27/09/2016</p> </div> | |

The exploratory hole locations were set out by a BAM Ritchies Geotechnical Engineer using the site plan and coordinates provided. The positions are shown on the exploratory hole plans which comprise Figure 2.

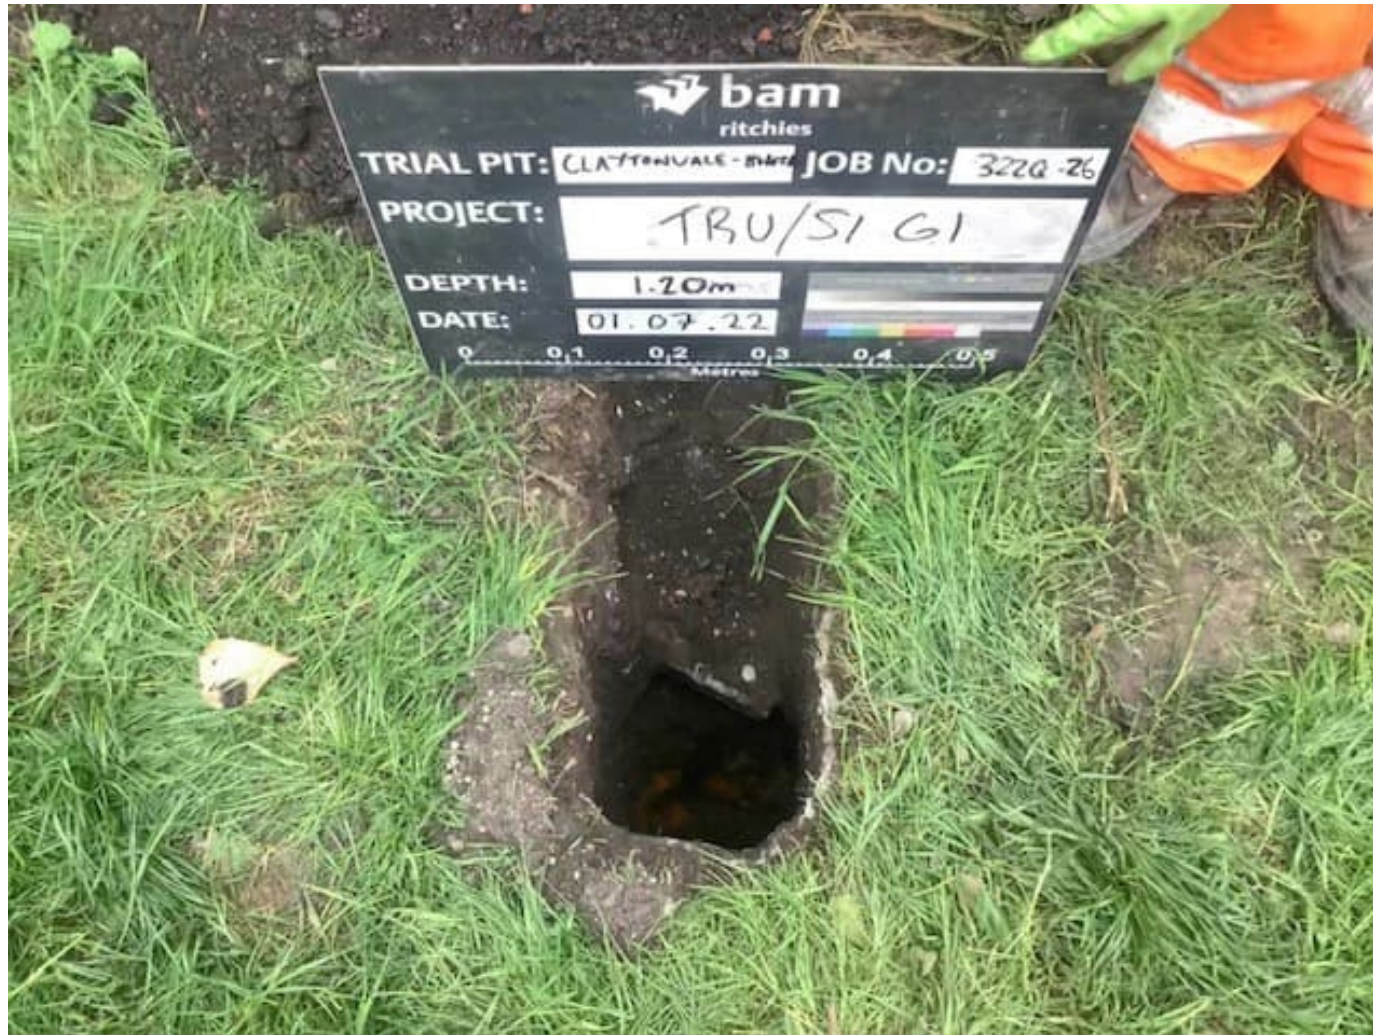
CLAYTON VALE-BH02A - 0.00 - 1.20m - East

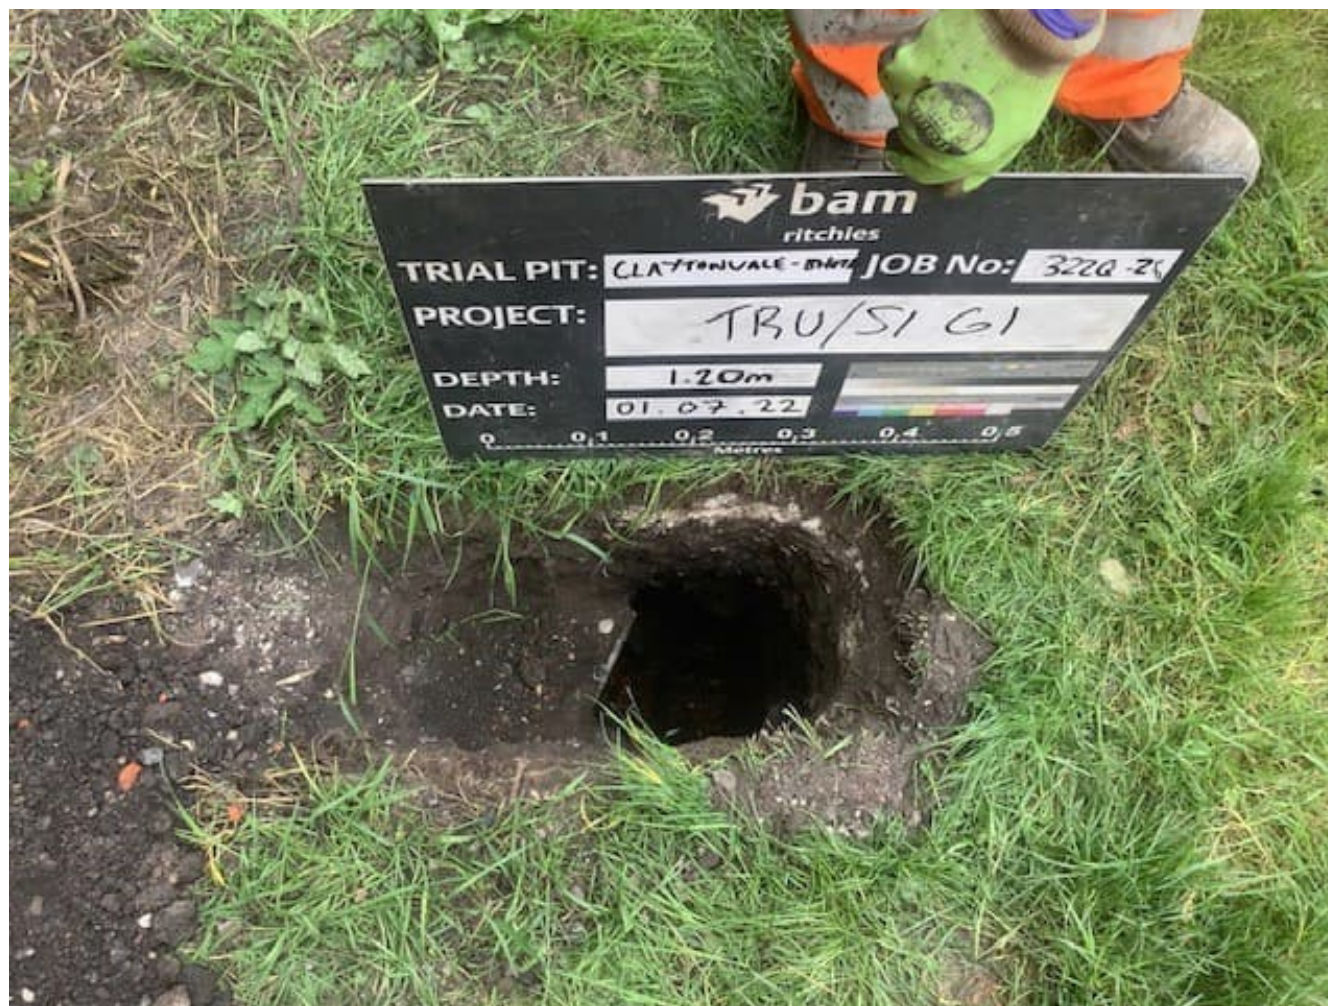
CLAYTON VALE-BH02A - 0.00 - 1.20m - North

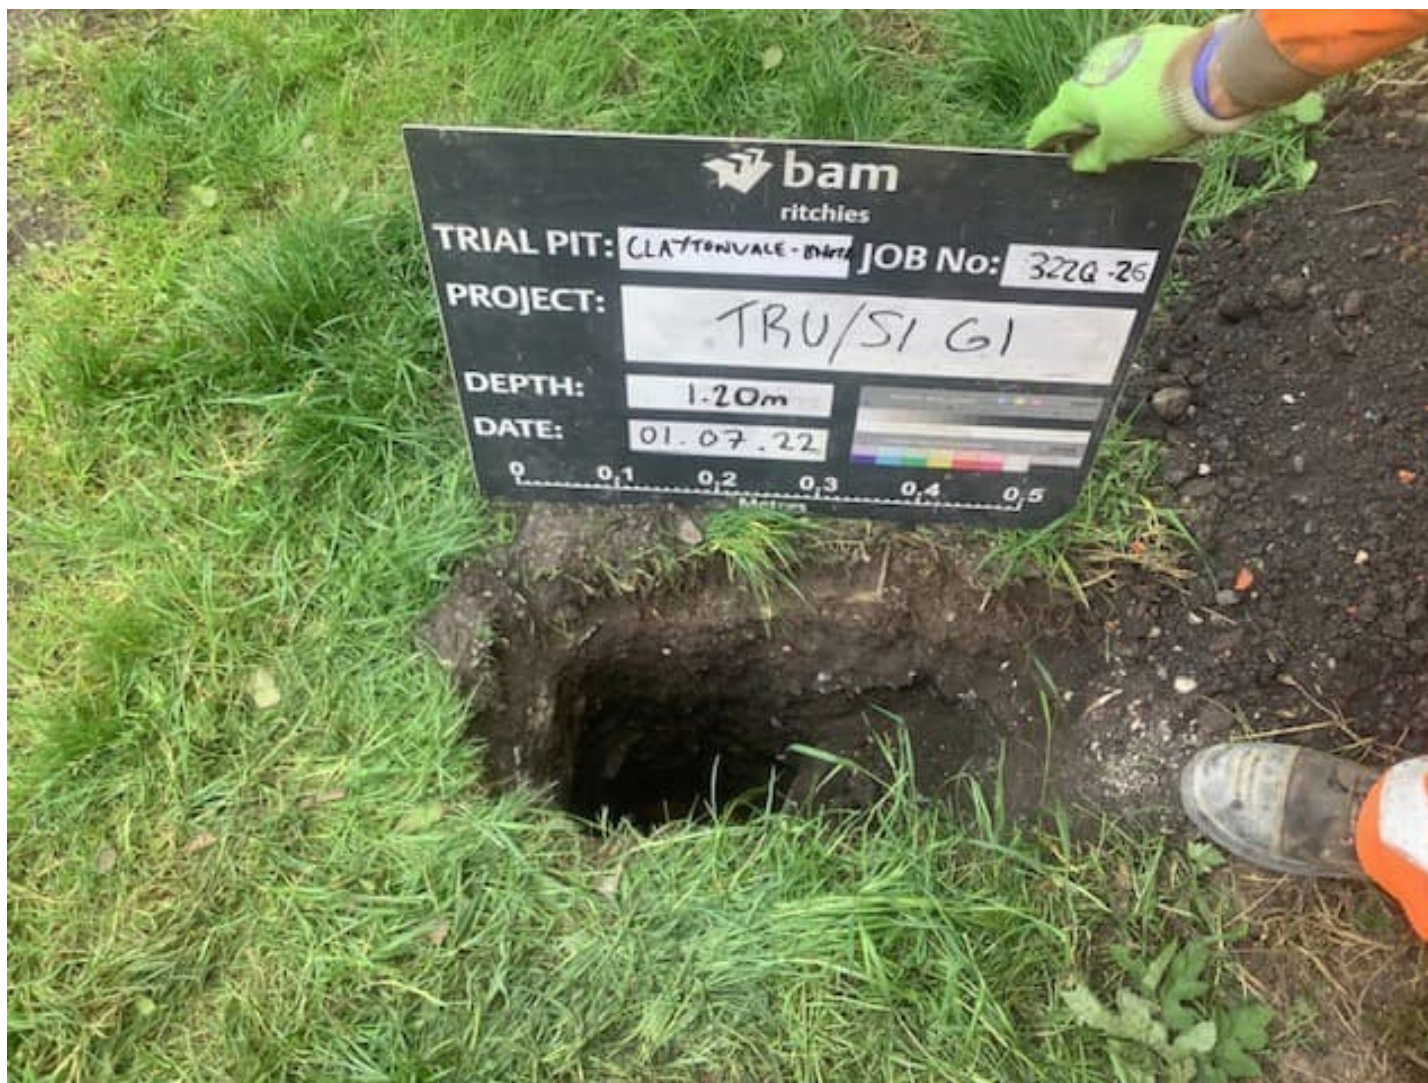
CLAYTON VALE-BH02A - 0.00 - 1.20m - South

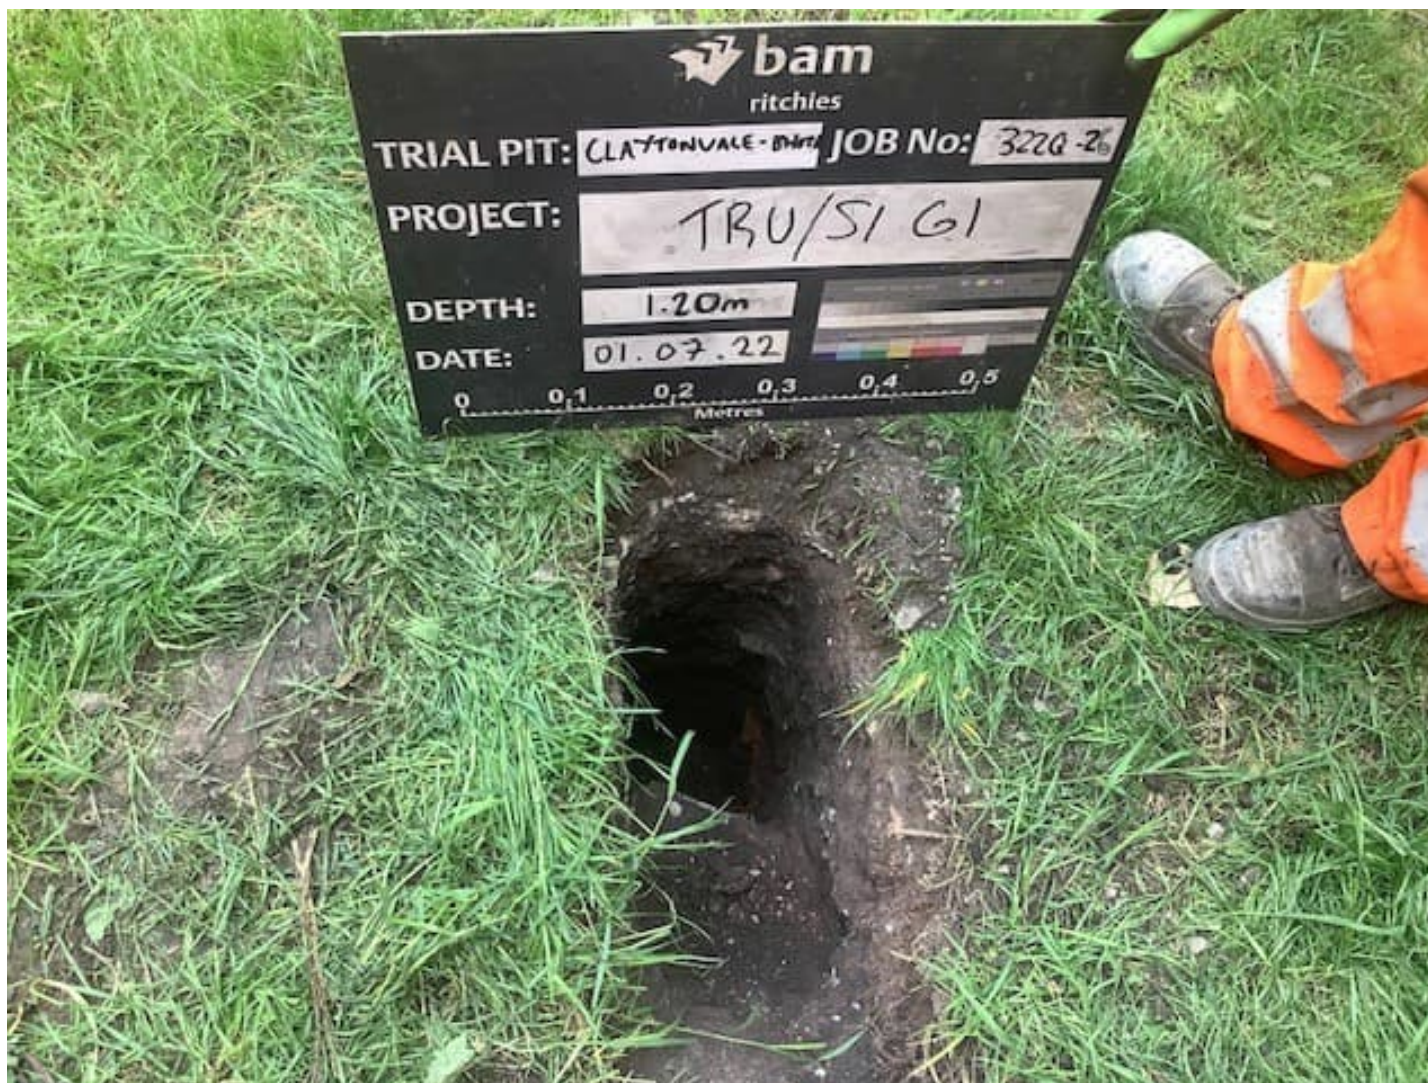
CLAYTON VALE-BH02A - 0.00 - 1.20m - West

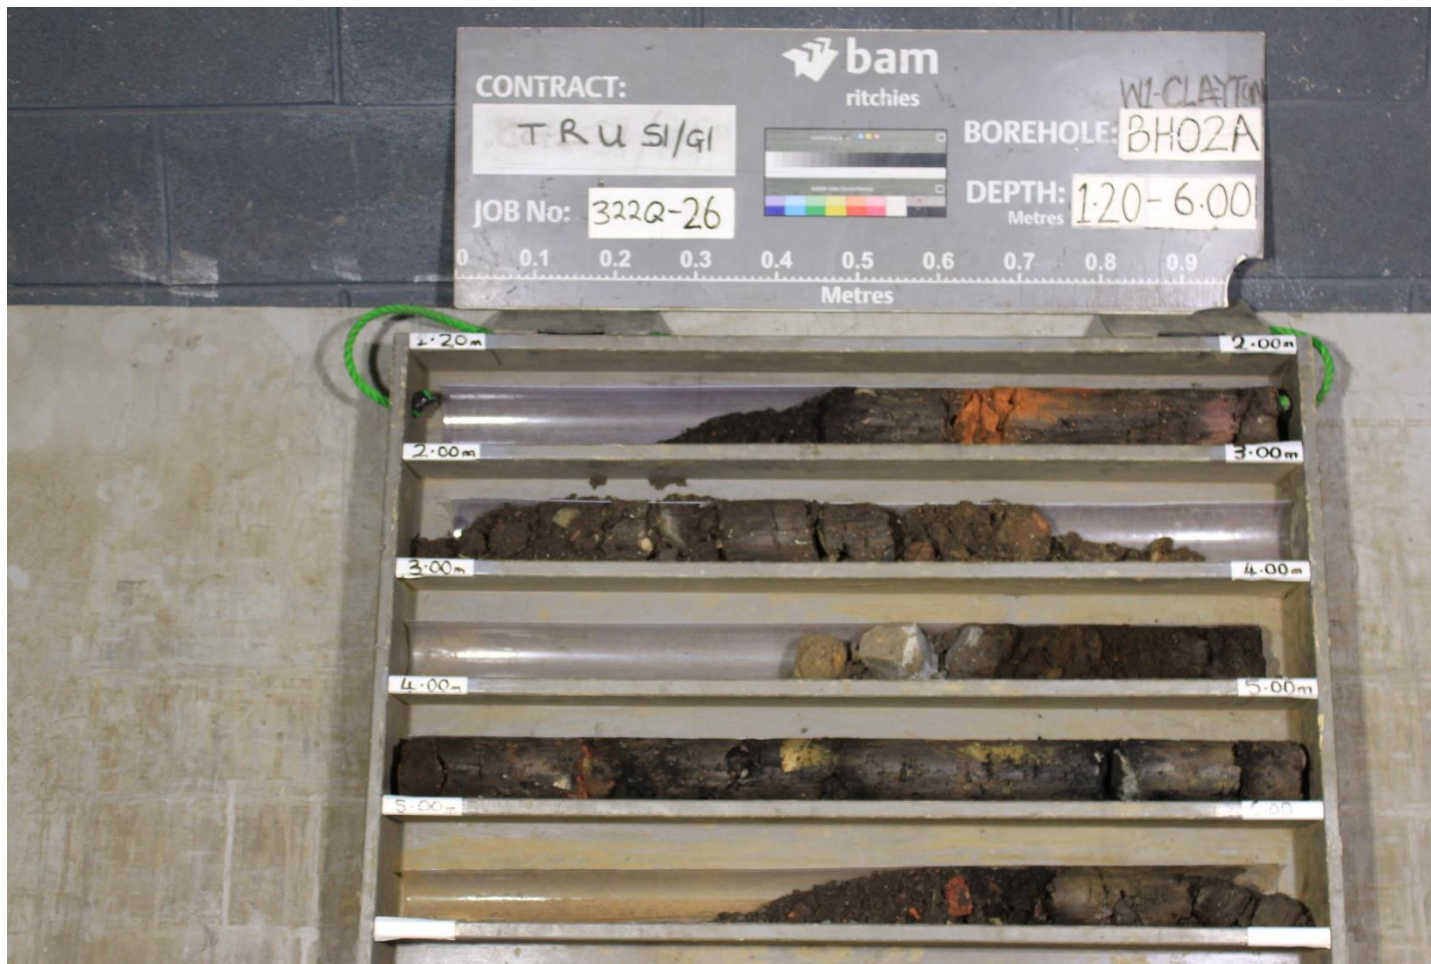
W1-CLAYTON-BH02A\_1.20-6.00m
