Sports Pavilion,  
Manchester Grammar School  
Old Hall Lane, Manchester  
M13 0XT

## **Level 2 Building Record**

*Prepared for: MGS*

May 2024

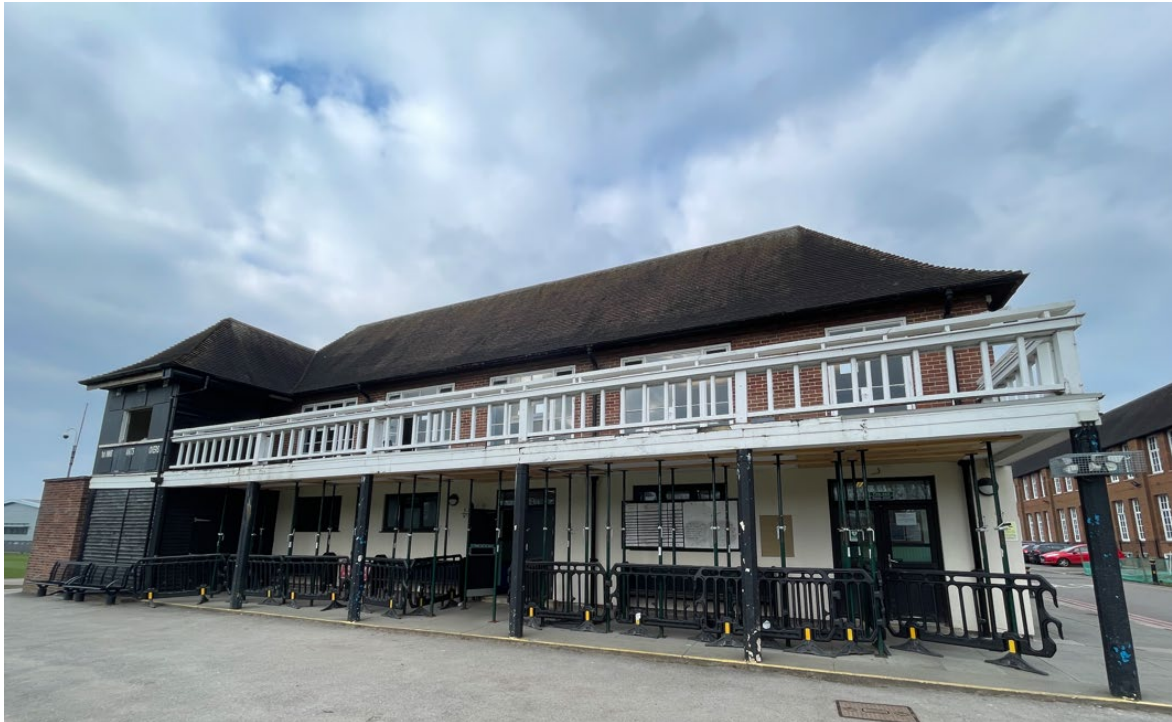
**Figure 1:** 1950s Sports Pavilion, south elevation. Source: Pictured March 2024, site visit, SLHA.

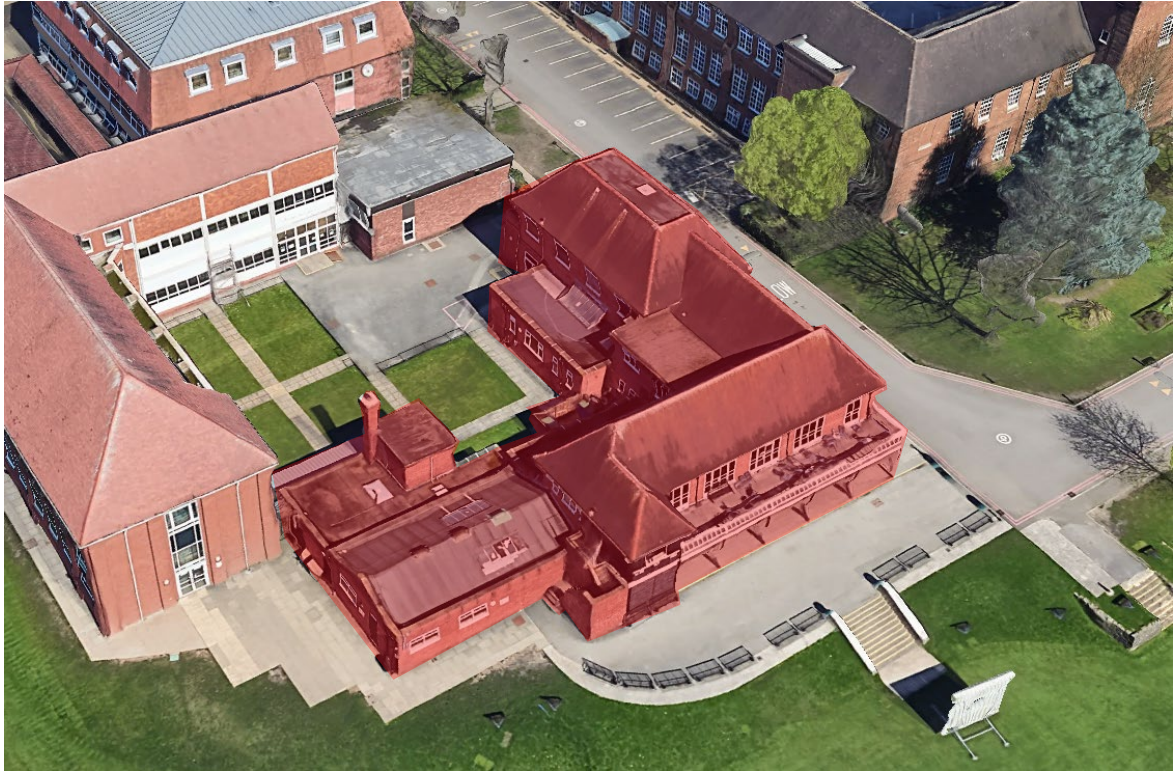
**Figure 11:** Phasing Plan. Oblique aerial view of 1959 Pavilion adapted from Google Earth. The building was erected in a single phase (shaded red), this is evidenced by site surveys.

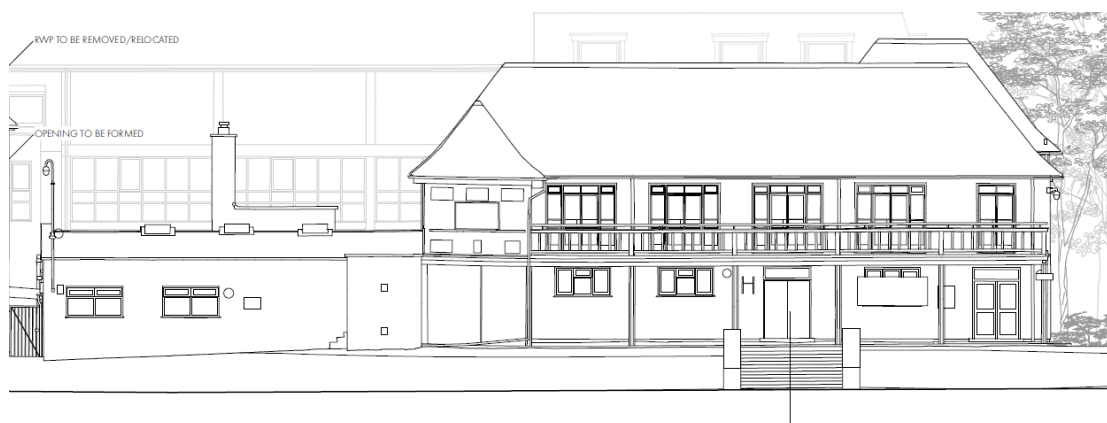
**Figure 12:** South elevation, Measured Survey Drawing. Source: Survey Operations, OBI.

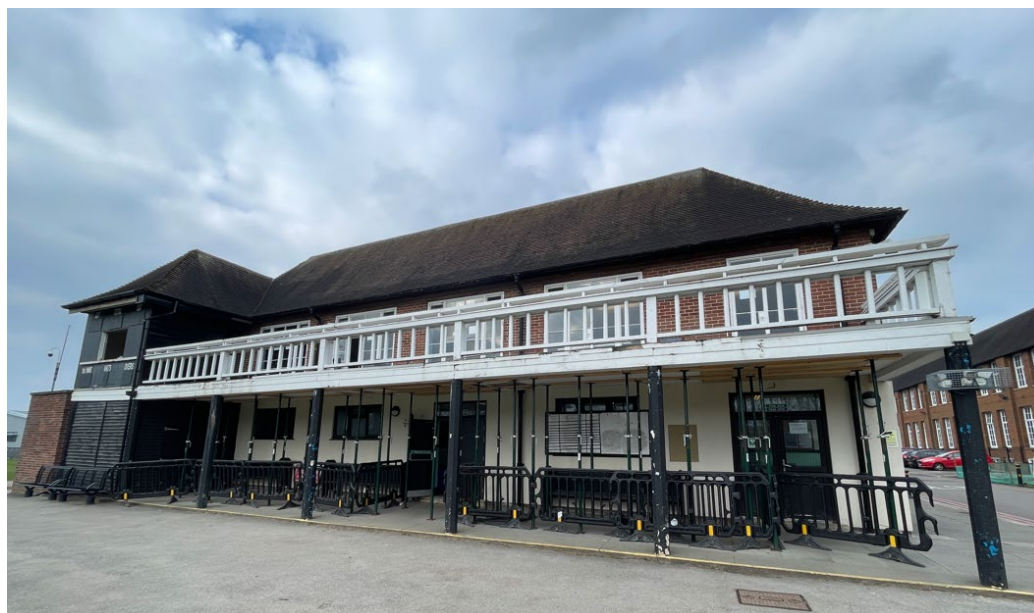
**Figure 13:** South elevation, illustrating the veranda to the ground floor and terrace above. The projecting bay to the left contains a room and opening from which the cricket scores are hung. The timber cladded infill and central opening to the ground floor are alterations. The original windows and door have also been altered and replaced with modern double glazed units. Bellcast / sprocketed eaves and clay roof tiles.

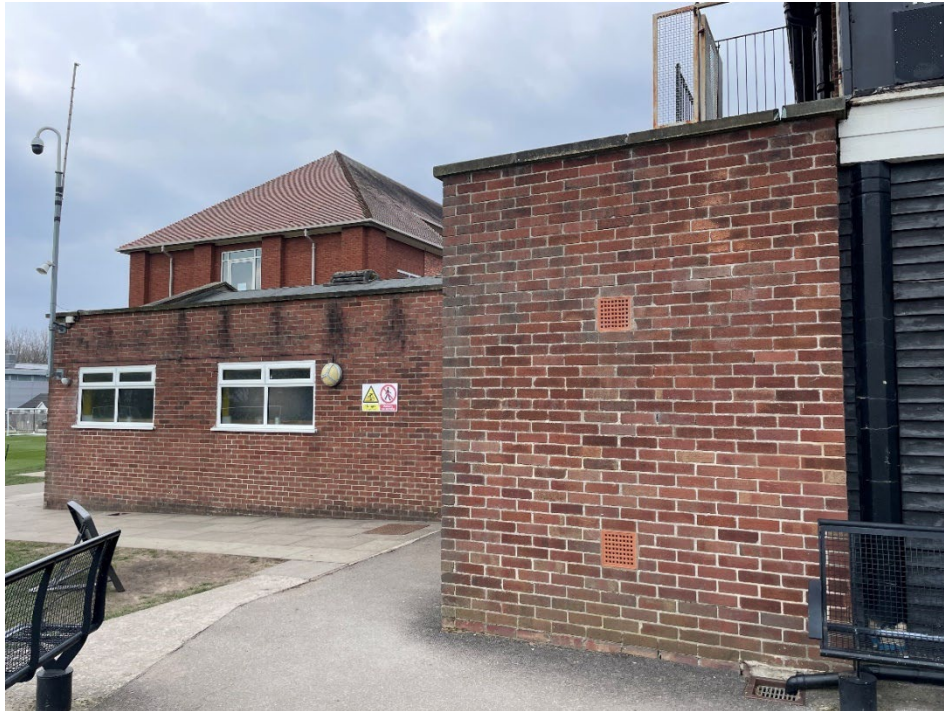
**Figure 14:** South elevation, single storey – western aspect. Section to the right of the image is illustrative of the external stair, single-storey building recessed to the left is the dining hall. Traditional mid-20<sup>th</sup> century brown brick in stretcher bond. Windows to the left of the image are shown to have been replaced with upvc.

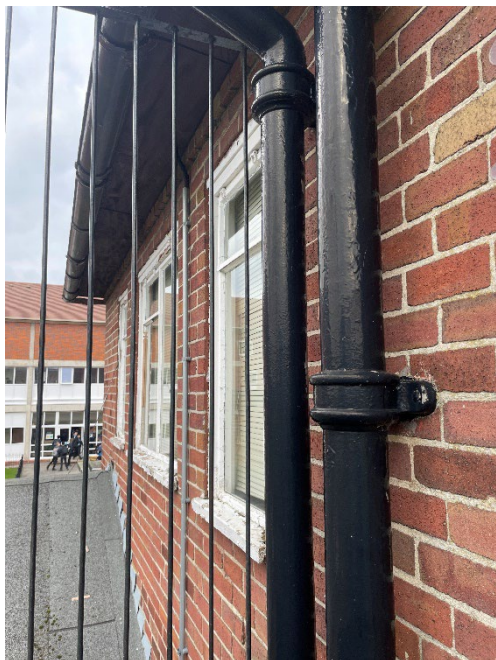
**Figure 15:** External rainwater goods detail (north / west elevation).

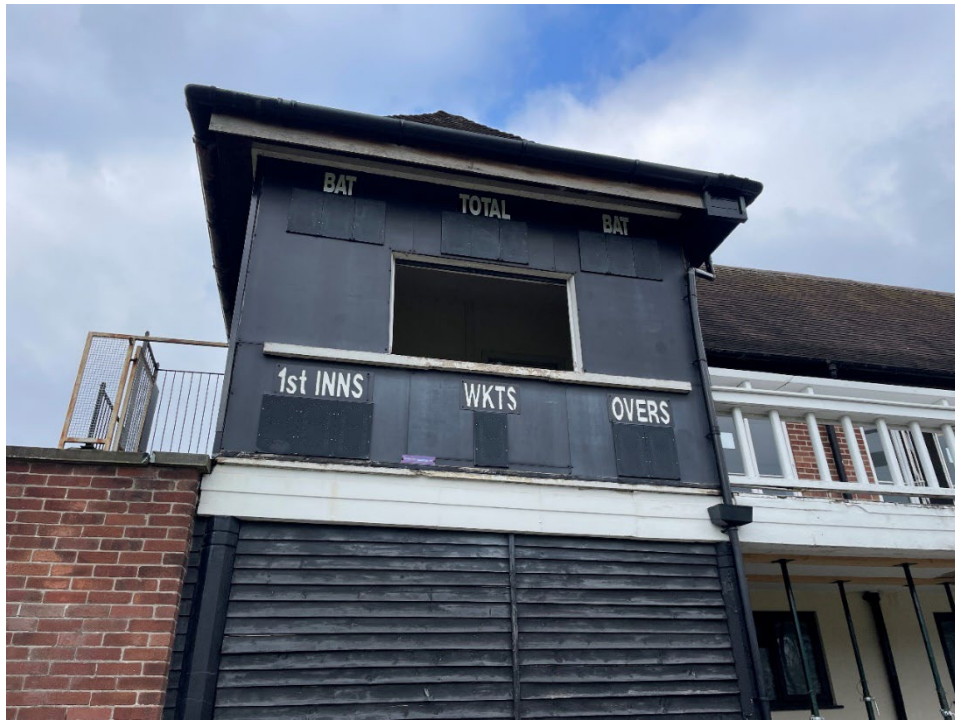
**Figure 17:** View of the south elevation illustrating the veranda to the ground floor and terrace above. The projecting bay contains a room and opening from which the cricket scores are hung. The timber cladded infill and central opening to the ground floor are alterations. The original windows and door have also been altered and replaced with modern double glazed units.

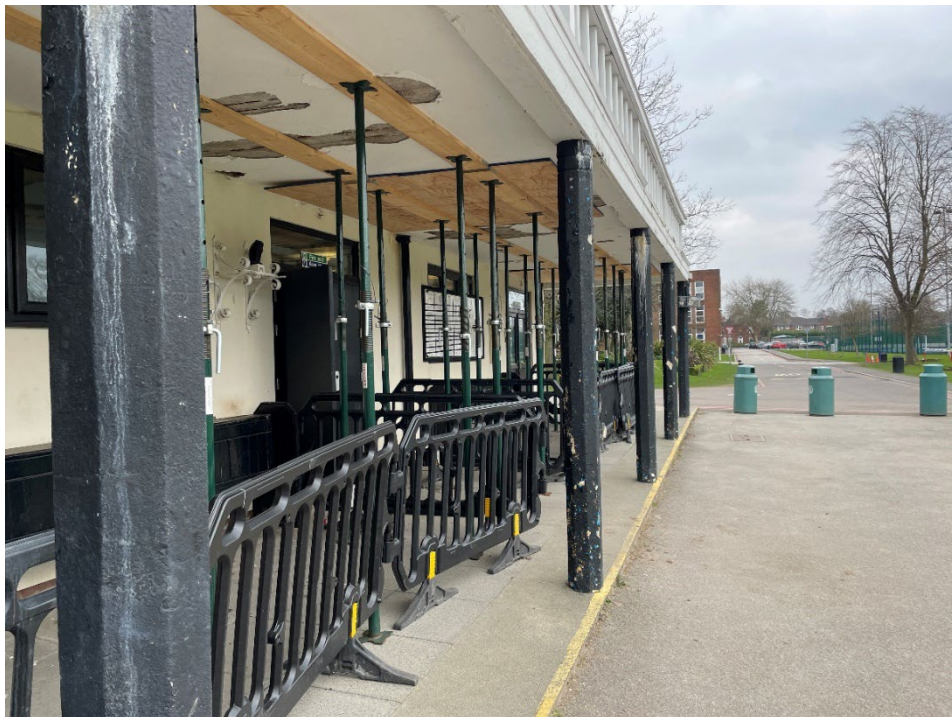
**Figure 18:** View of the south elevation, looking east across veranda. Currently propped with temporary supports. Six original columns feature. Blue paint visible below black coating.

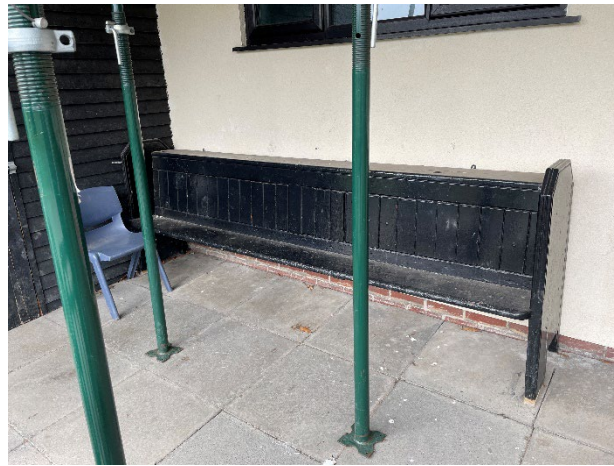
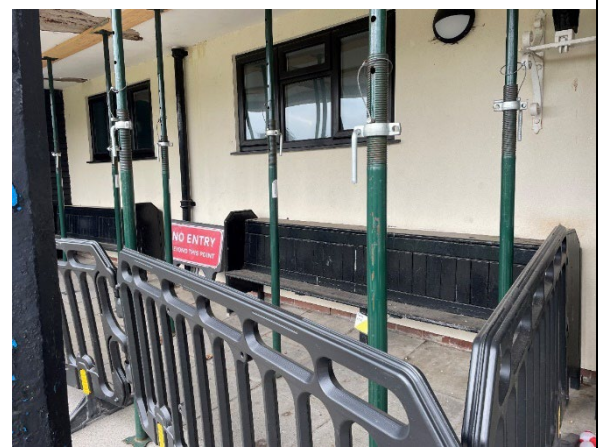
**Figure 19:** Fixed timber benches feature to the south elevation. Replacement uPVC windows apparent above.

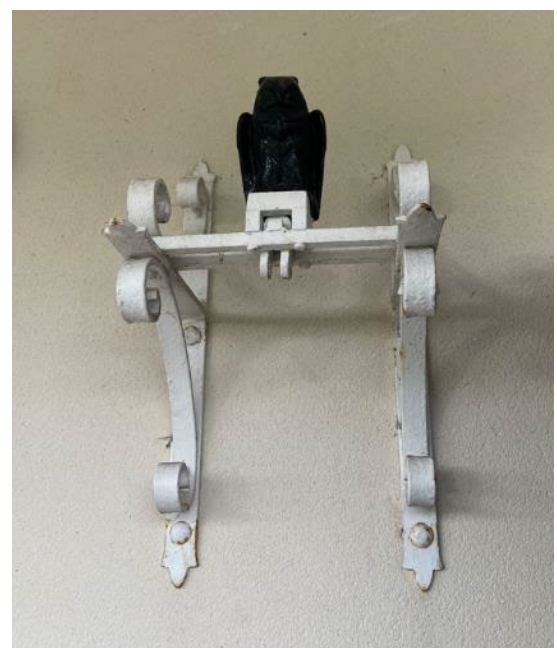
**Figure 21:** Decorative metal frame which hangs by the south entrance into the building and held the bell that marked intervals in cricket matches. It was presented to the School by a Mr. F. Beattie in memory of his son who had died in August 1957. Bell is missing.

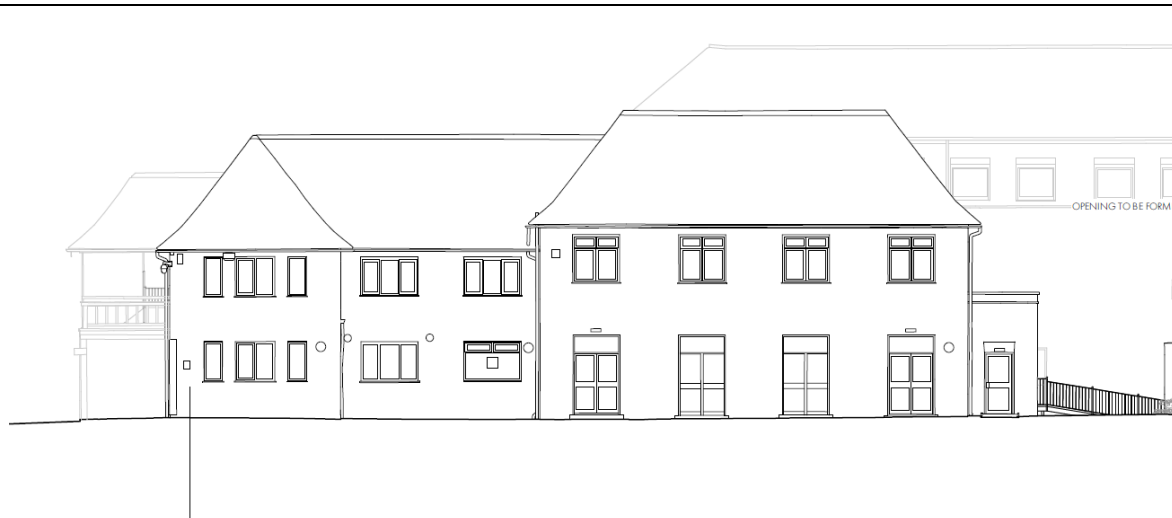
**Figure 22:** East elevation, Measured Survey Drawing. Source: Survey Operations.

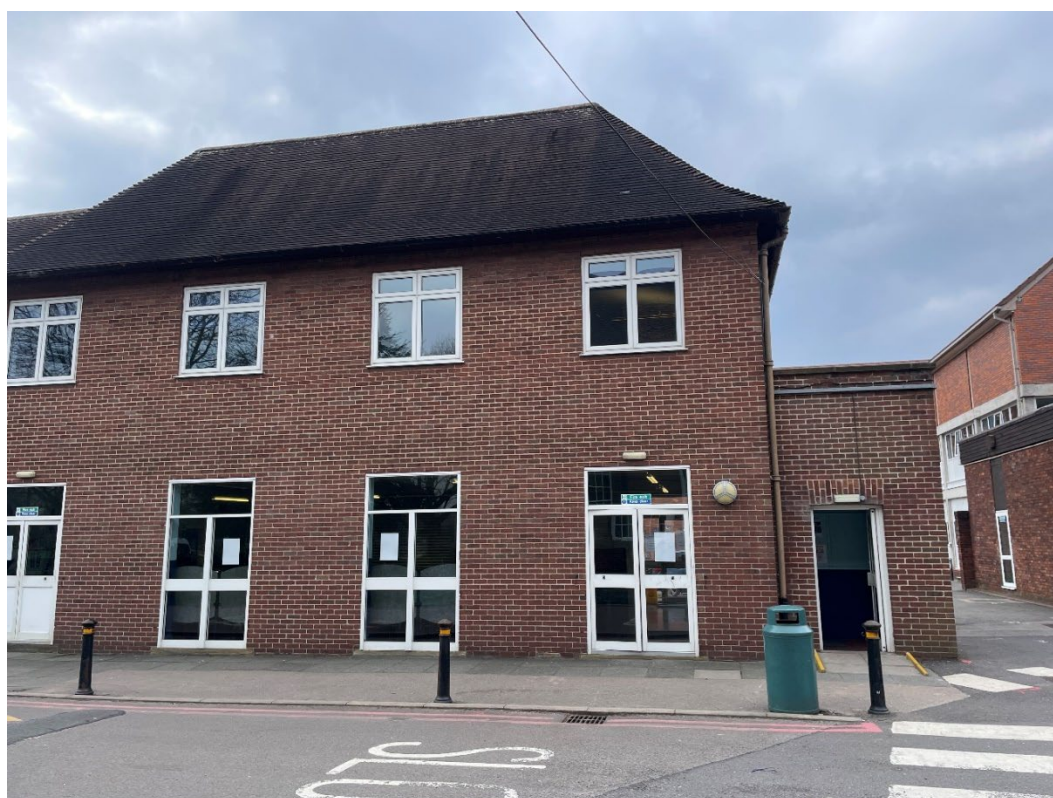
**Figure 23:** East elevation, north side. Brown brick in stretcher bond, original bellcast / sprocketed eaves and clay roof tiles. Replacement upvc windows / modern doors across the elevation. Single storey lean-to with flat roof to north.

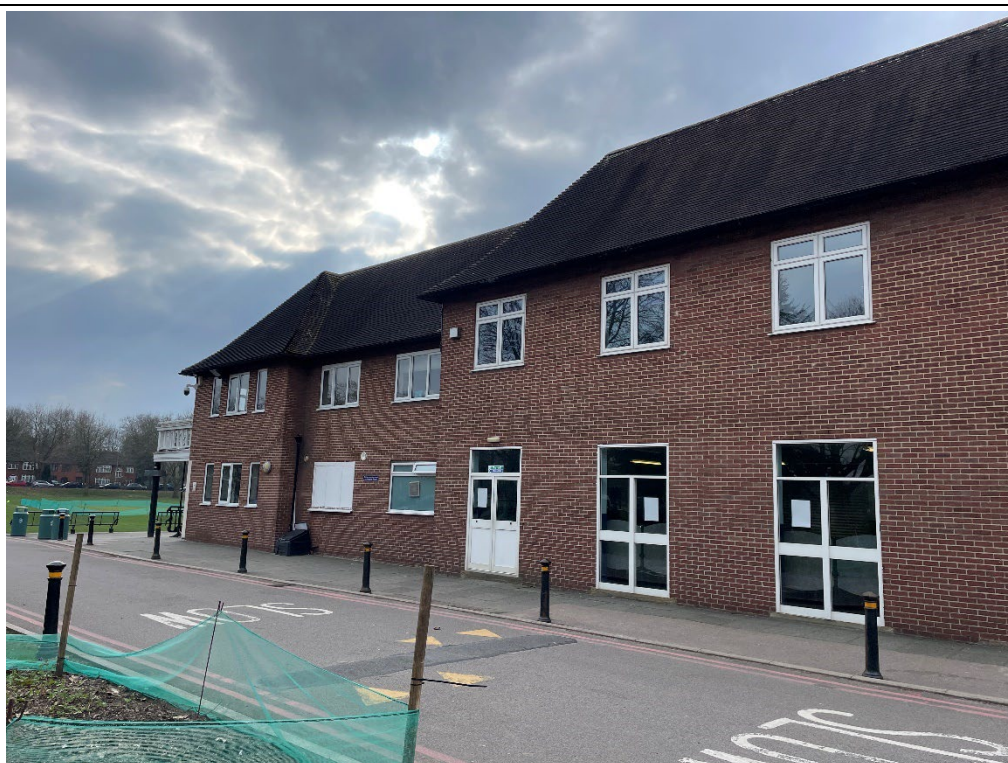
**Figure 24:** East elevation, south side. Brown brick in stretcher bond, hipped clay tile roof and replacement upvc windows / modern doors across the elevation. Recessed section and slight projecting bay to southern end.

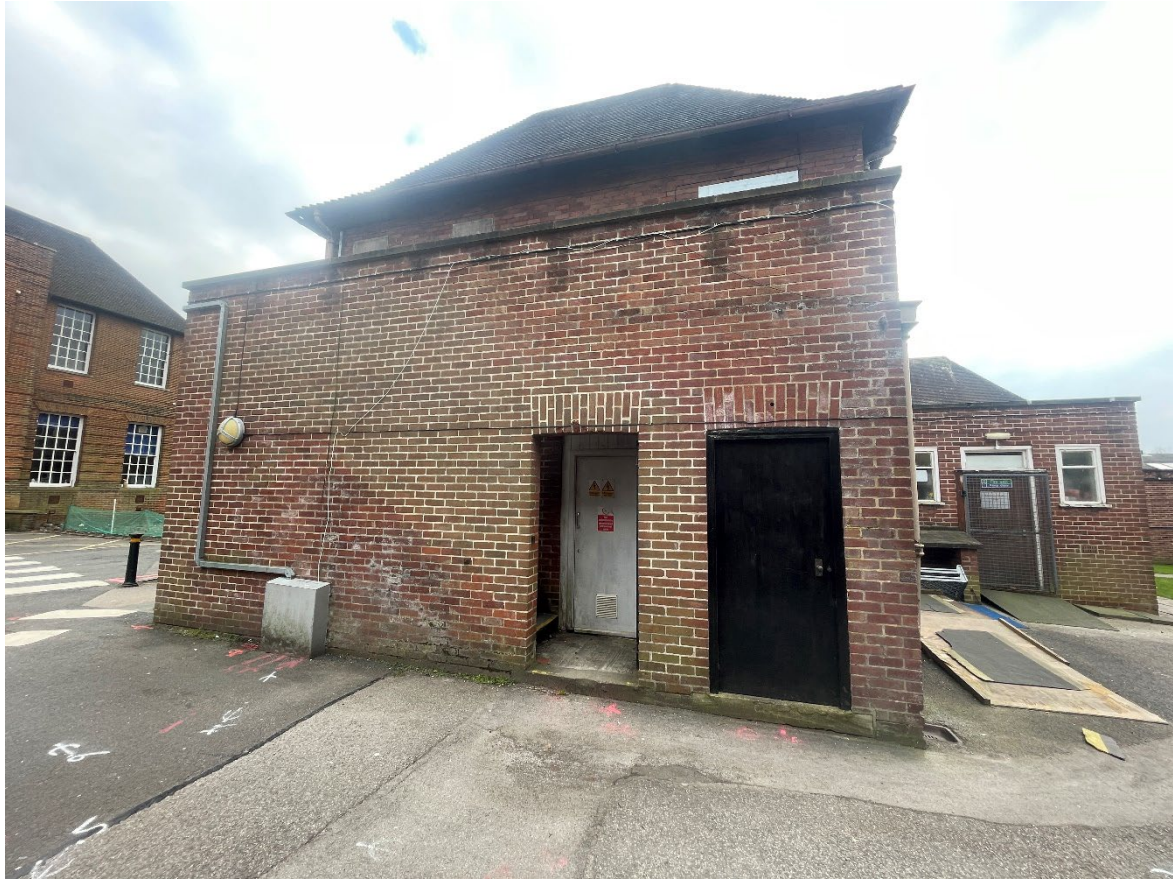
**Figure 26:** North elevation, east side. Two single-storey sections shown to be connected to the main building. Both built of brown brick in stretcher bond, featuring a flat roof. Principal building behind hipped clay tile roof. Simple flat arch signalling original doorways. Modern M&E and lighting.

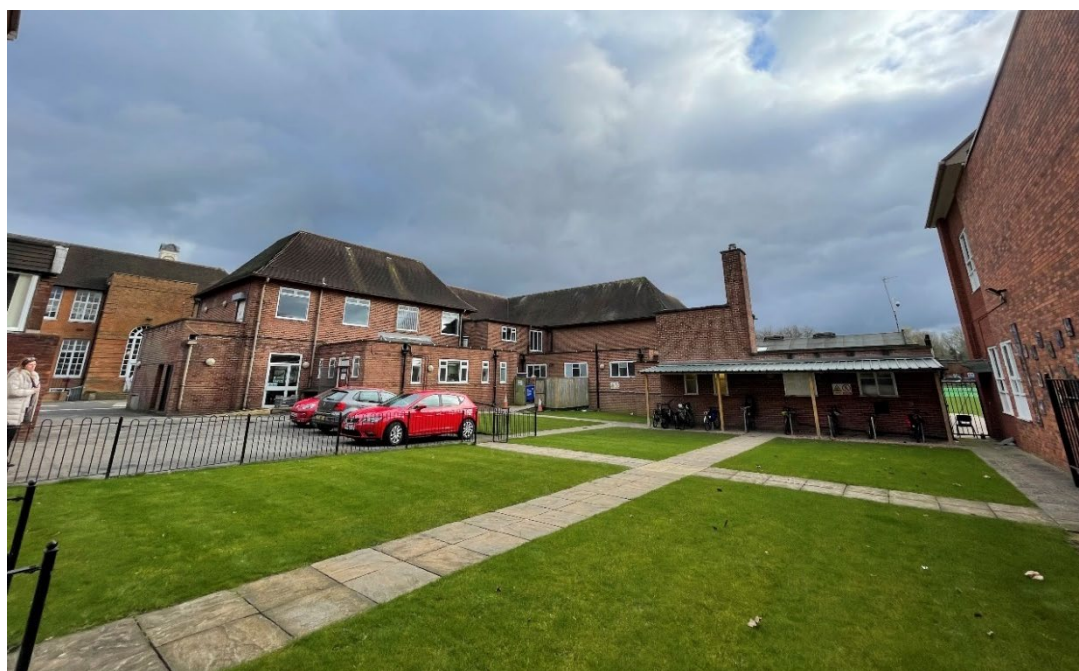
**Figure 29:** View of the north and west elevations of the pavilion illustrating the utilitarian appearance of the 'back' of the building. Original bellcast / sprocketed eaves and clay roof tiles feature to 2-storey elements. Note modern, replacement windows and doors. The block to the far right (west) comprises the toilet / plant room block. Later veranda fixed to north elevation.

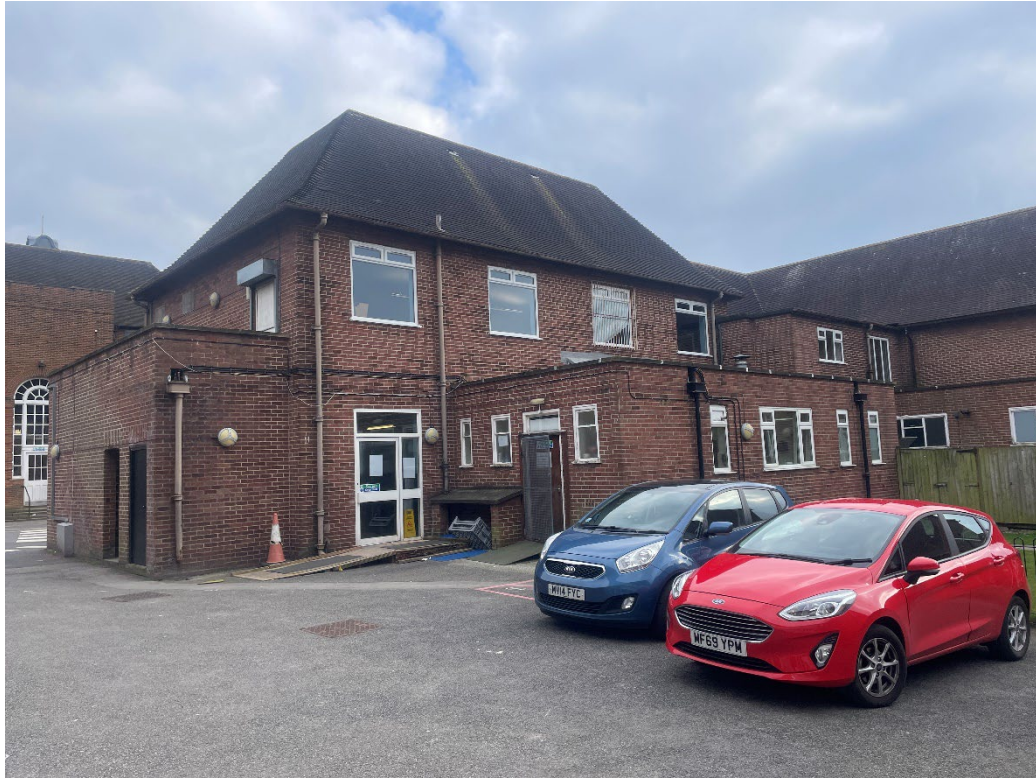
**Figure 30:** View of the north and west elevations of the pavilion. Note modern, replacement windows and doors. Original bellcast / sprocketed eaves and clay roof tiles feature to 2-storey elements.

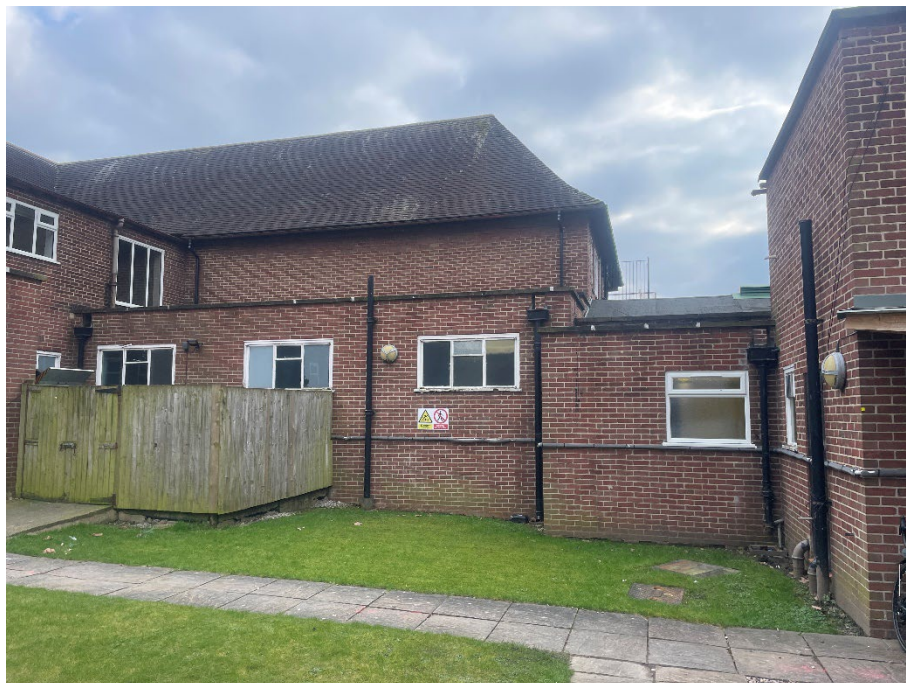
**Figure 31:** View of the north elevation of the pavilion (centre). Note modern, replacement windows and doors. Original rainwater goods, later timber enclosure.

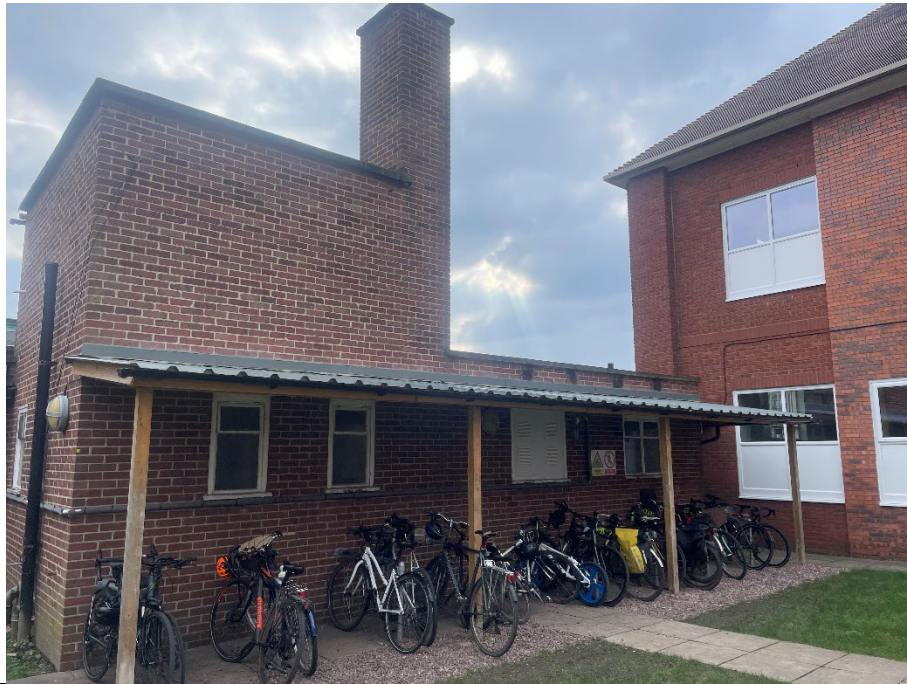
**Figure 32:** View of the north elevation of the pavilion (west side), brown brick in stretcher bond, featuring chimney. Original casement windows. Later veranda fixed to north elevation.

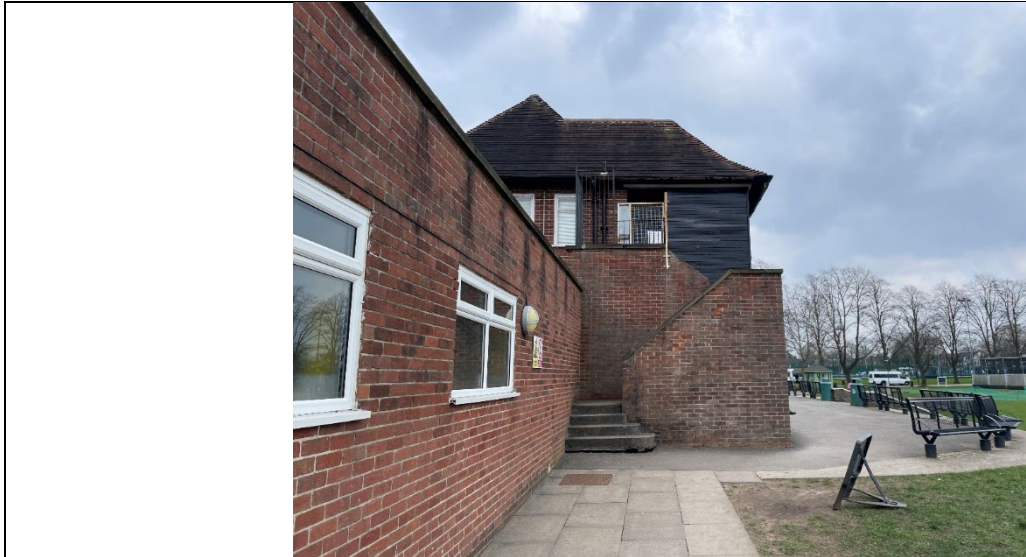
**Figure 34:** View of the east and north elevation. Brown brick in stretcher bond. Modern replacement upvc windows. External stair leading to terrace.

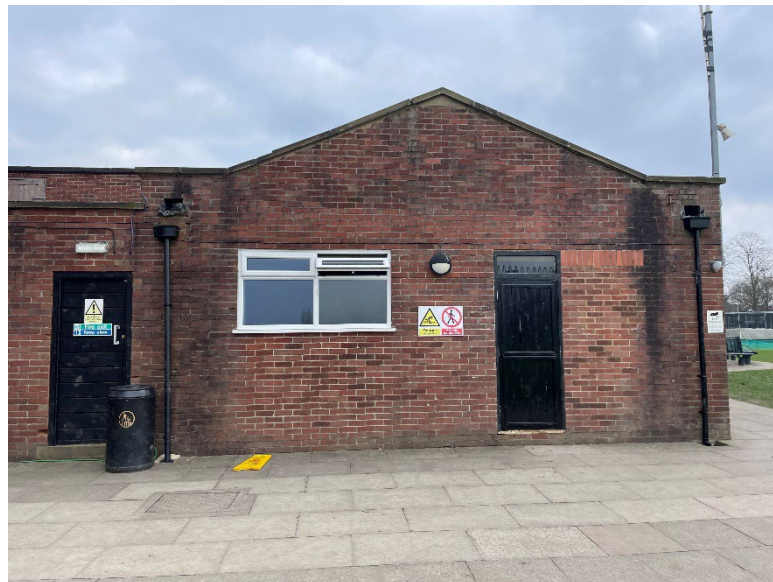
**Figure 35:** View of the east elevation. Brown brick in stretcher bond. Single pitched roof, modern replacement upvc windows. Two utilitarian timber panelled doors feature.

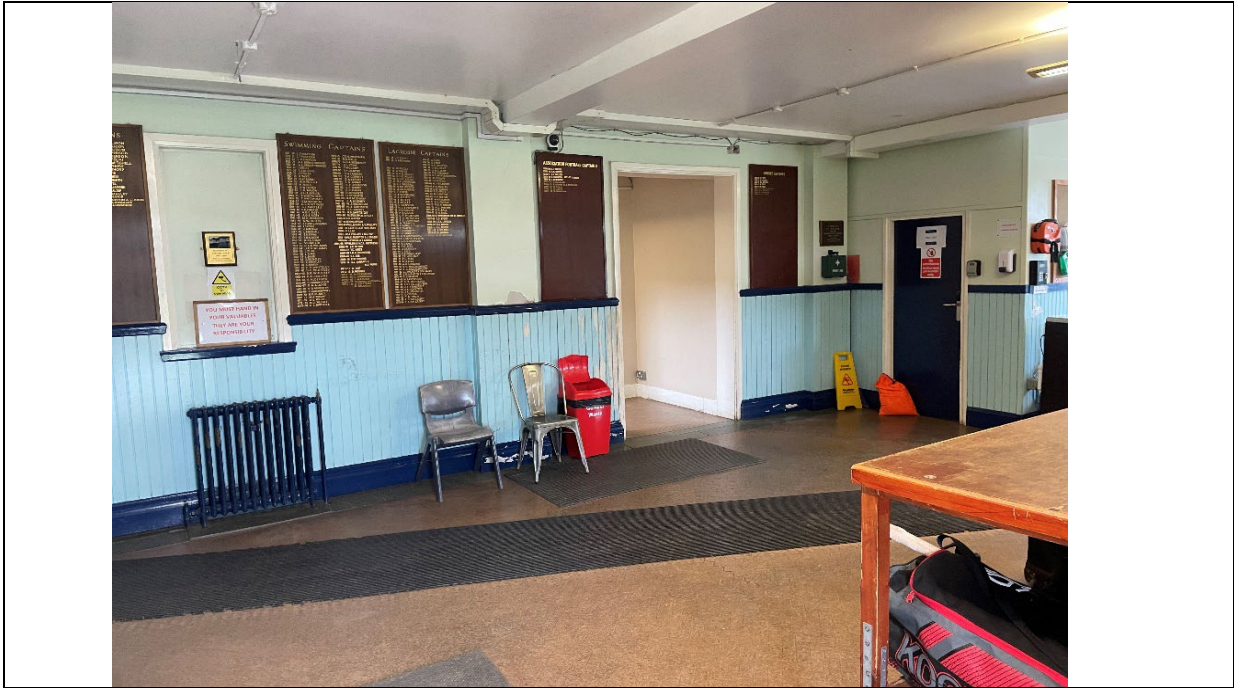
**Figure 36:** Room 1, looking north-east. Entrance hall with wooden honour boards, with gold lettering, featuring to each wall. Timber panelling to dado height, overpainted in light blue. Dark blue paint applied to original dado and moulded skirting. Original woodblock floor and green terrazzo to perimeter.

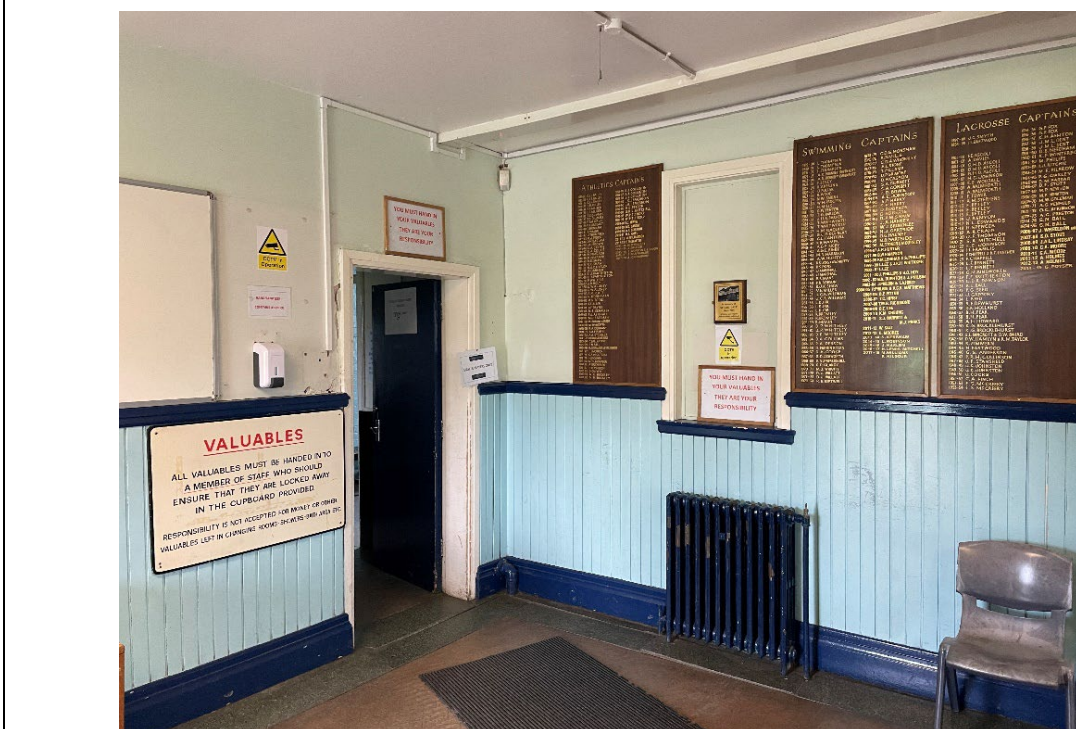
**Figure 37:** Room 1, looking north-west. Entrance hall with wooden honour boards. Original radiator and hatch above. Original architraves and doors. Fixed signage, whiteboards and M&E feature.

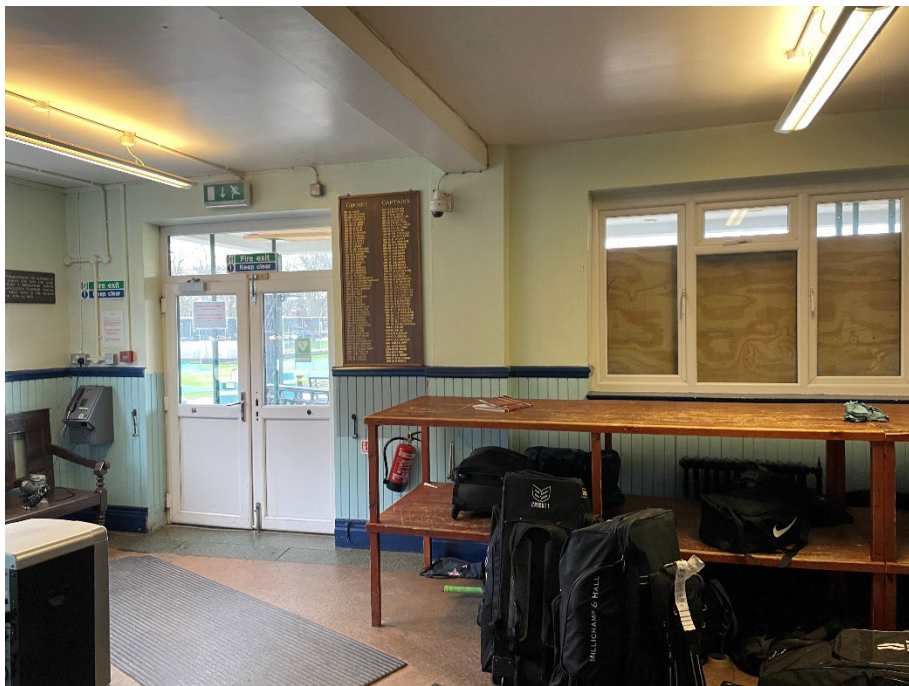
**Figure 39:** Room 1, looking south-east. Entrance hall with wooden honour boards. Fixed telephone to far SE corner. Replacement upvc windows and doors. Later M&E / lighting.

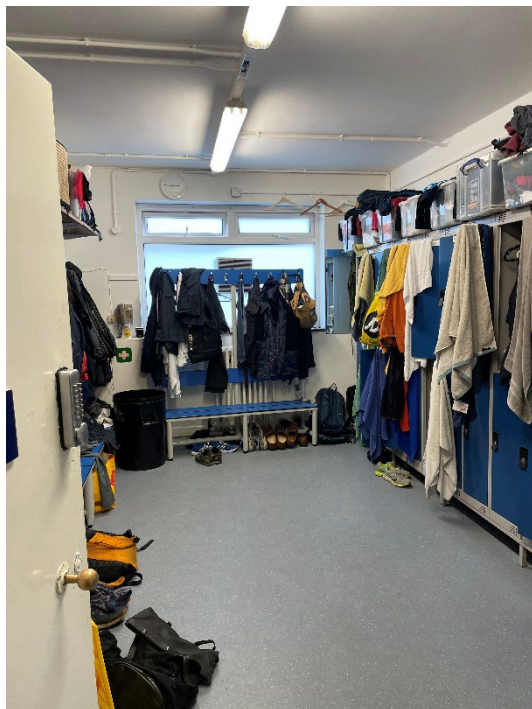
**Figure 49:** Room 5, staff changing room. Modern flooring, replacement windows. Original radiator to east wall.

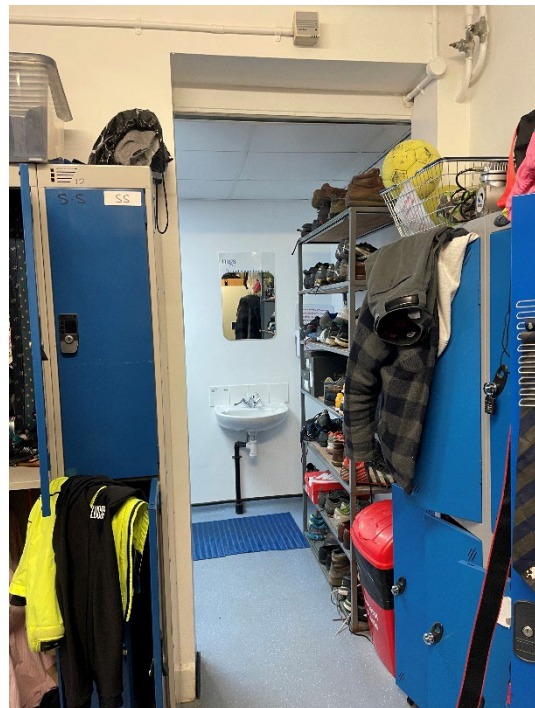
**Figure 50:** Room 5, staff changing room, looking south into shower area. Modern flooring, ceiling, lighting and fixed sinks / shower units.

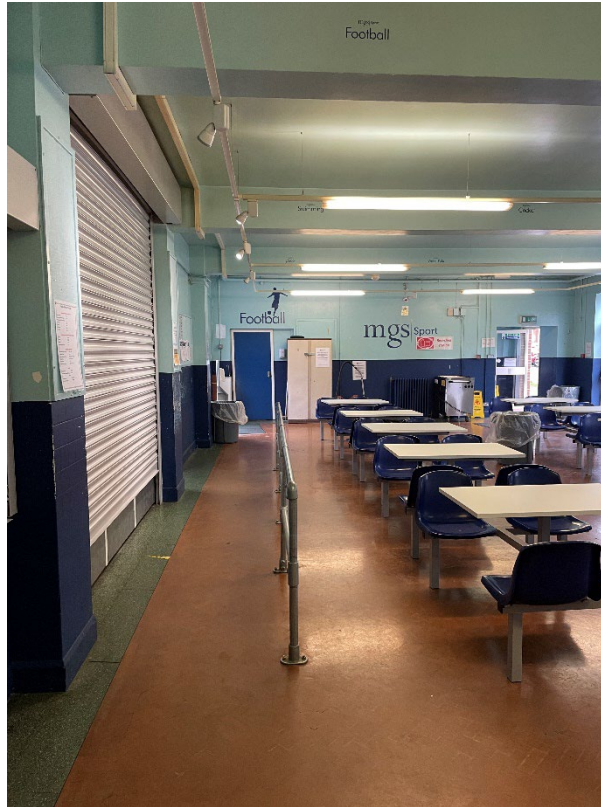
**Figure 54: Room 6.** View of the ground floor canteen space to the east side of the building, looking north across space. Walls part tiled (half height) to western wall, painted dark blue. Original woodblock floor and green terrazzo to perimeter. Roller shutter to west wall (kitchen behind) Fixed railing to west side of floorspace and fixed seating to centre.

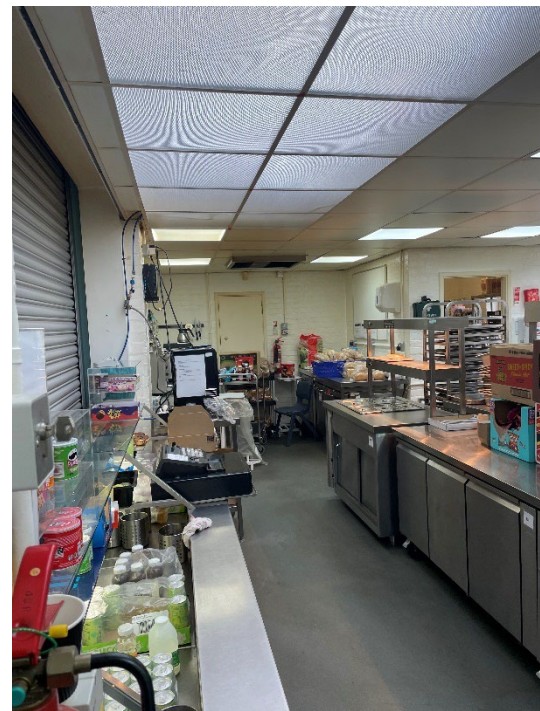
**Figure 57 (left):** Door from canteen into kitchen (Room 7 on plan above). Windows have been replaced with upvc. **Figure 58 (right):** Kitchen space, looking south. Modern suspended ceilings and floor coverings. Original brick walls.

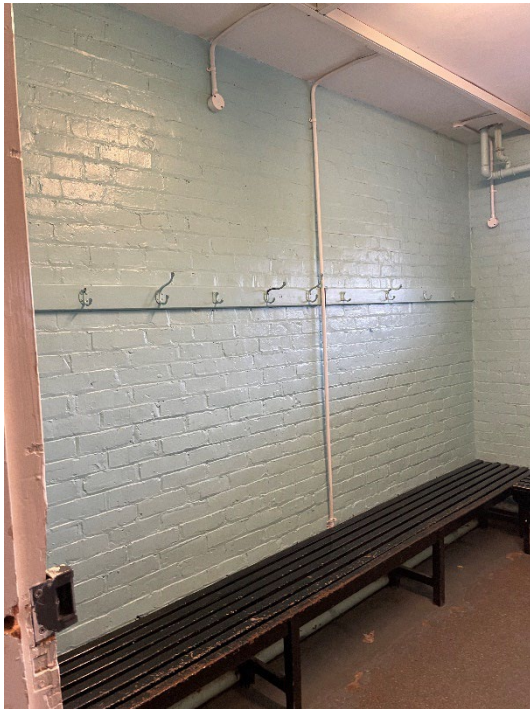
**Figure 66:** Changing room 2.1, south-east corner. Fixed bench seating to each side. Brick walls overpainted blue. Original fixed hooks.

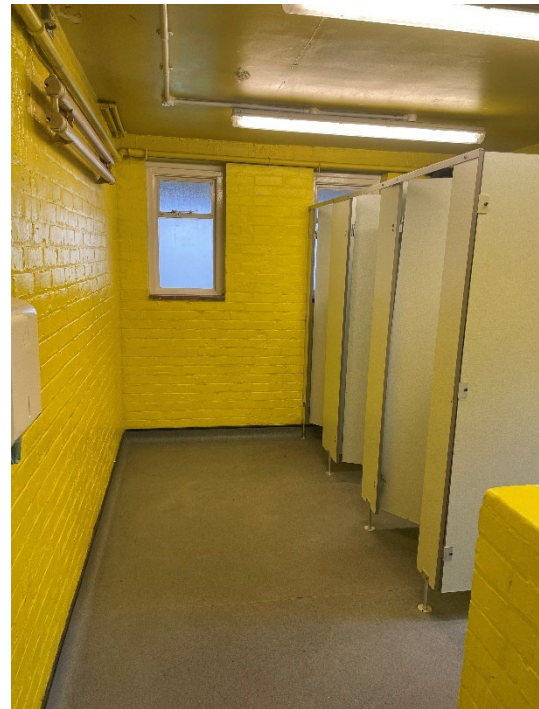
**Figure 92:** Toilet area to north-west end of floorplate. Original windows with frosted glass. Modern cubicles.

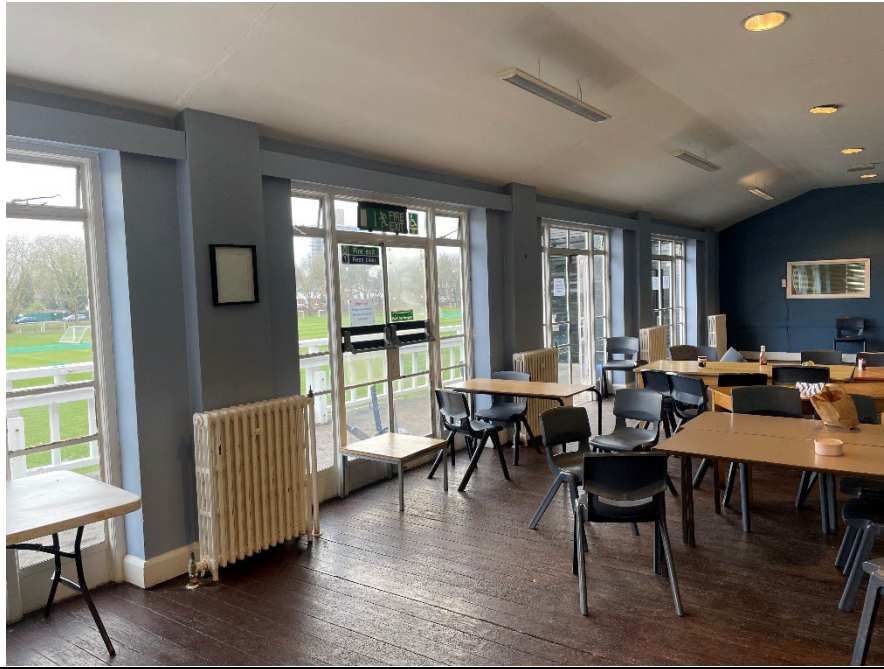
**Figure 116:** View of the linear room to the south aspect of the building. The doors to the left provide access out on to the terrace. Metal framed windows/ doors, timber board flooring and radiators are original / 1950s.

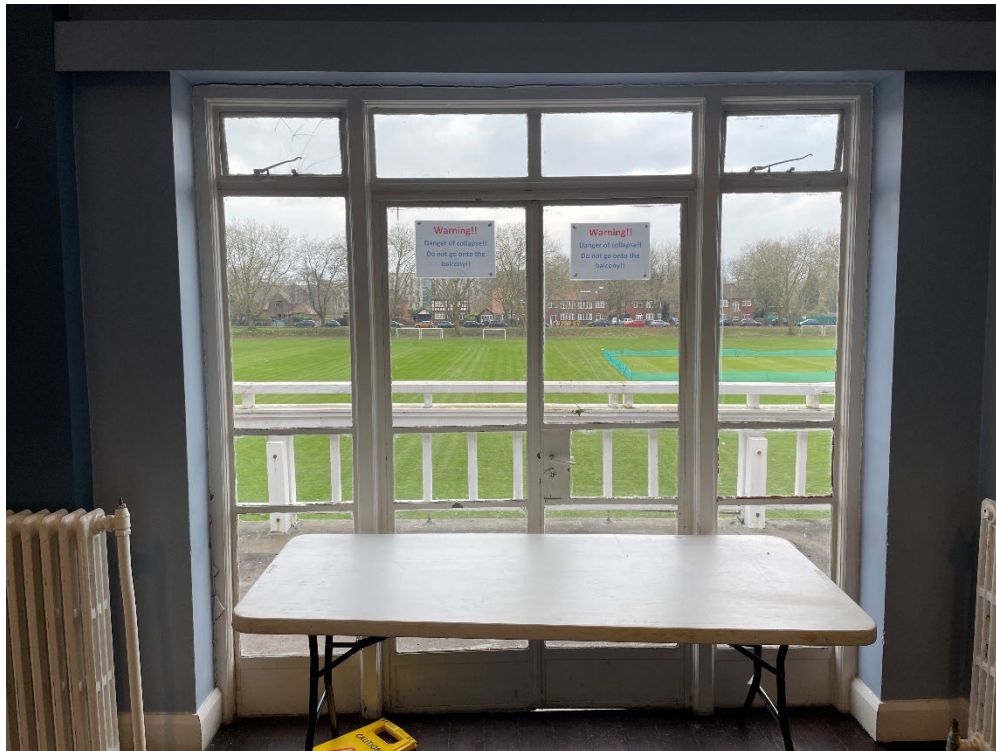
**Figure 117:** Detail of one of the metal framed doors from the linear, first floor room to the terrace, orientated south towards fields.
