# National Transgender Monument - Sackville Gardens

Preliminary Ground Conditions Report

**FINAL**

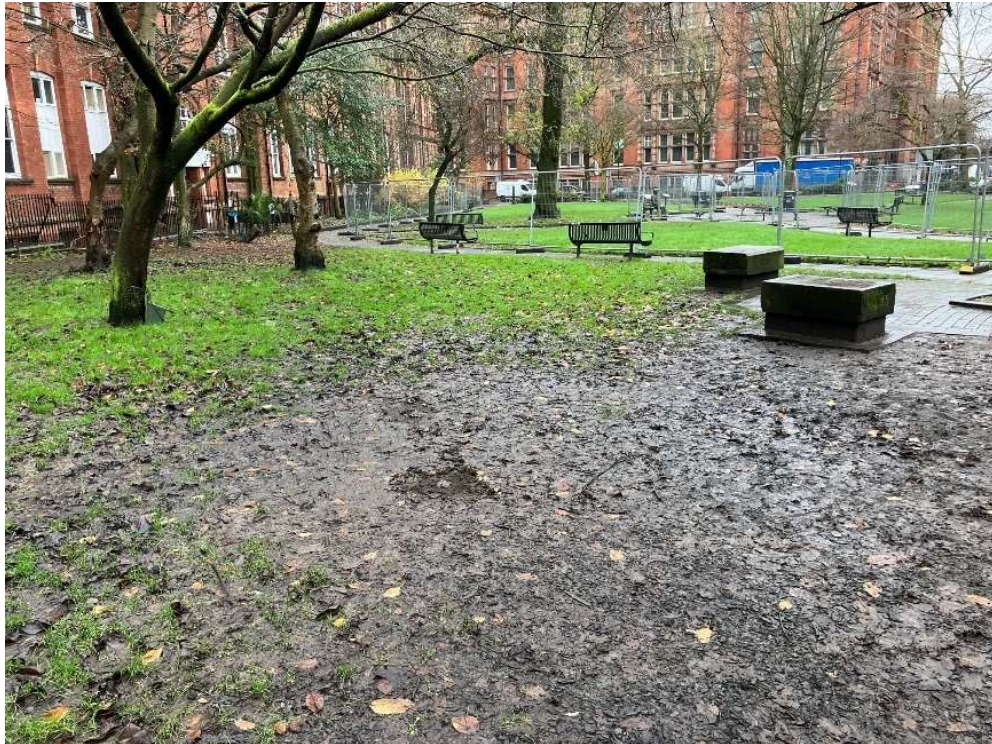
**Figure 2 - Area surrounding sample location (North-East)**

The site visit identified that there was no evidence of contamination in the proposed location of the monument, nor were there any potential sources of contamination identified in the immediate vicinity of the site. The general site setting and location of the proposed structure are identified on the following photographs:
