# TV/FM & DAB RECEPTION SURVEY REPORT

**DATE OF SURVEY:** 15th May 2023  
**REF NO:** TBAER022  
**REVISION DATE:** 09<sup>th</sup> July 2024

This report has been prepared by SCS Technologies Ltd on behalf of Northside (Manchester) Ltd (trading name – Lamington Group) to support a full planning application for an aparthotel development (hereafter referred to as the 'Proposed Development') at 12-16 Manchester Piccadilly, Manchester M1 3AN (hereafter referred to as 'the Site')

Room2 Hometel Piccadilly Manchester

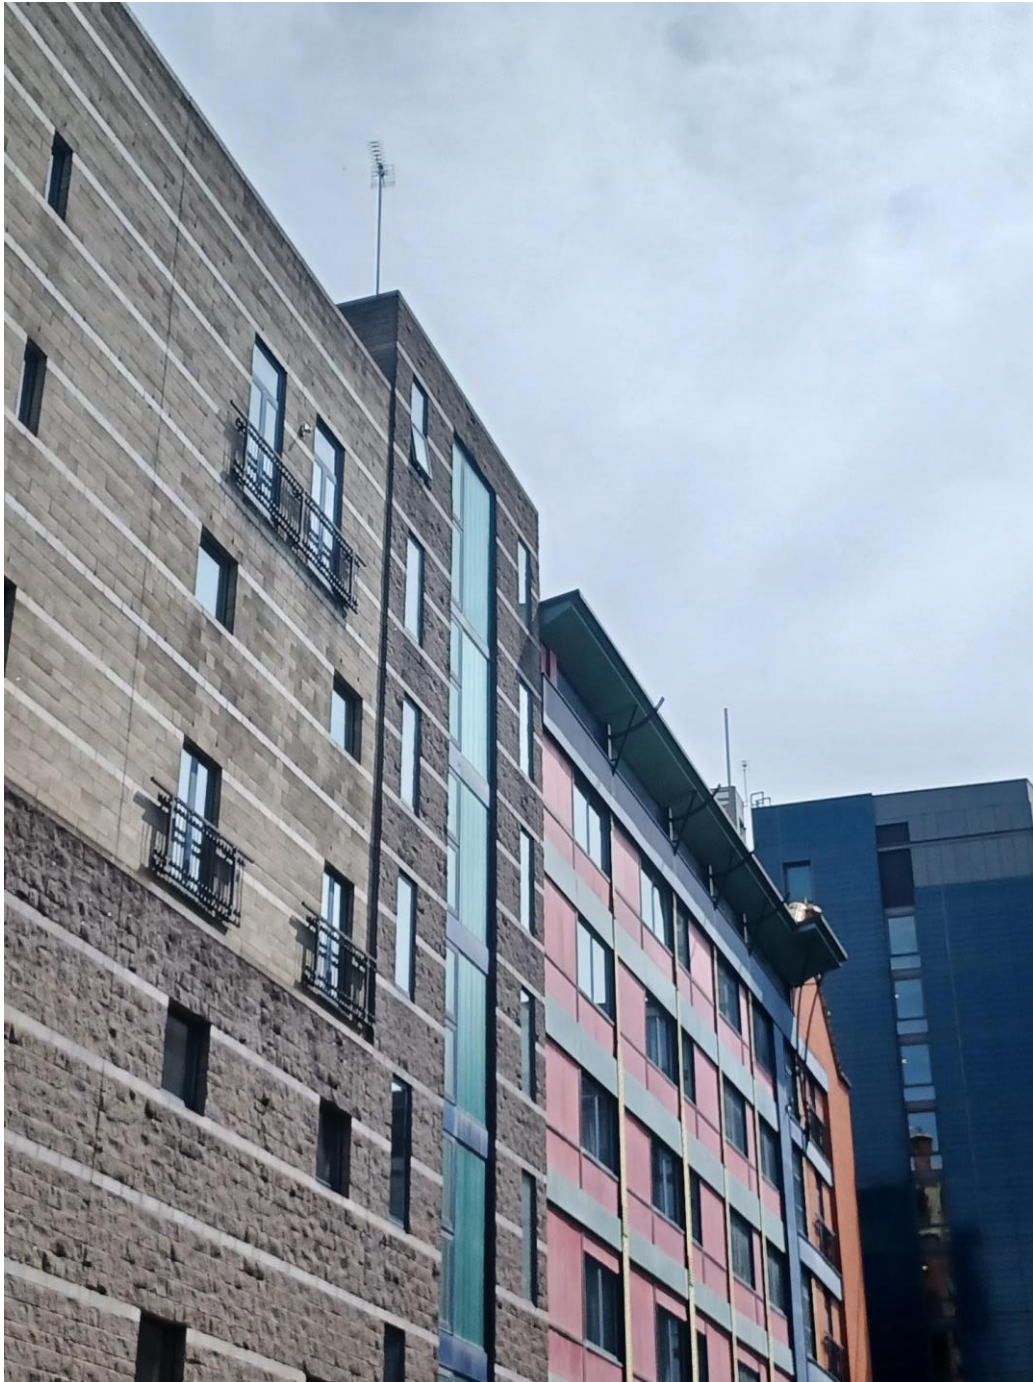
## VISIBLE TV AERIAL LOCATED IN THE AREA OF TEST POINT 1

High gain antenna on 3m mast, mounted at rooftop height on multistorey storey property, directed towards the Winter Hill Transmitter

Television reception is of a poor quality and strength.

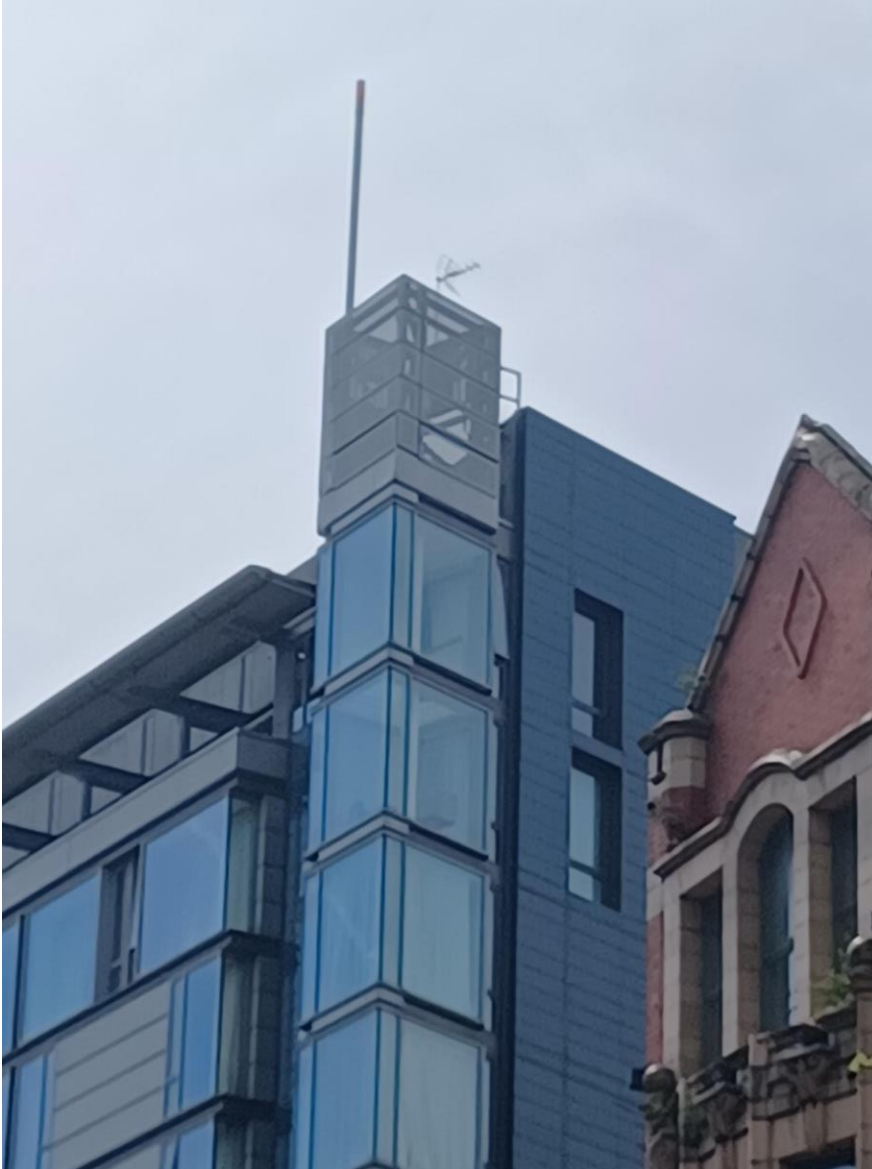
## VISIBLE TV AERIAL LOCATED IN THE AREA OF TEST POINT 3

Television reception is of a poor quality and strength.

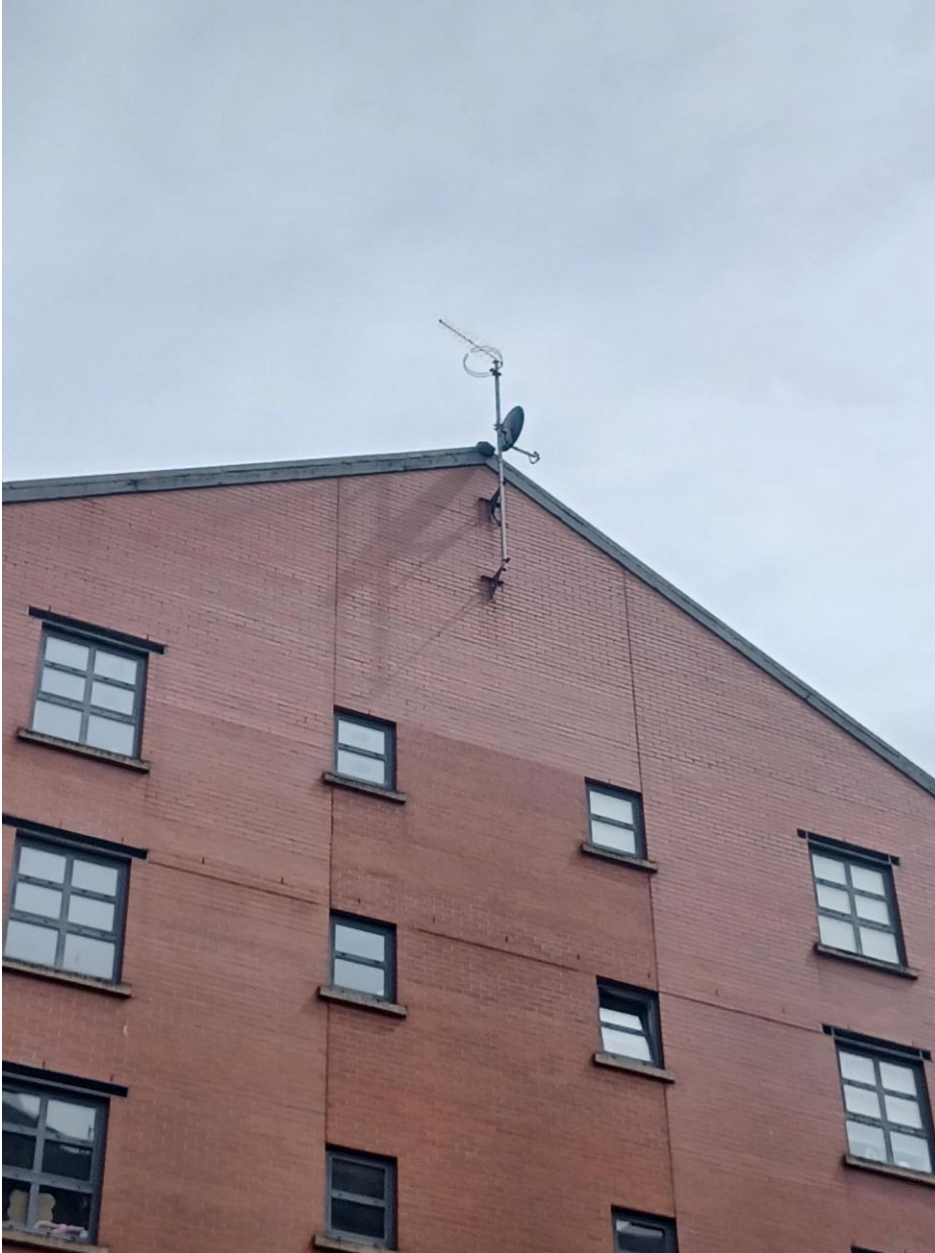
## VISIBLE TV AERIAL LOCATED IN THE AREA OF TEST POINT 6

Television reception is of a low quality and strength.
