## UXO Desk Study & Risk Assessment

**Document Ref.** P14415-24-R1

**Project Title** Embassy Village, Manchester

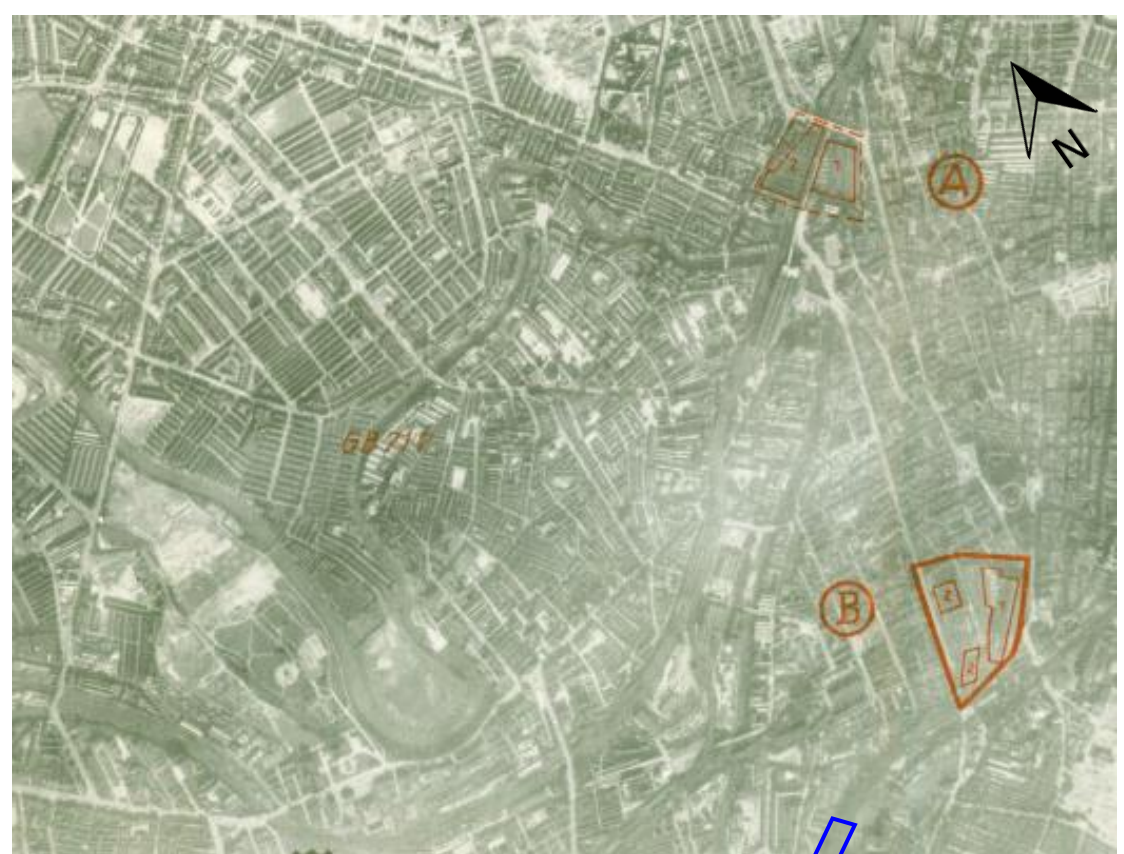
**Plate 2 Luftwaffe target photograph of Manchester, 4<sup>th</sup> October 1939**

Plate 2 is a Luftwaffe target photograph of Manchester, dated the 4<sup>th</sup> October 1939. This shows Manchester Central Station (Target B), approximately 0.8km east of the Site, Manchester Victoria Station (Target A), approximately 1.8km northeast of the Site, and the Broughton Copper Works (GB 717), approximately 1.7km north of the Site.

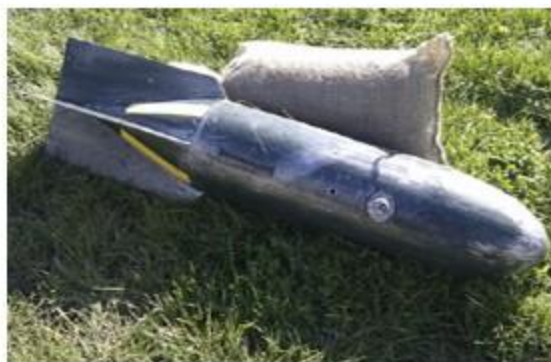
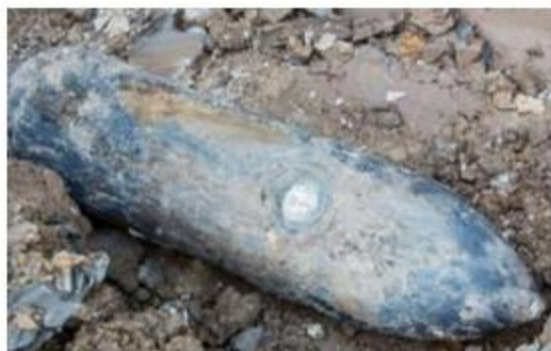
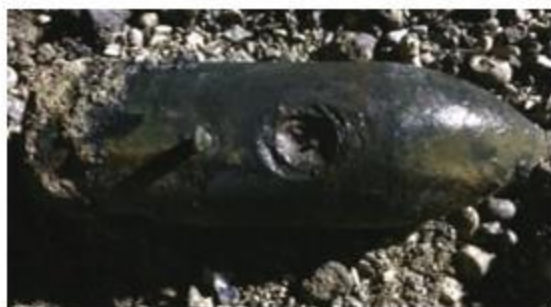
### 50kg High Explosive Bomb

| Description | Cylindrical with pointed nose and four-fin tail | Function | General Purpose (Blast and Fragmentation) |

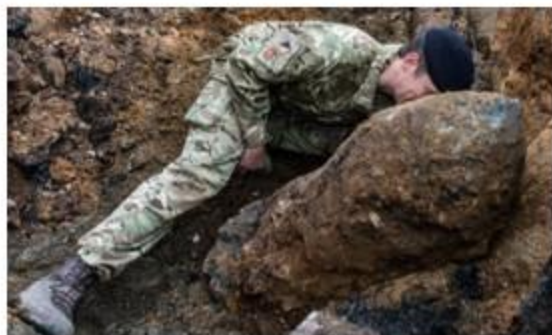
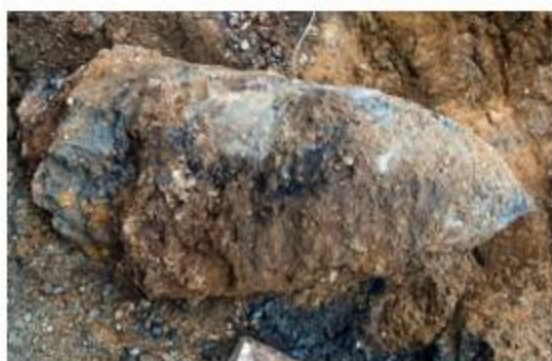
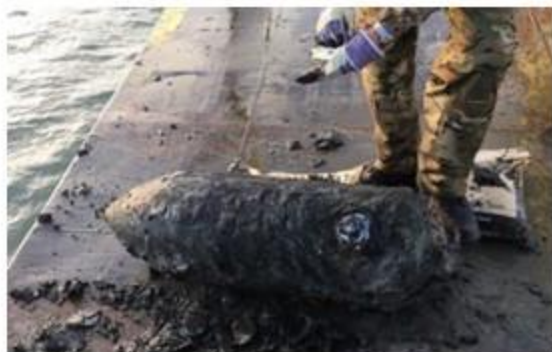
## 250kg High Explosive Bomb

| Description | Cylindrical with pointed nose and braced four-fin tail | Function | General Purpose (Blast and Fragmentation) |

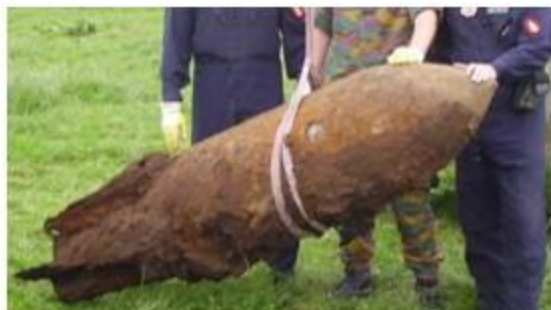
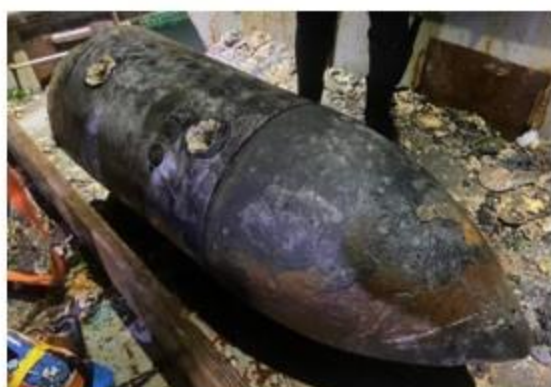
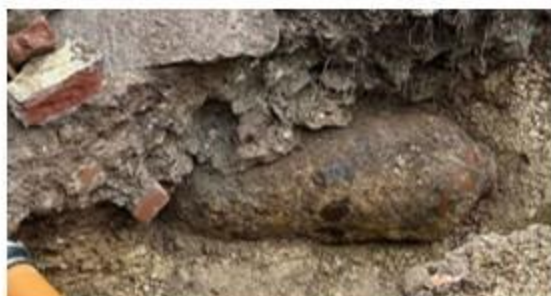
## 500kg High Explosive Bomb

| <b>Description</b> | Cylindrical with pointed nose and braced or ring-bound four-fin tail | <b>Function</b> | General Purpose (Blast and Fragmentation) |

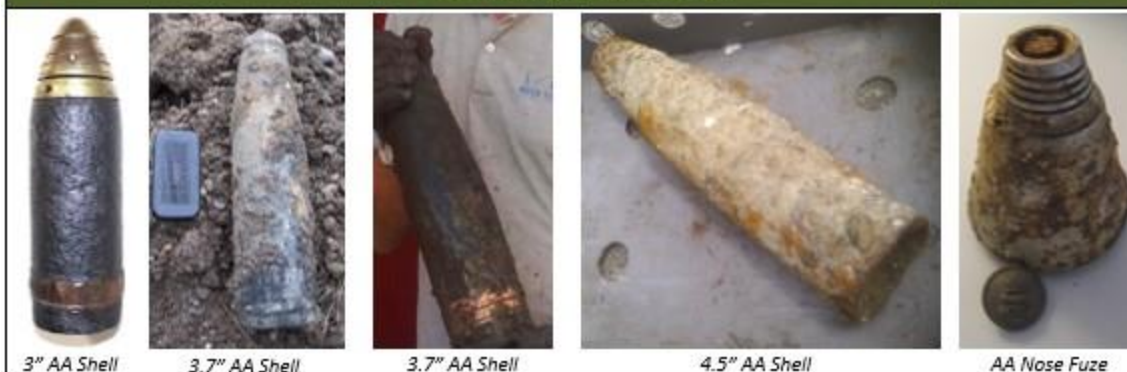
## Anti-Aircraft Shells

Anti-Aircraft (AA) guns are artillery pieces designed to engage aircraft. They may be classed as Heavy AA (HAA) or Light AA (LAA). HAA shells are typically streamlined, made of steel, and equipped with driving bands. They usually carry a High Explosive (HE) or shrapnel filling and use time or proximity fuzes. LAA guns are often autocannons. Indicative specifications for common British HAA shells are given below.

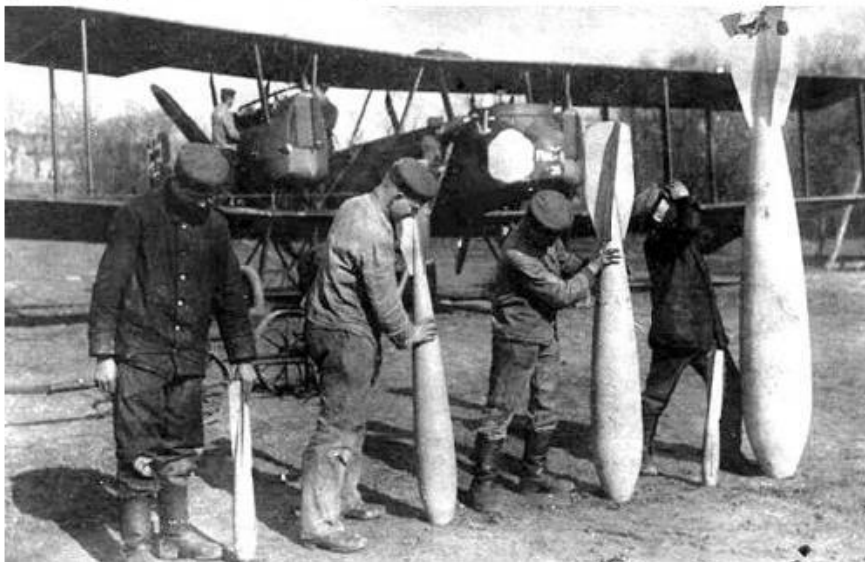
A variety of WWI German bombs

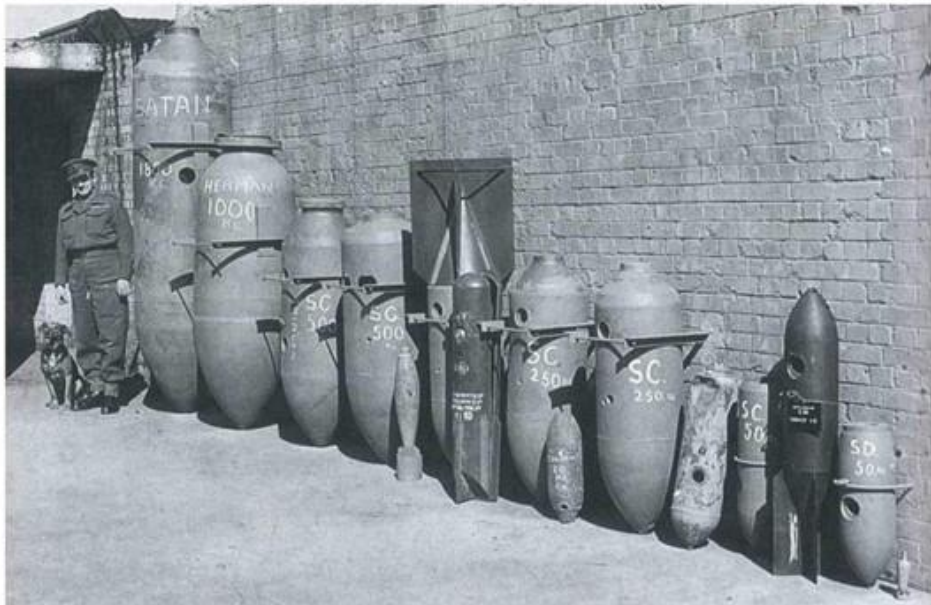
The German bombing campaign saw the extensive use of both High Explosive (HE) bombs and Incendiary Bombs (IBs). 50kg and 250kg HE bombs were most commonly used, although 500kg were also used to a lesser extent. More rarely 1,000kg, 1,400kg and 1,800kg bombs were dropped. HE bombs tended to contain about half of their weight in explosives and were fitted with one or two fuzes. Not all HE bombs were intended to explode on impact and some contained timing mechanisms where detonation could occur more than 70 hours after impact.

Incendiary devices ranged from small 1kg thermite filled, magnesium bodied IBs, to 250kg and 500kg Oil Bombs (OB). Occasionally IBs were fitted with a bursting charge which exploded after the bomb had been alight for a few minutes, causing burning debris to be scattered over a greater area. Large OBs were similar in appearance to HE bombs, although their design was sufficiently different to warrant a specially trained unit of the Royal Engineer (RE) to deal with their disposal.

**Variety of WWII bombs**

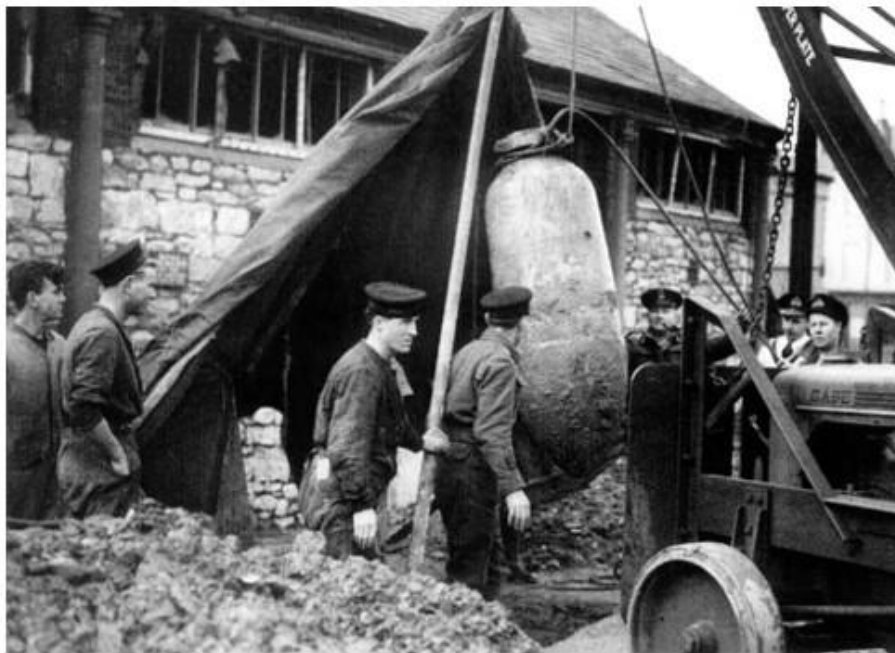
Removal of an UXB

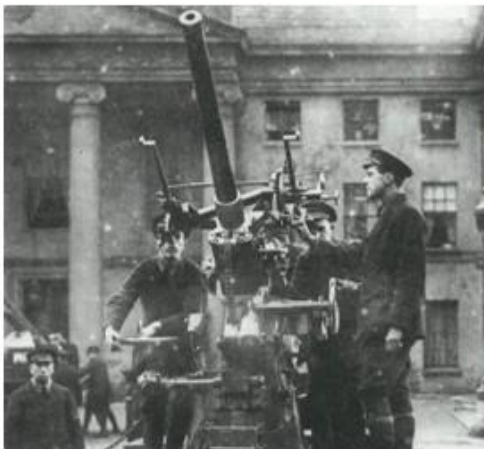
Common WWI AA defences included 3", 75mm, 6-pounder (pdr), and 1pdr guns. Many of these guns were mobile and would follow the course of an airship, firing from areas of open land.

WWI 3-pdr mobile Vickers AA gun

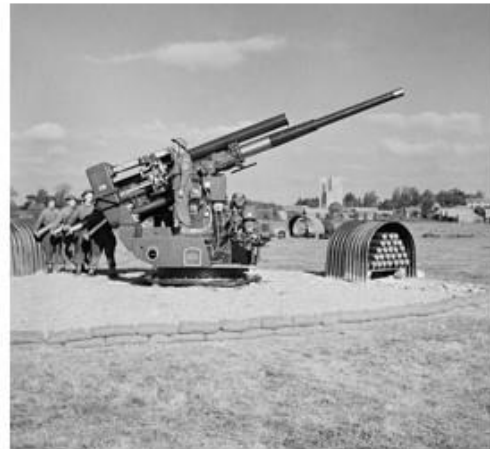
WWII 3.7" static AA gun

During World War Two (WWII), AA gun batteries were used extensively to counter the threat posed by enemy aircraft. AA shells could be distributed over a wide area and could land up to 27km from the firing point, although they more typically fell within 15km.

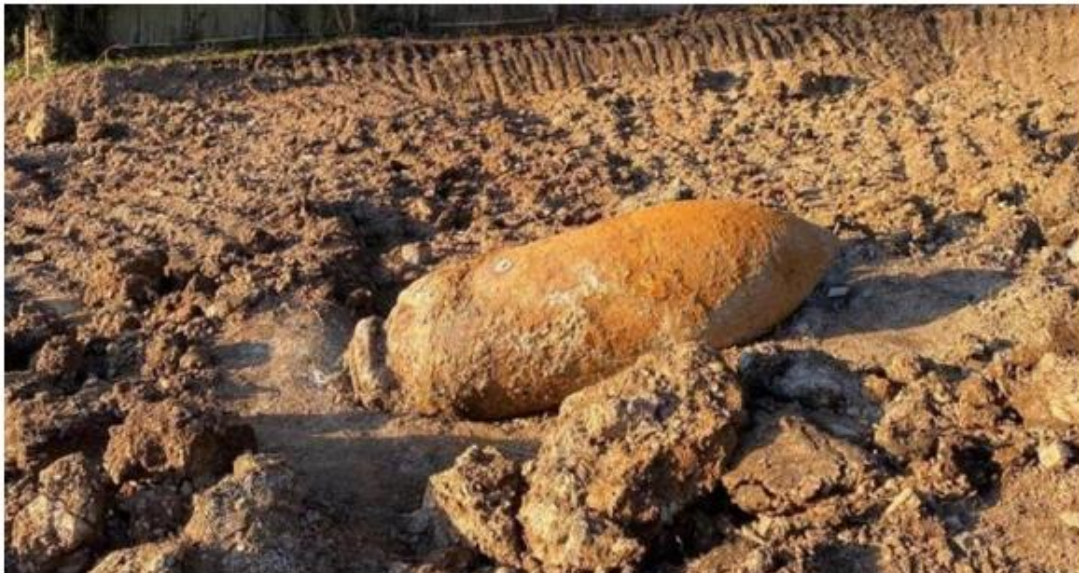
On the 26<sup>th</sup> February 2021, a 1,000kg German "Hermann" UXB was discovered by builders at Exeter University campus (see below). It was investigated and detonated in-situ following the evacuation of nearby properties and University halls of residence.

**1,000kg German UXB discovered in Exeter, 2021**

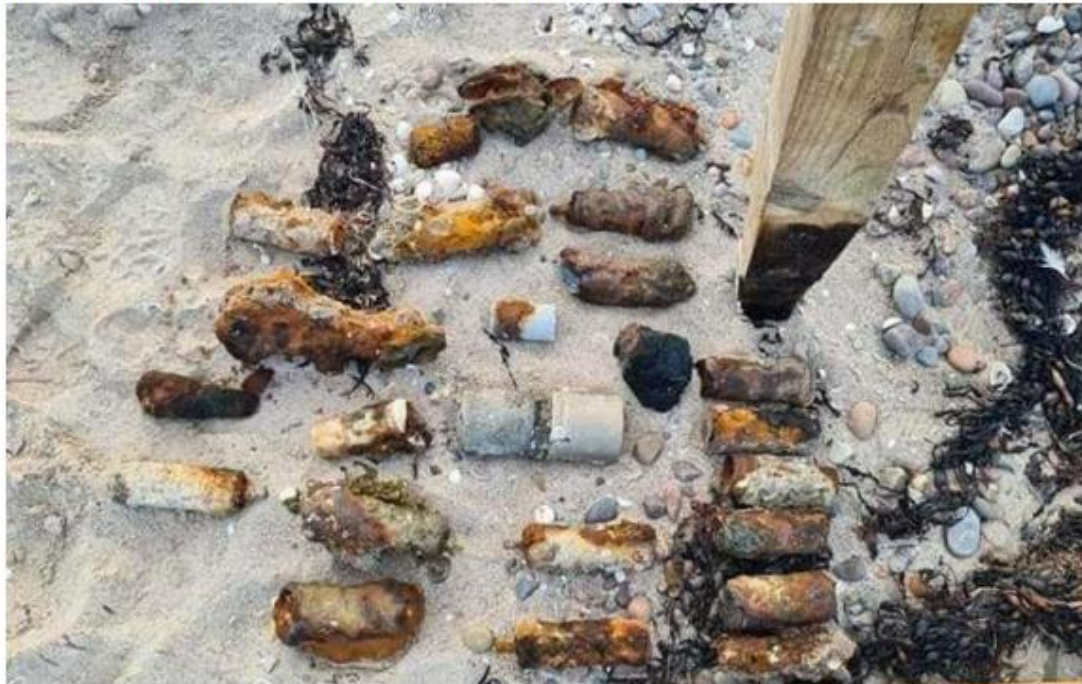
On the 10<sup>th</sup> September 2021, EOD teams destroyed 25No. mortar bombs which had been washed up onto beaches around Nairn and Ardersier in Morayshire. These beaches had been used during WWII for training prior to the D-Day landings in Normandy.

**Mortar bombs found on beaches in Nairn and Ardersier, 2021**
