# GEOSHIELD Verification Report

## VERIFICATION ITEM ONE

LOCATION/GRID LINE: Basement slab - Pour 5

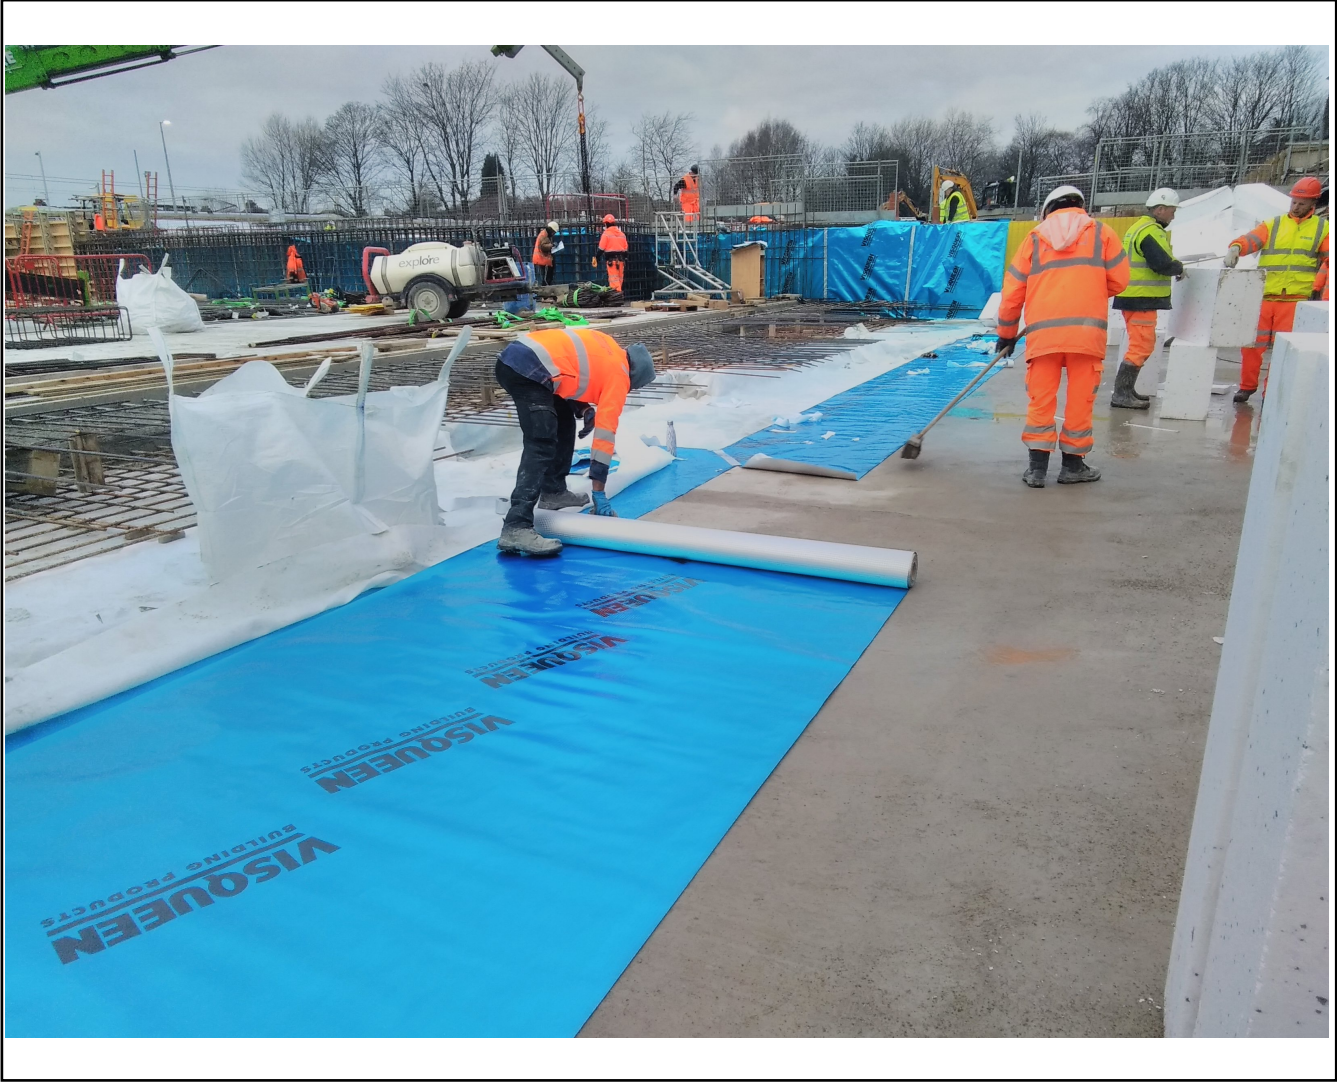
Overview photograph of the area verified during installation

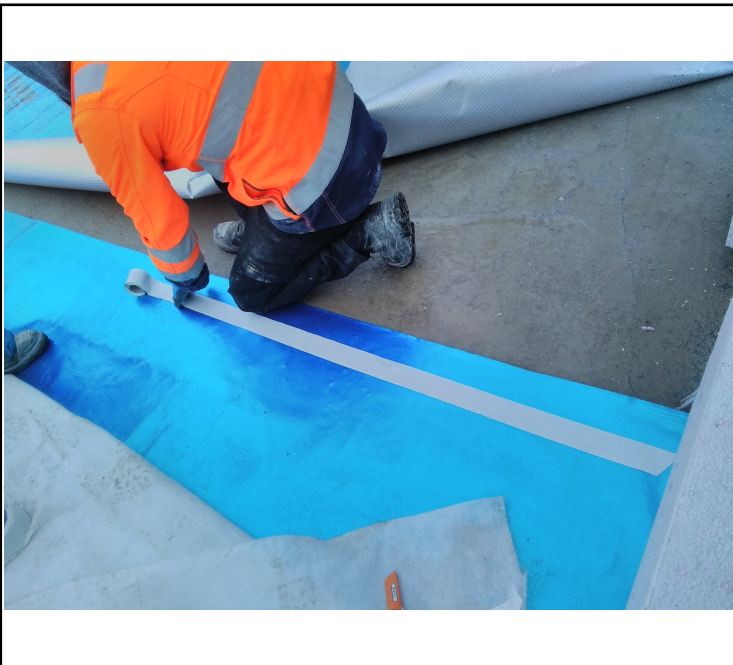
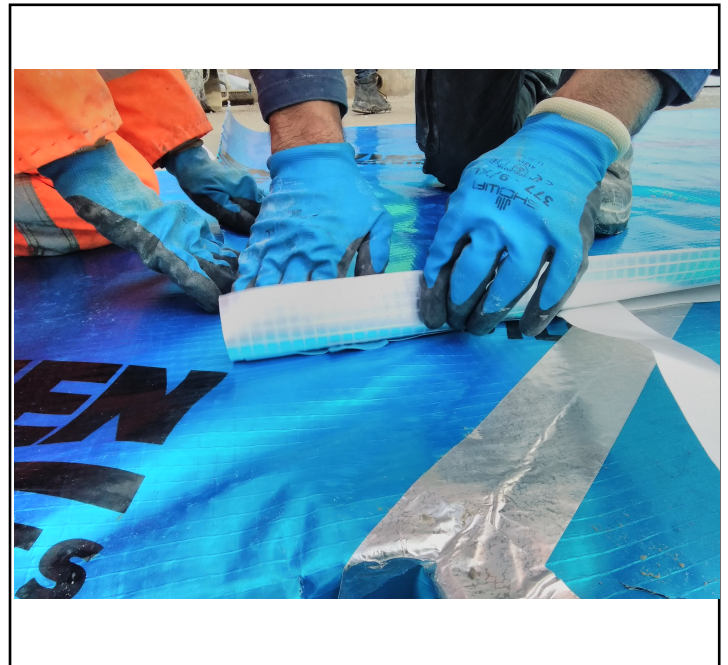
NOTES: Tape Lap Joint

Visqueen Standard Gas Barrier has been installed to the area of Pour 5 and lapped up the walls vertically where applicable. Overlaps of 100mm minimum have been created which have been sealed using Visqueen double sided butyl tape, forming a complete

and continuous barrier. The above photos show the application of double sided butyl tape.

Visqueen silver foil tape has been used to complete the detail.

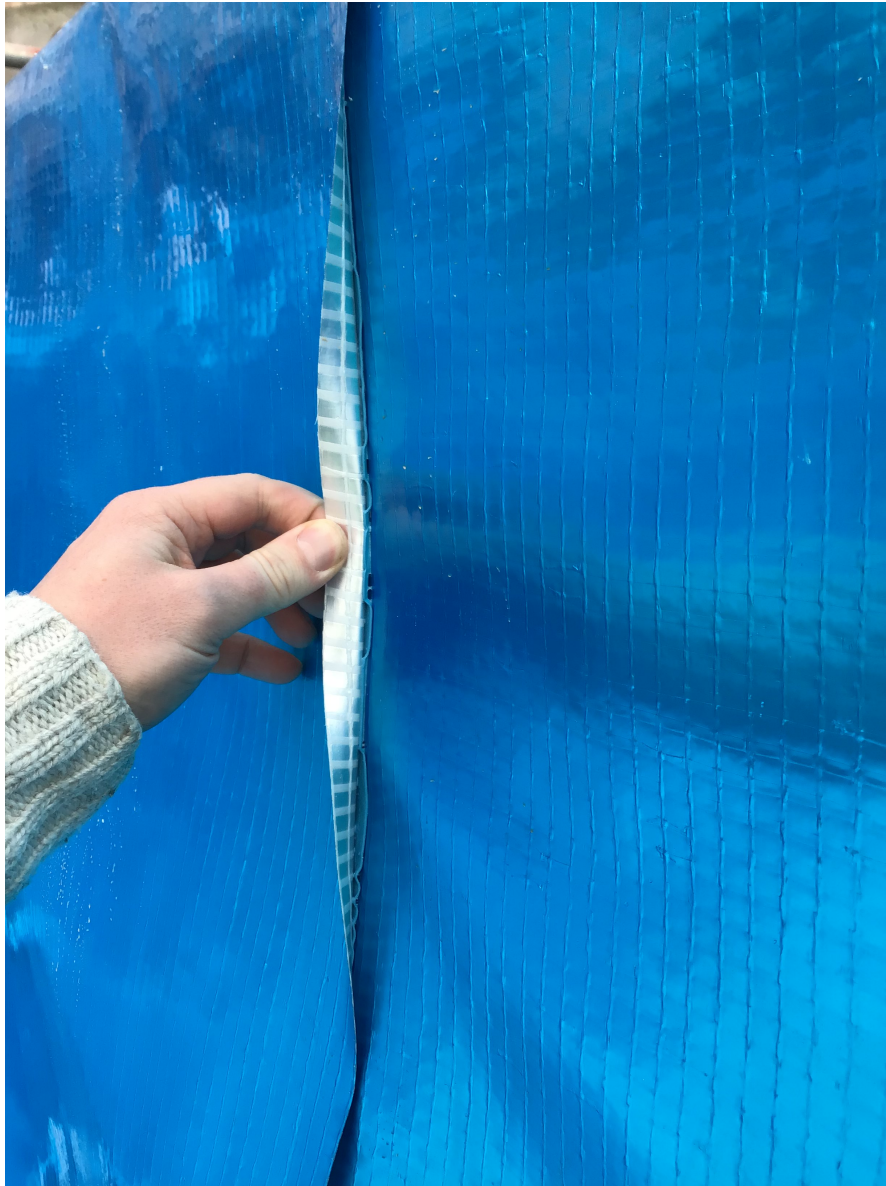
Due to no access air lancing was not conducted however this was replaced by a

thorough pick and probe test. Testing returned no faults with the material installed

to manufacturers specification and an excellent overall standard.

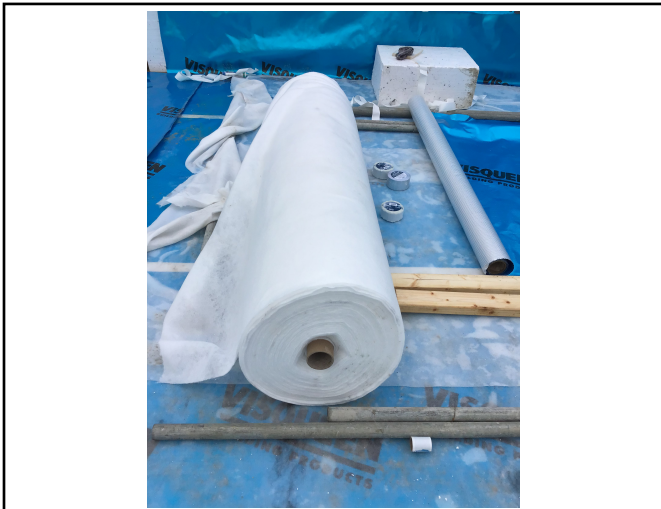
LOCATION/GRID LINE: Basement slab - Pour 5

NOTES: Fleece and Spacer Application

Protective Fleece has been installed to the Visqueen Standard Gas Barrier, this is designed to protect the membrane from follow on trade and UV light damage. This has also been overlapped stopping any areas from being exposed.

The left photo shows a roll of Protective Fleece used during the installation.

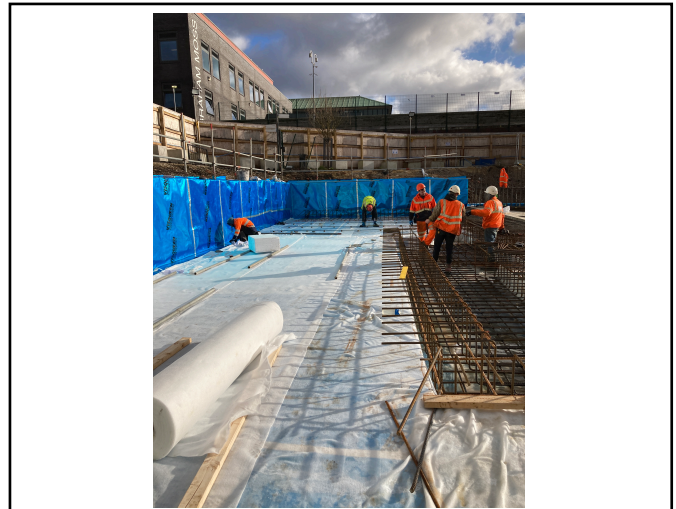
The right photo shows the fleece installed protecting the membrane from steel mesh and any other follow on trades.

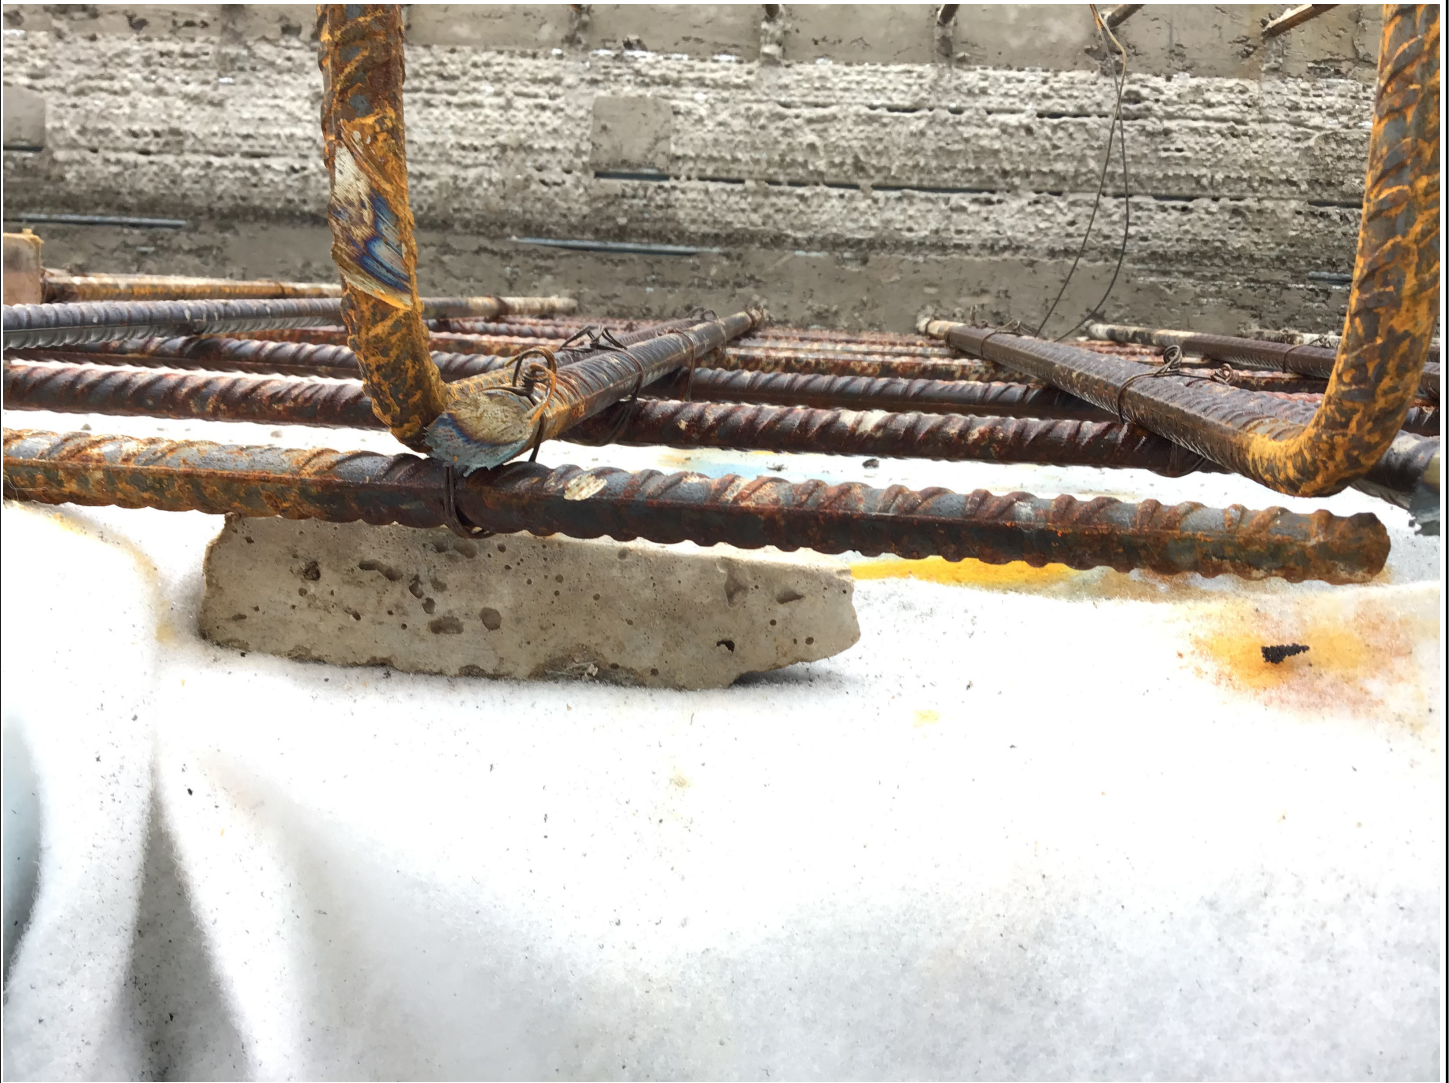
Concrete spacers have been applied on top of the protective fleece to help reduce the risk of damage that can be caused to the membrane by sharp edges of steel mesh.
