# Contaminated Land Phase Two Intrusive Investigation for proposed residential development at 4 Thirsfield Drive, Manchester, M11 4BF.

Prepared for

Building Design Services  
6 Stock Close  
Rochdale  
OL12 6BB

June 2024

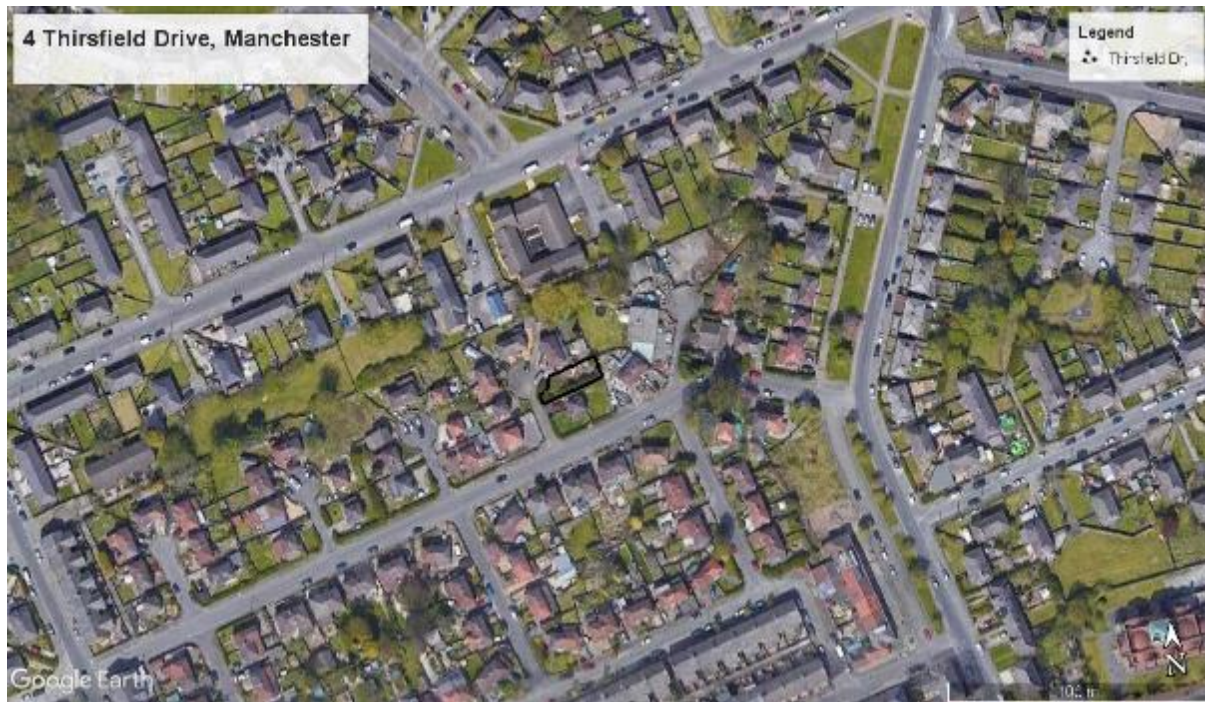
**Figure 1 – Aerial Photograph**

An aerial photograph of the site is included in Figure 1.

The site currently consists of an open piece of rectangular land which has now been cleared of vegetation and foundations had been dug at the time of the phase II investigation. Residential properties lie to the immediate north, east and south with Thirsfield Drive to the west and more residential properties beyond.

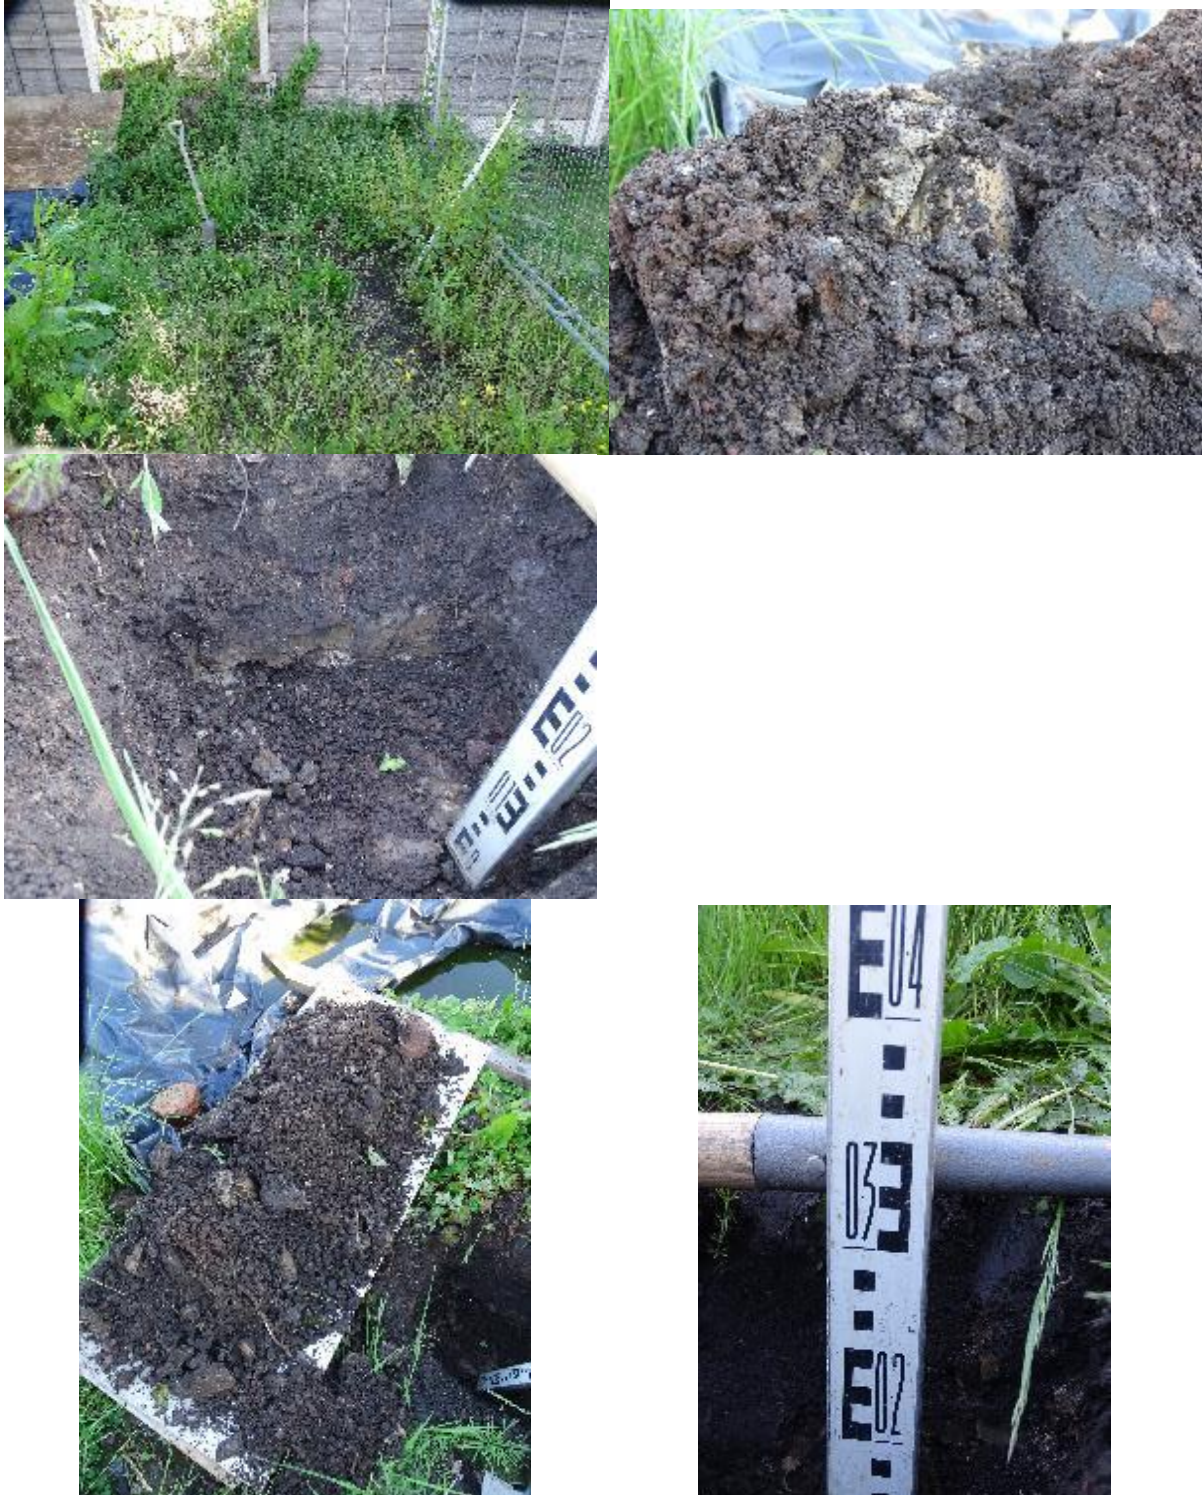
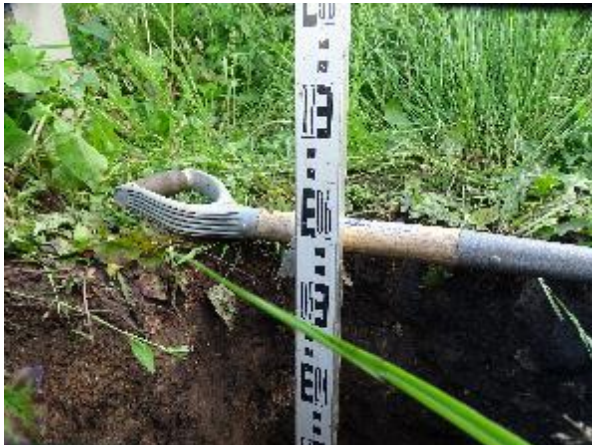
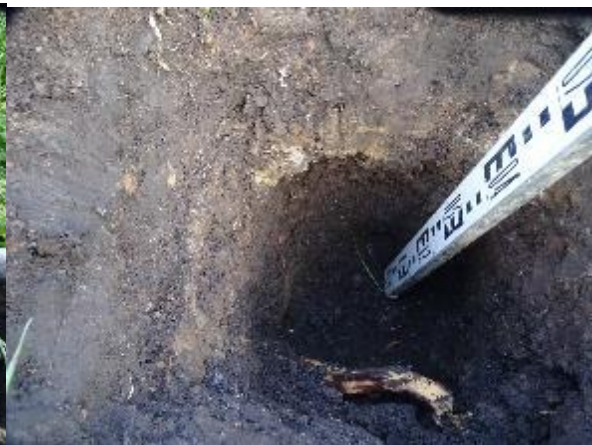
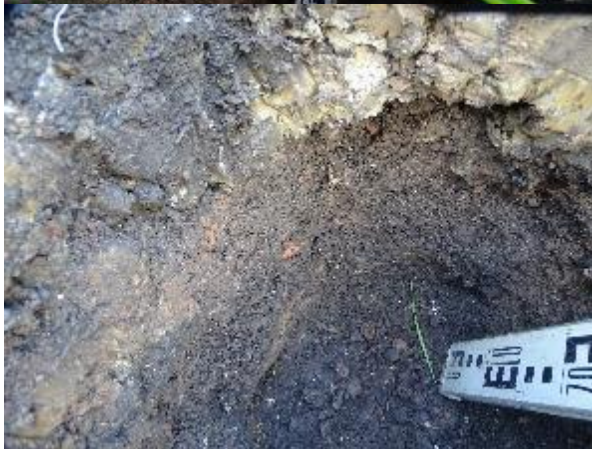
### TP1 – Rear right side of site (proposed garden area)

Trail pit 1 – Rear right side of garden

| 0.00-0.15m | Topsoil, grass roots |
| 0.30-0.60m | sandy loamy clay, gravel and<br>brick, roots |

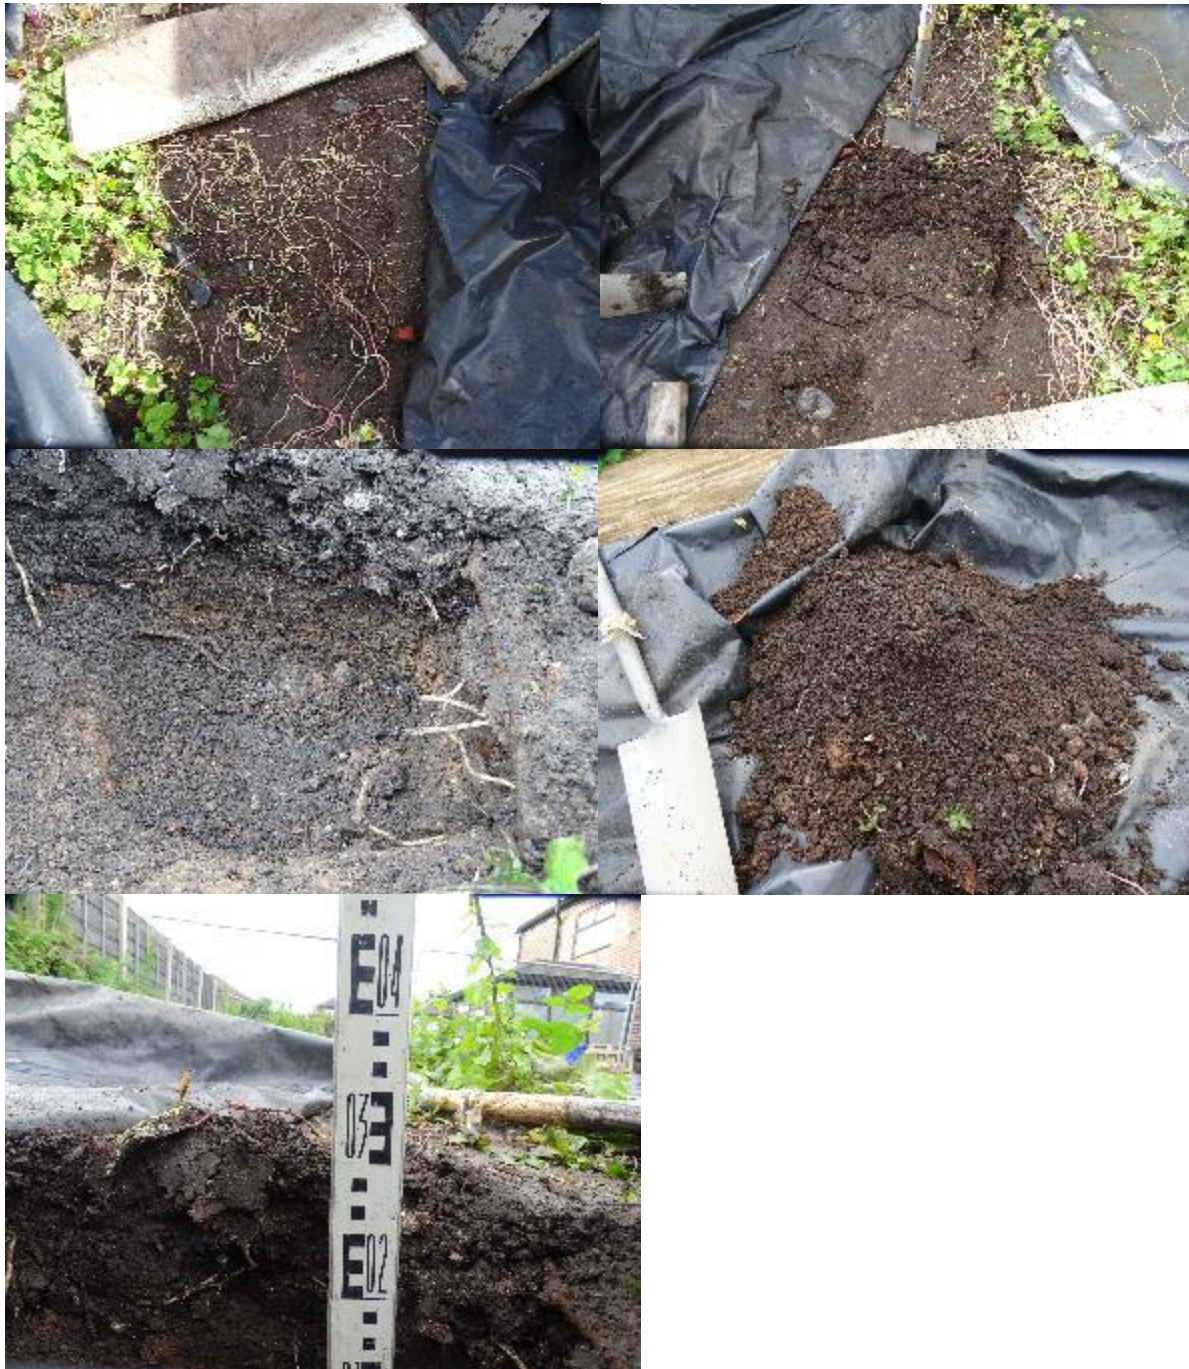
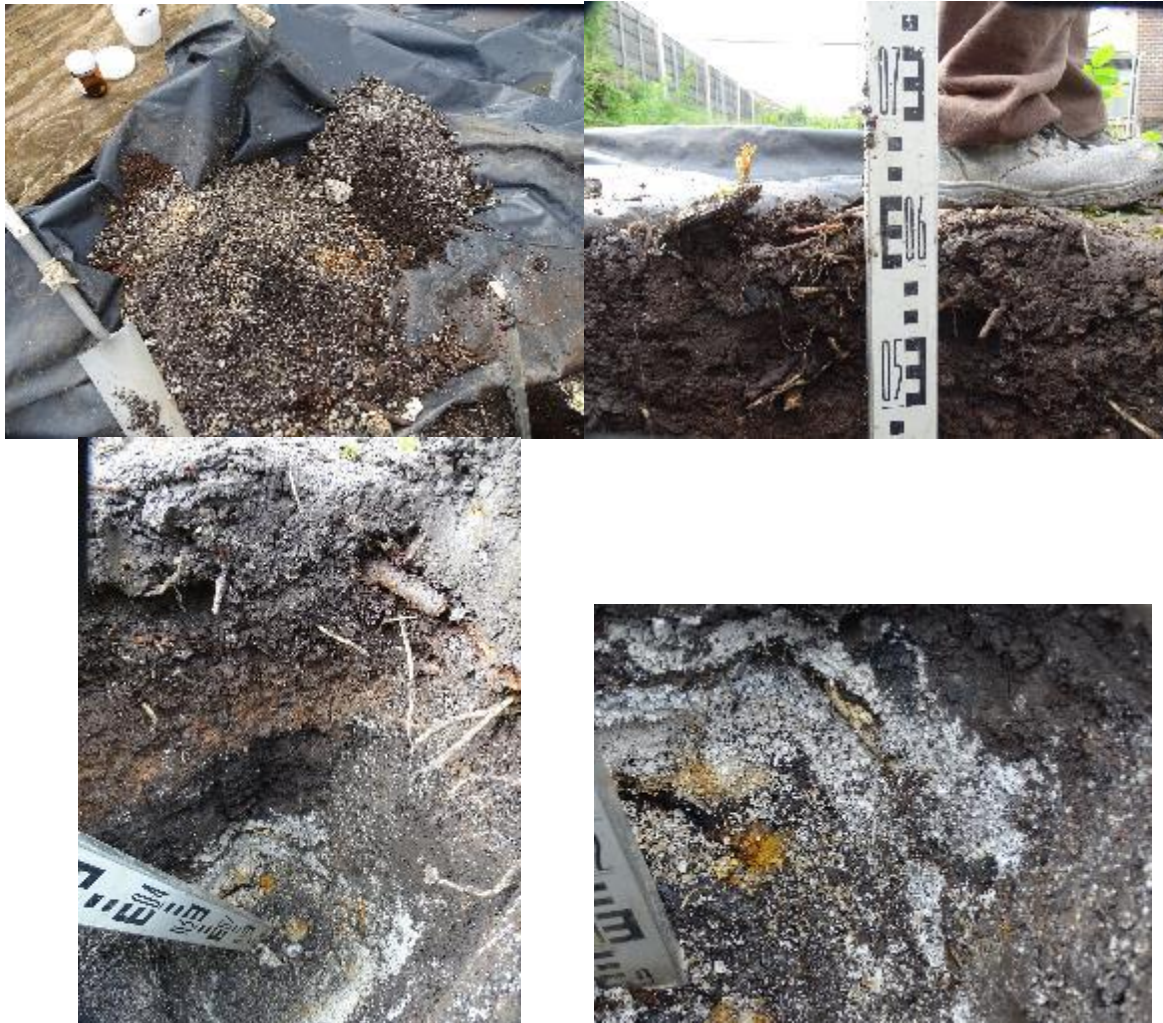
**TP2 – Rear left side of site (proposed garden area)**

Trail Pit 2 – Rear left side of garden

| 0.00-0.00m | roots |
| 0.45-0.65m | sandy loamy clay, gravel. |

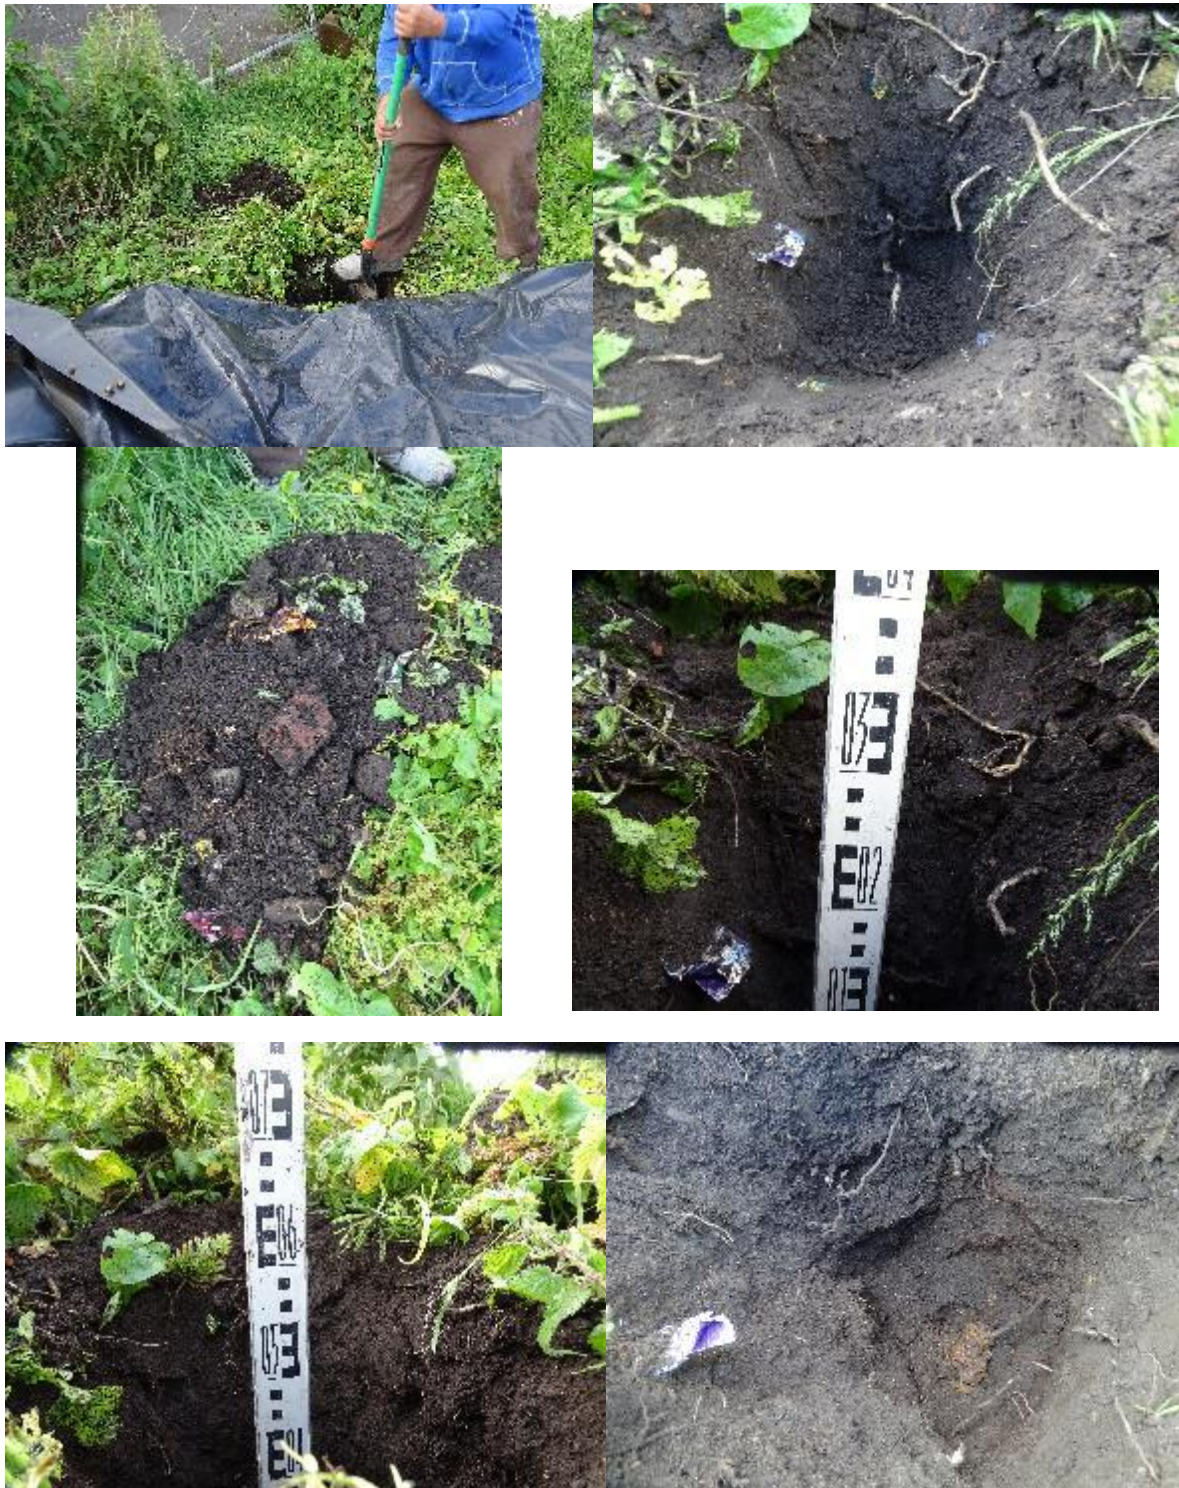
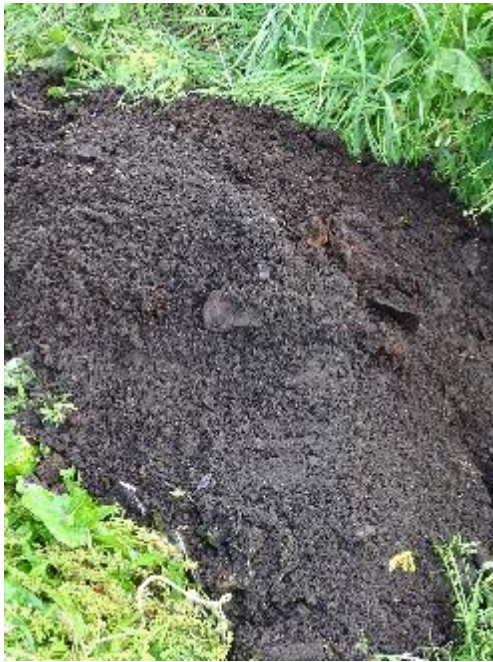
**TP3 – Front right side of site (proposed garden area)**

Trail Pit 3 – Front right side of garden

| 0.00-0.20m | grass and topsoil |
| 0.30-0.60m | sandy loamy clay, gravel,<br>some stone and brick |

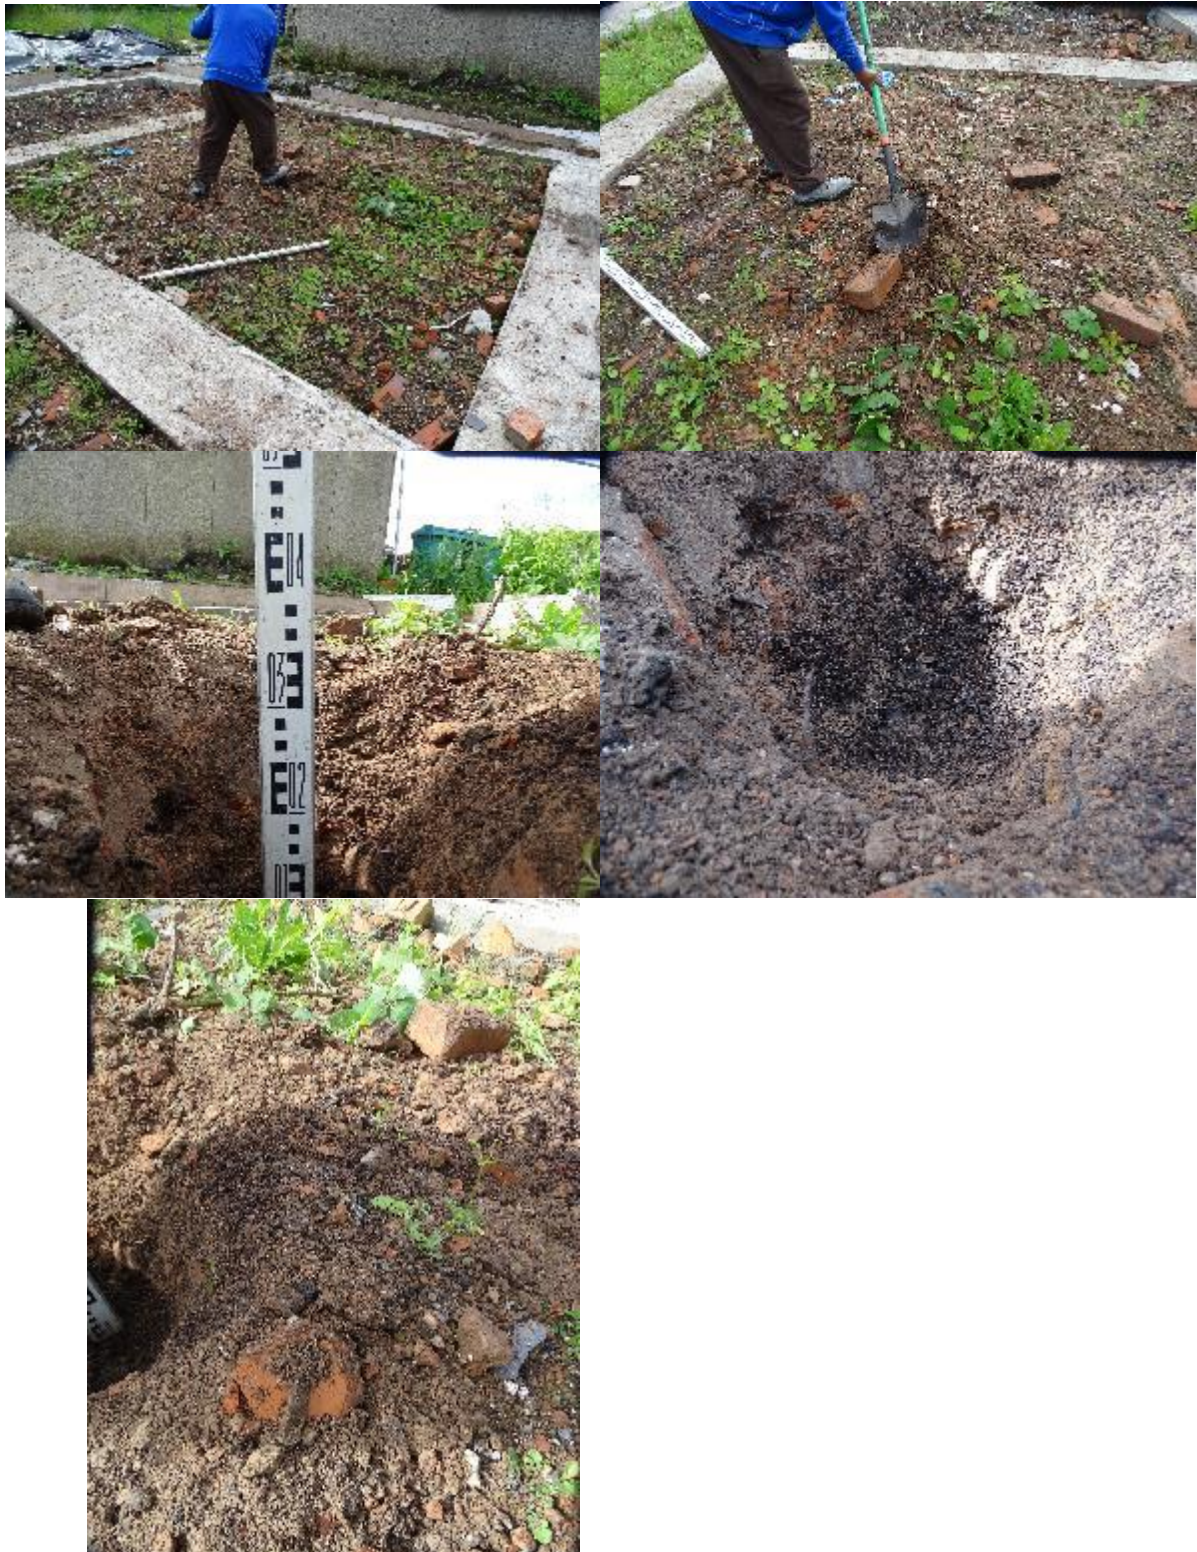
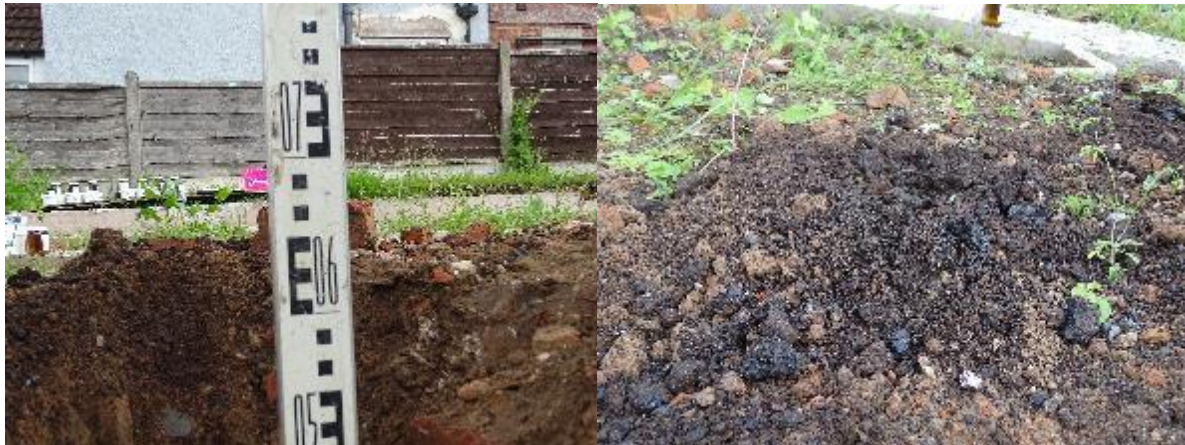
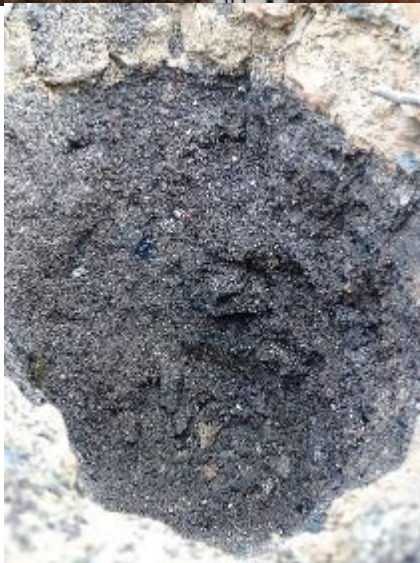
**TP4 – Centre of site and proposed building**

Trail Pit 4 – Centre of Site

| 0.00-0.30m | sandy loamy clay, lots of stone, brick, some coal fragments |
| 0.30-0.60m | sandy loamy clay, gravel, cleaner clay at base. some stone |

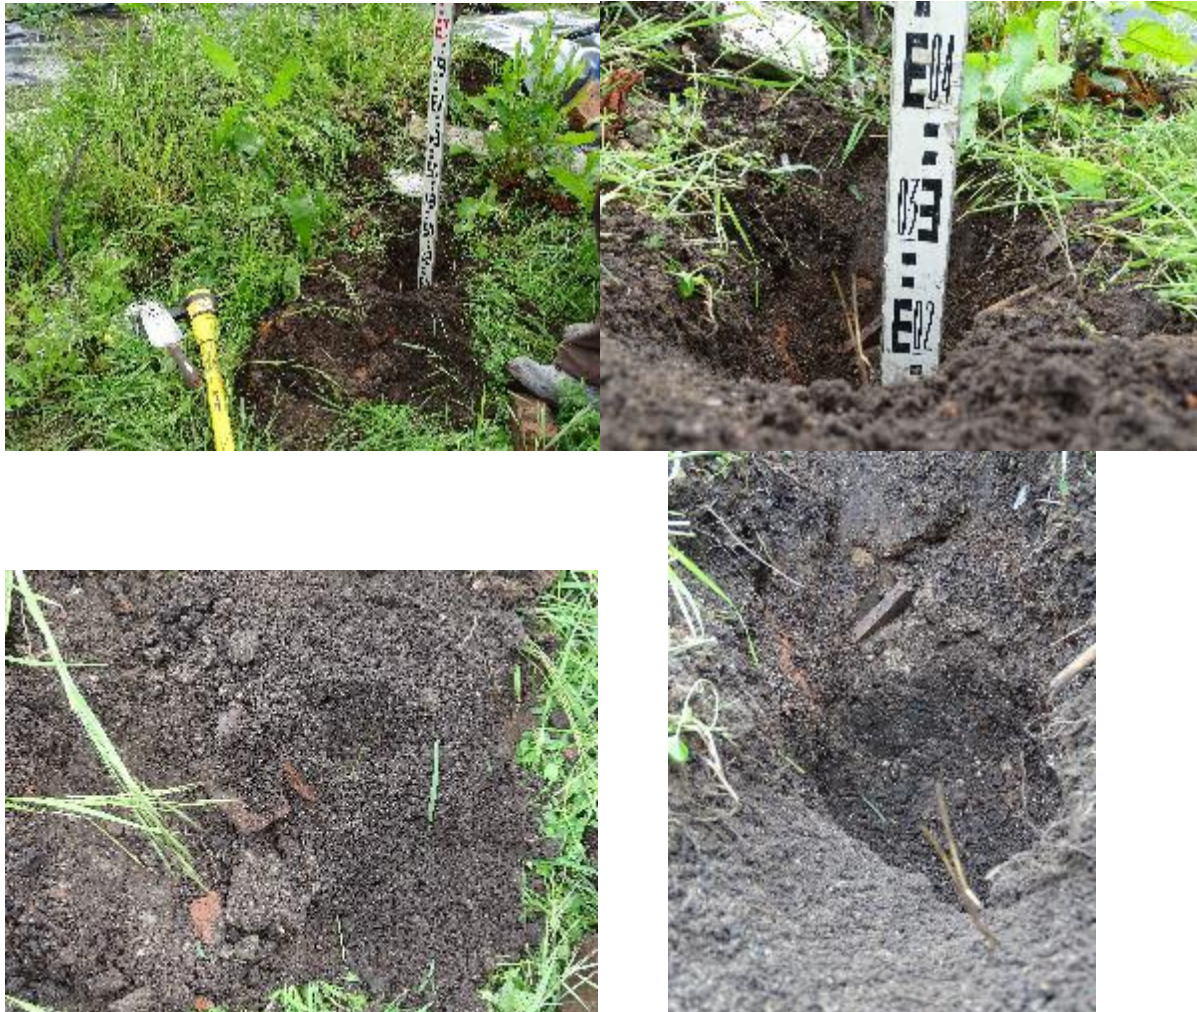
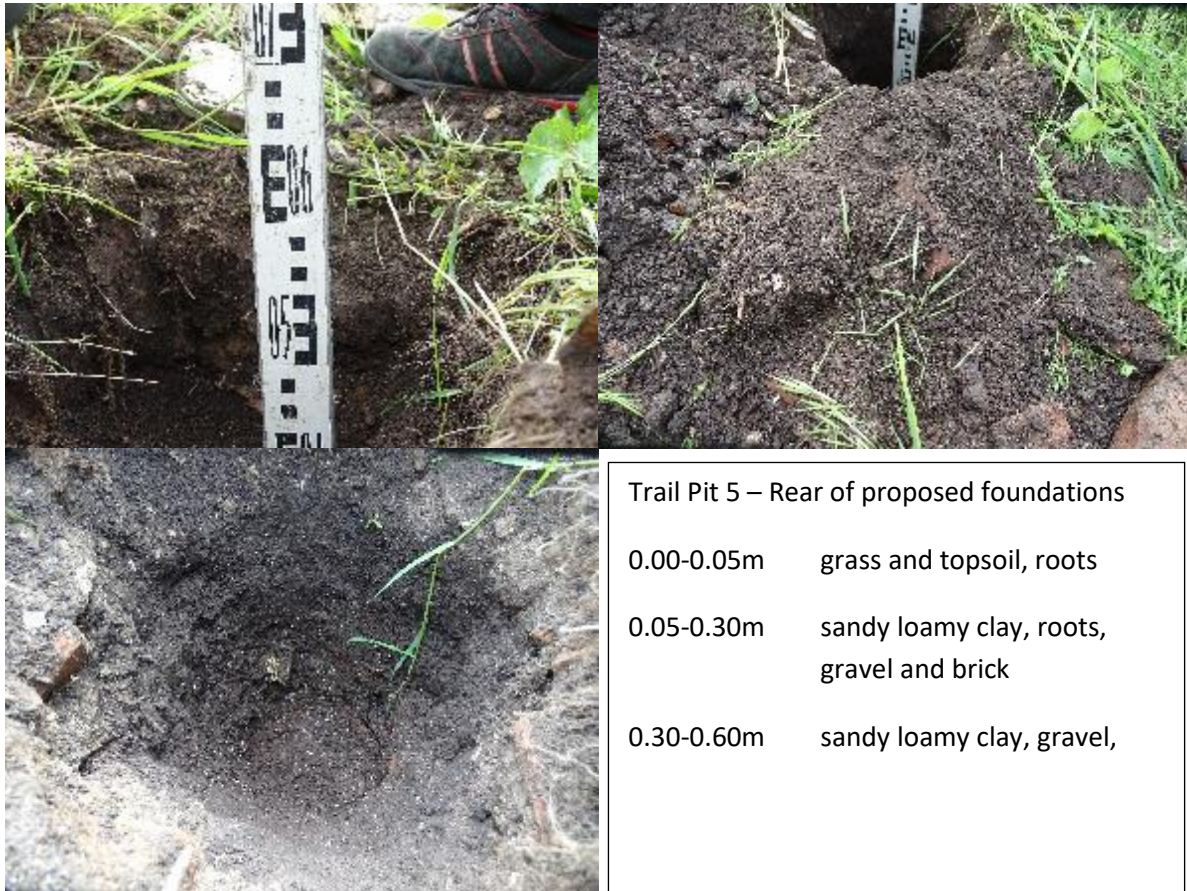
**TP5 – Rear of Proposed house foundations**

Trail Pit 5 – Rear of proposed foundations

| 0.00-0.05m | grass and topsoil, roots |
