# Hough Hall, Moston

## Bat Survey Report

13<sup>th</sup> May 2024

| Document ref: MBE/BAT/2024/046/01 | | | | |

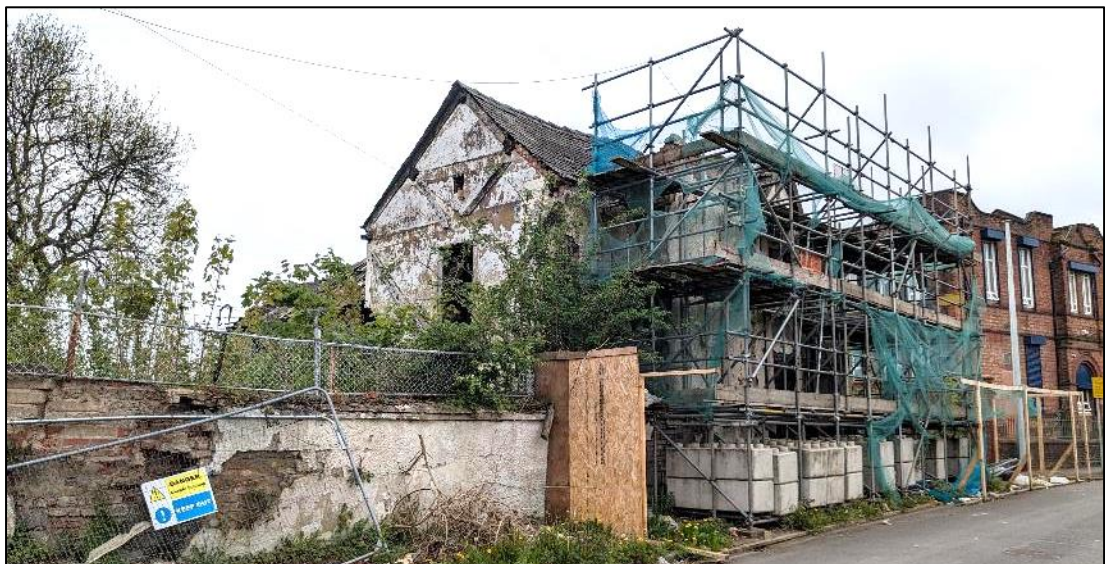
**Plate 1. Northeast elevation of Hough Hall, enclosed by scaffold**

- 5.2.3 The surveyed building comprised a former farmhouse, sections of which appear to date back to early 17<sup>th</sup> Century. This two storey timber-framed building was in a state of partial collapse at the time of survey with large sections of the southeast, southwest and northwest elevations open-sided due to the collapse of walls. The building included gables facing northeast, southeast, southwest and northwest. The roof was multi-pitched with roof coverings comprising a mix of Welsh slate with clay ridge tiles and

corrugated cement-asbestos roof sheets. Remaining sections of wall were constructed from brick infilled sections between the framework timbers, with a stone-built chimney visible through a collapsed section of wall adjacent to the northwest gable. All windows were missing. Scaffold was enclosing the northeast elevation of the Hough Hall, where it fronted Hough Hall Road.

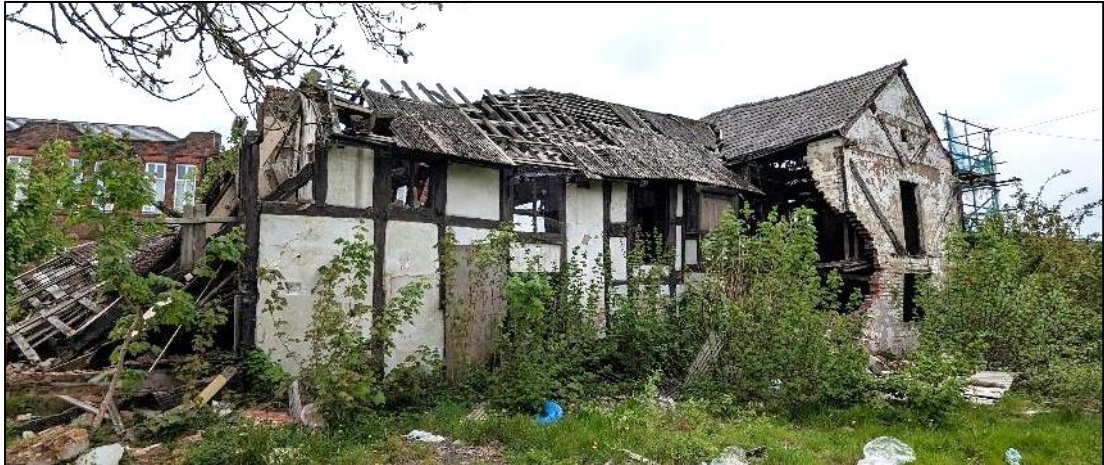
**Plate 2. Southeast elevation**

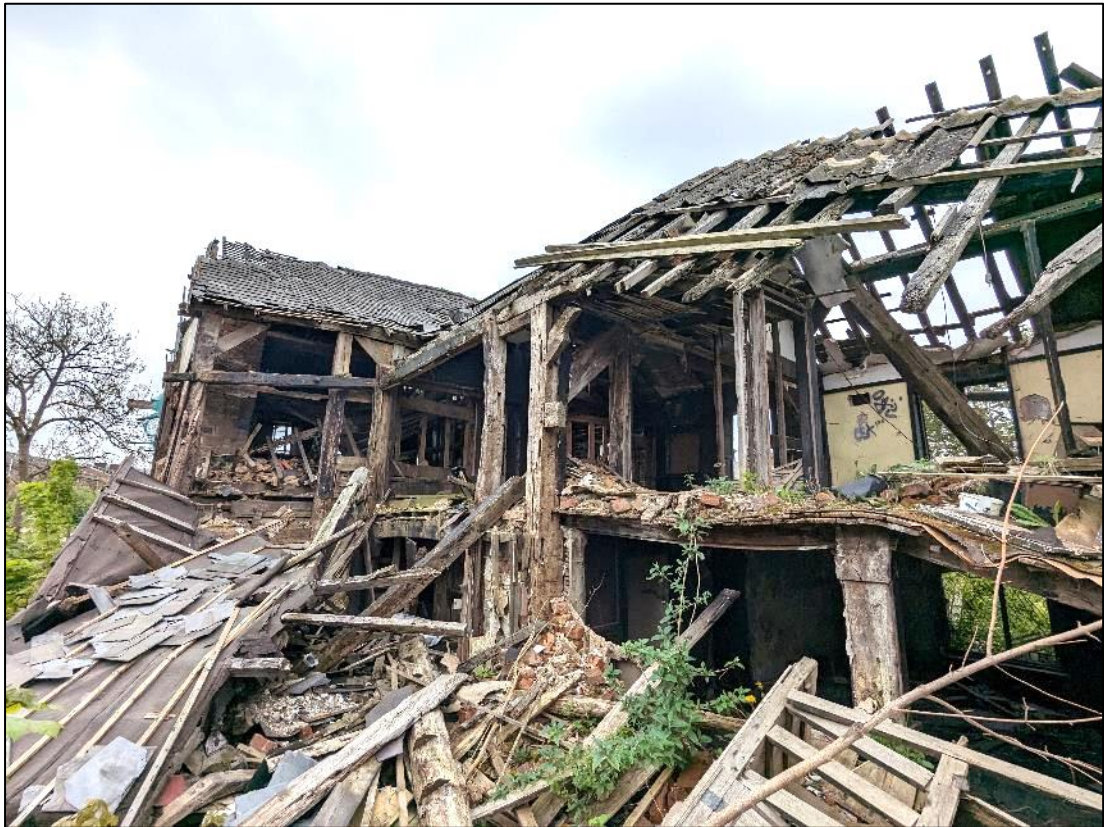
**Plate 3. Northwest elevation**

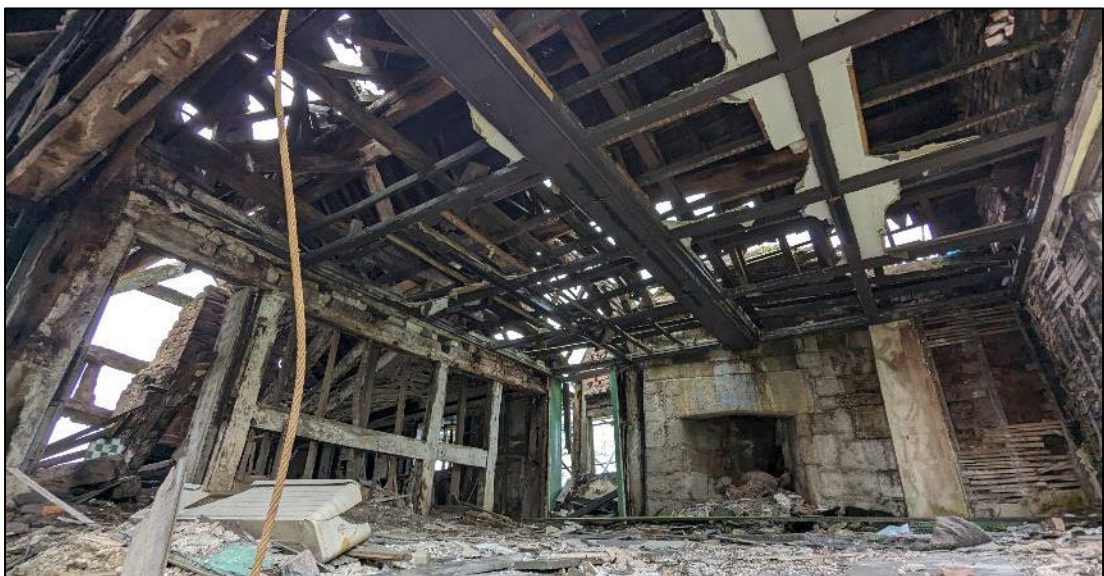
- 5.2.4 The interior of the building could not be accessed, however, much of it was visible to some degree through missing sections of wall and window openings.
- 5.2.5 The roof was found to be unlined and suspended on a ridge beam, broad timber trusses, purlins, rafters and battens. A roof void had been present but the ceiling had been largely destroyed.
- 5.2.6 Across the building lath and plaster coverings on the interior of many of the walls had been stripped off, exposing external brickwork. Extensive wood cladding was also visible within internal rooms, with this panelling also damaged.
- 5.2.7 No bat droppings or other evidence of bat presence was recorded from either the interior or exterior of Hough Hall.

### **Plate 4. First floor**

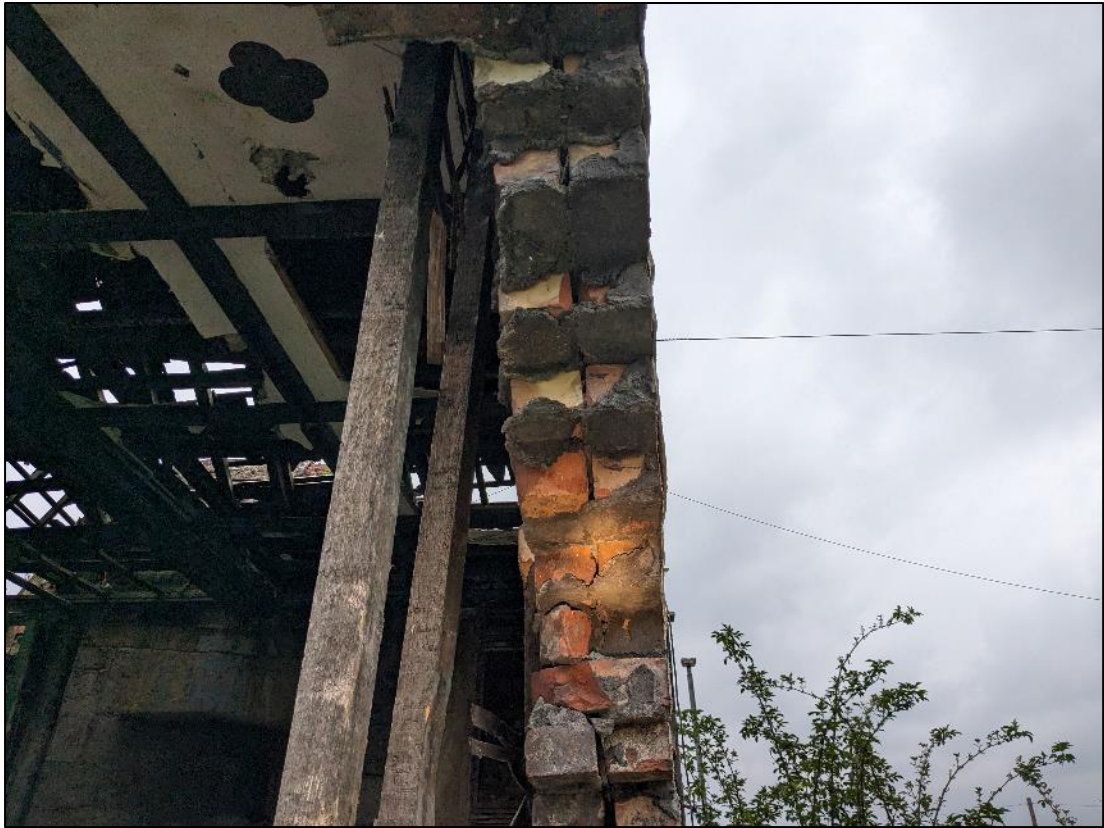
- 5.2.8 A range of potential bat roosting features were recorded from Hough Hall. Potential roost features on both the exterior and interior were considered together, given the ease with which bats can access the interior of the building. Potential roost features included the following:
  - Missing ridge bedding mortar.
  - Open joints between bricks in external walls, access onto brick wall tops and into space between brick skins (Plate 5).
  - Desiccation fissures (Plate 6) and open mortice and tenon joints associated with roof timbers.
  - Gaps behind wooden panelling on interior of structure.
  - Open joints within stone chimney breast.
- 5.2.9 Taking into account the building location, condition and the range of potential roost features present, Hough Hall was considered to display a low level of bat roost suitability.

**Plate 5. Crevice spaces between bricks in external wall**

- 6.3.1 In order to confidently determine the presence/absence of roosting bats, a single nocturnal survey is required.
- 6.3.2 The nocturnal survey should be undertaken during the bat activity season (peak period: mid-May to August) (Collins, 2023), with site buildings to be covered by two surveyor positions and the survey led by a licensed bat surveyor. It is considered unnecessary to cover the northeast elevation, which fronts Hough Hall Road, given that both the adjacent street lighting and enclosure with scaffold, reduce its suitability as a potential roosting area. Infra-red lit video cameras should be used to assist surveyor observations.
- 6.3.3 The requirement for bat roost mitigation and licensing have yet to be determined.

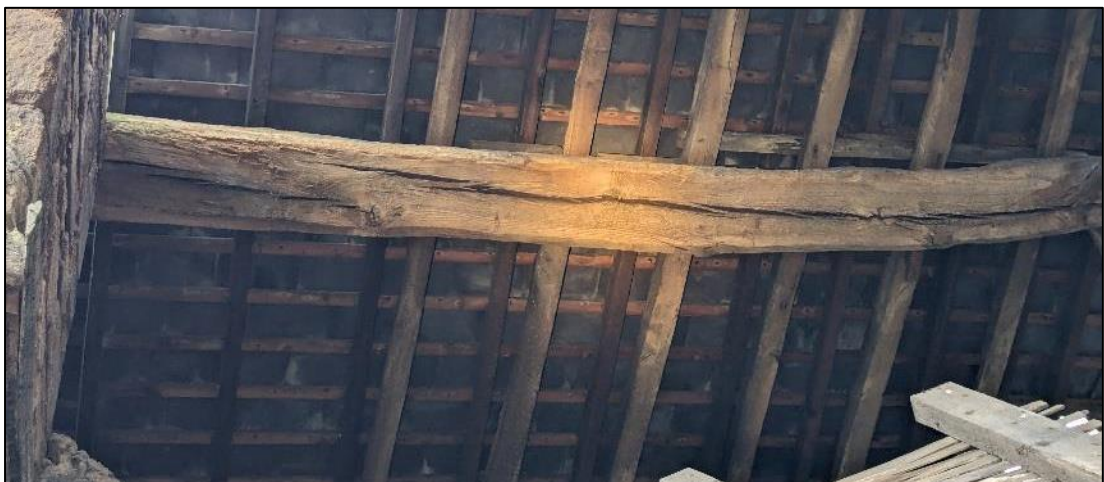
**Plate 6. Desiccation fissures/cracks in purlin**
