**RE: EMBASSY VILLAGE- PRELIMINARY BAT ROOST ASSESSMENT**

The Environment Partnership (TEP) was commissioned in December 2022 by Arcadis (UK) Limited to undertake a Preliminary Roost Assessment of built structures, including railway arches and a hut, between the Bridgewater Canal and River Medlock in Manchester (SJ 82719 97479) to discharge planning condition 3 for the development of 40 single-occupancy residential accommodation pods, services, amenity space and hard/soft landscaping (Planning Ref: 129923/FO/2021):

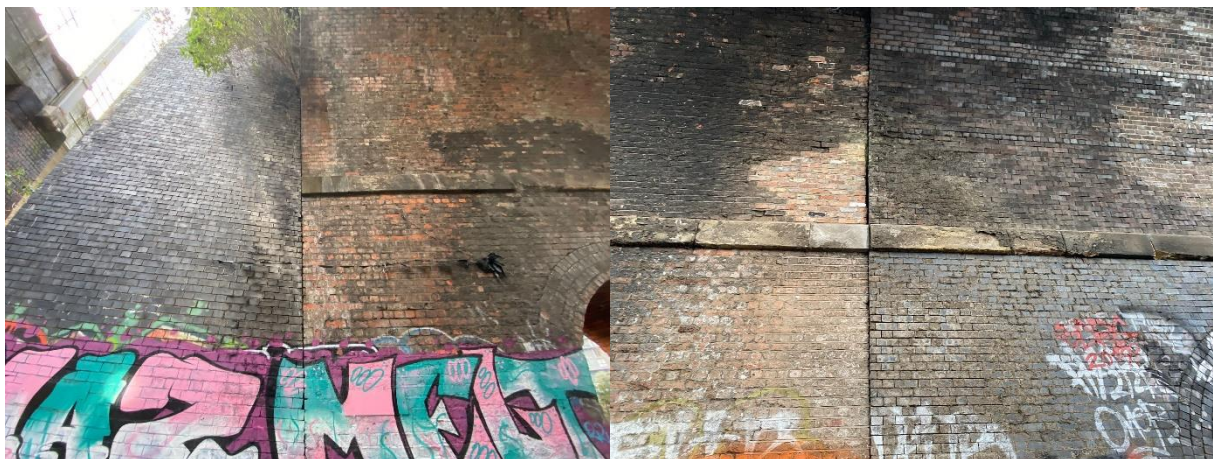
The Network Rail arches are comprised of brick and sandstone and are generally well-pointed. Potential Roost Features (PRFs) identified include small gaps between the brick arch and the southern brick abutment on the western-most four arches (Figure 1). These PRFs extend from approximately 1m to the top of the abutment. The gaps at ground-level could be inspected with an endoscope and provide a depth of approximately 3cm. The feature could not be fully inspected for the full length due to the height. Additionally, gaps between the brickwork in the

centre of the arch within the 6<sup>th</sup> and 7<sup>th</sup> arches from the west were noted. The gaps at ground-level could be inspected with an endoscope and provide a depth of approximately 3cm (Figure 2). The feature could not be fully inspected for the full length due to the height. The overhead railway line will generate a level of disturbance to the PRFs identified. These PRFs were assessed as having low suitability for roosting bats, due to the conditions offering limited shelter/protection and would likely be used on an opportunistic basis. These PRFs do not provide suitable hibernation potential. Given that the structures support an active railway line, no direct impacts on these structures are anticipated as a result of the proposed development. There will be an approximate 3m stand off from the existing Network Rail arches and proposed development. Indirect impacts from proposed external lighting are possible on any potential roosting bat. Feral pigeon were noted in the steel girders.

Figure 1: Gaps between the Network Rail arches and southern abutment

Figure 2: Gaps between brickwork in the centre of the Network Rail arches (Arches 6 & 7).

The gaps between the brickwork in the Network Rail arches and gaps between the plywood and brick in the TfGM arches were assessed as having low suitability for roosting bats. Due to overriding health & safety reasons, it is not suitable to undertake nocturnal surveys in this area. As such, it is recommended that these PRFs are inspected, during the daytime, by a licenced bat ecologist to determine the presence/absence of roosting bats. As the PRFs are assessed as having 'low' suitability, one daytime inspection is required between May and August to determine the presence/absence of roosting bats, prior to any demolition works.

Due to the height of the PRFs in the Network Rail arches, it is recommended these features are inspected by safe access from scaffolding or a Mobile Elevating Work platform (MEWP).

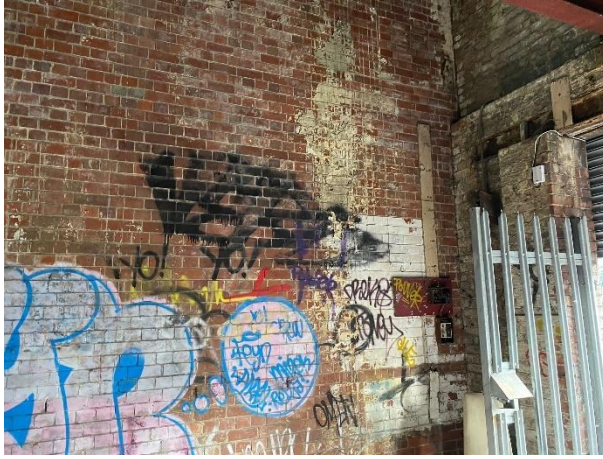
The TfGM arches comprise five closed arches and six open sided arches. The open arches comprise brick piers supporting a concrete girder. No PRFs were identified in any of the open, six TfGM arches. The closed arches, used as cold stores, were inspected internally. A number of plywood boards were fixed to the walls in the cold stores which provide a crevice suitable for roosting between the brick wall and plywood boards (Figures 3 & 4). Additionally, gaps in the external brickwork provide access to the interior of the cold stores and internal PRFs. These PRFs were assessed as having low suitability for roosting bats, due to the conditions offering limited shelter/protection and would likely be used on an opportunistic basis only. These PRFs do not provide suitable hibernation habitat. No other roost features were identified in the closed TfGM arches. Two of the closed stores will have the northern and southern walls demolished to open up the arches to facilitate development (Proposed Demolition Plan MP\_02\_1100 Rev A). As a result, the identified PRFs will be lost and demolition works have potential to damage, destroy or disturb any potential bat roost.

Figure 3: Plywood board fixed to the interior wall of cold store

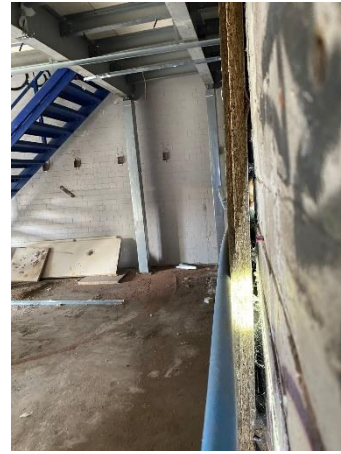
Figure 4: Gap between plywood and brick wall.

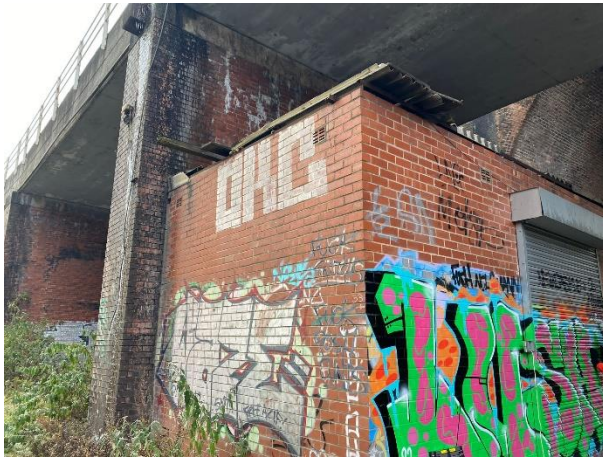
The 'hut' comprises a single storey brick storeroom. The roof is flat, with corrugated uPVC and is in a state of disrepair with large openings. There are no windows, no soffits, and no barge boards. No suitable PRFs were identified, and the 'hut' was assessed as having negligible suitability for roosting bats. The 'hut' will be demolished to facilitate development, there are no further implications for the development with regard to roosting bats.

Figure 5: The brick 'hut'
