26A Wilbraham Road, Fallowfield

## Phase 1 Preliminary Risk Assessment

**Job Number:** LKC 22 1757

**Client:** Creative People Property Ltd

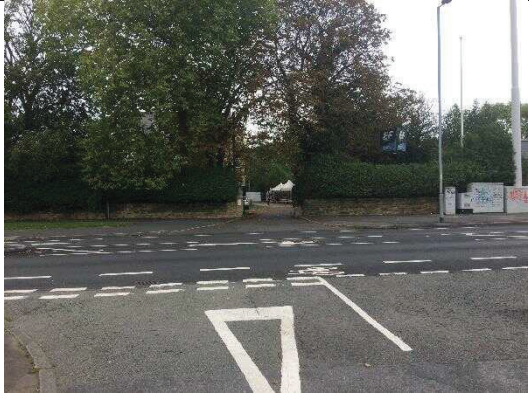
| <p><b>Photograph 1:</b> View of site access from across Wilbraham Road, facing N.</p> | <p><b>Photograph 2:</b> View across car park, taken facing W.</p> |

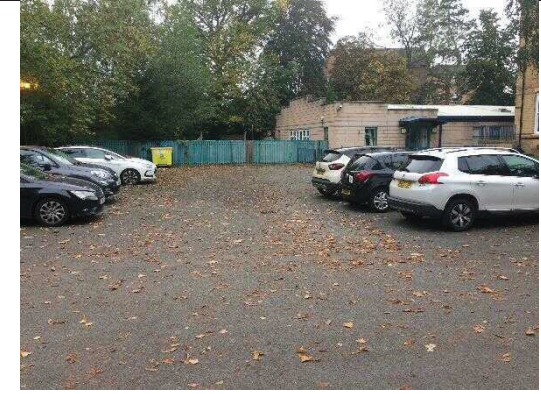
- The south-east of the site is occupied by a car park for EF Language School (located to the north-east of site) and the nursery. The car park comprises tarmac in good condition.

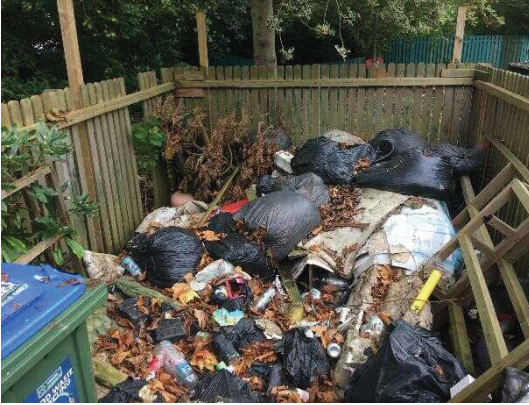
- Bin storage is present on the southern edge of site, to the west of the site entrance.
- Services were identified on site, including lamp posts, drains and service covers.

| <p><b>Photograph 3:</b> Bin storage in the south of the site.</p> | <p><b>Photograph 4:</b> Soft landscaping in the south of site.</p> |

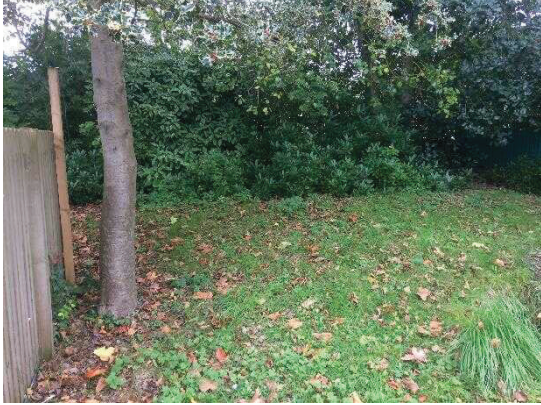
- The play areas associated with the nursery comprise soft play surfacing.
- Soft landscaping is present along the southern site boundary with several mature trees present.

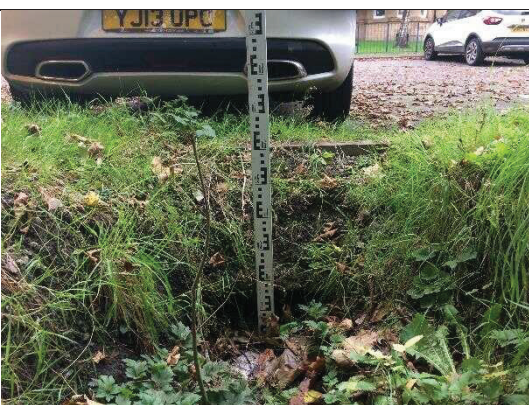
Hand dug pits were carried out in 2no. locations and are summarised in Table 4-1.

| HD101 | HD102 |
|---|---|
| 0.00-0.30m Made ground (gravelly sand with frequent brick fragments, occasional glass, ash, coal and rootlets). | 0.00-0.30m Made ground (silty gravelly sand with occasional brick, ash, clinker). |
| 0.30-0.50m Made ground (sand and gravel with occasional glass and ash). | 0.30-0.60m Made ground (sand and gravel with occasional brick fragments, ash, and glass). |

| <p><b>Photograph 5:</b> View of hand dug pit, taken facing N.</p> | <p><b>Photograph 6:</b> Southern side of nursery building, taken facing W.</p> |

| <b>PL 1, 2, 5</b> | Intrusive investigation work recommended to confirm ground conditions across the site.<br>Testing of contaminants of concern based on preliminary conceptual model and field observations (PID tests and visual / olfactory evidence). |

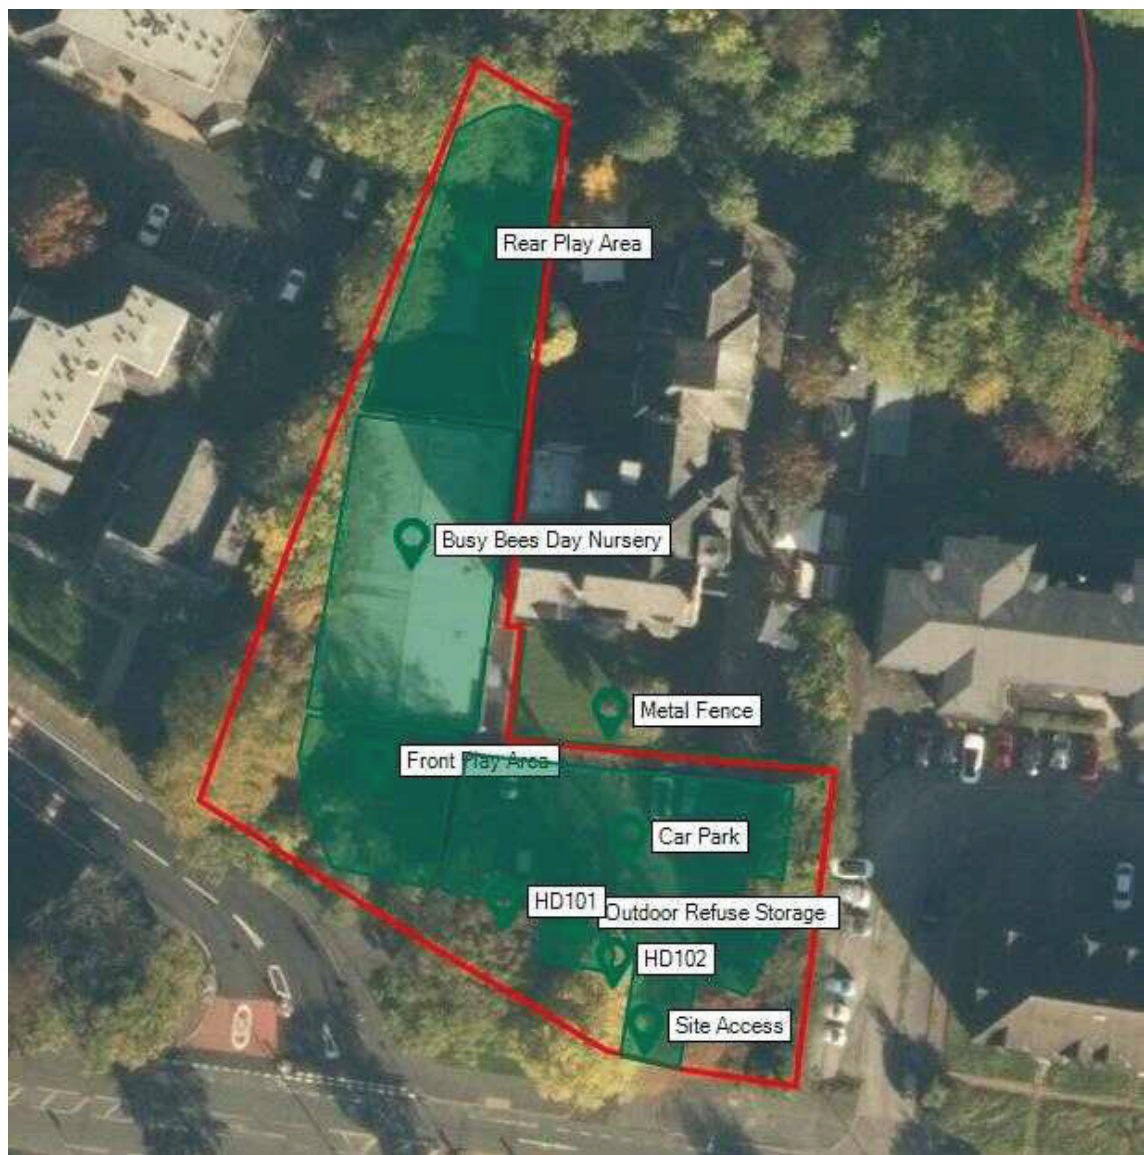
Site features are also shown on Plate 4-1.

Plate 4-1: Plan showing relevant site features.
