Midland Hotel  
West Elevation  
for Leonardo Hotels

## Repair Details

PROJECT REF. 2045  
DRWG NO. P(400)  
REVISION  
SCALE AS NOTED@A3  
DATE 1st Feb 24  
DRAWN HW

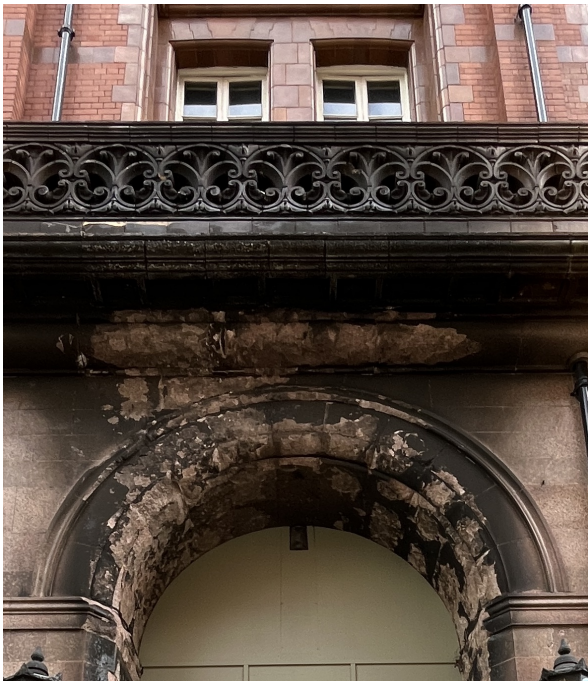
Cosmetic damage to faience terracotta balcony. Cleaning work only.

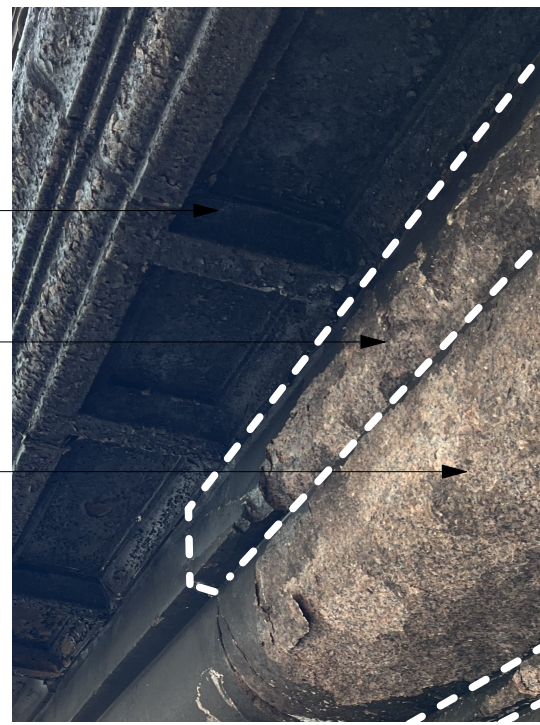
3 Localised Details - Cantilevered Stone  
Scale: 1:10

Curved surface of cantilevered stone redressed to a new smooth line

- Profile the newly redressed face where meets sound adjacent stone/mortar joint.
- Damaged surface to be redressed - nom. 10mm back.
- Stone indents to replace damaged orthogonal details.
- Stone indents to replace damaged faces. Matching stone secured with stainless steel dowels and resin.
- Proprietary ant-slip carborundum insert strips. Adhesive fixed into new grooves.

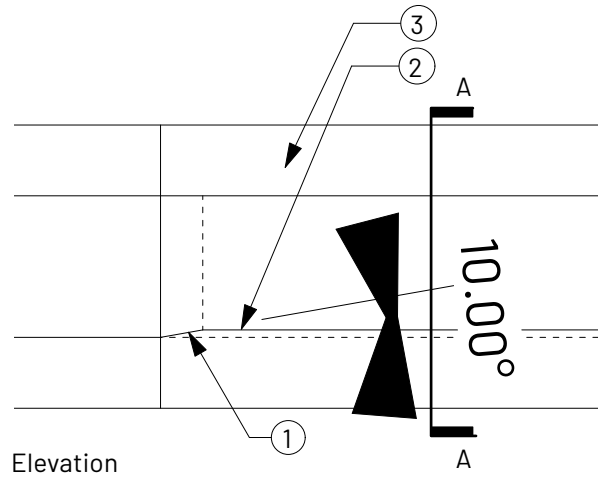
4 Localised Details - Stone Indents  
Scale: 1:10

The upper and lower orthogonal pieces to have localised indents as per the main facade repair work
