# Clough Bank B

Preliminary Bat Roost Appraisal Report

Manchester Airports Group

December 2023

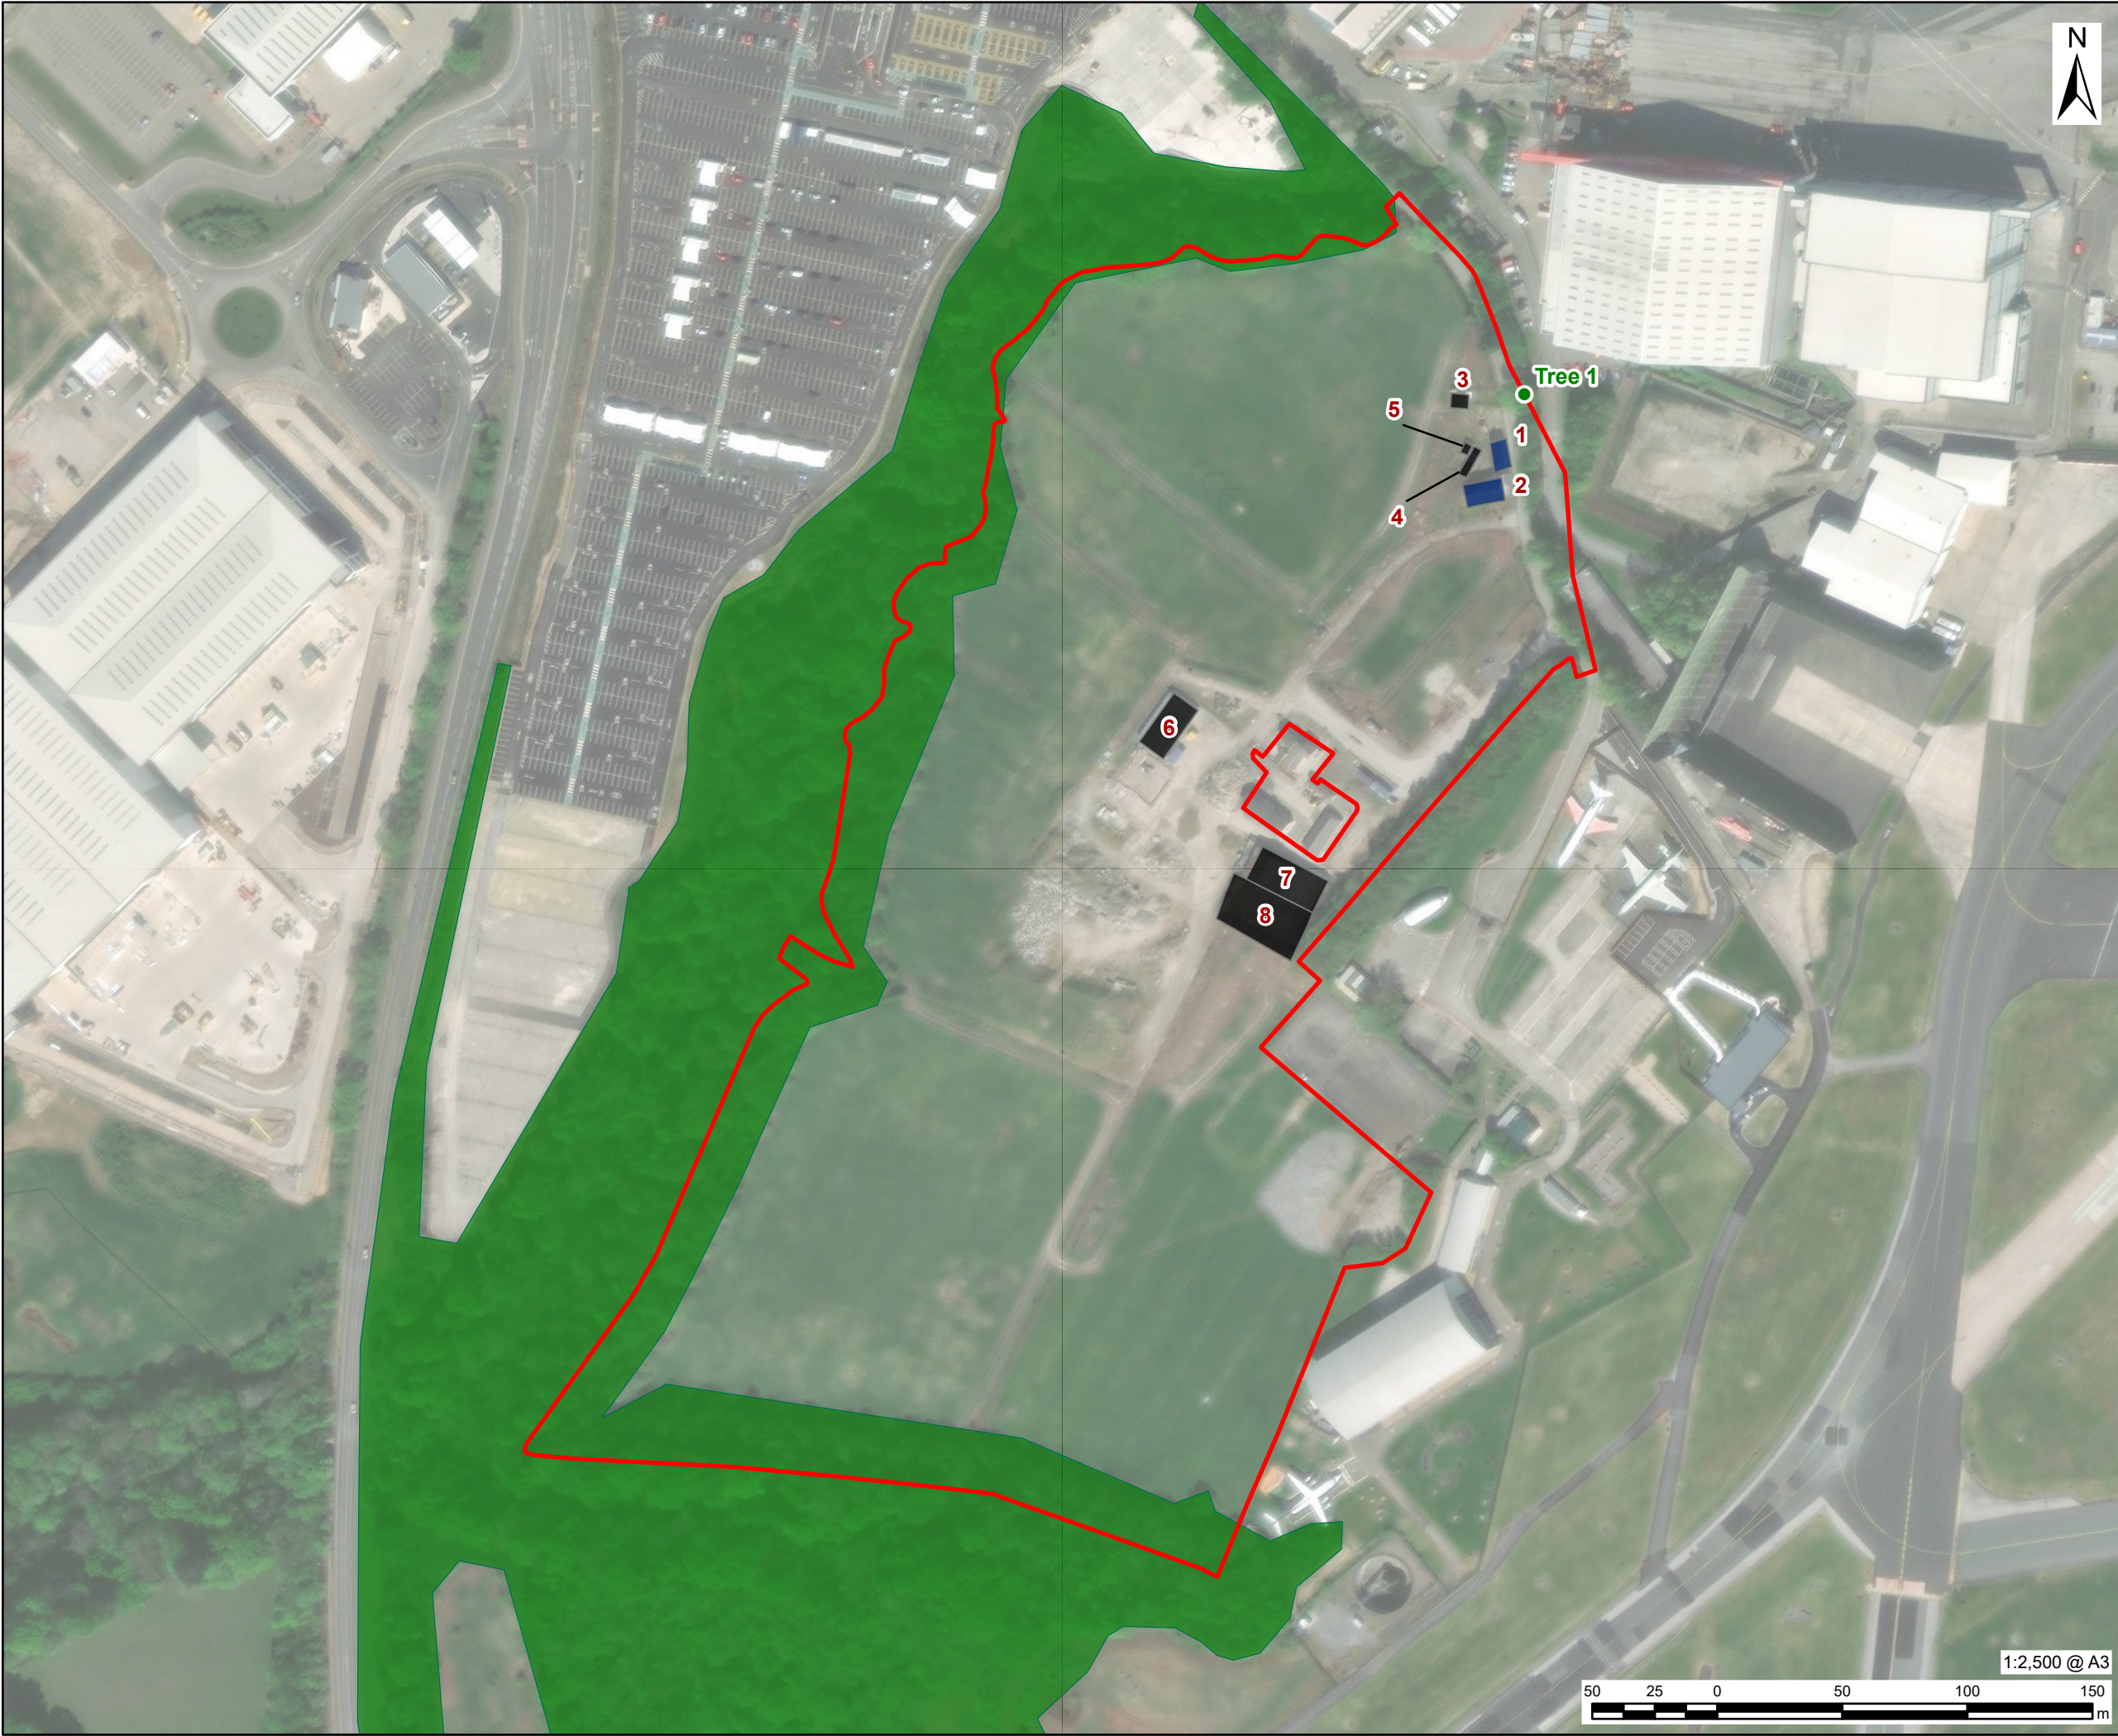
**FIGURE NUMBER**  
Figure 1

**FIGURE TITLE**  
Clough Bank B Preliminary Bat Roost Appraisal

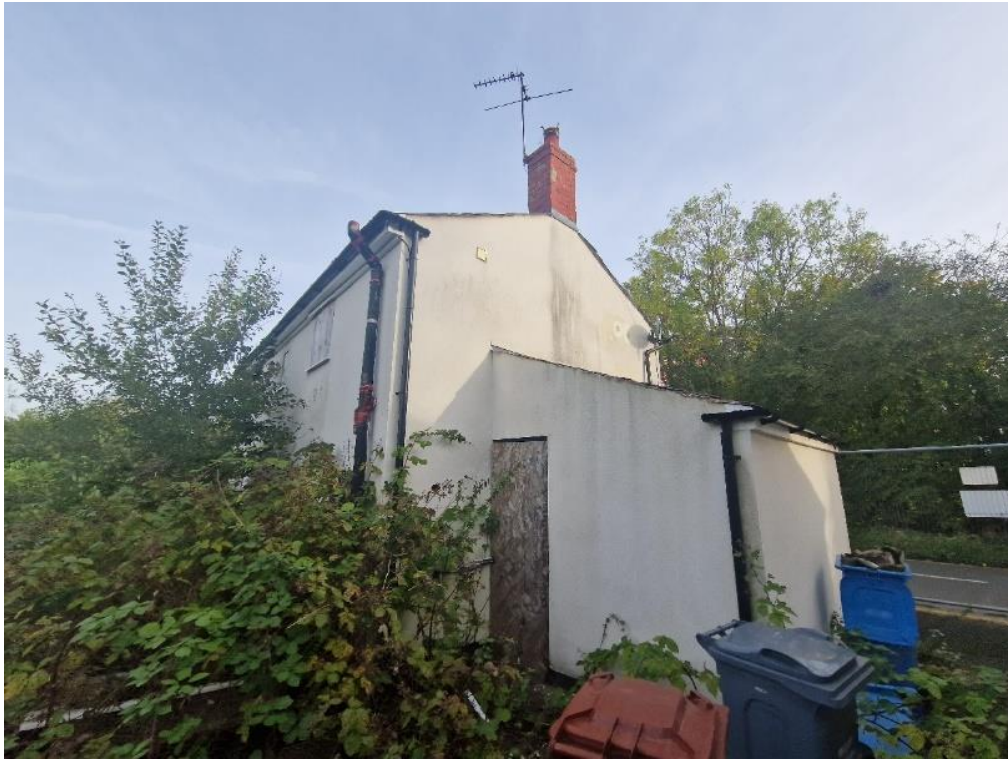
| Building Number | Roost Suitability | Description |
|---|---|---|
| 1 | Confirmed Roost | Vacant residential building with rendered walls, plastic soffit and fascia boards, pitched slate roof in general good state of repair. Some damaged slate tiles and gaps in the soffits which may provide access to the roof void, which, given the building materials, is suitable for a roost of high conservation status, such as a maternity roost. Previously confirmed as a roost during surveys carried out by AECOM. |

| Building 1 =<br>confirmed<br>roost | |

There are two structures (Building 1 and Building 2) within the Site which were categorised as being a confirmed roost. Therefore, Buildings 1 and 2 will require update surveys to confirm the presence of a bat roost, and to confirm the roost characterisation to inform a EPSML. Buildings 3 – 8 were categorised as being Negligible suitability for roosting bats. Therefore, no further survey is required for these buildings, however, an appropriate Precautionary Working Method Statement (PWMS) will be required for their removal given the proximity of known bat roosts at Vicarage Cottages and Cloughbank Farm to ensure that roosting bats are not disturbed.

| Feature | Recommendation | Timing |
|---|---|---|
| Building 1 and 2 | Three separate dusk emergence surveys | Between May and August, Surveys should be a minimum three weeks apart. |

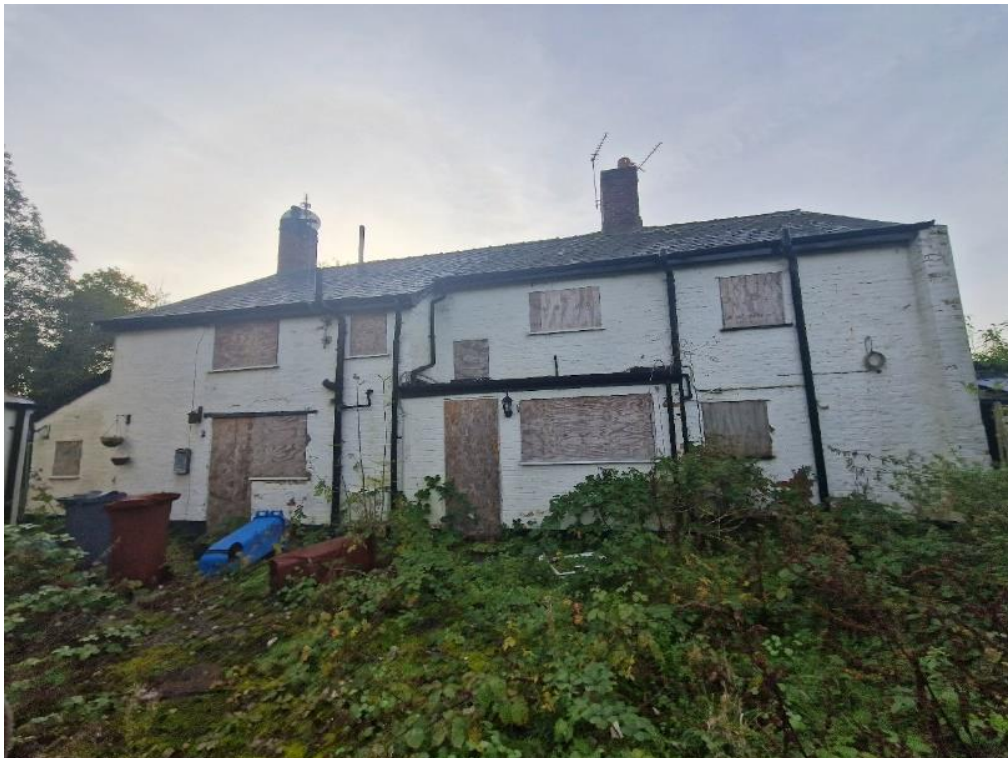
| Building Number | Roost Suitability | Description |
|---|---|---|
| 2 | Confirmed Roost | Vacant farmhouse with brick walls, wooden soffit and fascia boards in poor state of repair. Pitched slate roof in reasonable state of repair, however, multiple broken and loose tiles which may provide access into the roof void, which, given the building materials, is suitable for a roost of high conservation status, such as a maternity roost. Previously confirmed as a roost during surveys carried out by AECOM. |

| Building 2 –<br>confirmed<br>roost | |

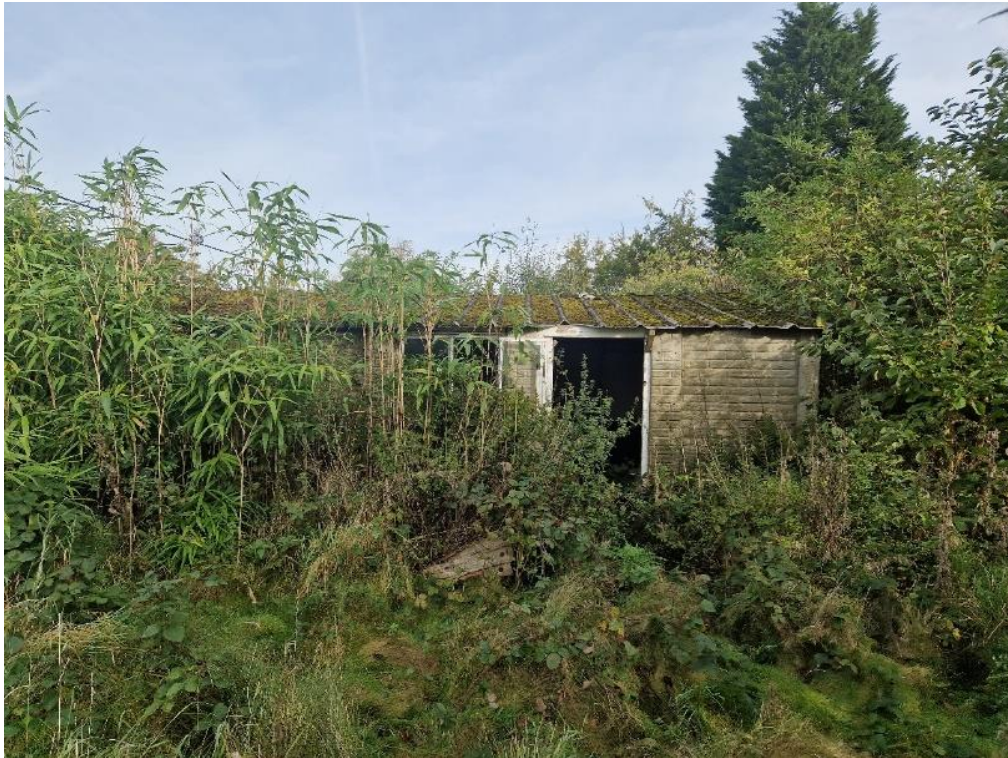
| Building Number | Roost Suitability | Description |
|---|---|---|
| 3 | Negligible | Small derelict garage, with corrugated asbestos roof, single layer prefabricated concrete walls. |

| Building 3 –<br>negligible<br>bat roost<br>suitability | |

| Feature | Recommendation | Timing |
|---|---|---|
| Building 3 – 8 | An appropriate PWMS to be implemented for their removal | Prior to works |

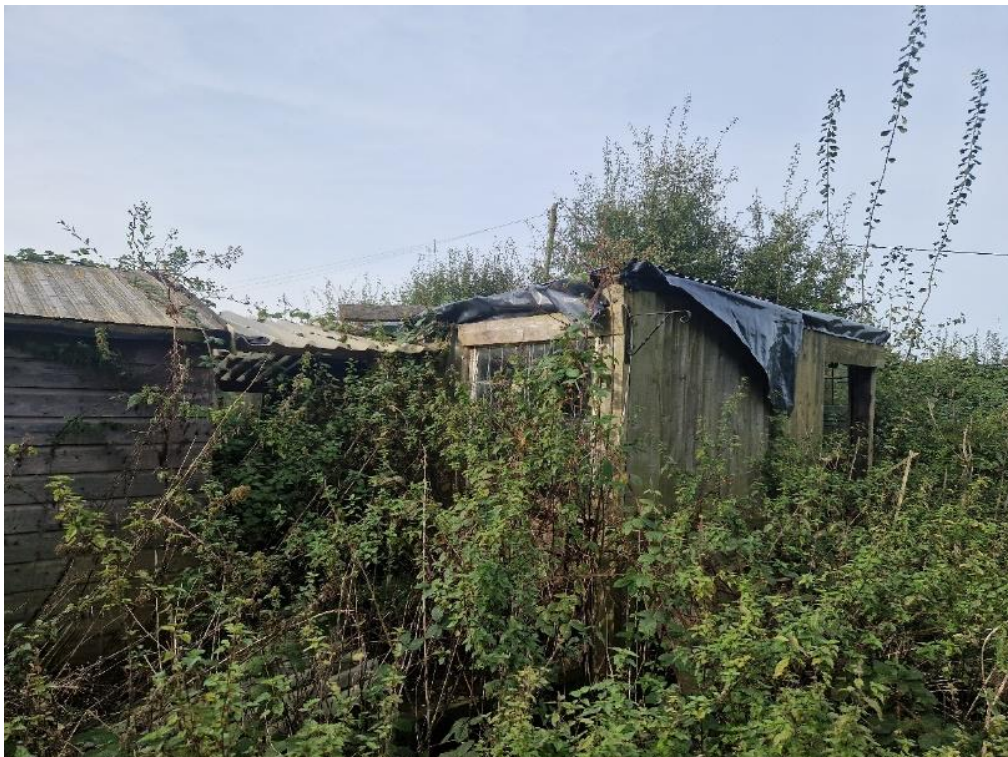
| Building Number | Roost Suitability | Description |
|---|---|---|
| 4 | Negligible | Derelict wooden outbuilding with a lean-to, corrugated metal roof, with wood panels or corrugated plastic walls. |

| Building 4 –<br>negligible<br>bat roost<br>suitability | |

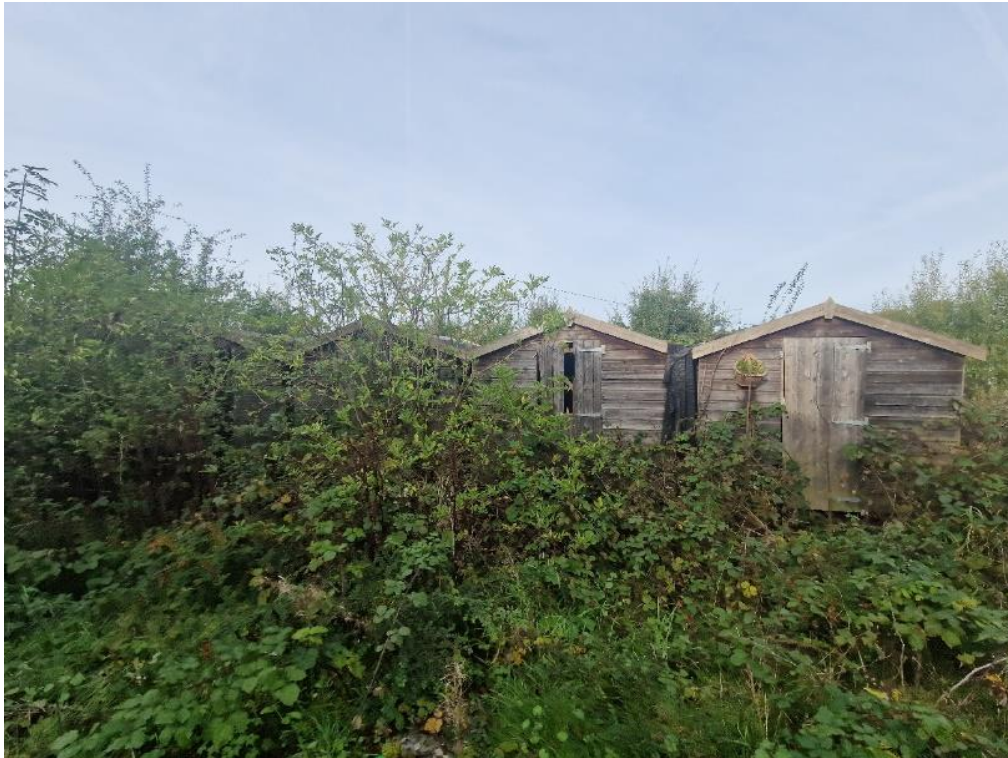
| Building Number | Roost Suitability | Description |
|---|---|---|
| 5 | Negligible | Row of small derelict sheds made of wood panels. |

| Building 5 -<br>negligible<br>bat roost<br>suitability | |

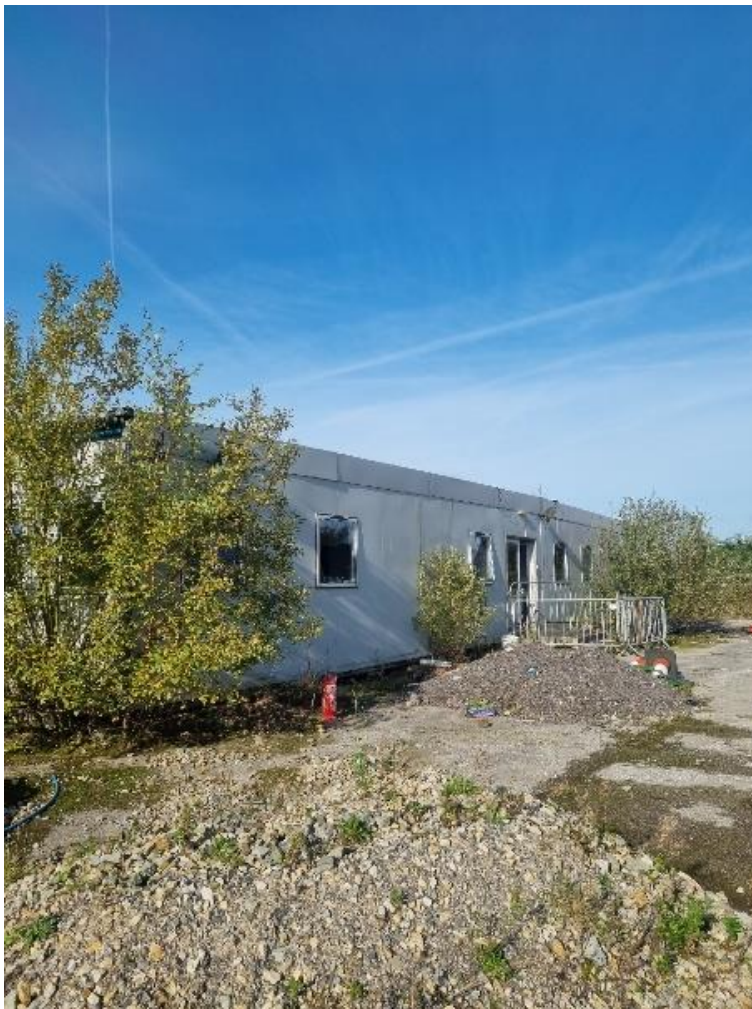
| Building Number | Roost Suitability | Description |
|---|---|---|
| 6 | Negligible | Prefabricated derelict mobile office building. In very poor state of repair, with a highly exposed and damp roof void. |

| Building 6 -<br>negligible<br>bat roost<br>suitability | |

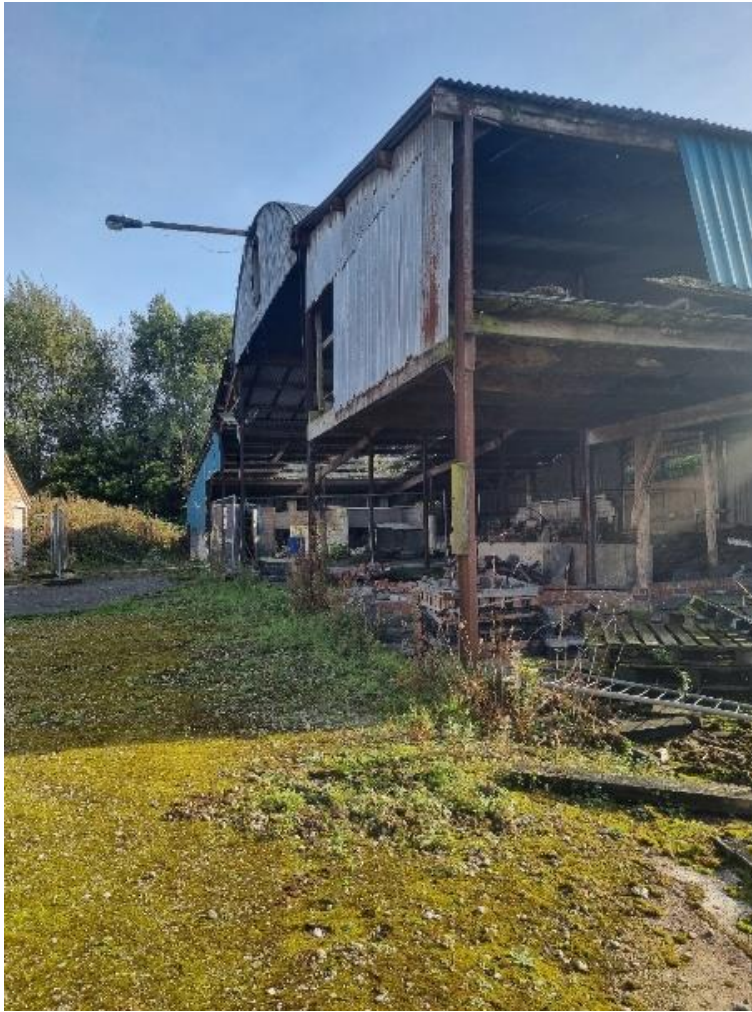
| Building Number | Roost Suitability | Description |
|---|---|---|
| 7 | Negligible | Large derelict corrugated metal barn, in very poor state of repair and largely exposed. Internally, single skin breeze block and brick walls. |

| Building 7 -<br>negligible<br>bat roost<br>suitability | |

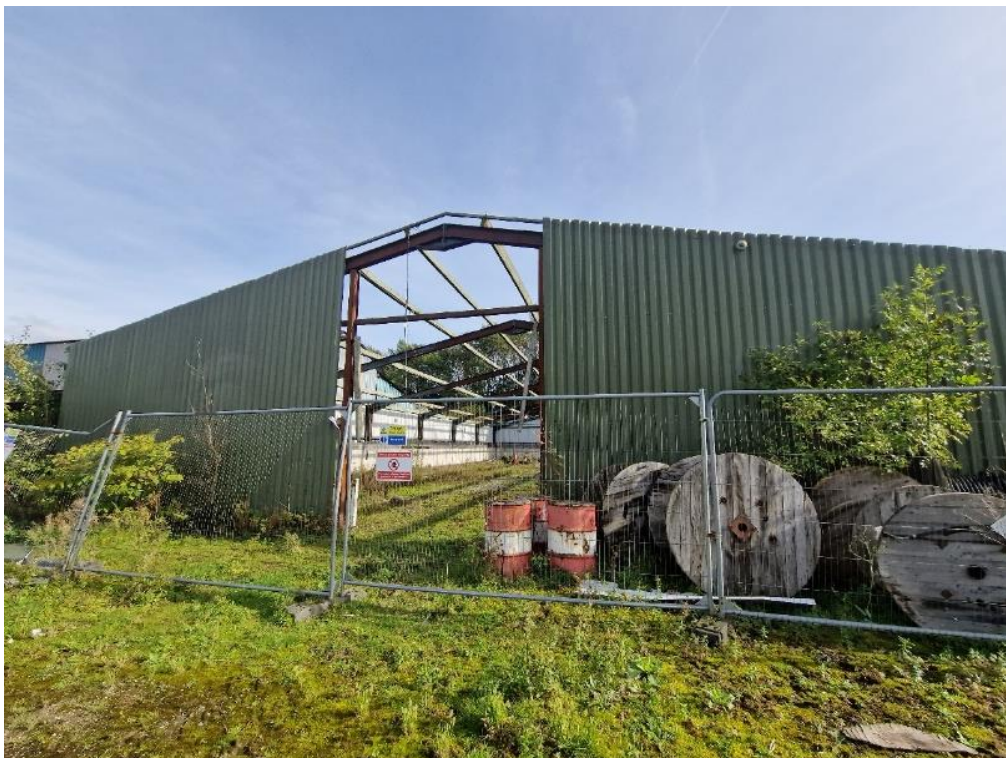
| Building Number | Roost Suitability | Description |
|---|---|---|
| 8 | Negligible | Large derelict metal barn in poor state of repair, mostly collapsed and exposed. Internally, single skin breeze block and brick walls. |

| Building 8 -<br>negligible<br>bat roost<br>suitability | |

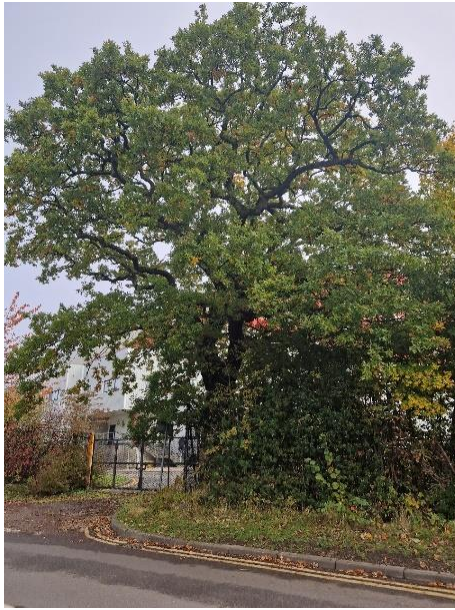
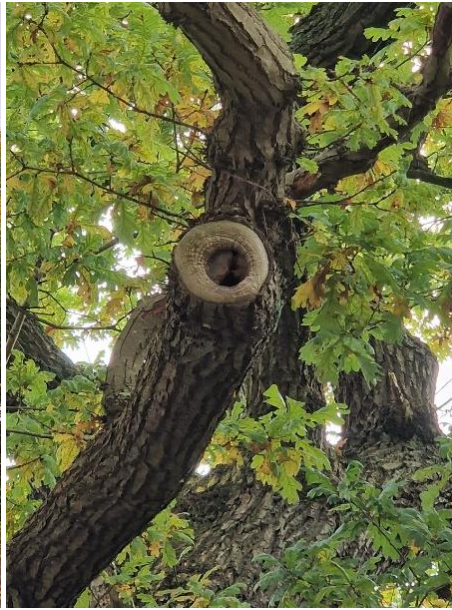
| Tree | Roost Suitability | PRF Categories Present | Description |
|---|---|---|---|
| Tree 1 | PRFs present | PRF-I | Mature oak with branch cavity and broken branches. |

| Tree 1 –<br>PRF-I |

Tree 1 was identified as having PRF-I present, should this tree be removed it will need to be carried out under an ecological watching brief and soft felled in sections.

| Feature | Recommendation | Timing |
|---|---|---|
| Tree 1 | Soft felled/watching brief | Prior/during works |

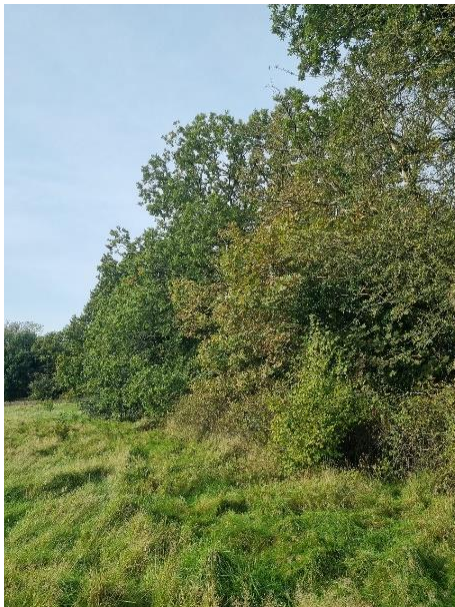
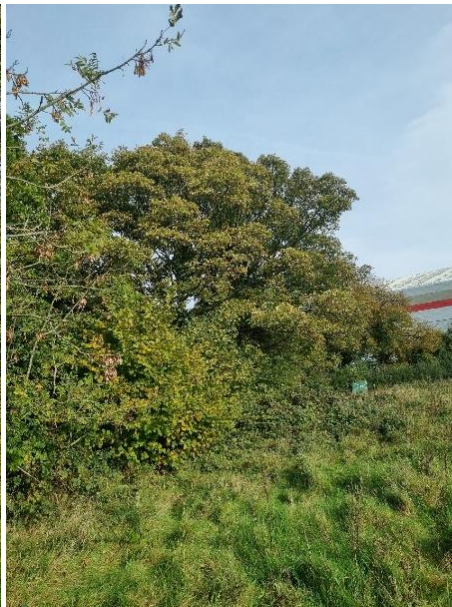
| Tree | Roost Suitability | PRF Categories Present | Description |
|---|---|---|---|
| Woodland 1 | PRFs present | Not assessed | The woodland has multiple mature trees which are likely to provide suitable roosting features for bats, though these are generally more centralised in the woodland. The area of woodland within the Site appeared to be less mature, though still may provide trees with suitable roosting features for bats. |

| Woodland 1 |

Woodland 1 was identified as having PRFs present, but, given the current design is not expected to impact trees within the woodland, no further survey is recommended. However, if works impacting this woodland are required, a GLTA for trees to be impacted will be required to inform the requirement for further survey and appropriate mitigation.

| Feature | Recommendation | Timing |
|---|---|---|
| Woodland 1 | GLTA to trees which may be impacted as part of the works | Prior to works. |
