## **Blackwin Street, Manchester**

### **Remedial Strategy Report**

For: John Southworth Builders Ltd

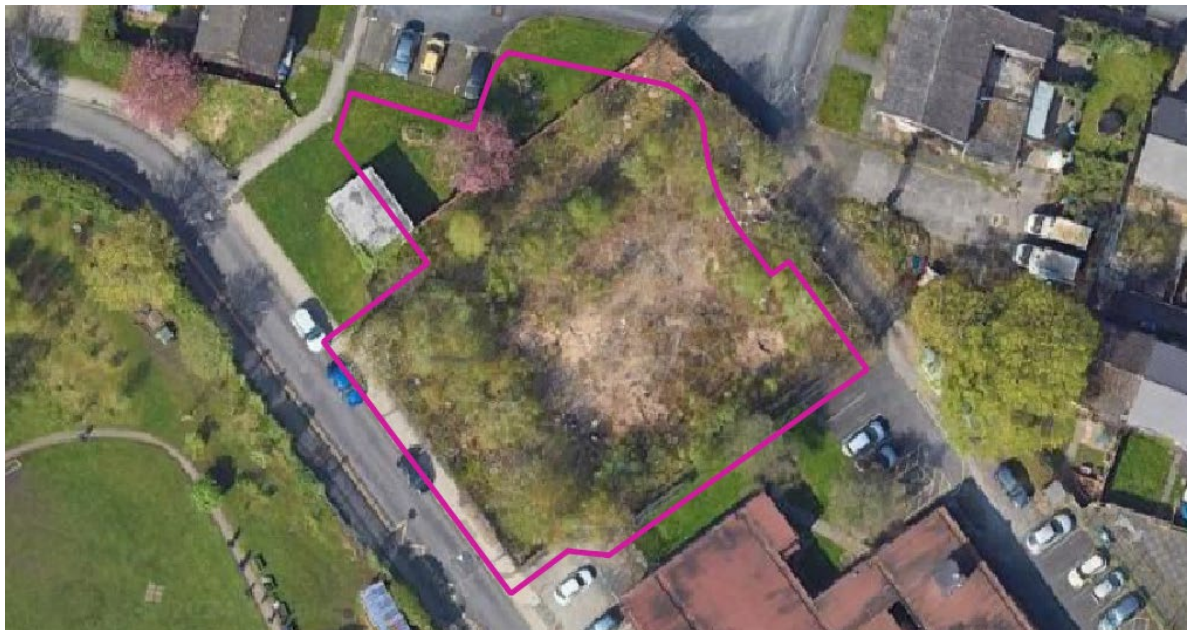
Figure 1: Aerial image of the site dated April 2023.

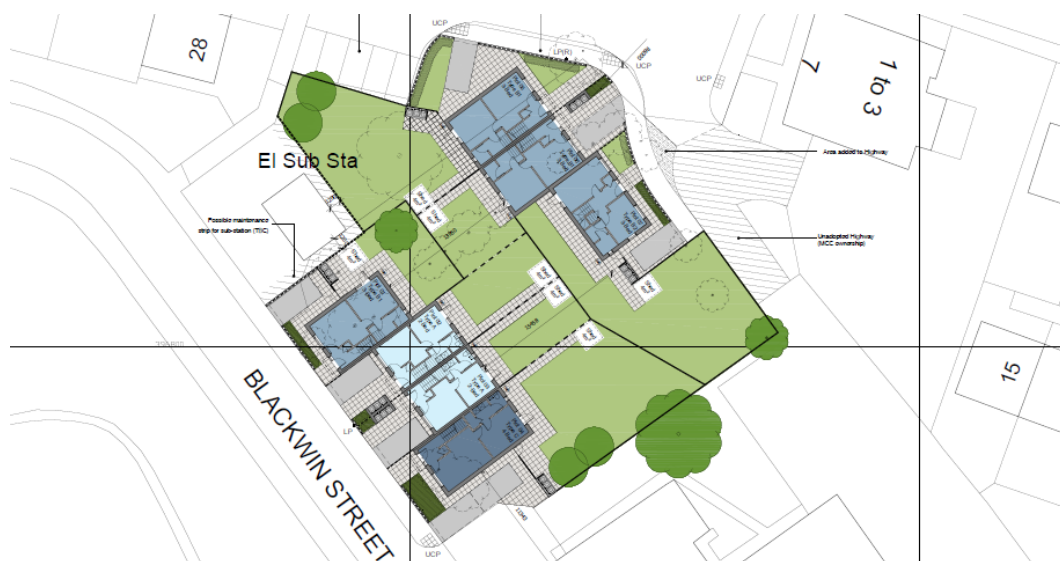
Figure 2: Extract of the proposed development plan (taken from Triangle Architects, Proposed Site Plan FINAL, SK11, dated October 2021).

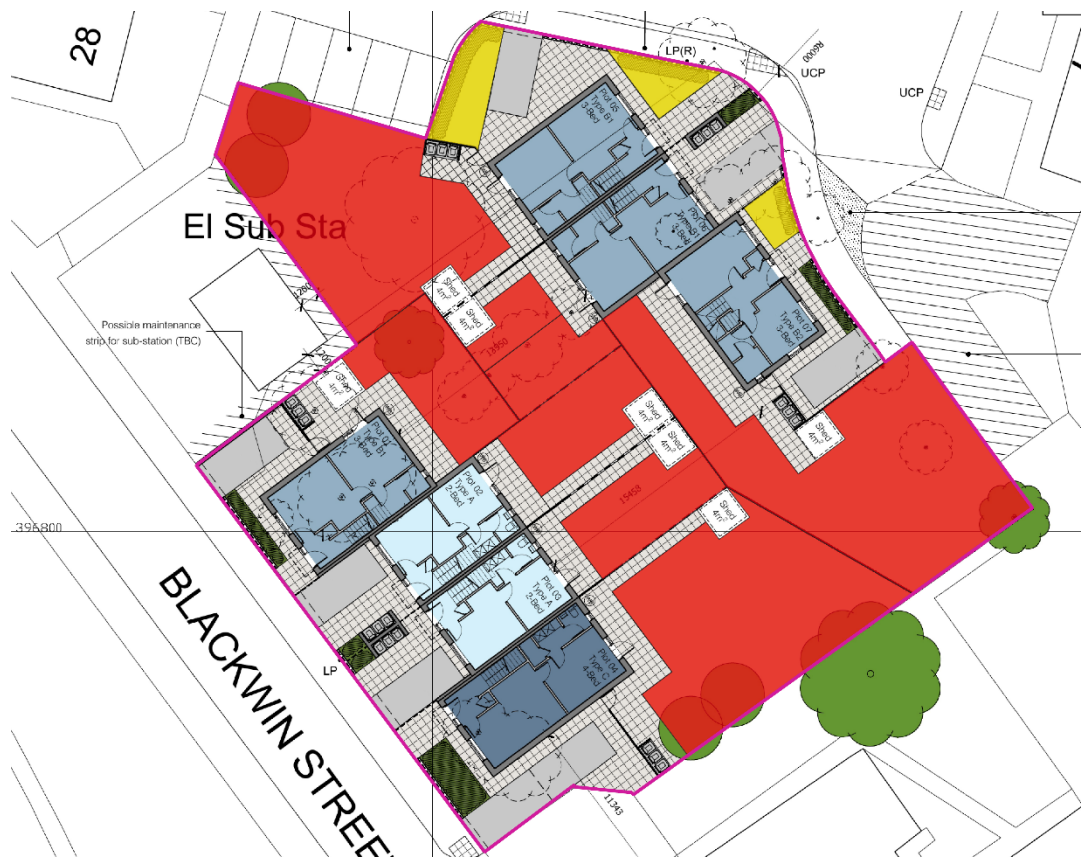
The following Landscaping Plan details the proposed private rear gardens (red) and POS soft landscaping (Public Open Space / POS<sub>resi</sub> – yellow).

Figure 3: Extract of the landscape plan of the site (SI-02 Landscaping Plan, Feb 2024).

**Red = private rear gardens. Yellow = soft landscaping / public open space.**
