Job Name  
**Neptune Mill**  
**Manchester, M1 2WQ**

Drawing Title  
**Proposed Typical Details - Sheet 1**

Drg No **2909-HTS-XX-XX-DR-S-2300**

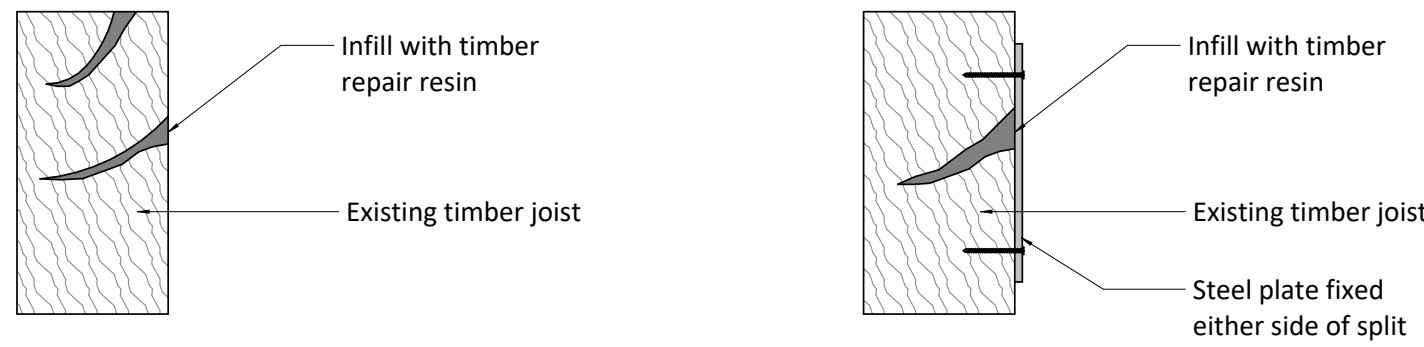
### Typical Timber Joist Repair Details

Typical Repair Detail to Splits

Typical Repair large / Continuous Splits in Beams
