# 68-70 HIGH STREET, MANCHESTER

## Bird and Bat Box Report

*February 2024*

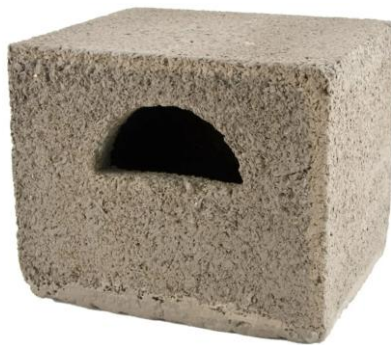
Figure 2.1.1 WoodStone Build-in Open Nest Box

2.1.1. The development will result in the unavoidable loss of potential breeding bird habitat for black redstart. To compensate for the loss, suitable nesting provisions should be installed on the building post-renovation. It is recommended three WoodStone Build-in Open Nest Boxes are installed within external walls to provide nesting cavities (Figure 2.1.1).

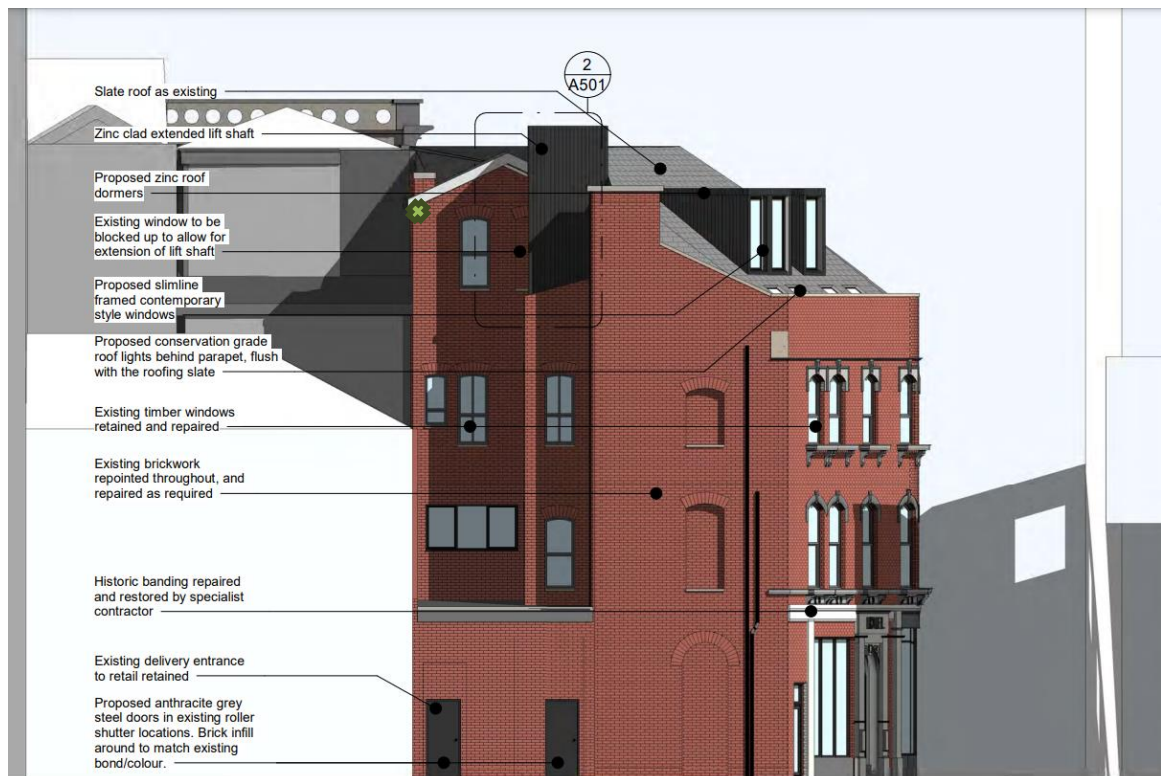
Figure 2.1.2 Location of the bat box on the development overlay on the southeastern elevation site plans (SEED Architects, 2023)

- 2.2.2. A European Protected Species Licence (EPSL) is being sought for the site to suitably discharge Condition 17 of the Decision Notice and lawfully destroy the roost to facilitate development. To compensate for the loss of the roost, one crevice bat box will be installed on the southeastern aspect of the building. Specifications such as the Greenwoods Single Crevice Bat Box (or similar) are recommended.

- 2.2.3. The bat box will be installed on the exterior of the building at close as possible to the existing roost (Figure 2.2.1).

- 2.2.4. As shown on Figure 2.1.1, there will be no external lighting proposed on the southwestern elevation of the building and the bat box will not be illuminated, thus preventing instances of disturbance to roosting bats. As the bat box is to be installed as close as possible to the existing roost and there are no other environmental changes (i.e. lighting), there is not anticipated to be a net loss in suitable roosting opportunities for urban dwelling bats such as pipistrelle species. Consultation with GMEU assured that this is sufficient to discharge Condition 18.

- 2.2.5. Care should be taken to make sure that the box is not angled in such a manner to allow rain to enter it. The box

will also be installed over 4 m from the ground, minimising the risk of predation by domestic cats and other species that may limit the value of the roosting provision for bats.

- 3.1.3. One crevice bat box will be installed to compensate for the loss of one non-breeding day roost for common pipistrelle on the southeastern aspect of the building. Additionally, no lighting is to be installed on this aspect, preventing disturbance to roosting bats and allowing for like-for-like roosting provision as the roost exists currently.
