**WELCOMB STREET, OPENSHAW,  
MANCHESTER**

**PRELIMINARY BAT ROOST  
ASSESSMENT**

Report No: RT-MME-157730-04

Date: June 2022

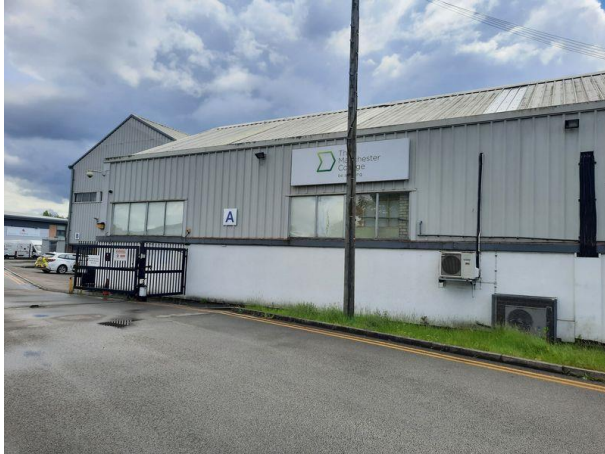
**Plate 1: B1 Northern Elevation**

Building B1 was of modern construction with a metal framework clad with rendered concrete and brick at the base and corrugated metal sheet walls above. The roof was also constructed of pitched corrugated metal with some translucent sections to allow light through. The rear of the building had a brick flat roofed extension. This side had a number of gaps in the walls where pipes had been removed and some appeared to lead into a wall cavity. The brick extension had a barge board along it that had a gap below. This was inspected and no evidence of bat ingress was recorded but it was found to lead into a cavity along the wall top.

Building B1 has been identified as having low potential to support roosting bats. Bat Surveys: Good Practice Guidelines, published by the Bat Conservation Trust (Collins, 2016), recommends for structures with low bat roosting potential that at least one survey (consisting of either a dusk emergence survey or a dawn re-entry survey) be undertaken during the peak season for emergence/re-entry surveys (May to August) to determine the presence/absence of roosting bats within the structure. Should this survey confirm the presence of roosting bats, it will be necessary to undertake additional surveys in order to inform a Natural England licence application. In addition, should the survey identify the presence of significant levels of bat activity at the site, it may be necessary to undertake further survey visits to comprehensively assess the value of the site to bats.

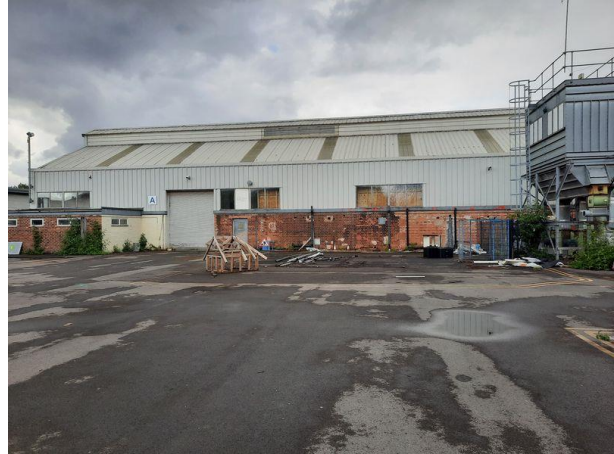
**Plate 2: B1 Southern Elevation**

Building B1 was considered to have low bat roost potential with only a few potential roost features provided by the holes in the brickwork and under a bargeboard on the brick extension to the south of the building.

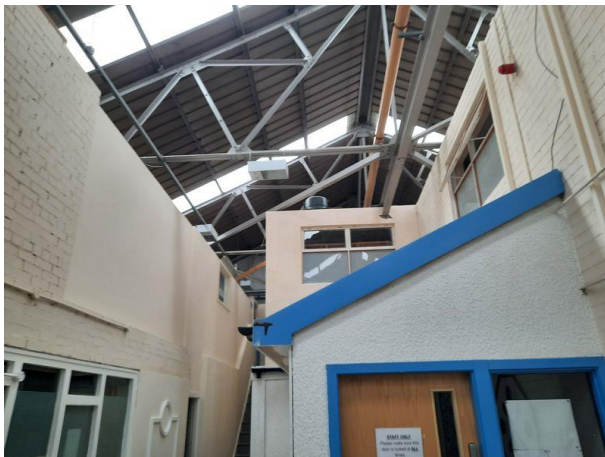
**Plate 3: Building B1 Internal Area**

The interior of B1 was open to the roof with the space divided into a series of rooms by internal breeze block walls on two levels, the upper level being a mezzanine floor. The internal rooms did not provide any dark loft spaces or other potential roost features. Some had no ceilings and those with ceilings were well sealed. The entire interior was well lit by the translucent panels in the roof which was unlined.

No evidence of roosting bats such as droppings, staining or scratch marks were recorded in the internal areas.

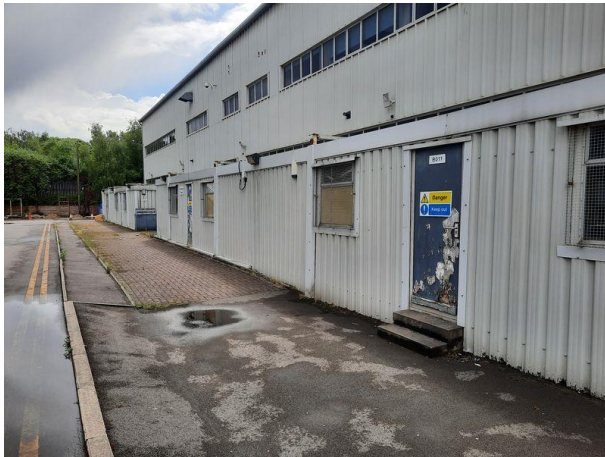
Plate 5: Building B2 Eastern Elevation

This was a two-storey, long, corrugated metal building on a low brick base. Metal framed windows ran along the eastern elevation and the windows and doors were all well sealed. To the east side of the building a line of prefabricated cabins was present. The cabins were also constructed of corrugated metal and had metal framed windows and wooden doors. The southernmost cabin had an open door which led into a single room. This had some damp boarding on the ceiling but was not considered to be suitable for roosting bats. The other cabins were closed and well sealed with no potential roost features recorded.

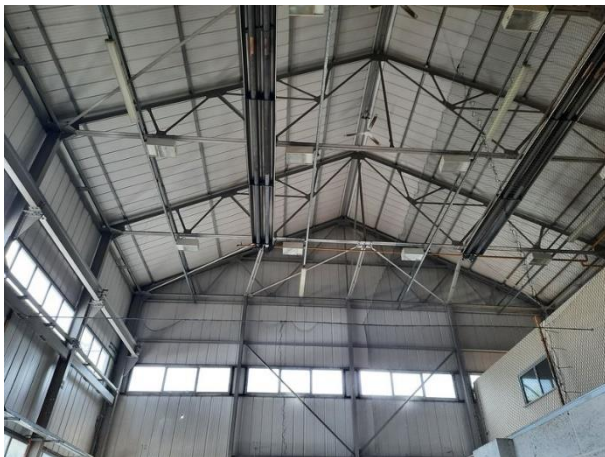
Plate 7: Building B2 Main Section Roof

In the main section, some classroom areas had suspended ceilings but the space above these was very light due to translucent panels in the roof. No evidence of roosting bats such as droppings, staining or scratchmarks were recorded in the internal areas and Building B2 was considered to have negligible bat roost potential.

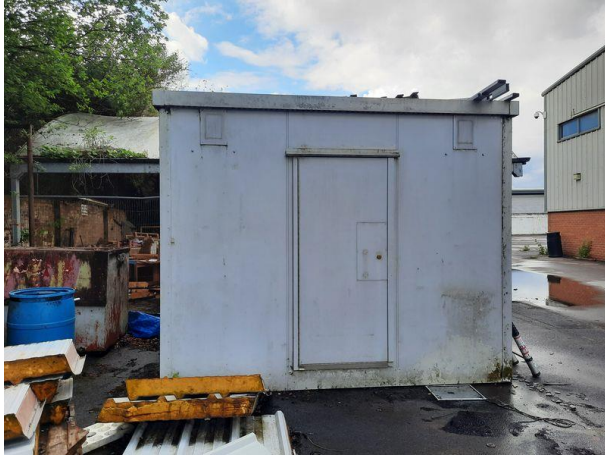
Plate 9: Building B3

This was a small metal portacabin with a flat roof. No potential roost features were present and it was considered to have negligible bat roost potential. No internal access was available, but this was not considered to be a constraint as there were no potential access points to the interior for bats.

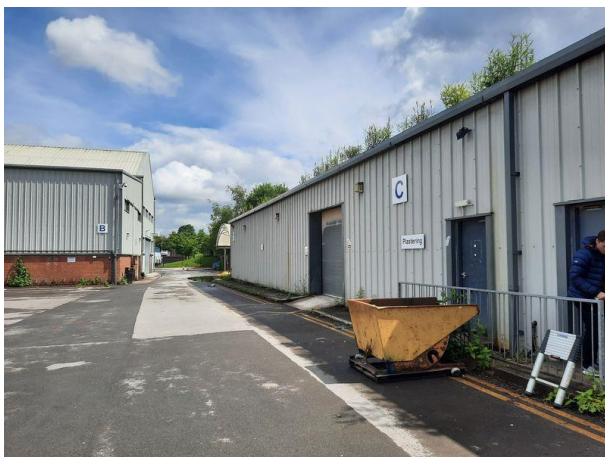
Plate 10: Building B4 Northern Elevation

Building B4 was a long, single storey corrugated metal building on a metal framework. It had a roller door to the north and translucent panels in the roof. No potential roost features were recorded externally and no access points were noted.

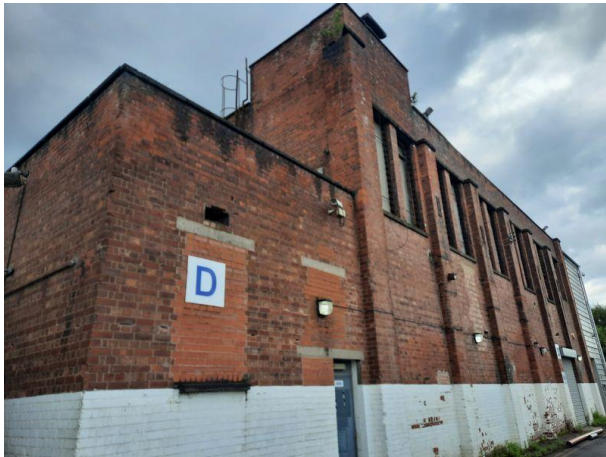
**Plate 12: Building B5 Northern Elevation**

Building B5 was of an older construction than the other buildings on site. It had tall brick walls and a flat concrete slab roof. A line of tall, wooden framed windows ran along the northern elevation. The brickwork and window frames were in good condition, but gaps were noted at the top of the walls below the concrete roof edges. Small gaps in the brickwork were also noted on the eastern elevation.

Building B5, the older brick structure to the south of the site was considered to hold high bat roost potential due to a number of potential roost features identified both internally and externally. In particular the boarded roof which could support bats between the roofing and boarding.

Building B5 has been identified as having high potential to support roosting bats. Bat Surveys: Good Practice Guidelines published by the Bat Conservation Trust (Collins, 2016) recommends that for structures with high bat roosting potential at least three dusk emergence and/or dawn re-entry surveys be undertaken during the bat emergence/re-entry survey season to determine the presence/absence of roosting bats within the structure. The bat emergence/re-entry survey season extends from May to September. At least two of the surveys should be undertaken during the peak season for emergence/re-entry surveys between May and August and one of the three surveys should be a dawn re-entry survey. If a roost is discovered during these surveys, a Natural England licence application may be required.

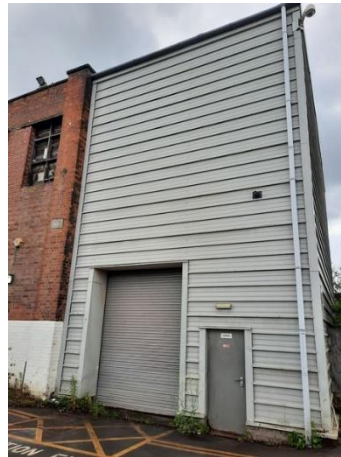
**Plate 13: Building B5 Extension on Western Elevation**

On the western side, a modern, corrugated metal extension was present. This was tight to the wall and did not offer any potential roost features. No access was possible to the southern elevation as it was tight to the boundary wall. A line of scrub ran along this side of the building offering a potential commuting route for bats.

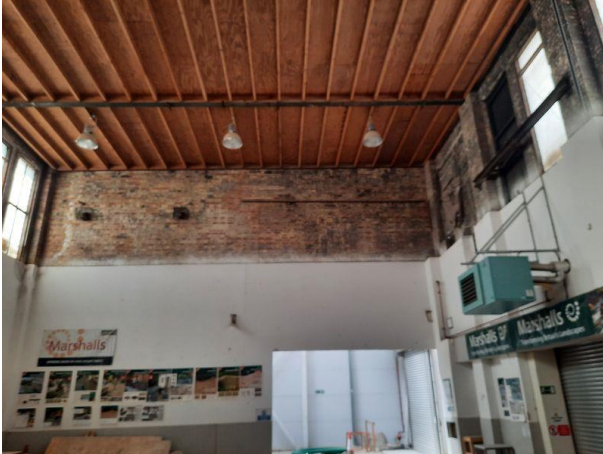
**Plate 14: Building B5 Interior with Boarded Ceiling**

Internally, building B5 had a tall central section that had a boarded ceiling. It was not possible to inspect the area between the ceiling and the roof and the potential exists for a roost feature to be present in this area. The main room was light from the windows to the north, but darker rooms were present inside constructed of plasterboard and brick. An internal area high up to the east of the building could not be accessed and could potentially provide a dark void within the building.

Given the presence of potential roost features at the wall tops and between the roof and boarded ceiling, plus the presence of dark internal areas that could not be fully inspected, Building B5 was considered to have High bat roost potential.

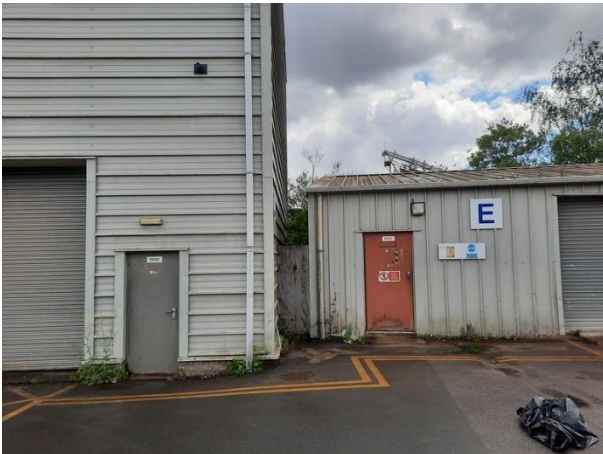
**Plate 16: Building B6 Eastern Elevation (to left of photograph)**

Buildings B6, B7 and B8 were all of similar construction. These were single storey, modern corrugated metal buildings with a metal framework and metal doors. There were translucent panels within the corrugated roofs to provide interior light. External areas were well sealed and no potential roost features were recorded.

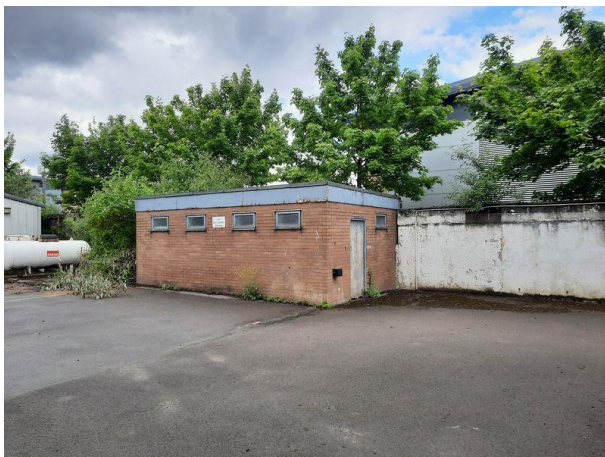
Plate 20: Building B9

This was a small brick toilet block with a concrete roof and wooden framed door and small windows. The roof was flat and felted with a wooden barge board running around the wall top. This was inspected and found to be tight to the wall. The windows and doors were all well sealed and no potential roost features or access points were recorded. No internal access to this building was possible but given the lack of access points, this was not considered a constraint. This building had negligible bat roost potential.
