# Overview of Findings

JURBY AVENUE,  
MANCHESTER, M9 6NG

#### **Con29m Non-residential Coal Mining Report**

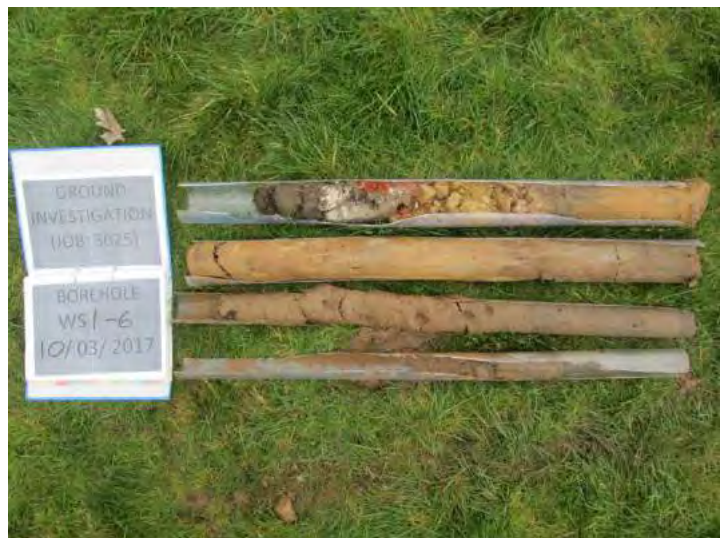
| 2.10 | | 2.70 | Loose orangish-brown slightly clayey silty fine SAND (TILL). | | | | | | | | |
| 2.70 | | 4.00 | Soft to firm brown silty sandy CLAY. Rare fine gravel of mixed lithology (TILL). | | | | | | | | |
| Notes. | | | Borehole location scanned by GPR and set-out by SEP Ltd prior to attending site. | | | | | | | | |

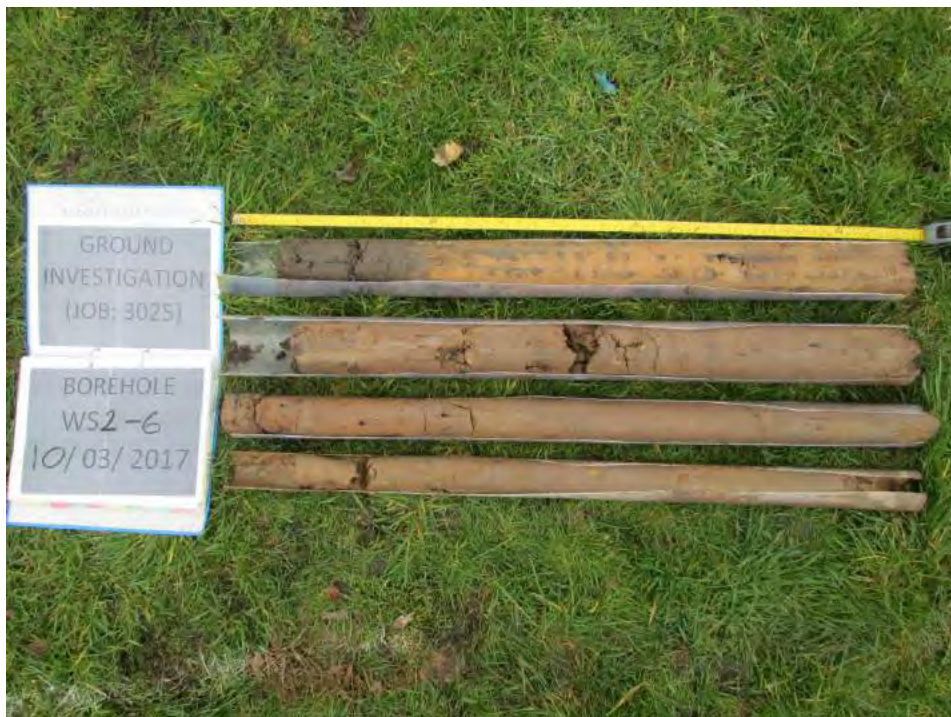
| 3.65 | 4.00 | Medium dense orange-brown silty fine SAND (TILL). | | | | | |
| Notes. | | Borehole location scanned by GPR and set-out by SEP Ltd prior to attending site. | | | | | |

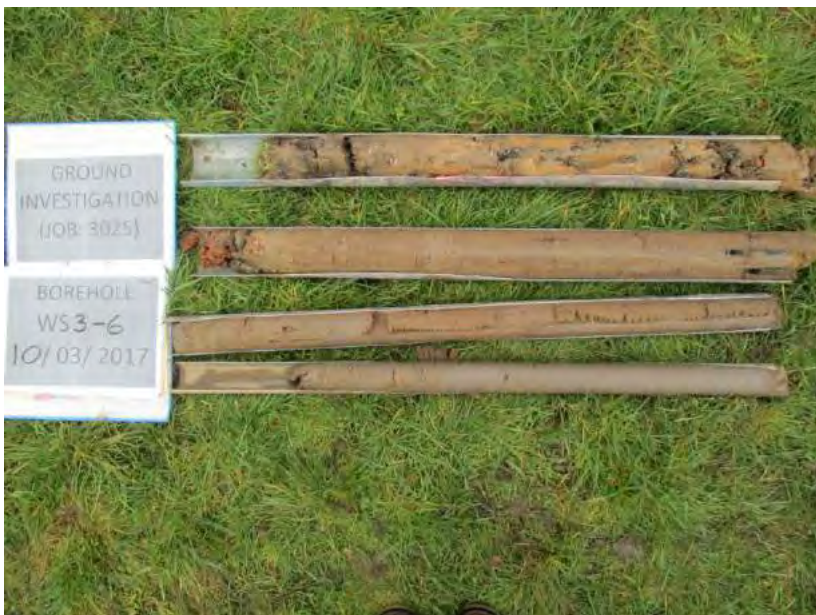
| 2.10 | 4.00 | Firm orangish-brown silty slightly sandy CLAY. Rare fine gravel of coal and sandstone (TILL). | | | | | |
| Notes. | | Borehole location scanned by GPR and set-out by SEP Ltd prior to attending site. | | | | | |

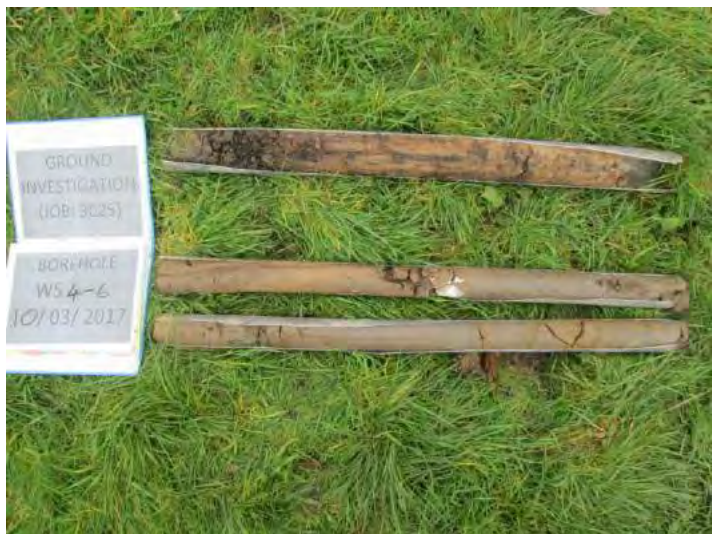
| 3.80 | 4.00 | Firm to stiff brown silty slightly sandy slightly gravelly CLAY. Gravel is subangular to subrounded fine to medium of mixed natural lithology (TILL). | | | | | |
| Notes. | | Borehole location scanned by GPR and set-out by SEP Ltd prior to attending site. | | | | | |

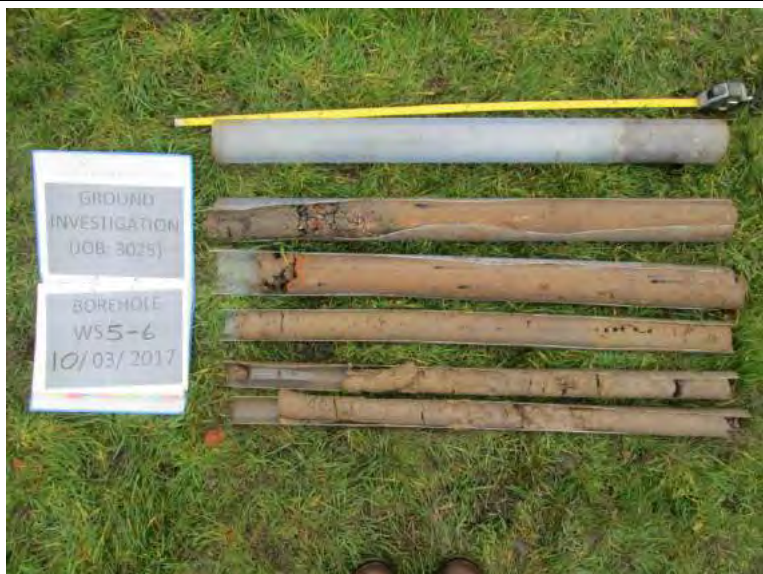
| 2.70 | 5.00 | Loose orangish-brown silty fine SAND with occasional soft clay laminations (TILL). | | | | | |
| Notes. | | Borehole location scanned by GPR and set-out by SEP Ltd prior to attending site. | | | | | |
