Project  
UNIVERSITY OF MANCHESTER  
RUTHERFORD BUILDING

Drawing  
MECHANICAL & ELECTRICAL  
SERVICES STRIP OUT DRAWING  
SECOND FLOOR

| Drawing Number<br>UOMRB-CAD-XX-02-DR-ME-10002 | Revision<br>P01 |

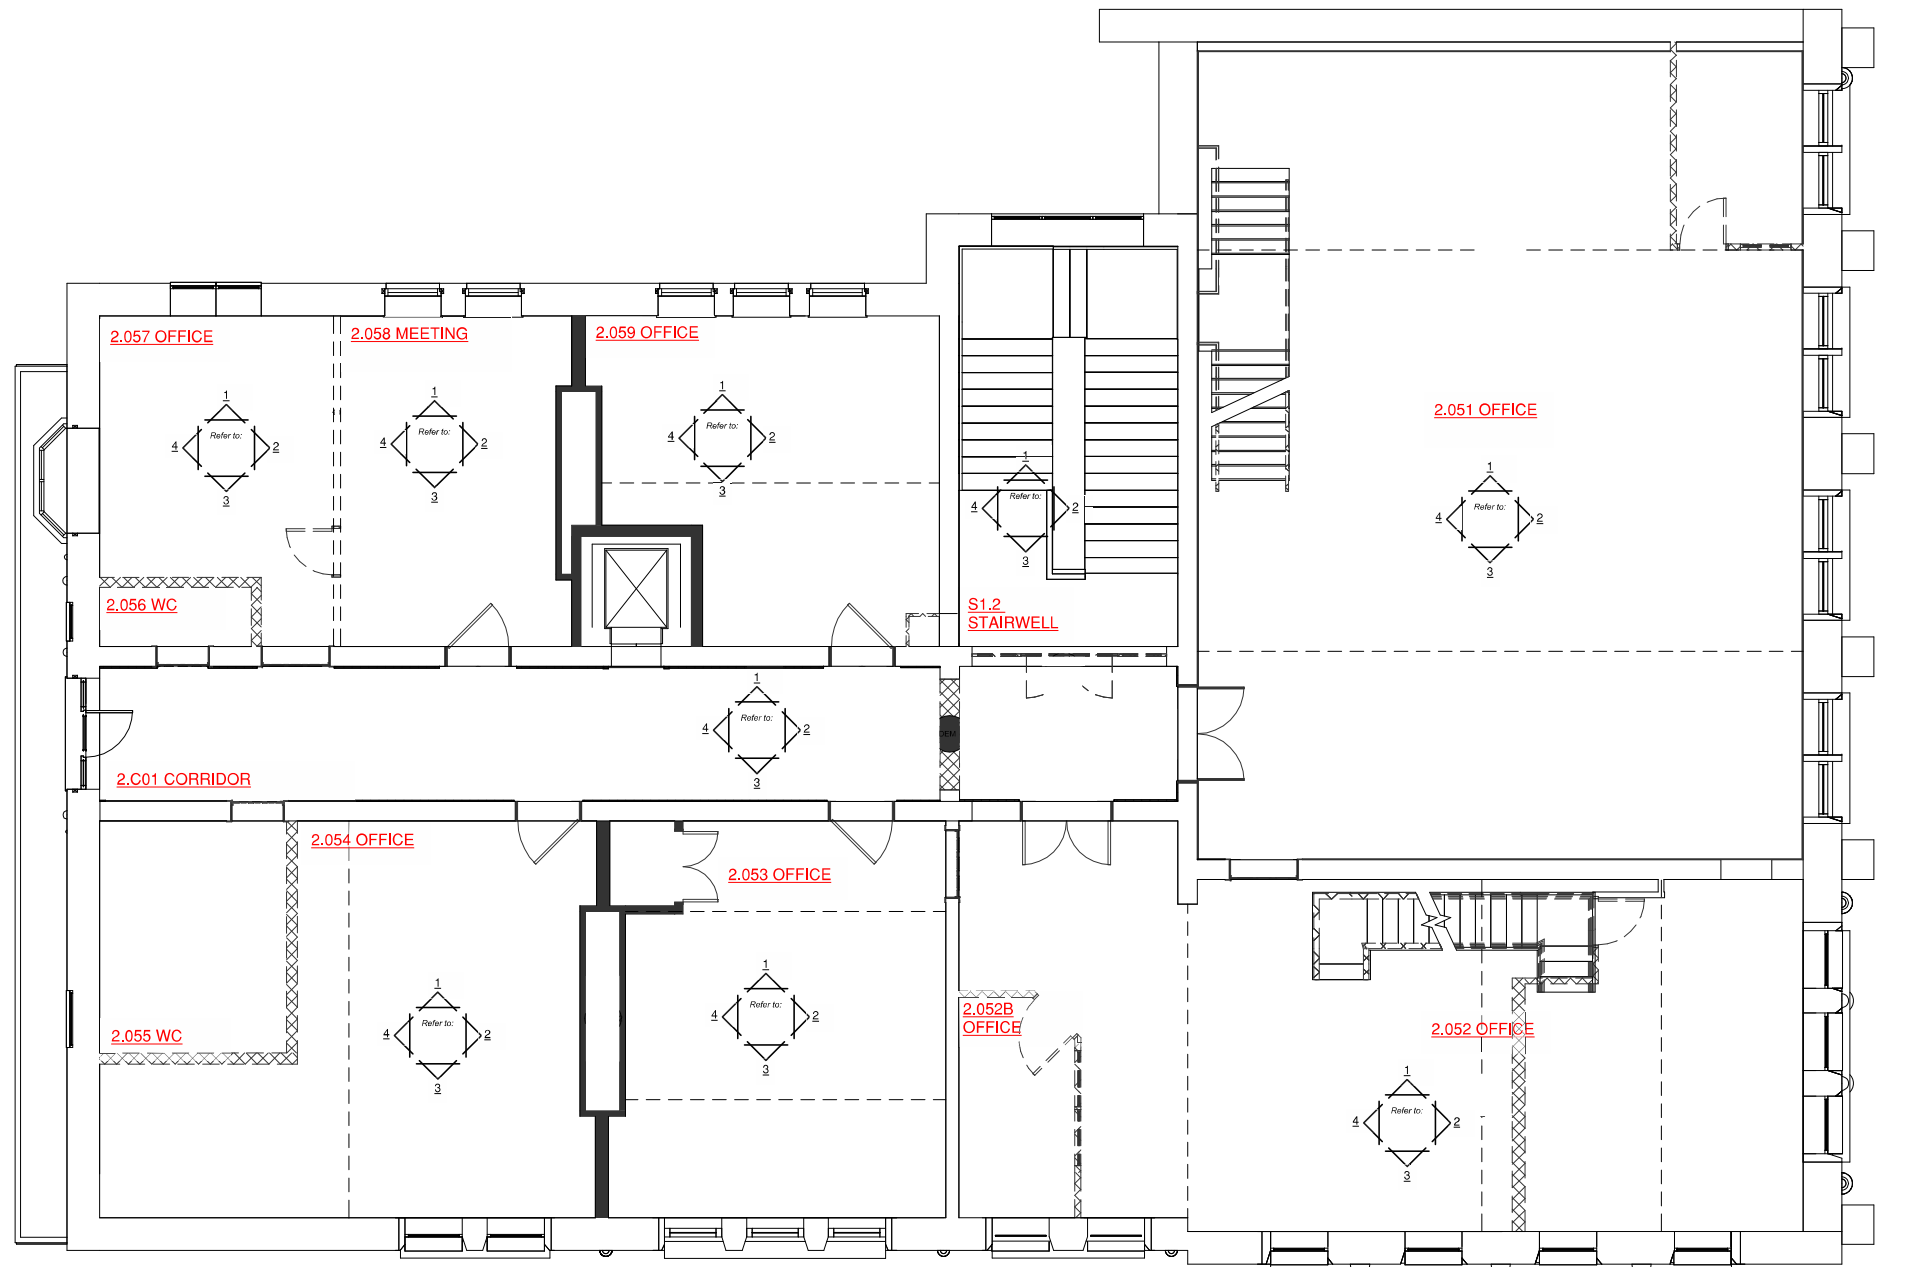
STRIP OUT SCHEDULE - ROOM 2.051 (OFFICE)

| WALL REFERENCE | DESCRIPTION | PHOTO |
|---|---|---|
| - | CEILING:<br>Existing lights and associated containment and fixings carefully stripped out and removed.<br>Existing smoke detection and associated cabling and clips carefully stripped out and removed | |
| 1 | Existing surface mounted trunking and fixings carefully stripped out and removed<br>Existing emergency lighting bulkhead fitting and associated conduit carefully stripped out and removed<br>Existing Fire Alarm sounder and associated cabling and fixing carefully stripped out and removed<br>Existing heating pipework carefully stripped out and removed (mezz level) | |
| 2 | Existing surface mounted trunking and fixings carefully stripped out and removed<br>Existing surface mounted conduit carefully stripped out and removed<br>Existing FA sounder and associated cabling and clips carefully stripped out and removed (mezz)<br>Existing radiators and associated pipework, brackets and fixings carefully stripped out and removed<br>Existing heating pipework carefully stripped out and removed | |
| 3 | Existing surface mounted trunking and fixings carefully stripped out and removed<br>Existing emergency lighting bulkhead fitting and associated conduit carefully stripped out and removed<br>Existing radiators and associated pipework, brackets and fixings carefully stripped out and removed<br>Existing heating pipework carefully stripped out and removed | |
| 4 | Existing surface mounted trunking and fixings carefully stripped out and removed<br>Existing emergency lighting bulkhead fitting and associated conduit carefully stripped out and removed<br>Existing radiators and associated pipework, brackets and fixings carefully stripped out and removed (mezz)<br>Existing fused spurs carefully stripped out and removed<br>Existing conduit, sensors, sockets and data outlets carefully stripped out and removed<br>Existing WiFi booster carefully stripped out and removed | |
