## Asbestos in Soils Management Plan

Crabtree Lane, Manchester  
Former Walkers Site  
Crabtree Lane  
Manchester  
M11 4GU

February 2024

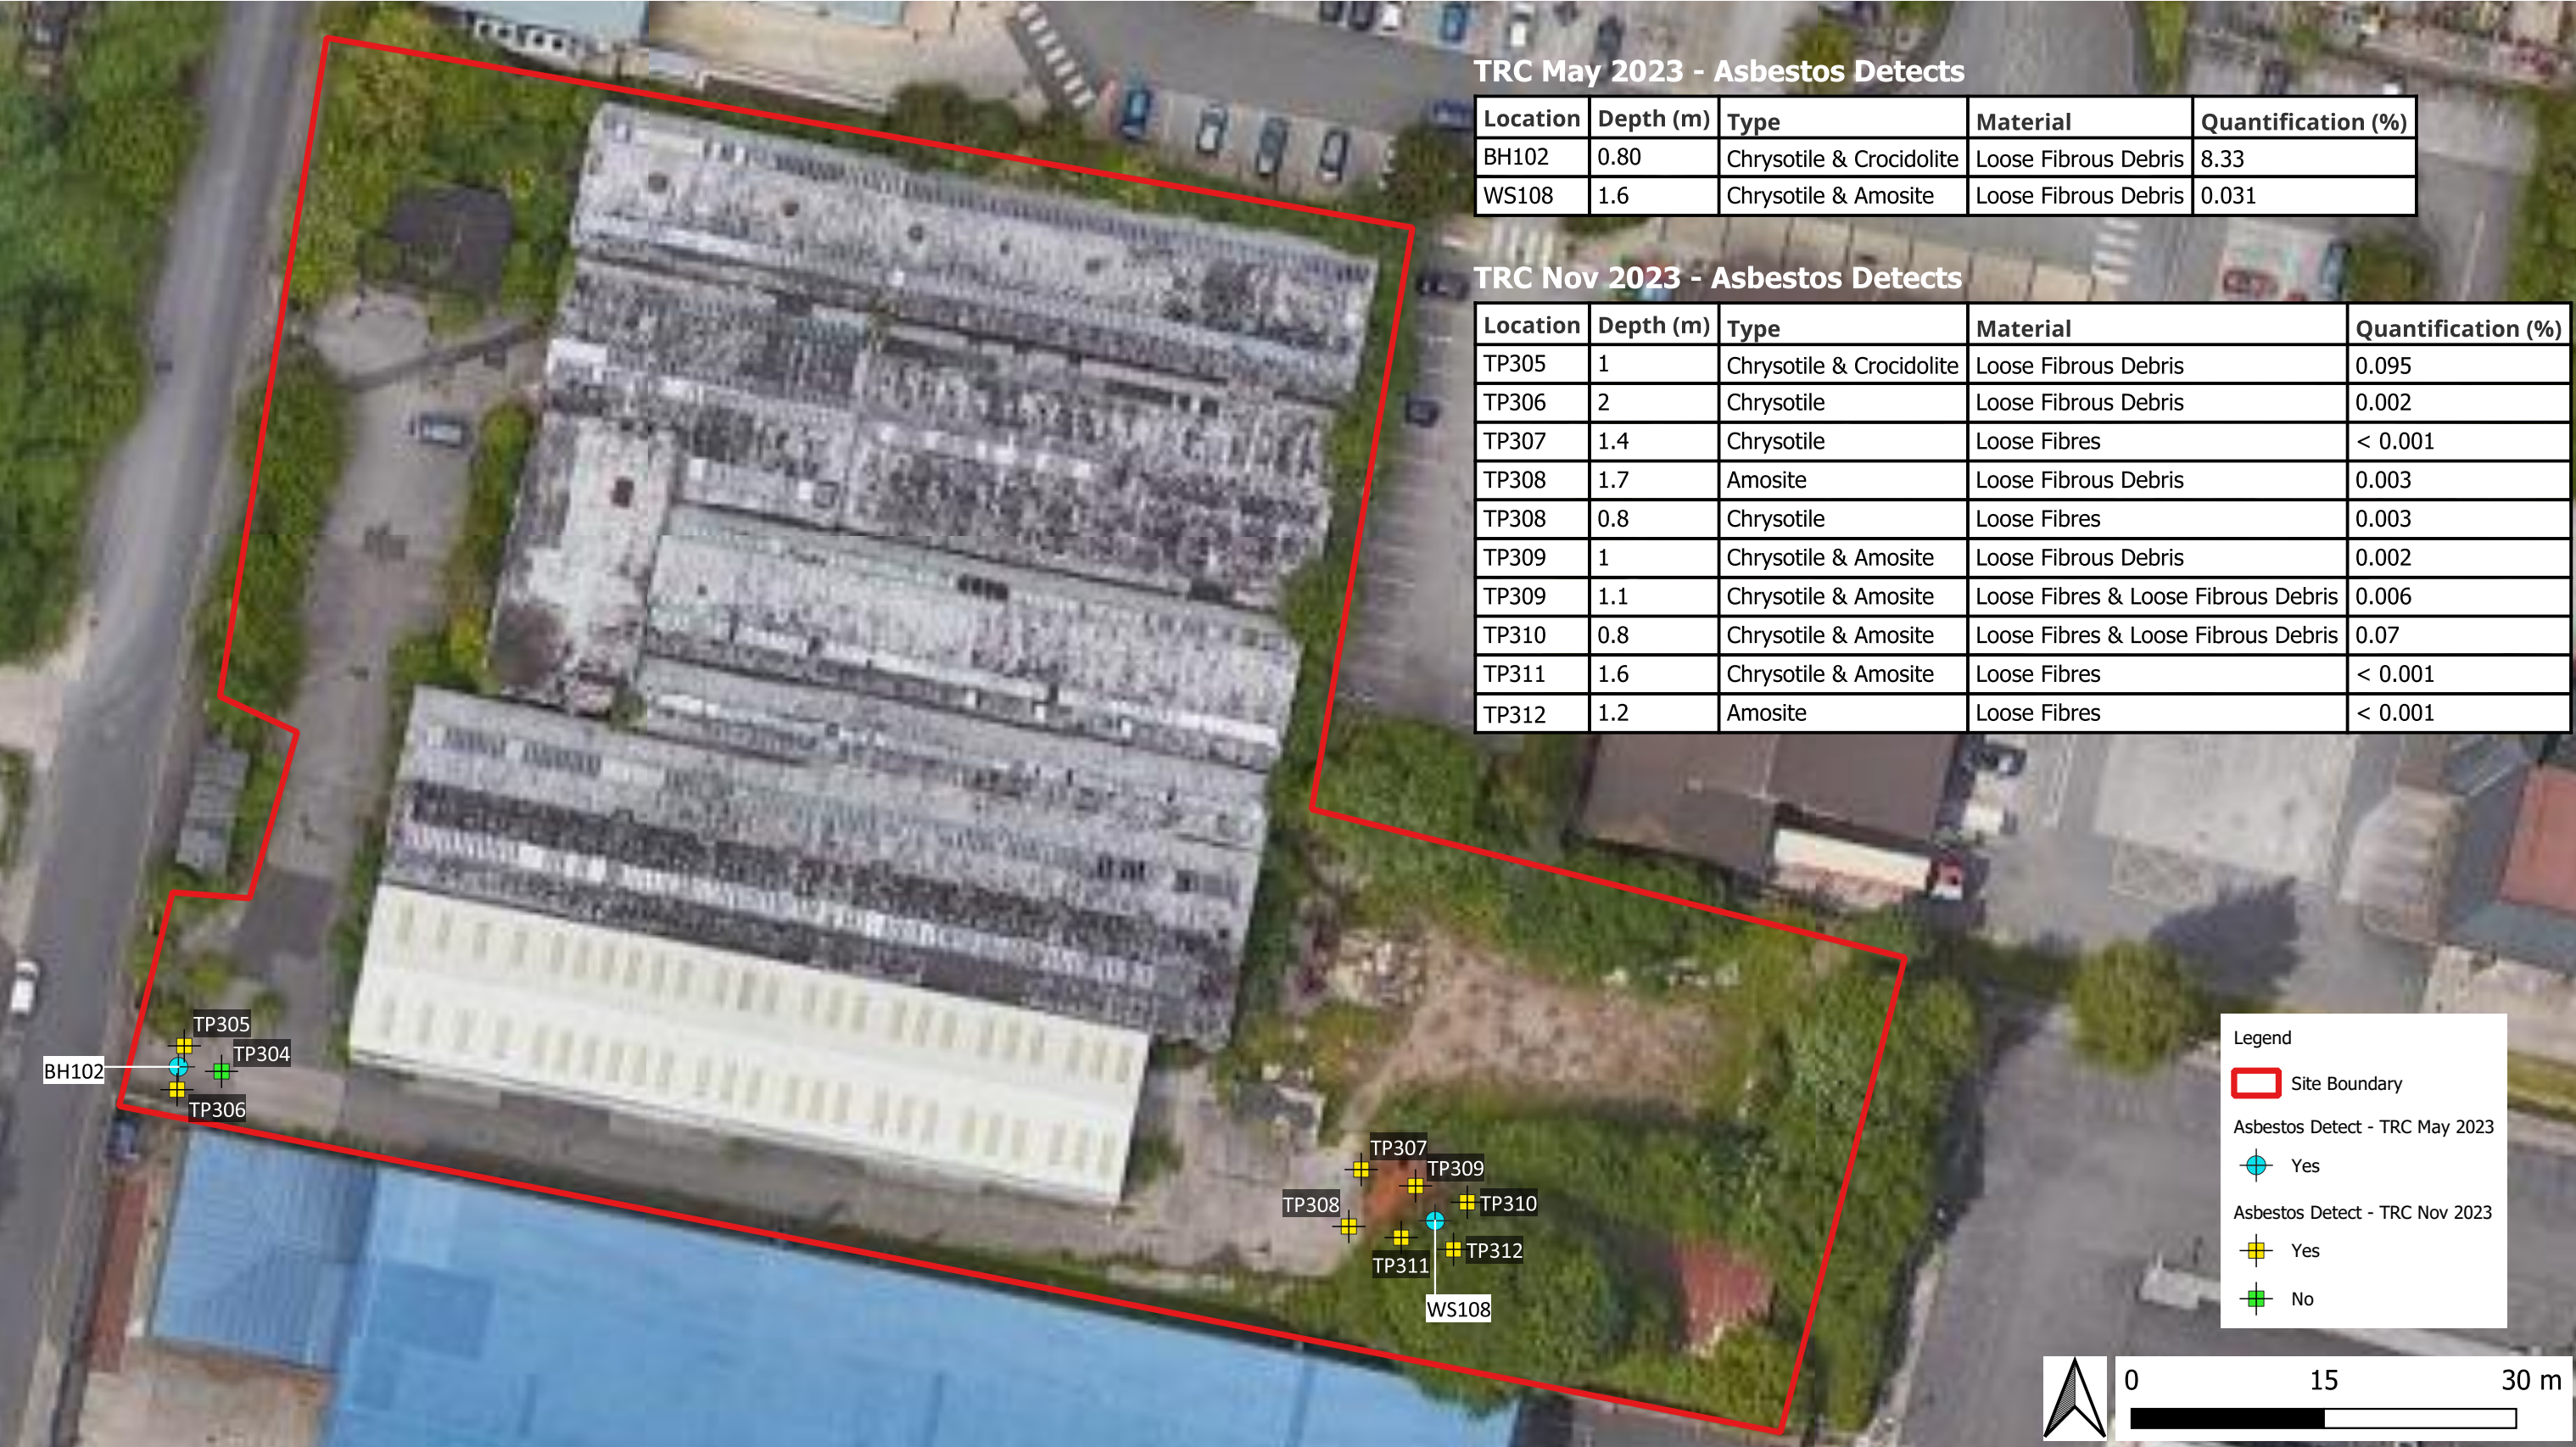
An exploratory hole location plan showing the location of asbestos detects is presented as Figure 3 in Annex A.

During the initial investigation, asbestos was detected within Made Ground at two locations (BH102 and WS108). During the supplementary investigation, asbestos was detected at a further eight locations encompassing BH102 and WS108. Details of the asbestos contamination are presented in the table below.
