**Intelligent  
Ground  
Remediation**

## Validation Report

Land off Oldham Road,  
Oldham Road,  
Manchester,  
M40 1EZ

17 May 2024  
Report ref. 24/1435.1.1

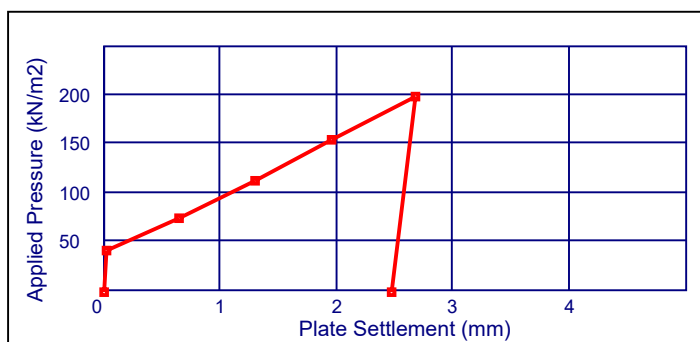
| <b>Material Type</b> | 6F2 | <b>App Weight (kg)</b> | 40 |

**Maximum Applied Pressure (kPa):**  
**Maximum deformation (mm):**  
**Modulus of subgrade reaction K (MN/m³):**  
**K762 (MN/m³):**  
**Estimated CBR (%):**

**Cycle 1**  
**203**  
**2.67**  
**89.1**  
**55.5**  
**10**

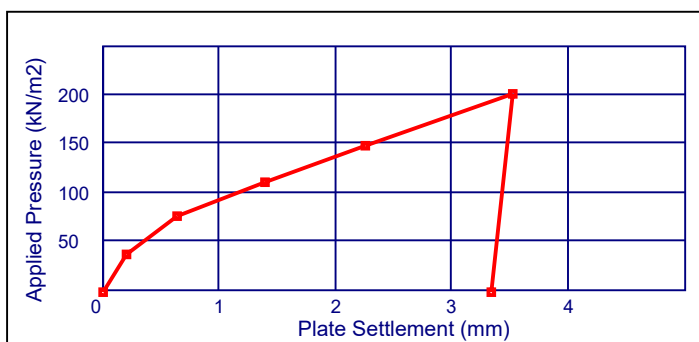
| <b>Material Type</b> | 6F2 | <b>App Weight (kg)</b> | 40 |

**Maximum Applied Pressure (kPa):**  
**Maximum deformation (mm):**  
**Modulus of subgrade reaction K (MN/m3):**  
**K762 (MN/m3):**  
**Estimated CBR (%):**

**Cycle 1**  
**206**  
**3.52**  
**85.0**  
**53.0**  
**9.4**

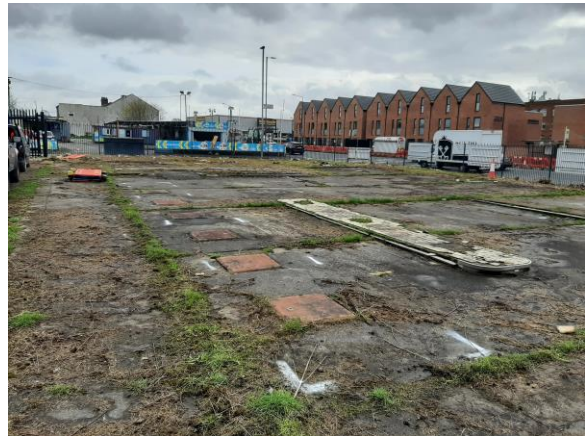
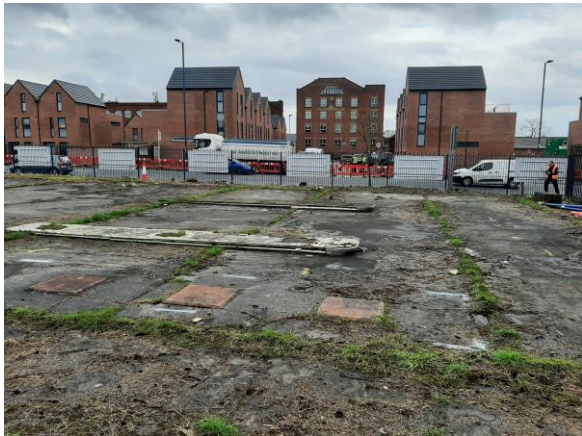
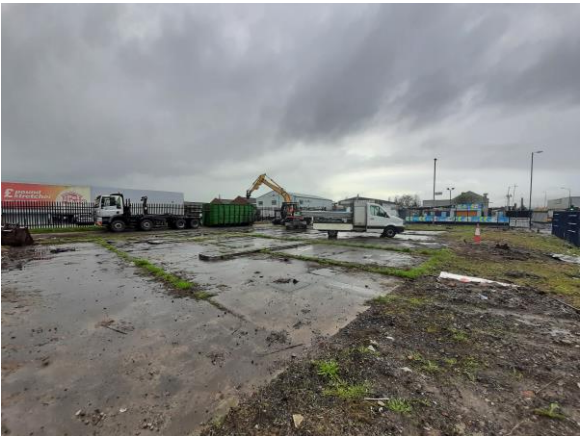
| <p>Image 1: Pre-works site condition</p> A wide-angle photograph of a large, flat, muddy construction site. The ground is dark brown with patches of green grass and some debris. In the background, there are several red brick buildings and a white fence. | <p>Image 2: Pre-works site condition</p> A photograph of the same construction site, showing a different angle. The ground is muddy with some grass. In the background, there are red brick buildings and a white fence. | <p>Image 3: Pre-works site condition</p> A photograph of the construction site showing a large area of muddy ground. In the background, there are red brick buildings, a white fence, and a yellow excavator. |

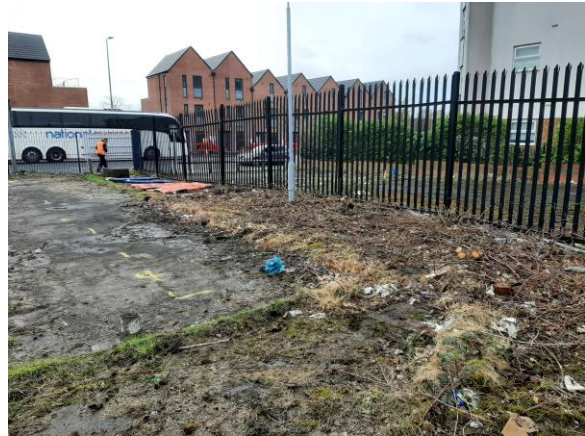
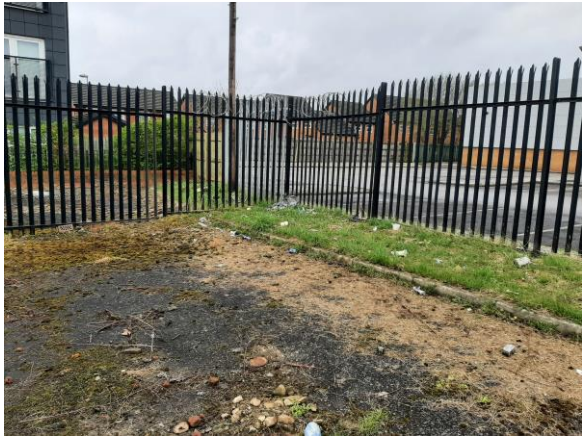
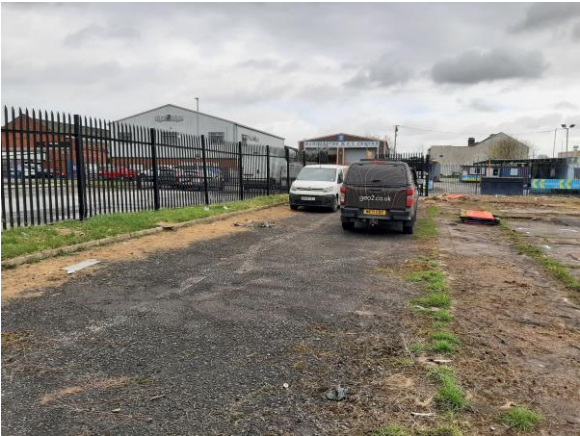
| <p>Image 4: Pre-works site condition</p> A photograph of the construction site showing a muddy area with some debris. In the background, there are red brick buildings and a white fence. | <p>Image 5: Pre-works site condition</p> A photograph of the construction site showing a muddy area with some grass. In the background, there are red brick buildings and a white fence. | <p>Image 6: Pre-works site condition</p> A photograph of the construction site showing a muddy area with some grass. In the background, there are red brick buildings and a white fence. |

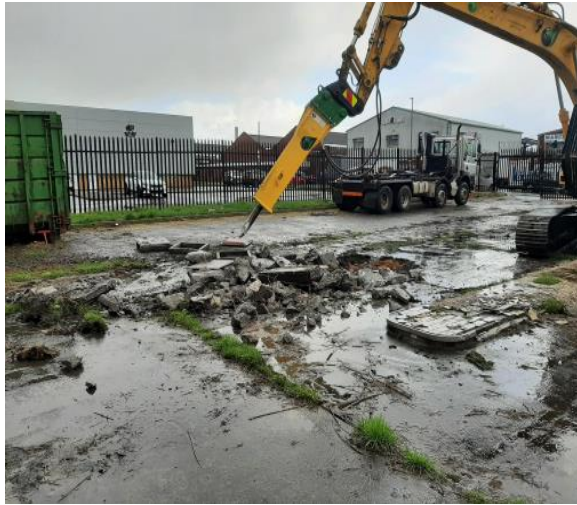
Image 7: Commenced breaking out

Hard standing concrete from across the site was broken out using a mechanical excavator. Two large subsurface concrete stanchion bases were identified and broken out. Identified areas of brick foundation and historical manhole chambers were broken out unless otherwise requested by Be-EV such as the main drainage outlet from site. In some areas minor sections of hardstanding were left due to concerns relating to the stability of the palisade fence that surrounds the site.

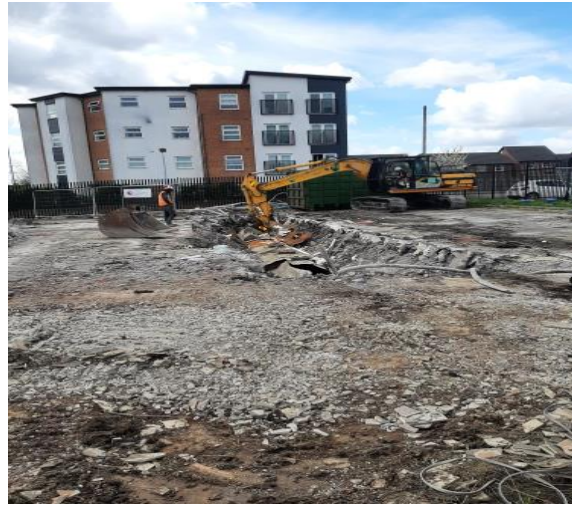
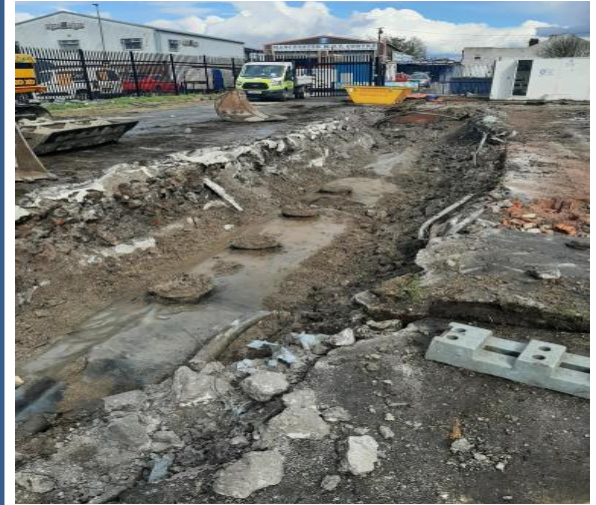
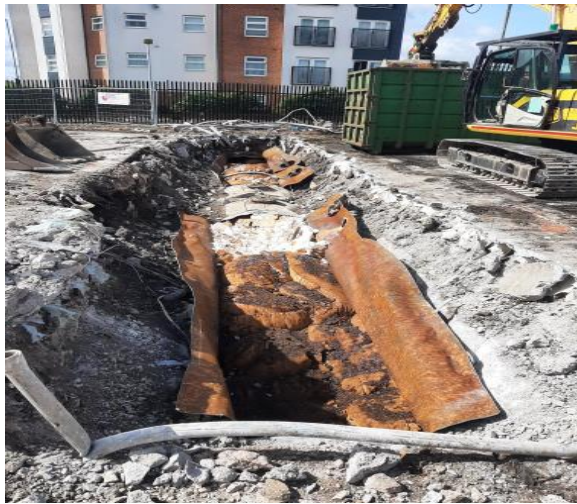
Image 8: Tank excavation

Image 9: Tank exposure

Image 10: Tank foams

The two tanks in the north of the site were observed to be approximately 54,000 litres in capacity and of single skin steel construction. These tanks were split with the western tank having three compartments and the eastern tank having two compartments. All compartments in both tanks had historically been cleaned and foam filled. Both tanks were observed to be in good condition. The tanks were opened using cold cutting techniques before the foam was mechanically excavated and removed from site in skips by an appropriately licensed contractor. The tanks were broken out of the concrete cradle in which they were housed and removed from the subsurface. The tanks were then broken up with metal waste being removed from site by an appropriately licensed contractor. The concrete tank cradle was then broken out and removed from the excavation for crushing. Soil validation samples were obtained from the walls and base of the excavation. The soils surrounding the tank cradle were observed to be stiff to very stiff, plastic clay. No evidence of hydrocarbon contamination was observed in any of the soils surrounding the tank cradle.

A tank cradle was identified in the main tank farm area in the north of the site. This was constructed of concrete and observed to be in good condition. The cradle was approximately 0.5m thick and did not display any evidence of hydrocarbon staining. The concrete was broken out using a mechanical excavator and stockpiled. An L-shaped section of cradle remains in place along the west wall and south west corner of the main tank farm in order to support the gas main that runs through the area and to avoid potential damage caused by the excavator or soil collapse.

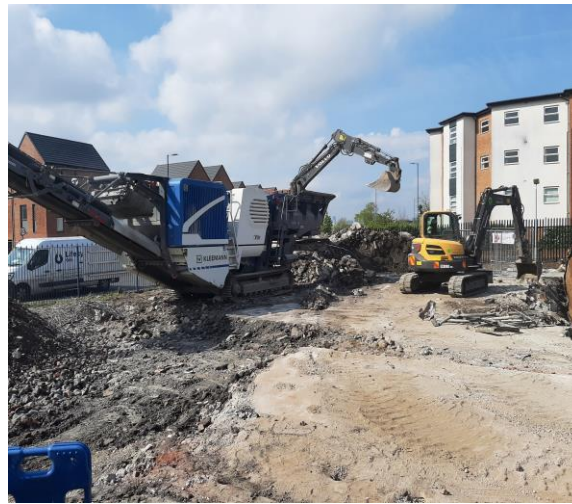
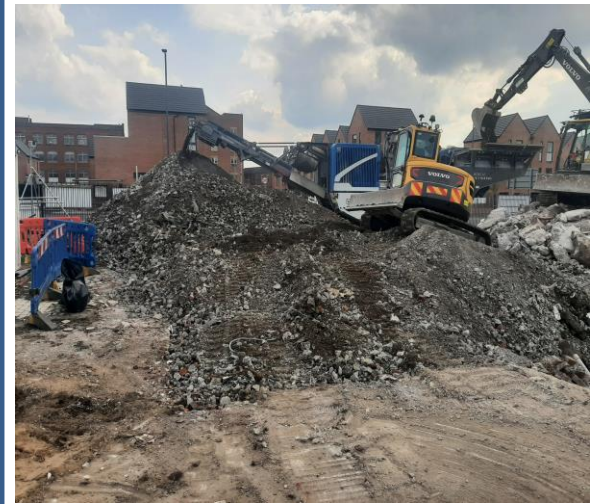
Image 11: Crushing works

Image 12: Continued crushing

- **Removal of tank cradle and hardstanding** – Removal of concrete tank cradle from main excavation and hard standing from across site surface. This was then crushed in line with the Earthworks specification for reuse on site. Works were undertaken under a U1 exemption.

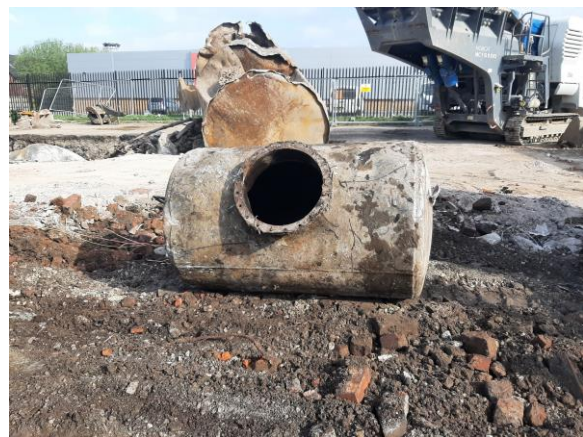
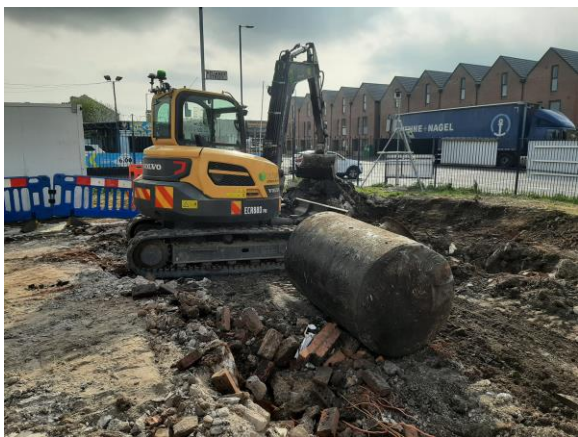
Image 7: Removed waste oil tank

Image 8: Removed Waste oil tank

The waste oil tank located in the south-east of the site was observed to be approximately 1,000 litres in capacity and of single skin steel construction. Waste oil was still present within the tank which was removed by vacuum tanker for disposal offsite by an appropriately licensed contractor. The tank was not observed to be housed in a cradle and the tank was removed from the subsurface. The soil surrounding the tank was comprised of made ground noted to be a sand and gravel fill of concrete, brick and sandstone with occasional brick and concrete cobbles and boulders. A hydrocarbon odour and elevated vapour readings (max 256.6ppm) were noted in the soils with an oil smear present on some gravels. As such, the soil was excavated and quarantined onsite before disposal by an appropriately licensed contractor. Grossly contaminated material was identified by an appropriately qualified engineer using visual, olfactory and vapour reading indications. Once the impacted made ground was removed by an appropriately licensed contractor, validation samples were obtained from the surrounding clean stiff clay.

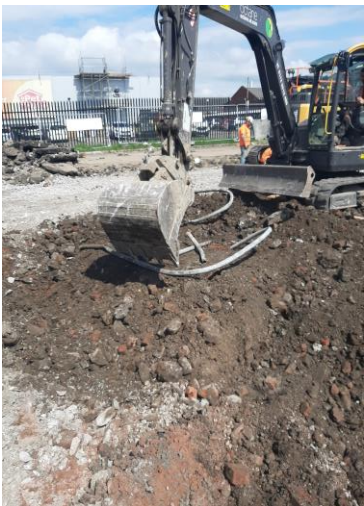
Image 9: Removal of fuel lines

Fuel lines, vent lines and offset fill lines were also identified in the area of the main tank farm and the historical forecourt. The vent and offset fill lines ran over the top of the tanks and as such removal was undertaken during breaking out of the tanks. The fuel lines were identified running south from the tanks to the historical forecourt. These were observed to be cut and capped. These were removed from the subsurface by mechanical excavation methods. Validation samples were obtained from beneath the identified fuel lines with no evidence of hydrocarbon contamination noted. The material underlying the fuel lines was identified as made ground comprising brown, sandy, very clayey gravel of concrete, brick and sandstone.

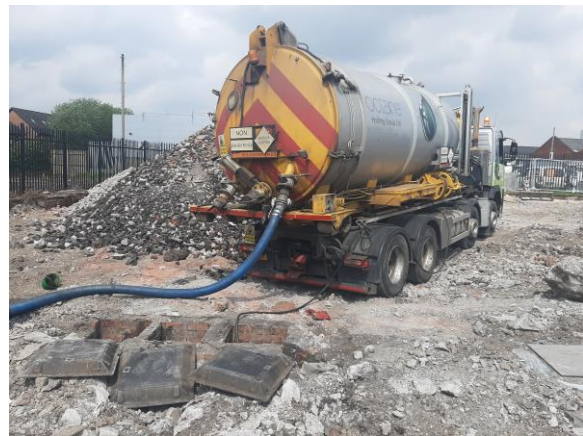
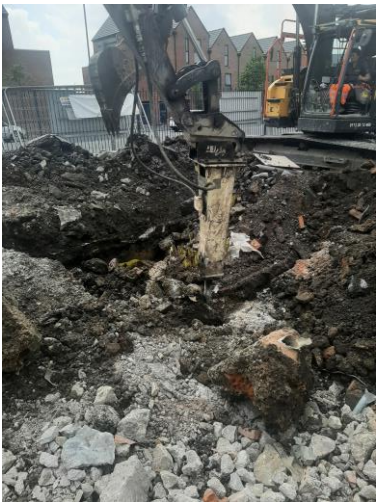
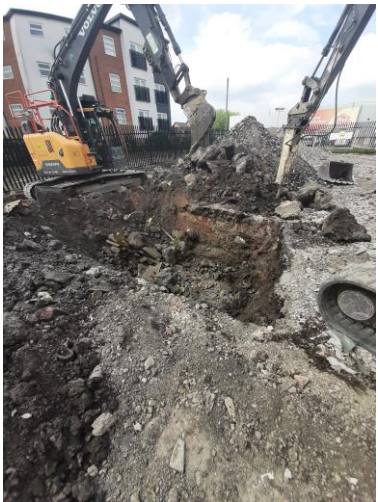
Image 10: Vac tanker removal of interceptor contents

Image 11: Breaking out of interceptor

Image 12: Removal of interceptor

A three-stage interceptor was identified in the south-west of the site. This was observed to be filled with water which was removed by vacuum tanker. The interceptor was then cleaned and mechanically excavated. The interceptor chambers were encapsulated in concrete which was broken out and crushed. The soils surrounding the interceptor comprised firm to very stiff, plastic clay. No evidence of hydrocarbon contamination was noted in these soils. Validation samples were obtained from the base and walls of the interceptor excavation.

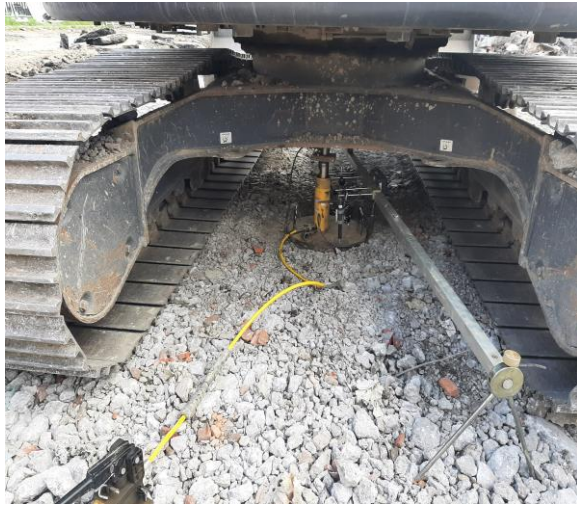
Image 13: CBR plate testing

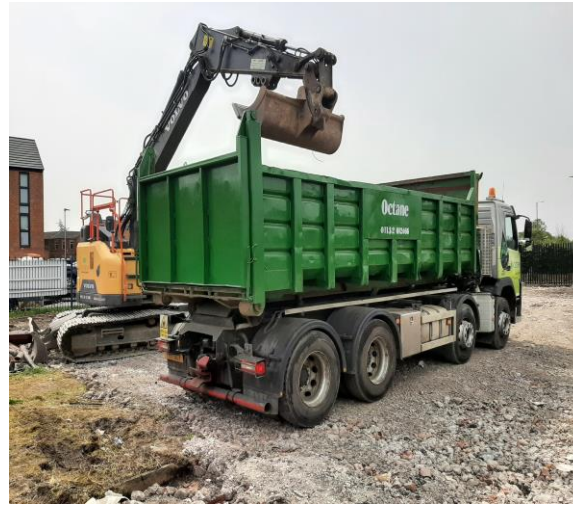
Image 14: Off-site disposal works

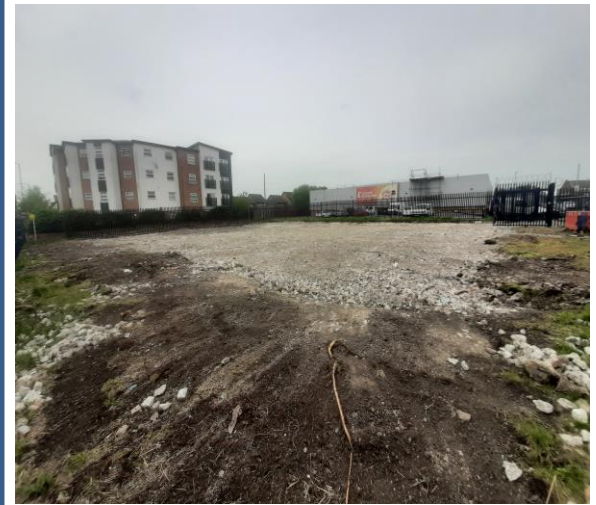
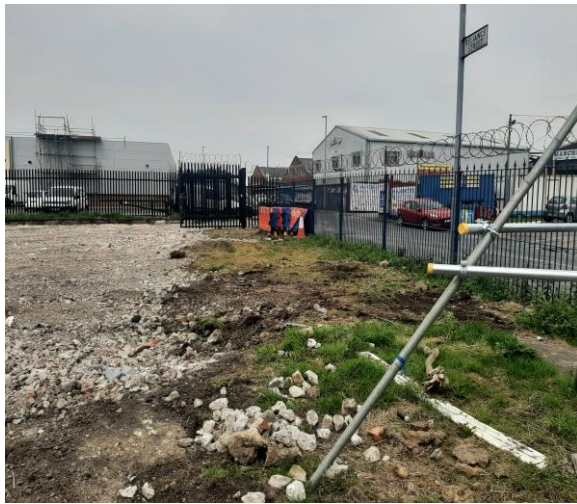
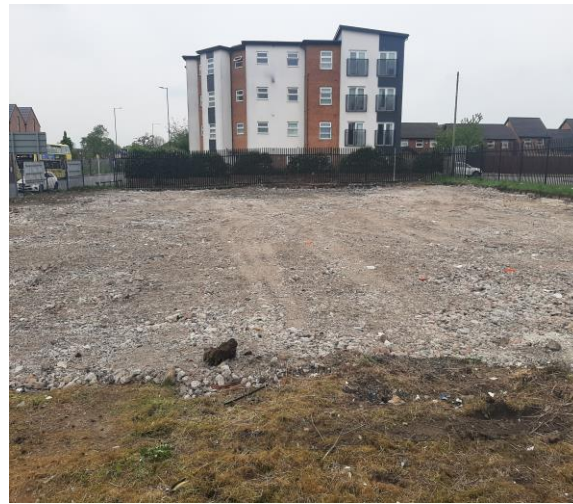
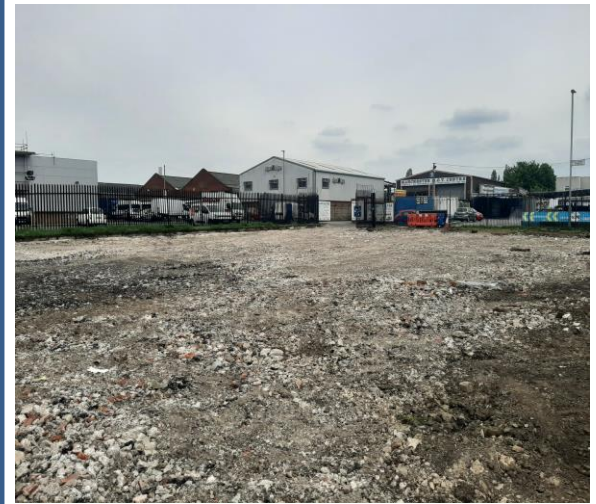
Image 15: Finished site condition

Image 16: Finished site condition

Image 17: Finished site condition

Image 18: Finished site condition

Upon demobilisation from site, all areas of site were left secure tidy. Photographic evidence for site condition has been provided within photologs presented in Appendix E.
