# Design Note

Project SIM Sitewide Works  
Subject LBC application - Strengthening brackets for scaffolding  
Project no 054704  
Date 2 April 2024

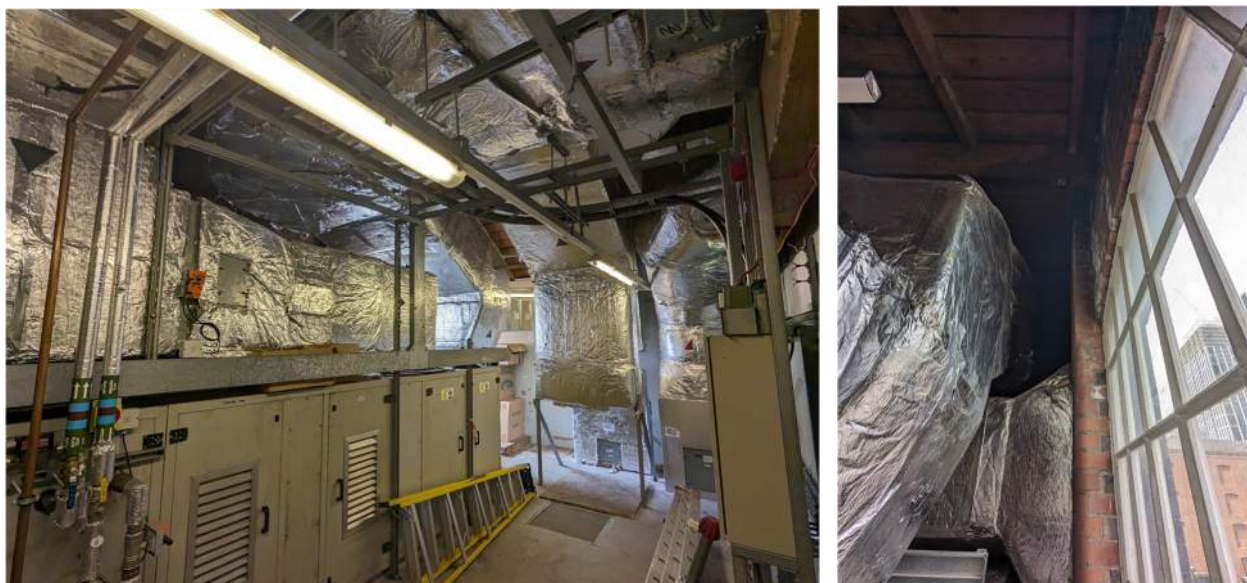
**Figure 3-1 Examples of heavily congested spaces along northern edge of New Warehouse, limiting strengthening options**

Once it was confirmed that some element of strengthening or temporary works would be required an optioneering exercise was undertaken to determine the most appropriate methodology. This assessment looked at several options for providing the required strengthening, from which a preferred option has been developed. The preferred option is a balance of practicality and minimising impact on the existing building fabric. The internal spaces of the New Warehouse are heavily constrained due to the presence of plant and equipment, and a commercial kitchen. Removing or reconfiguring this equipment would be prohibitively expensive and complex for the current works. This means that several more common methods for providing internal bracing are ultimately not feasible. See Figure 3-1.

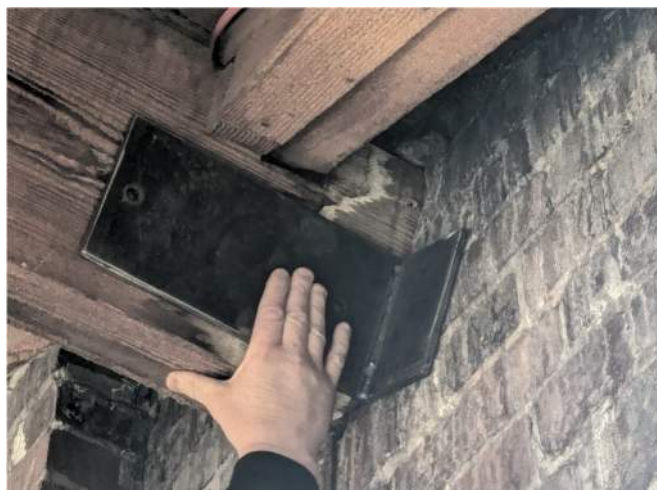
Figure 3-3 Site mock-up of standard bracket detail (unpainted)

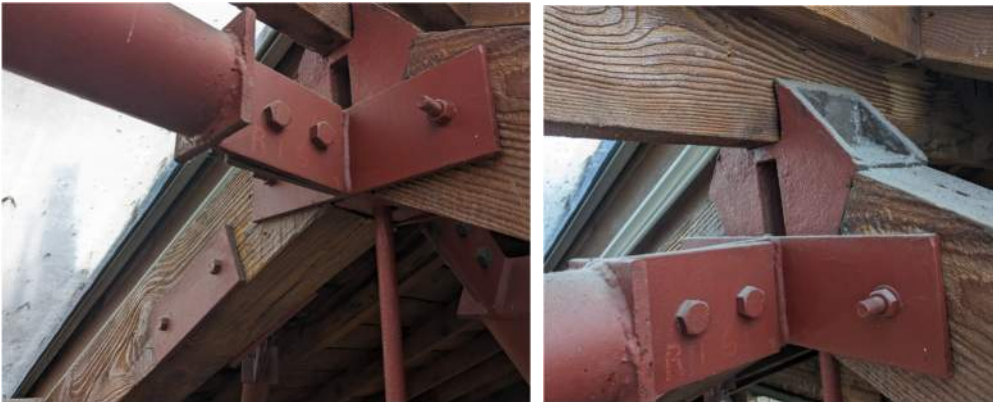
Figure 3-4 [left & right] 1980s steel bracing details, plus original cast iron truss nodes and ties beyond

The design of proposed strengthening option has been heavily influenced by existing metalwork within the New Warehouse roof structure. There are at least three sets of similar metalwork present in the existing roof. Figure 3-4 to Figure 3-6 show these existing details:

- Cast iron nodes, brackets and tie bars which are part of the original 1870s roof trusses,
- Plated strengthening details to purlins and roof timbers, presumably from some time in the mid 1900s,
- A series of more modern steel braces and plates which are assumed to have been added in the 1980s when the museum took over stewardship of the New Warehouse building.

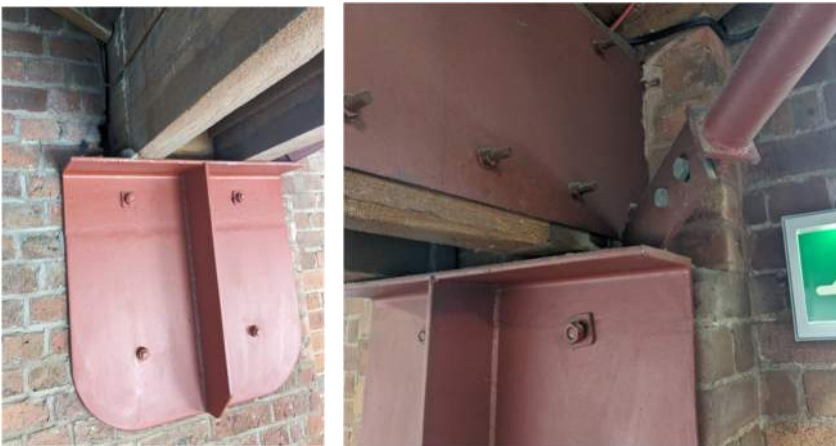
Figure 3-5 [left] 1980s strengthening plate detail at roof valley positions. [right] 1980s plate & diagonal brace, plus earlier strengthening plate detail to valley purlin

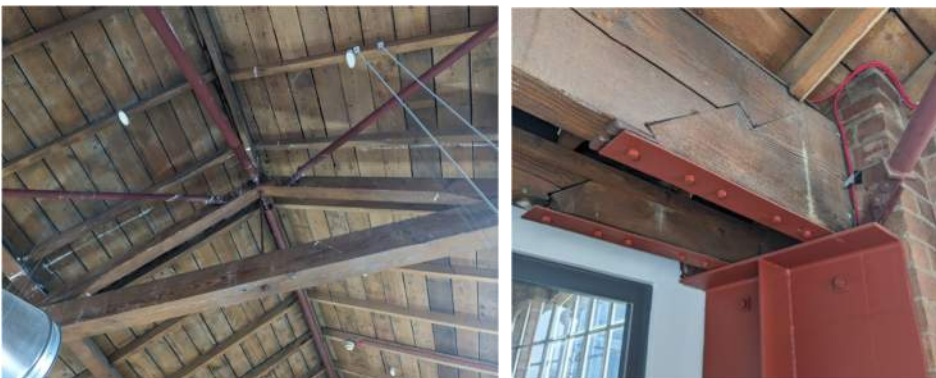
Figure 3-6 [left] 1980s diagonal bracing arrangement. [right] 1980s plate/brace, plus earlier steel plate strengthening to underside of purlin, combined with timber scarf repair.
