Preliminary Roost Assessment and Ecological Walkover

Cheetham Hill Road, Manchester

Reference: 81-135-R1-1

Date: July 2023

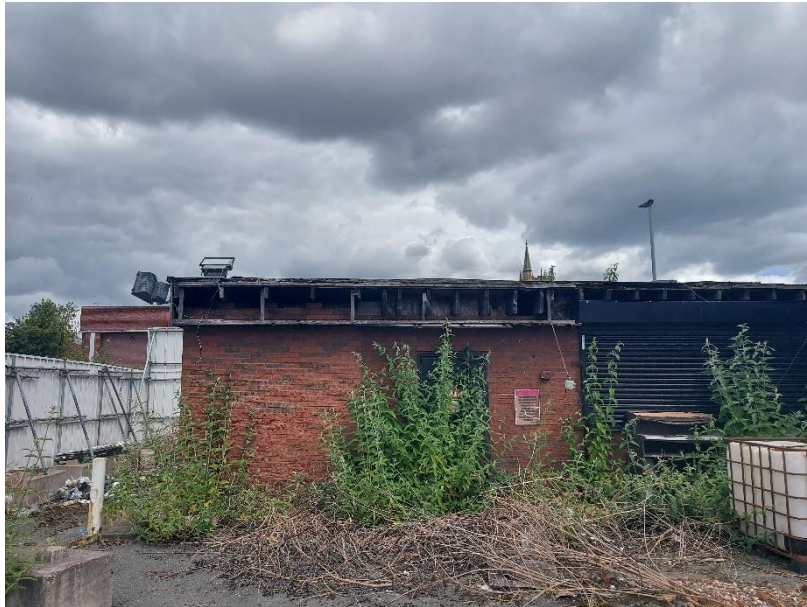
The building comprised brick walls with a flat roof. The brickwork of the building was mostly in good condition and well-sealed, with no gaps observed that could be used by crevice dwelling bat species. However, there was access into the building where the fascia had been damaged on the south-west facing aspect, which provided suitability for roosting bats. Due to the flat roof, the building has the potential to support nesting birds.

PLATE 1      SHOWING MAIN ENTRANCE ON SOUTH-WEST FACING ASPECT

Internal access could not be gained into the building during the survey. The building was assessed as having **MODERATE** bat roosting potential due to the missing fascia on the south-west facing aspect and the damaged brickwork on the north-east facing aspect. Both of these features lead into the building, and thus have the potential to support roosting bats on a regular basis.

The main building was assessed as having **MODERATE** bat roosting potential. As such, two Nocturnal Bat Surveys are required on the building between May and September, with at least one of the surveys between May and August. If bats are identified roosting within the building, a third survey to characterise the roost, and a European Protected Species Licence will be required and would require up to date surveys from the survey season prior to the application submission.

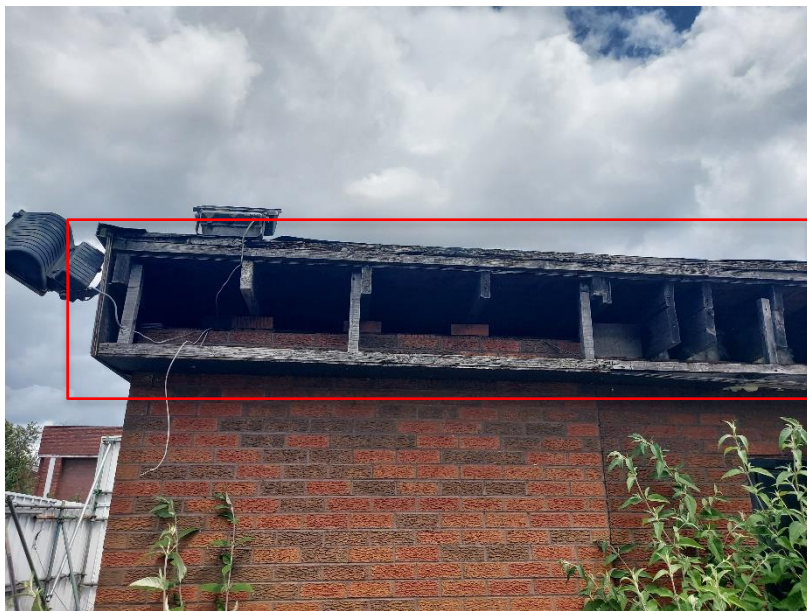
PLATE 2      SHOWING CLOSE UP OF ENTRY-WAYS INTO MAIN BUILDING

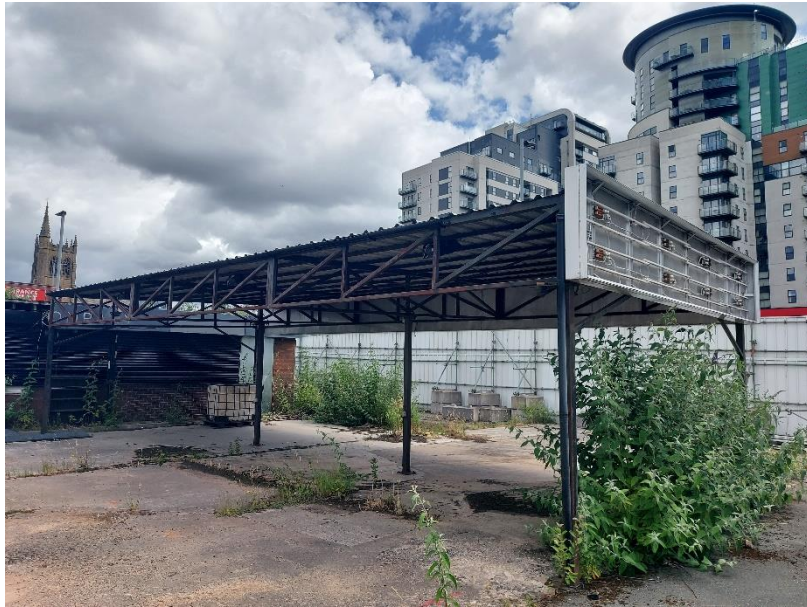
A flat roofed extension constructed from metal was present on the south-west facing aspect. The extension is unlikely to possess any potential to support roosting bats due to a lack of suitable features. Due to the flat roof, the extension has the potential to support nesting birds.

PLATE 3      SHOWING FLAT ROOFED EXTENSION

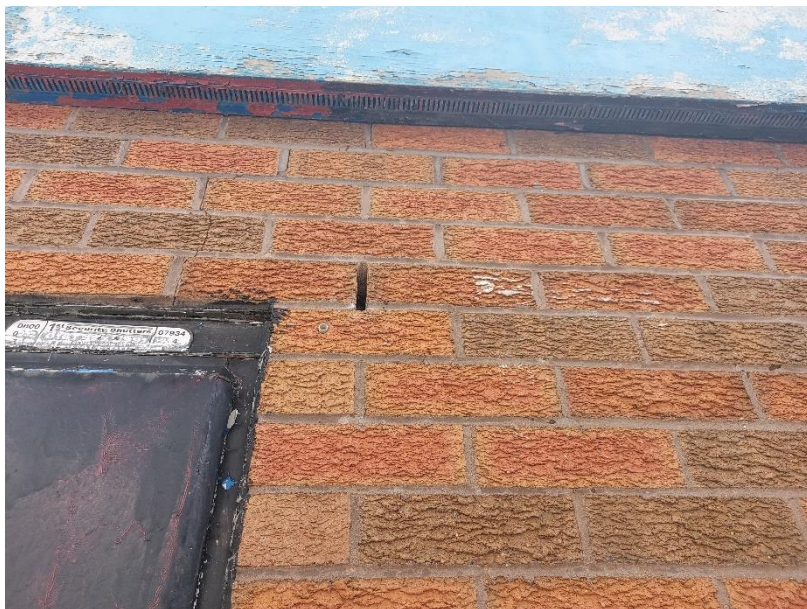
A weep hole and numerous holes were present on the north-east facing aspect of the building. These feature may support crevice-dwelling bat species on an occasional basis.

PLATE 4      SHOWING WEEP HOLE ON NORTH-EAST FACING ASPECT

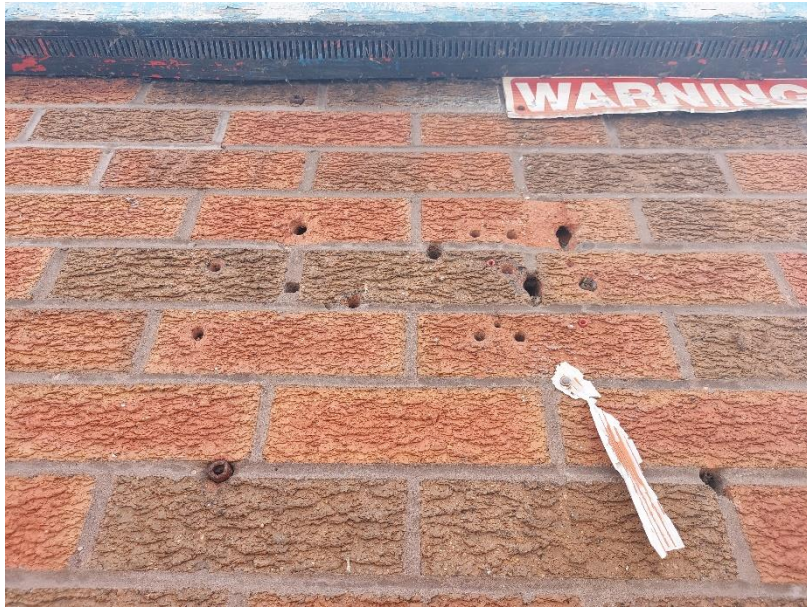
PLATE 5      SHOWING DAMAGED BRICKWORK

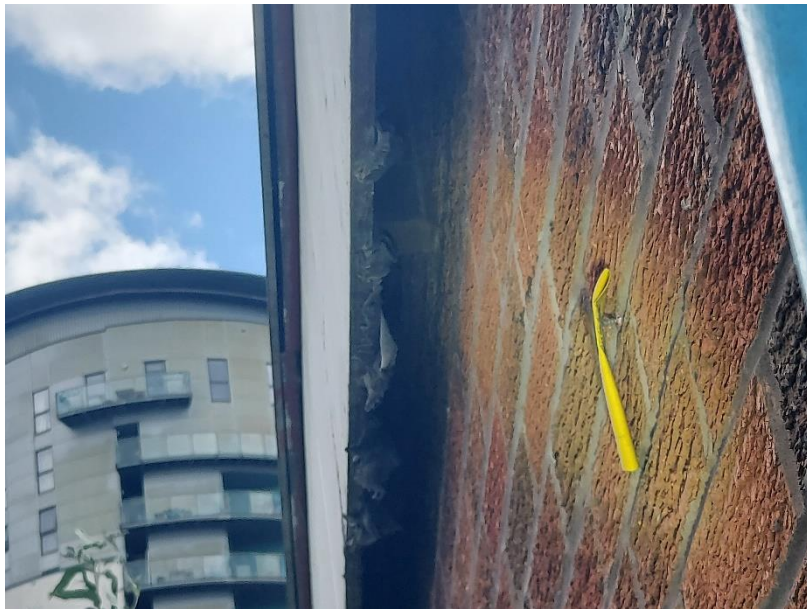
An entry way into the building was present underneath the fascia on the north-west facing aspect of the building. This feature may support roosting bats on a regular basis, and provide bats with access to the building.

PLATE 6      SHOWING GAP UNDER FASCIA

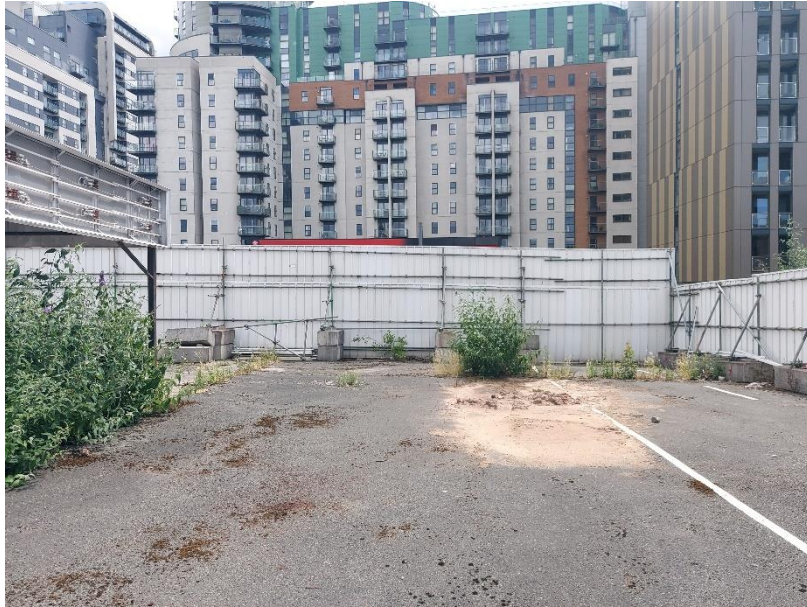
The hardstanding had been left unmanaged and colonised by flora comprising butterfly-bush (*Buddleja davidii*), smooth hawk's beard (*Crepis capillaris*), Canadian fleabane (*Erigeron canadensis*), narrow-leaved ragwort (*Senecio inaequidens*), and wall barley (*Hordeum murinum*).

PLATE 7      SHOWING HARDSTANDING

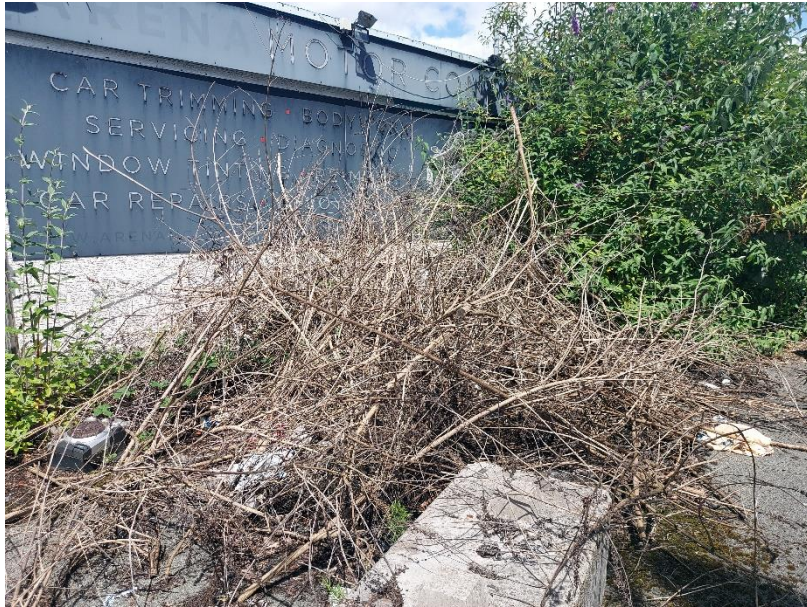
Brash piles were present throughout the site. The species could not be identified. The brash piles have potential to support nesting birds. Due to the urban nature of the site, the brash piles are unlikely to support a population of amphibians.

PLATE 8      SHOWING BRASH PILE

It is recommended that any demolition works or the removal of vegetation/brash piles take place outside of the breeding bird season (March–September inclusive). However, if this is not possible, then a suitably qualified ecologist should inspect the area no more than 24 hours prior to the removal. Should any nests, or nests in construction be located, a suitable stand-off distance should be maintained until the young have fledged. The ecologist will advise on suitable stand off and provide a toolbox talk to all site contractors regarding their working limits and legal implications.
