## Phase 1 & 2 Desk Study & Ground Investigation

New Canopy & New Extension at, Abraham Moss Community School, Crumpsall

Contract No./Report Type: 23-075/P1&P2  
Produced for The Dean Trust

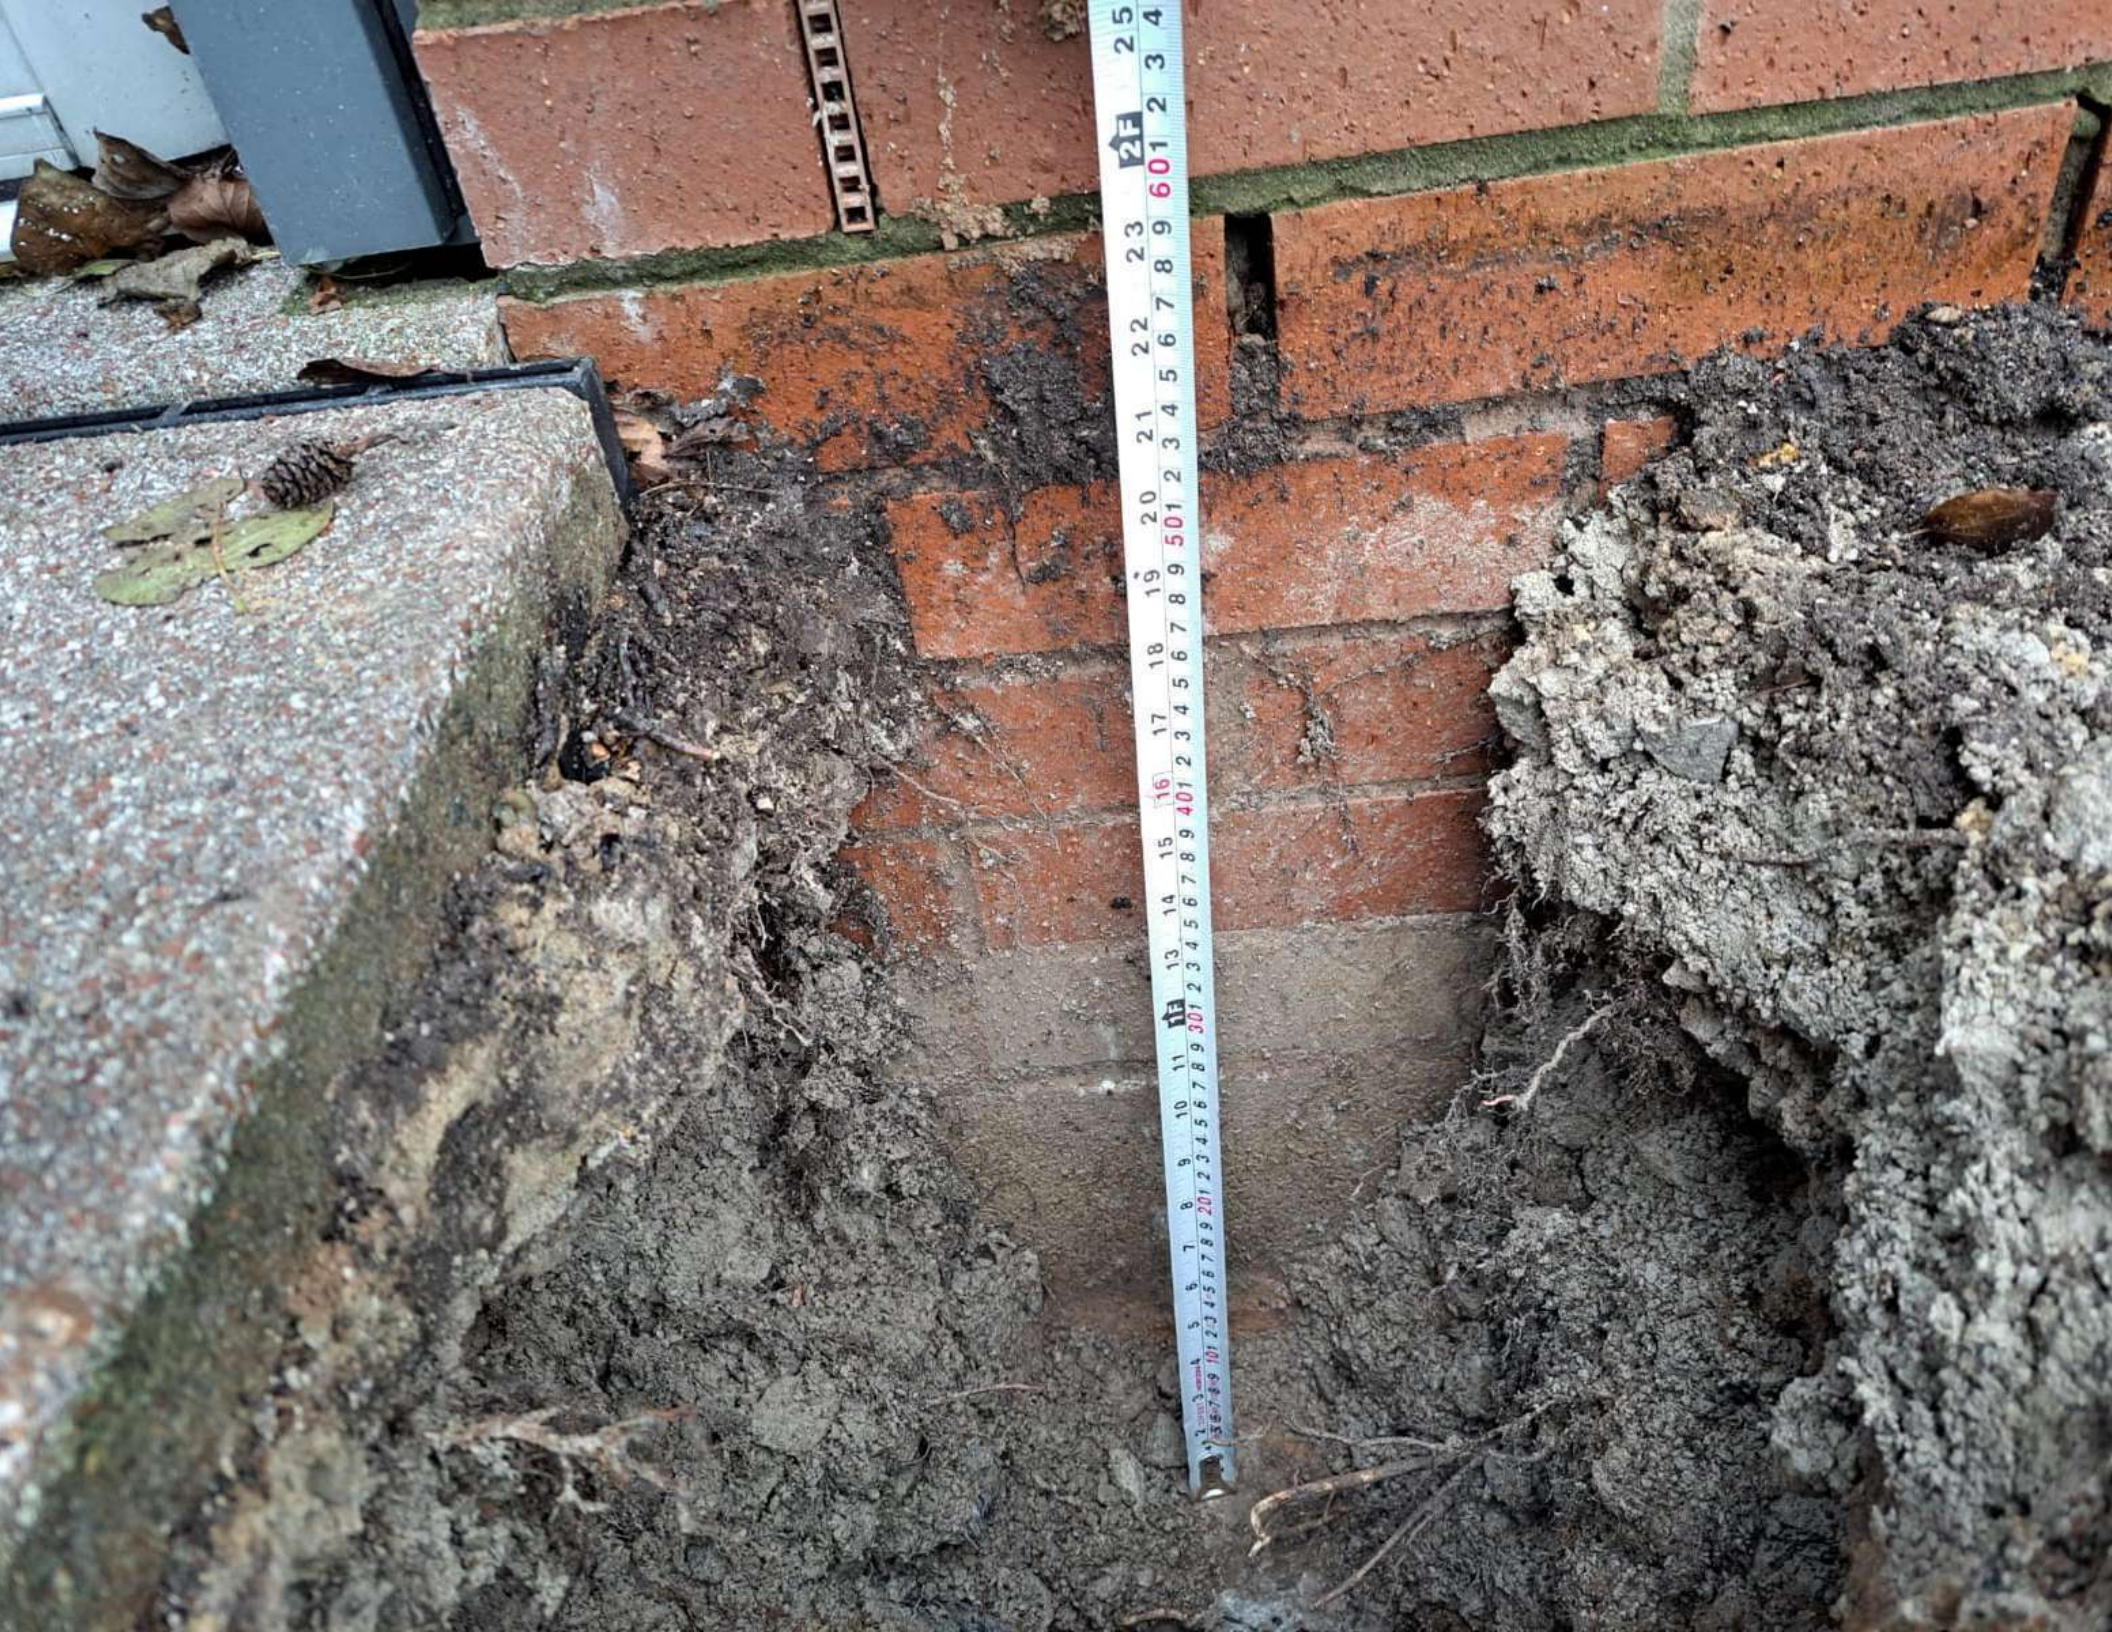
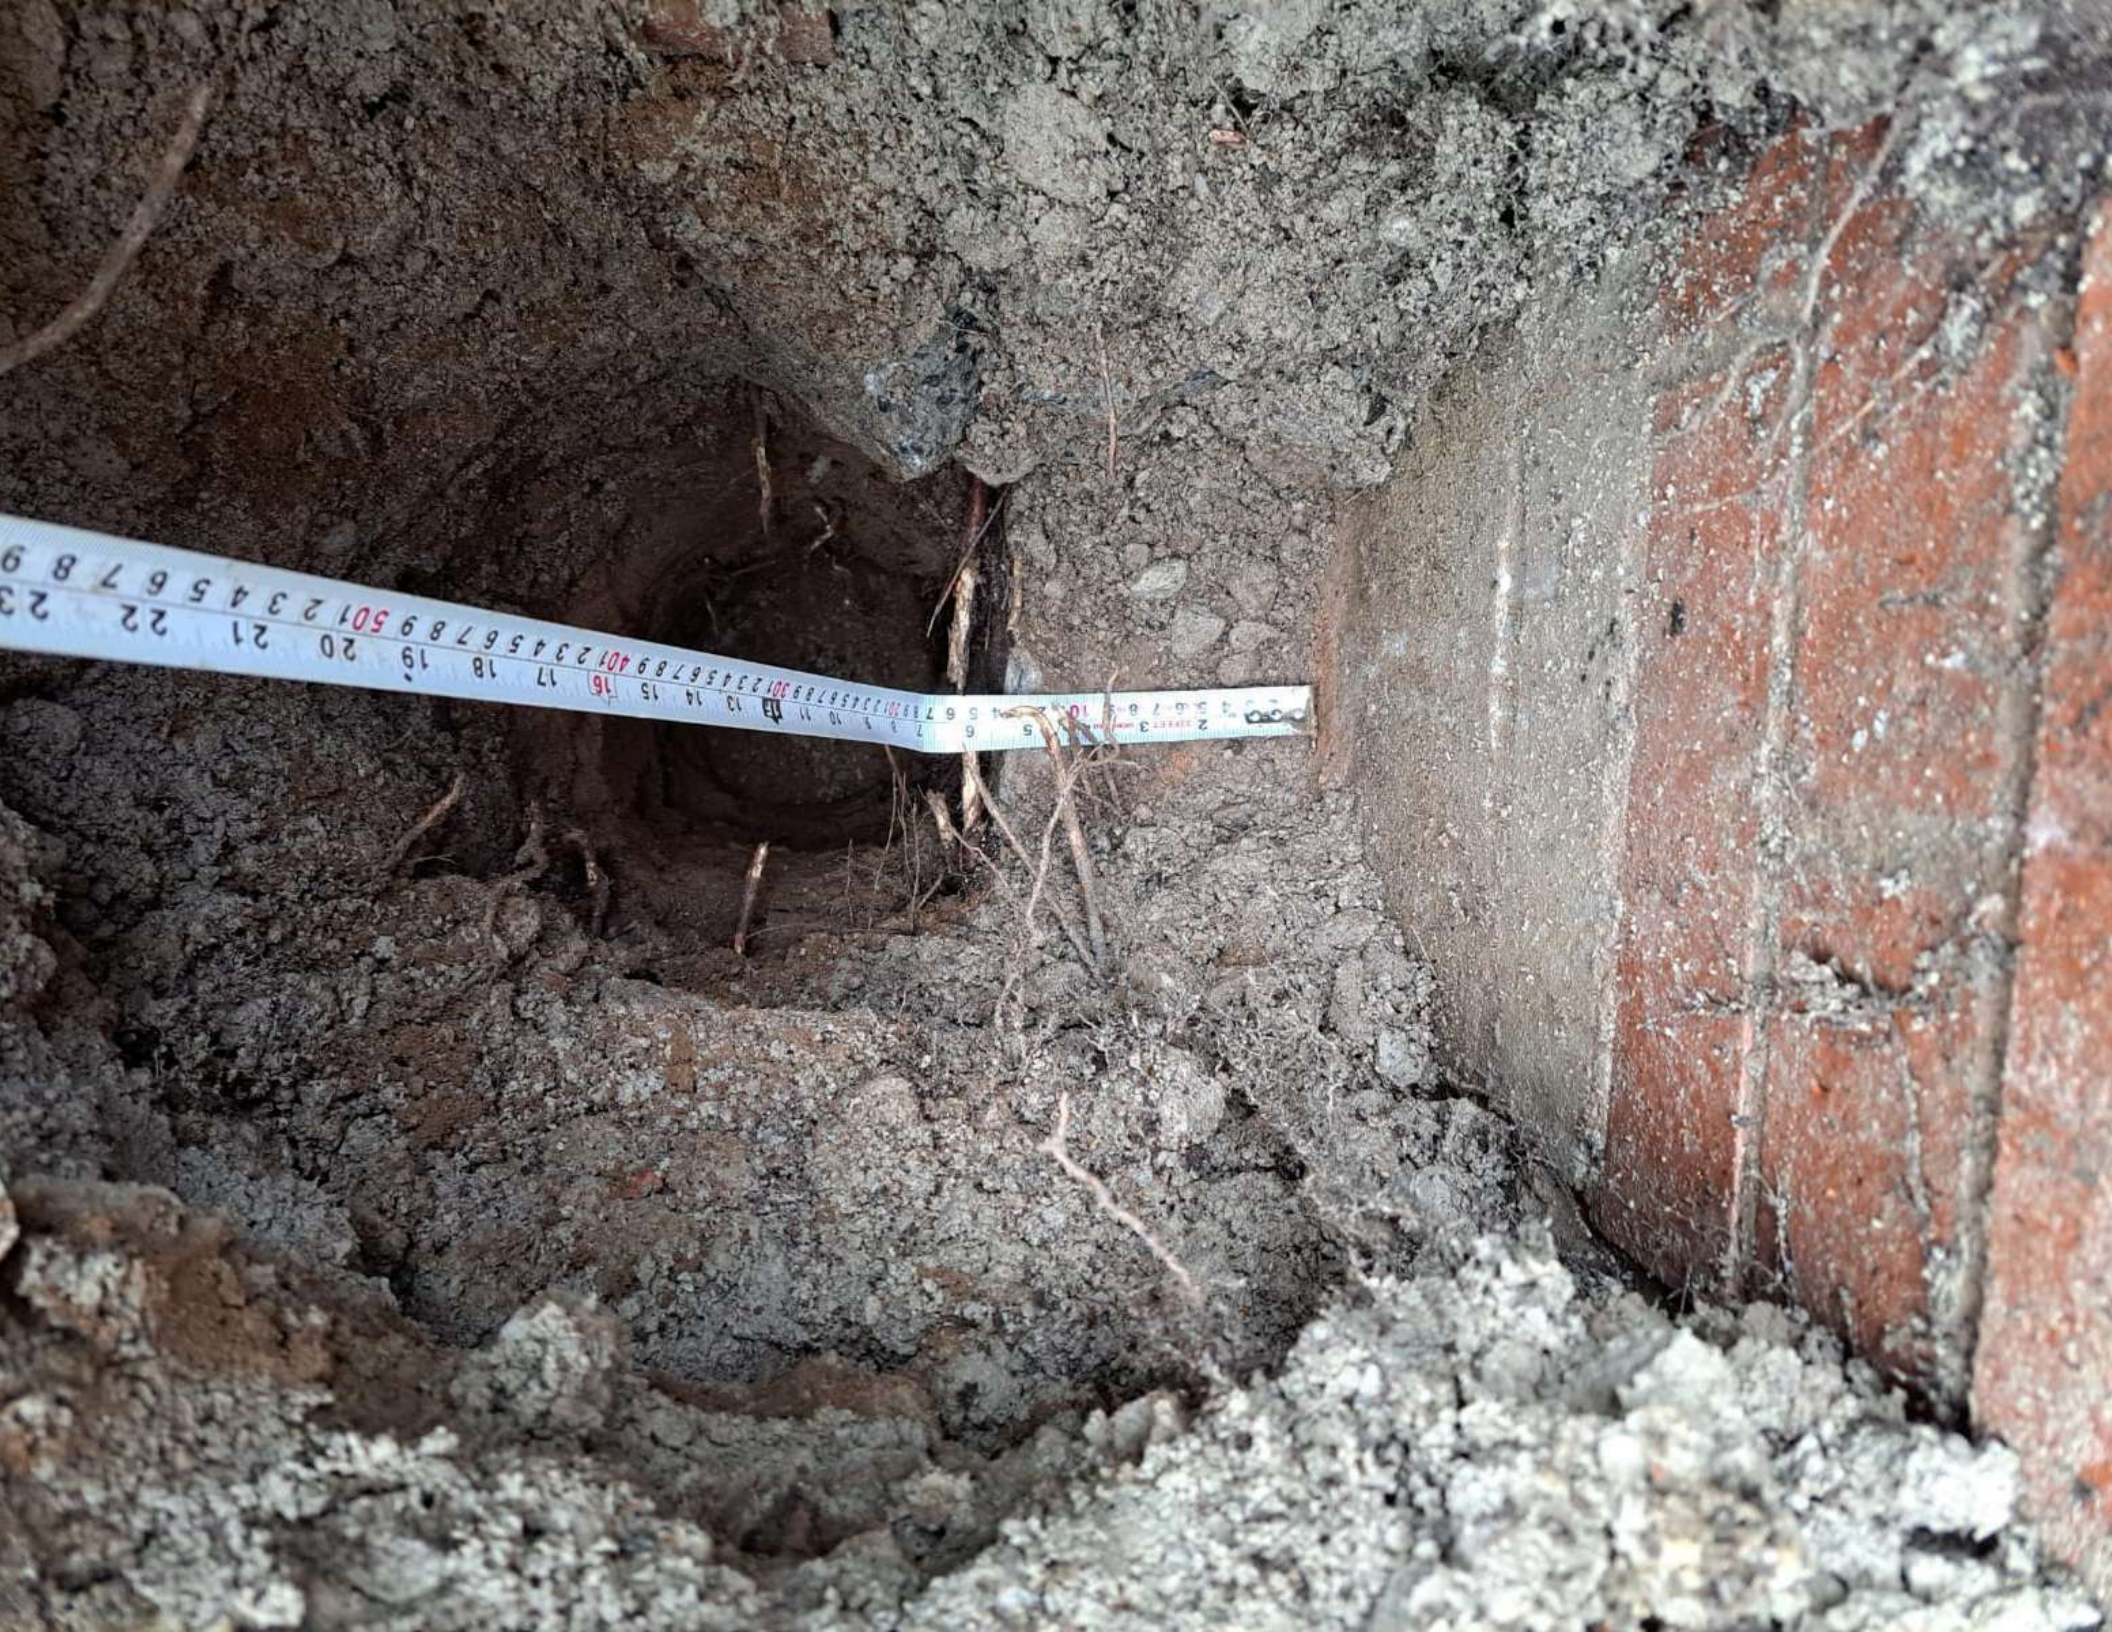
TR 01

- There was **0.3m of brickwork founding on 0.3m of concrete**, sitting on what appeared to be a 0.08m thick slab (which looked like a paving slab) lying at 0.4mbegl and protruding 0.3m from the building face.
- That seemed wrong and so we broke part of the slab and there is a pad footing beneath which **founds at >1.0mbegl and it protrudes 0.15m from the building face.**

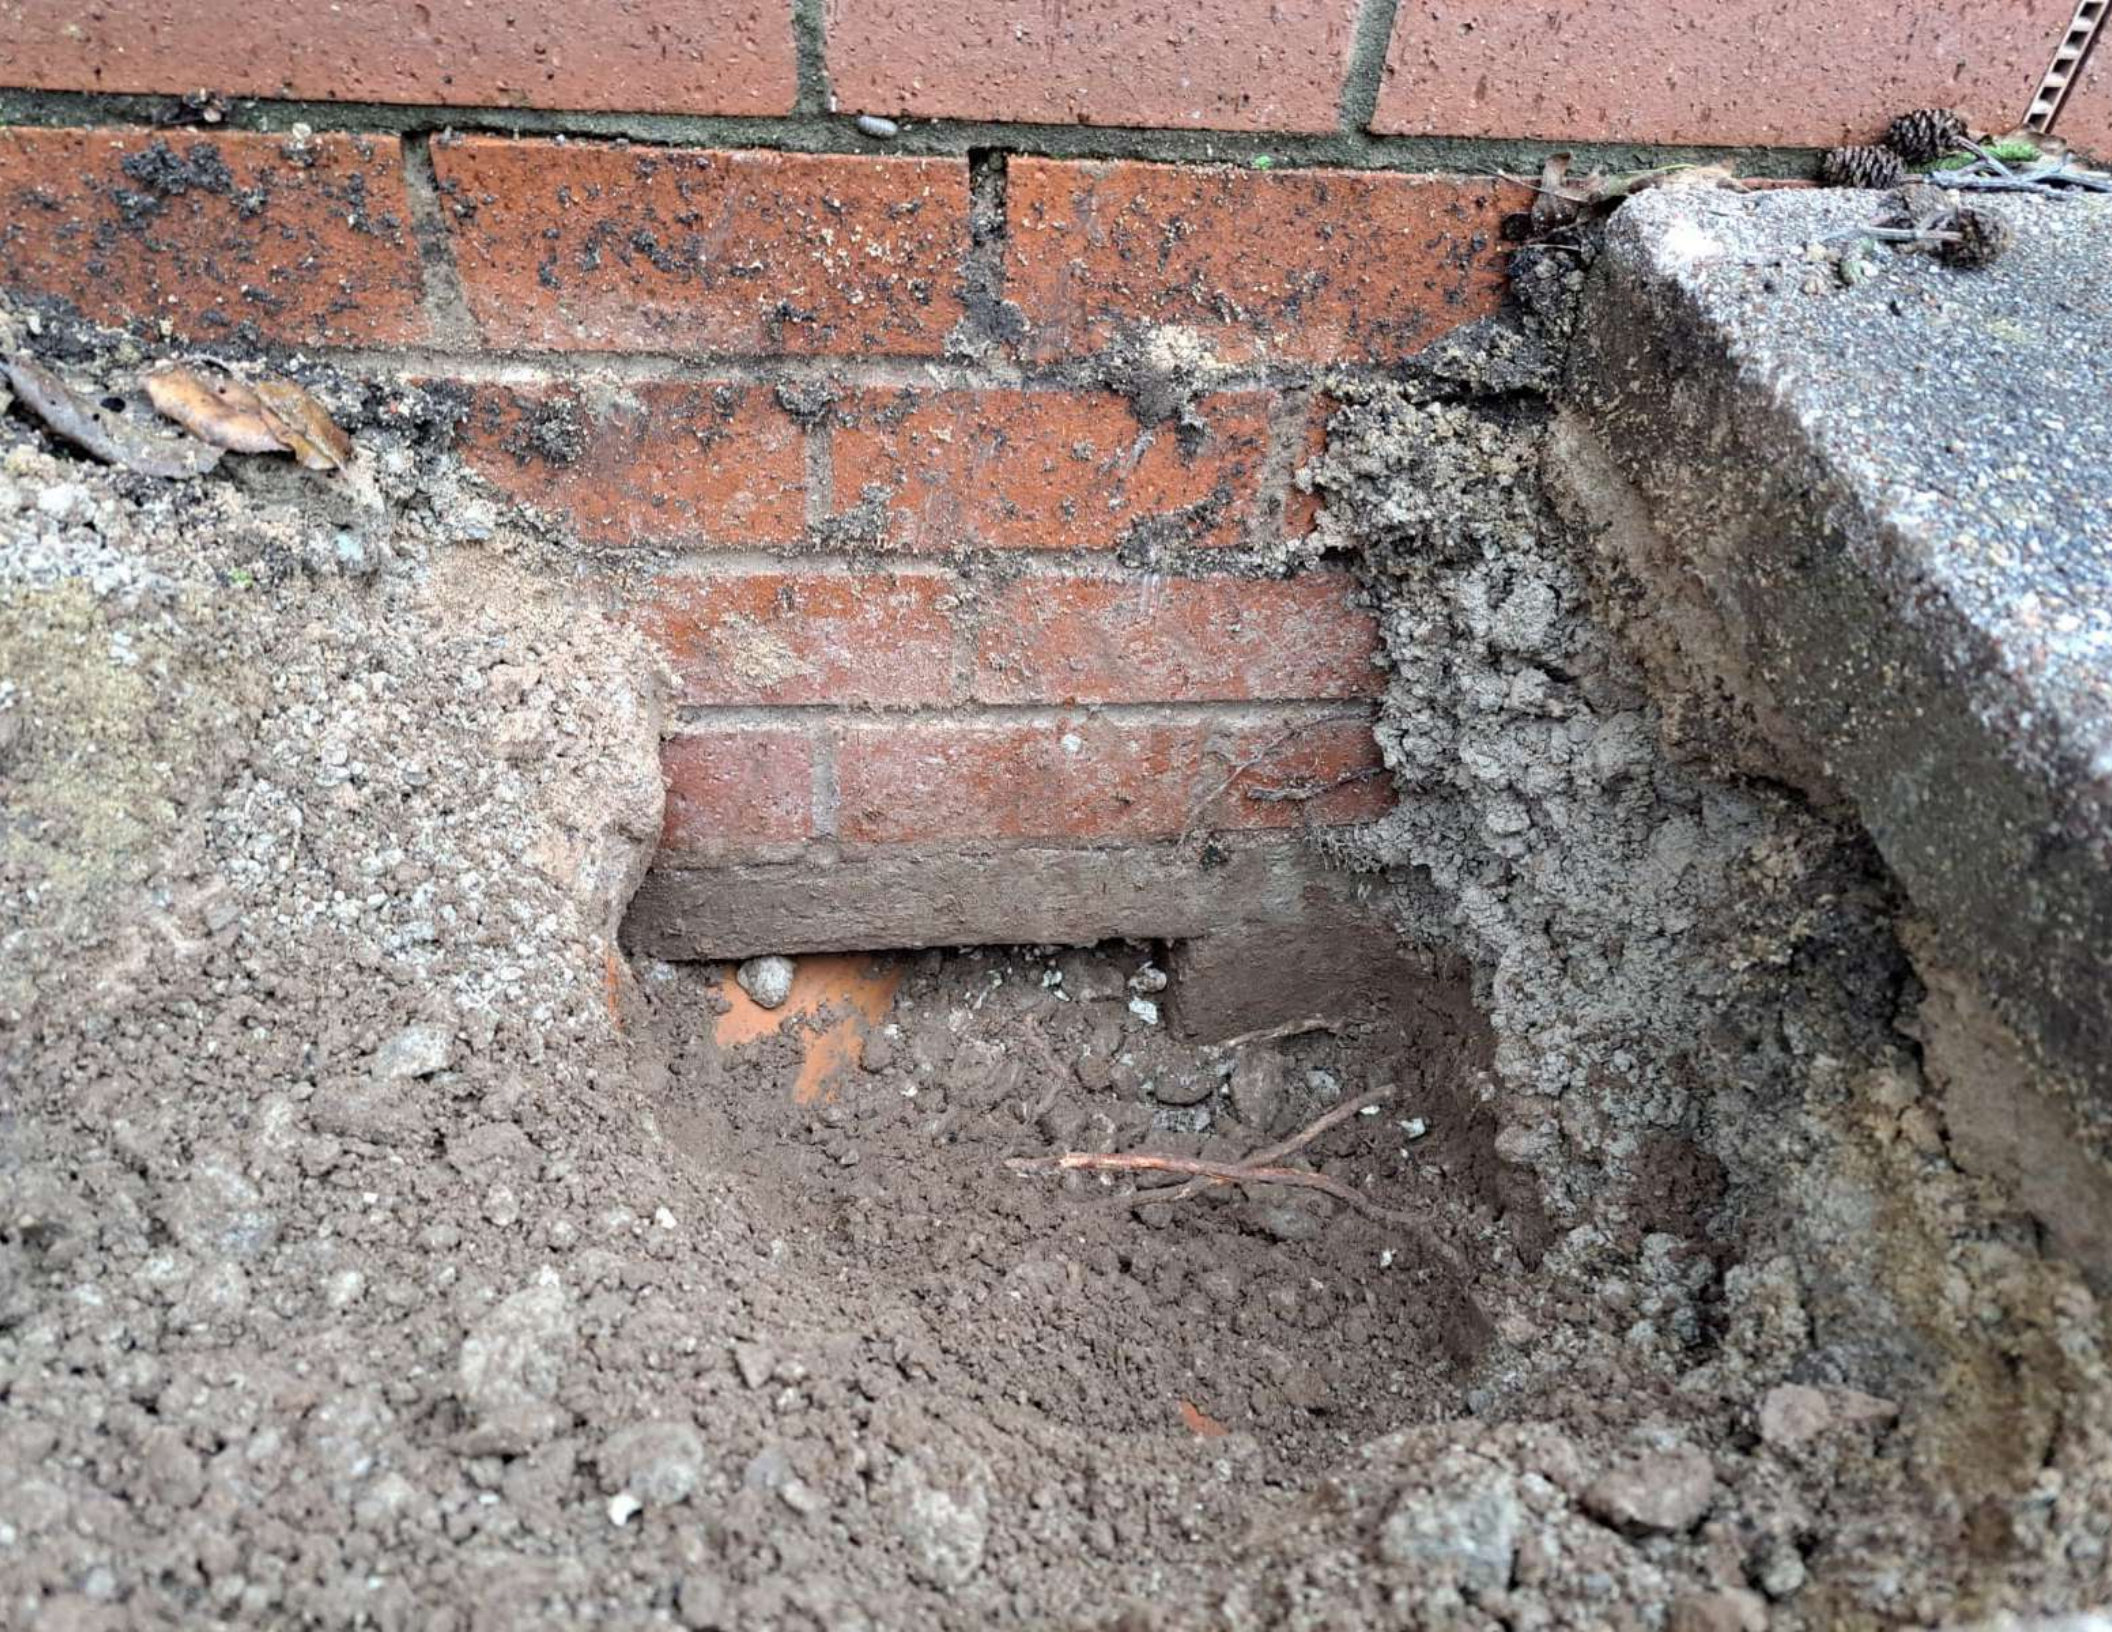
TP02

- There was a utility cover that we had to work around.
- There is **0.3m of brickwork founding onto 0.08m of concrete** (no protrusion). That concrete spans over (a separate) utility pipe (brown plastic and entering the building, see photo) and then **deepens to the side of the utility.**
- We then dug TP2a around the corner to try and find the pad footing.

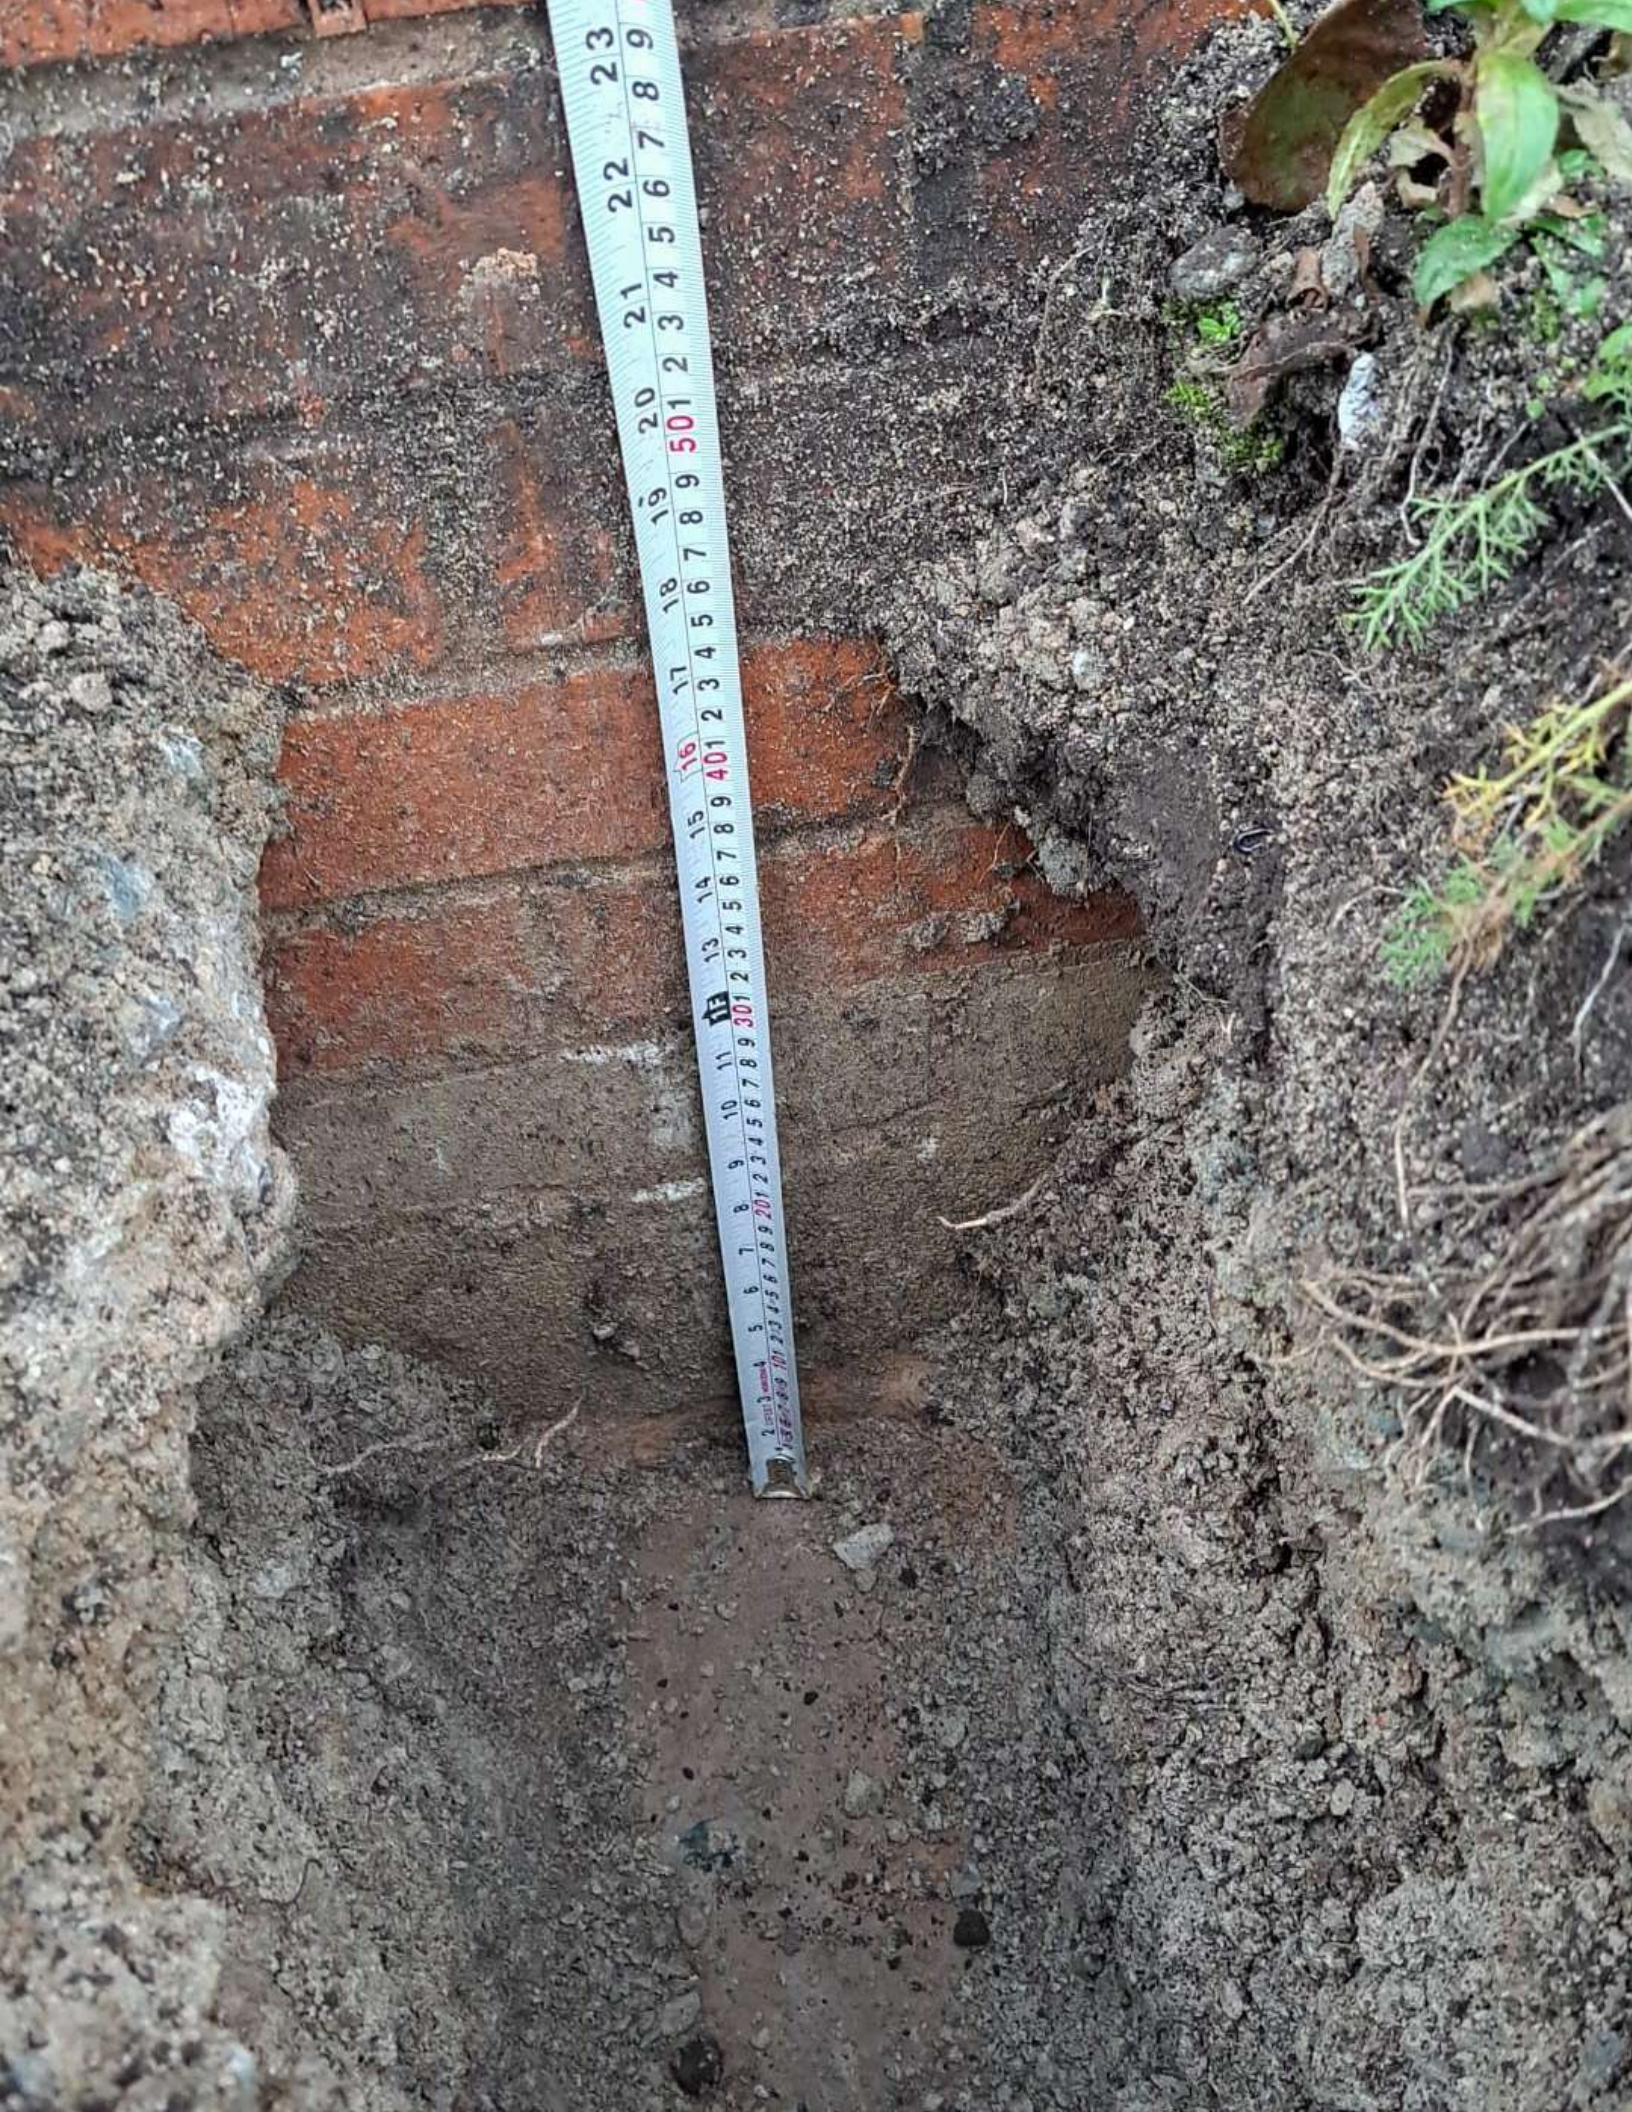
TP02A

- This pit had **0.3m of brickwork onto 0.3m of concrete** and then a 0.08m thick concrete pad/slab (?) protruding from the building face by 0.3m.
- **We assume this is hiding the same 0.15m protruding, pad footing (that founded at >1m depth) as TP01.**
