# VICTORIA NORTH INFRASTRUCTURE WORK

## PHASE 1 DELIVERY (PRE-DEVELOPMENT) REMEDIATION STRATEGY

**Job Number:** LKC 22 1587  
**Date:** December 2023  
**Client:** BAM Nuttall Ltd

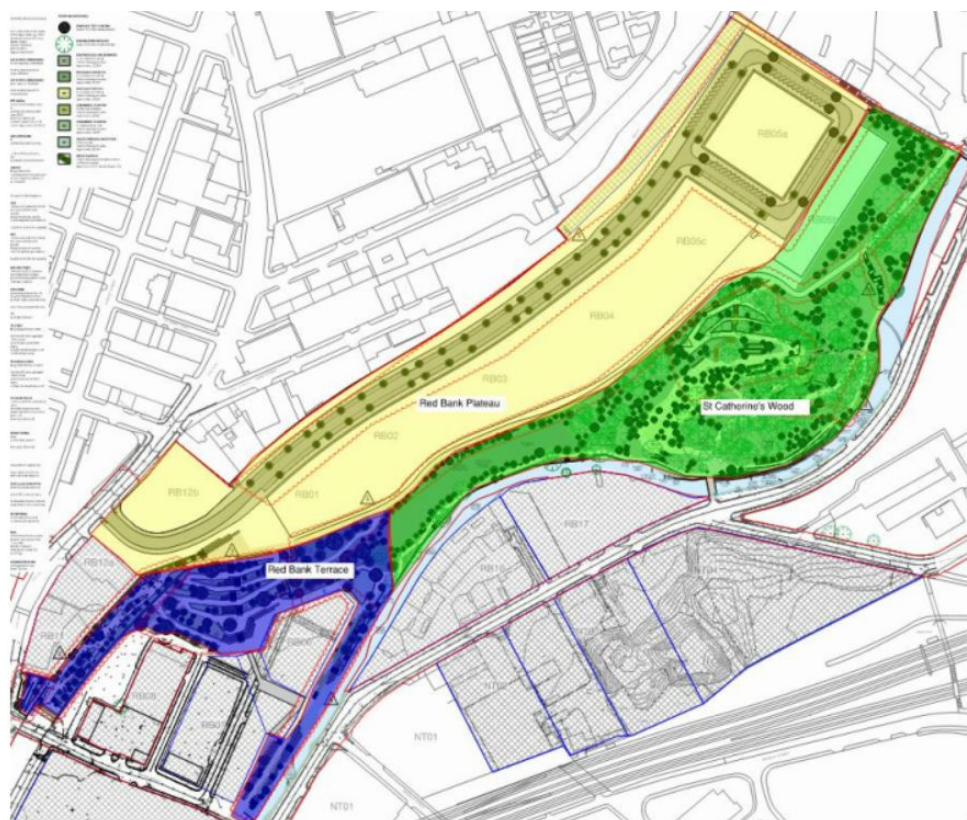
**Plate 1-1:** Site boundary and named areas (extract from Victoria North Infrastructure Works, Ground Investigation Interpretive Report, produced by ARUP, ref: VNIF-ARP-XX-YYY-RP-CG-0012 P03, date: 23<sup>rd</sup> Nov 2022).

There are 3no. parcels of land associated with the Victoria North Infrastructure Works named as Red Bank Plateau, Red Bank Terrace and St. Catherine's Wood. The site boundaries and named areas are shown on Plate 1-1 below:

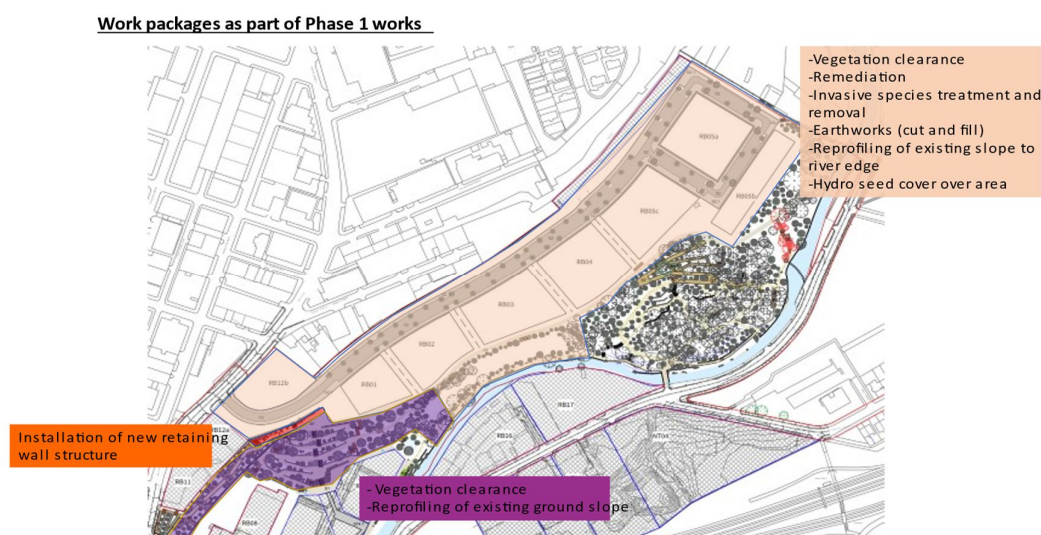
**Plate 1-2:** Summary proposals for Phase 1 delivery package. Provided by BAM. Note: minor amendment in the northwest to extend the boundary to the foot of the upper slopes / edge of the tarmac access track.

The works package for the Phase 1 delivery is presented in Plate 1-2 below.

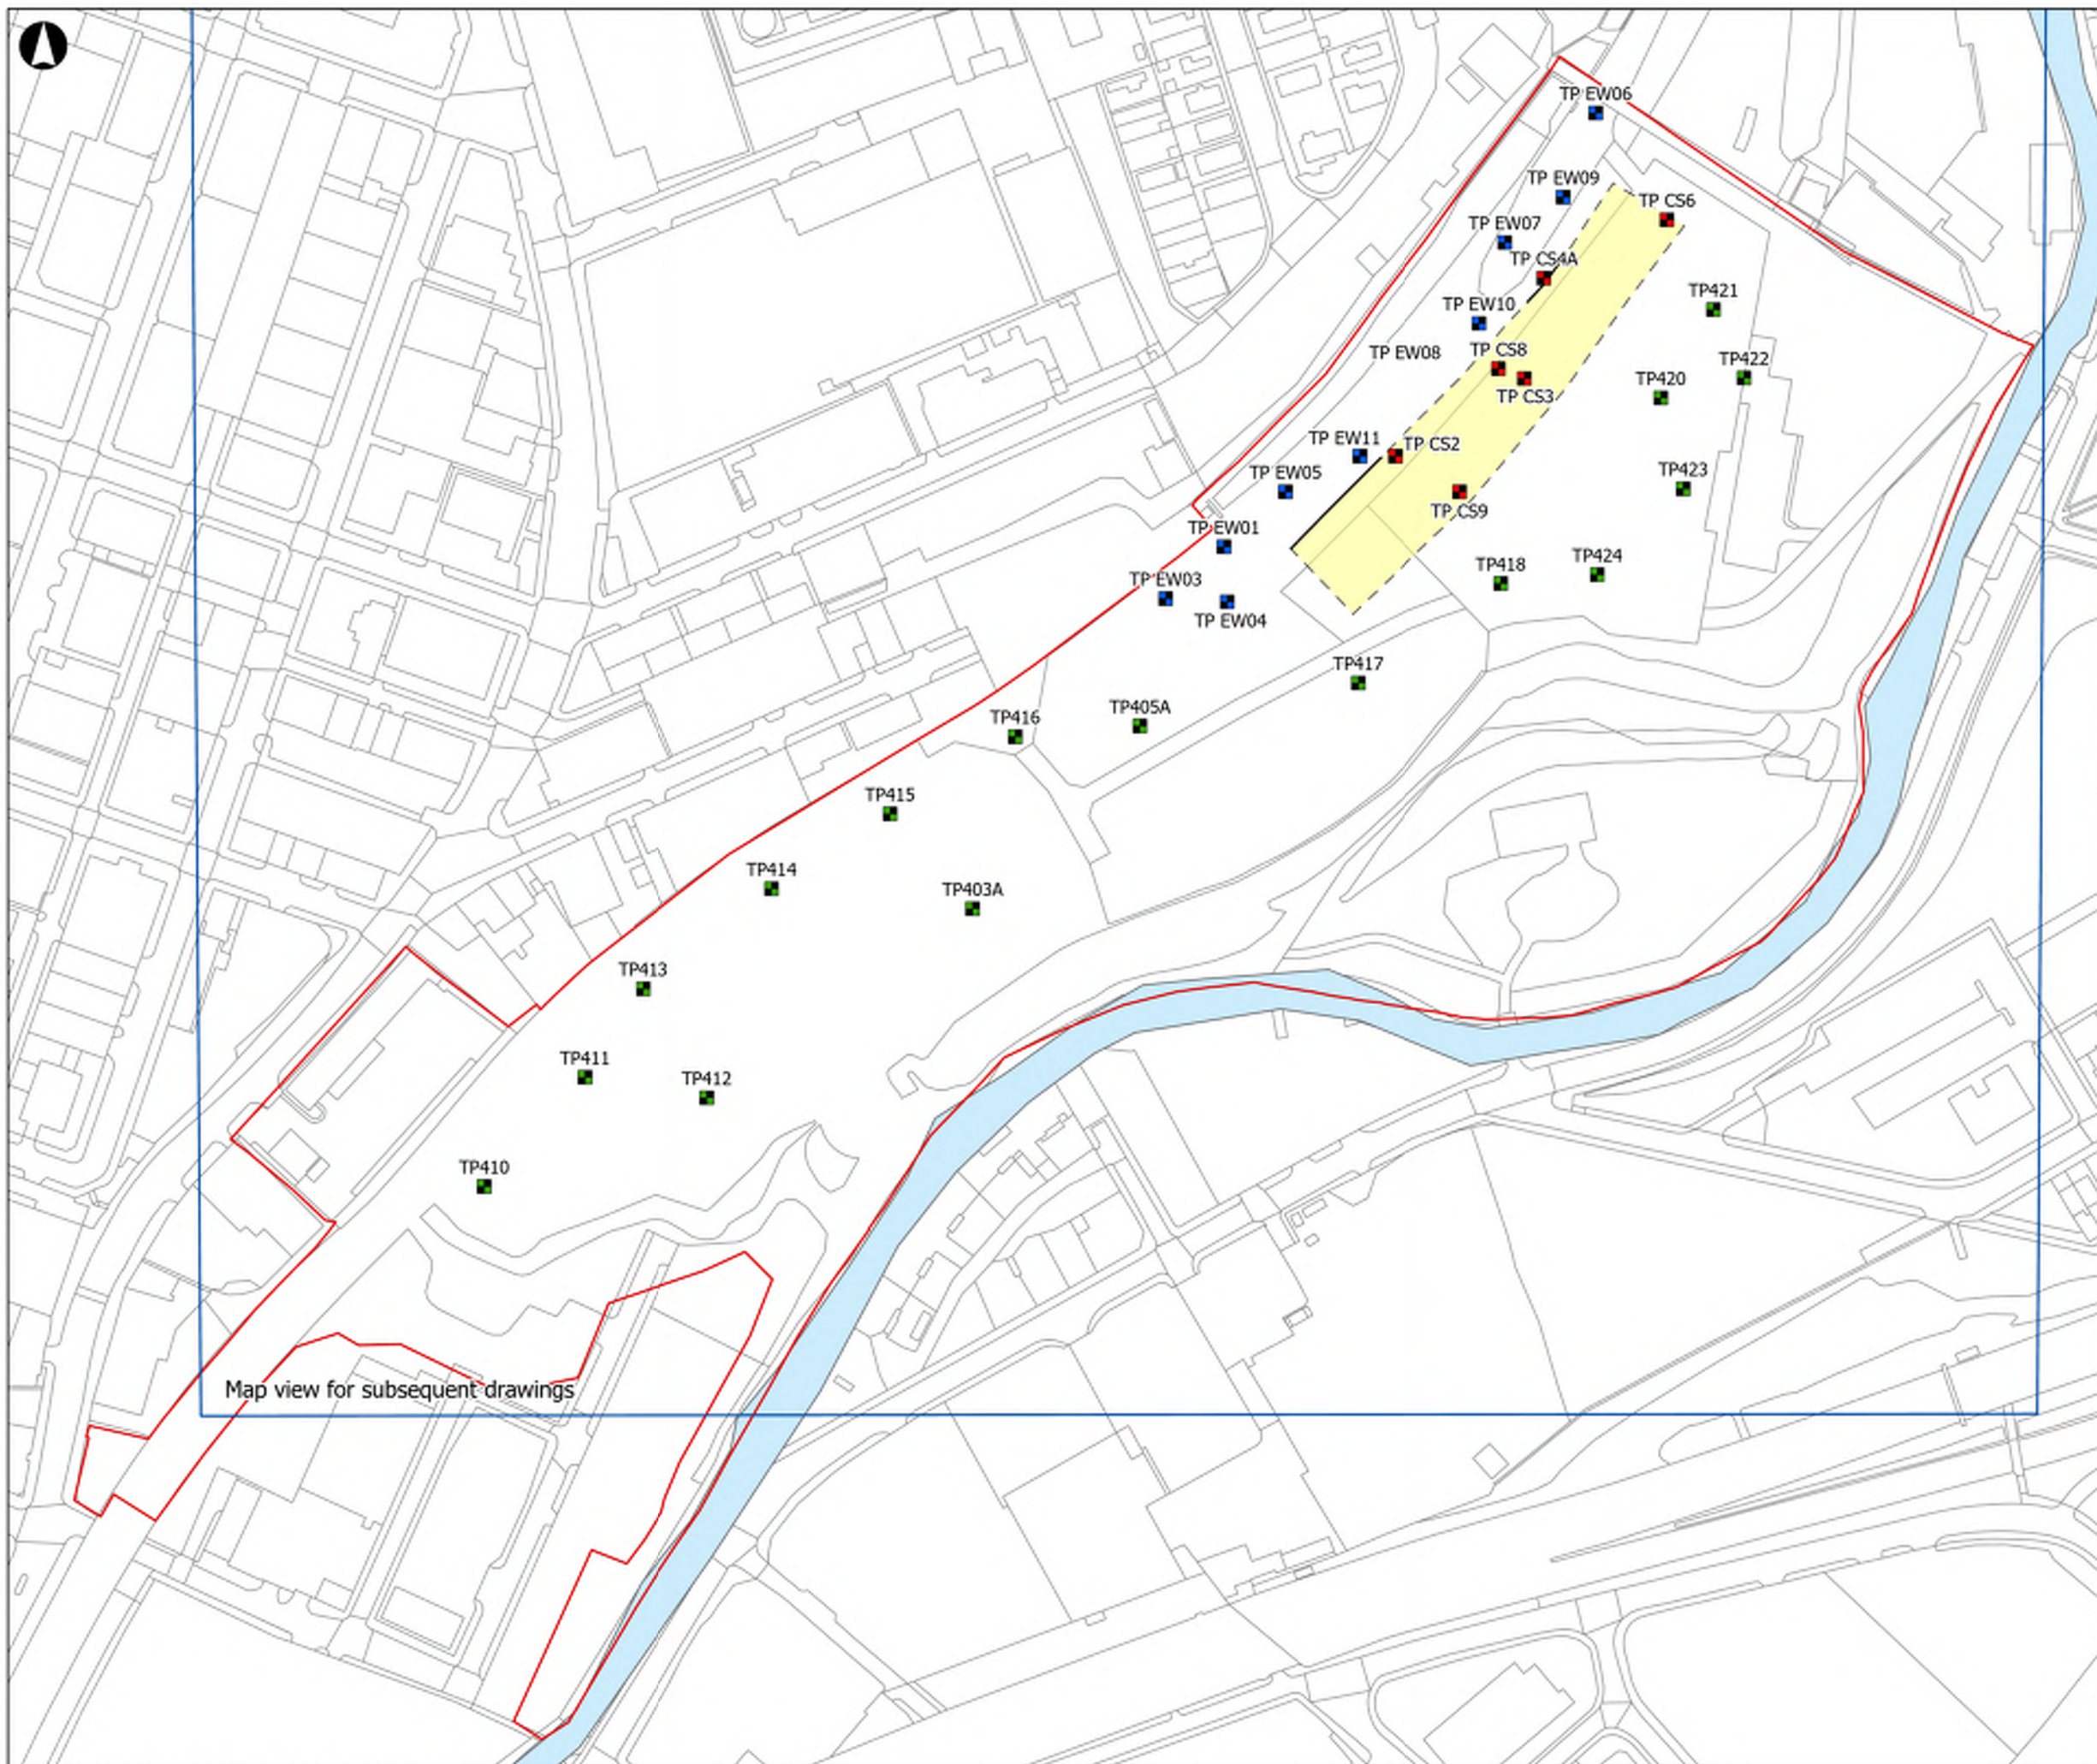
| Name<br><b>Drawing 15</b> | Rev<br><b>P1</b> |

Map view for subsequent drawings

- Site Boundary
- Trial Pit Locations
  - TP40X - 400 Series Trial Pits
  - TP EW0X - Emerging Water Trial Pits
  - TP CS0X - Carriage Shed Trial Pits
- Carriage Shed (Confirmed Boundary)
- Carriage Shed (Indicative Boundary)
- River Irk
