# Japanese Knotweed Solutions Ltd

Japanese knotweed Management Plan  
for  
Chorlton Baths, Manchester Road,  
Chorlton-cum-Hardy, Manchester, M21 0UA

| REPORT REFERENCE | JK24-9348-240325-JKMP |

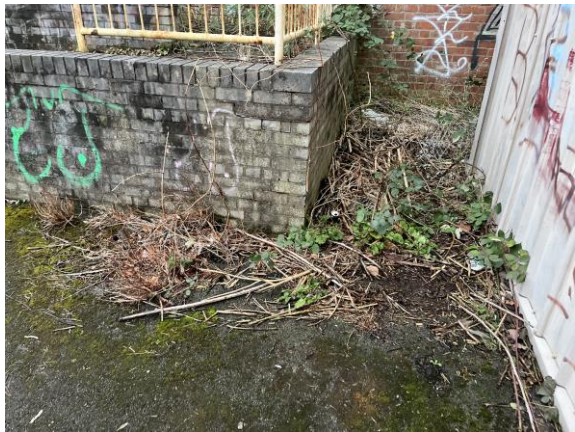
Evidence of stunted/bonsai surface growth with some cleared Japanese knotweed surface growth (JK5), situated within the development boundary (adjacent to existing building structures)

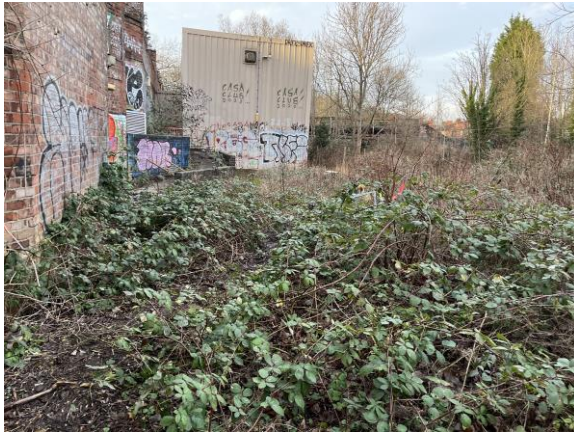
Evidence of Japanese knotweed surface growth, situated within the development boundary and also on neighbouring land (beyond the development boundary)

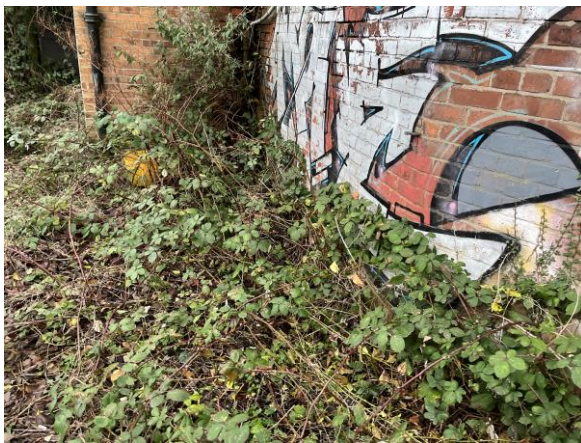
Japanese knotweed surface growth (JK1), situated within the development boundary, adjacent to existing building.

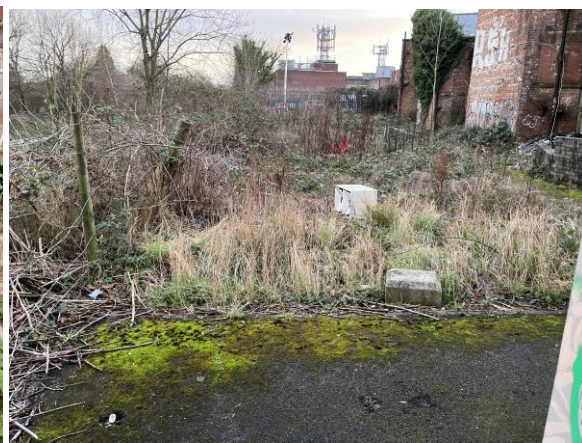
Evidence of Japanese knotweed surface growth, situated within the development boundary and also on neighbouring land (beyond the development boundary)

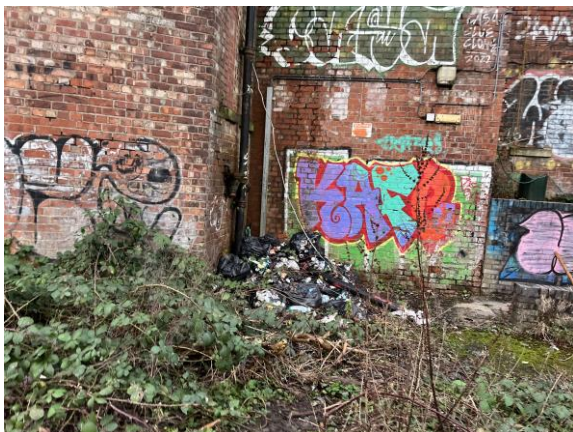
There was evidence of some fly-tipped material present on site, adjacent to the recorded areas of Japanese knotweed. Japanese knotweed is commonly fly-tipped because of the high costs of disposal. This means that sites which are subject to fly-tipping are generally at a higher risk of Japanese knotweed being spread via this contamination pathway, however it should be noted that the fly-tipped material appeared to be domestic waste (and didn't appear to contain soils and/or visible Japanese knotweed propagules).

Evidence of fly-tipped material.

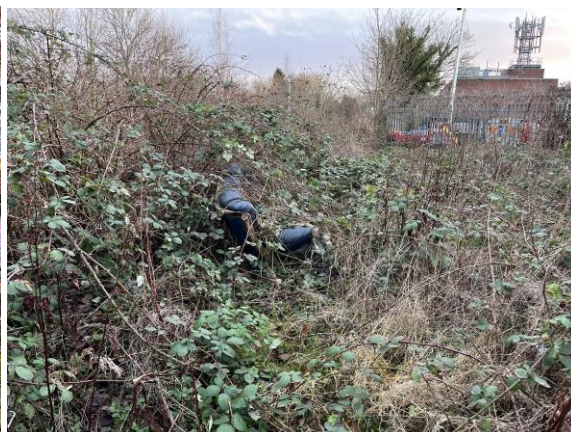
The presence of dense vegetation (and also the presence of boundary fencing) restricted viewing access onto neighbouring land during the survey.

The presence of dense vegetation restricted viewing/access (particularly onto immediate neighbouring land)

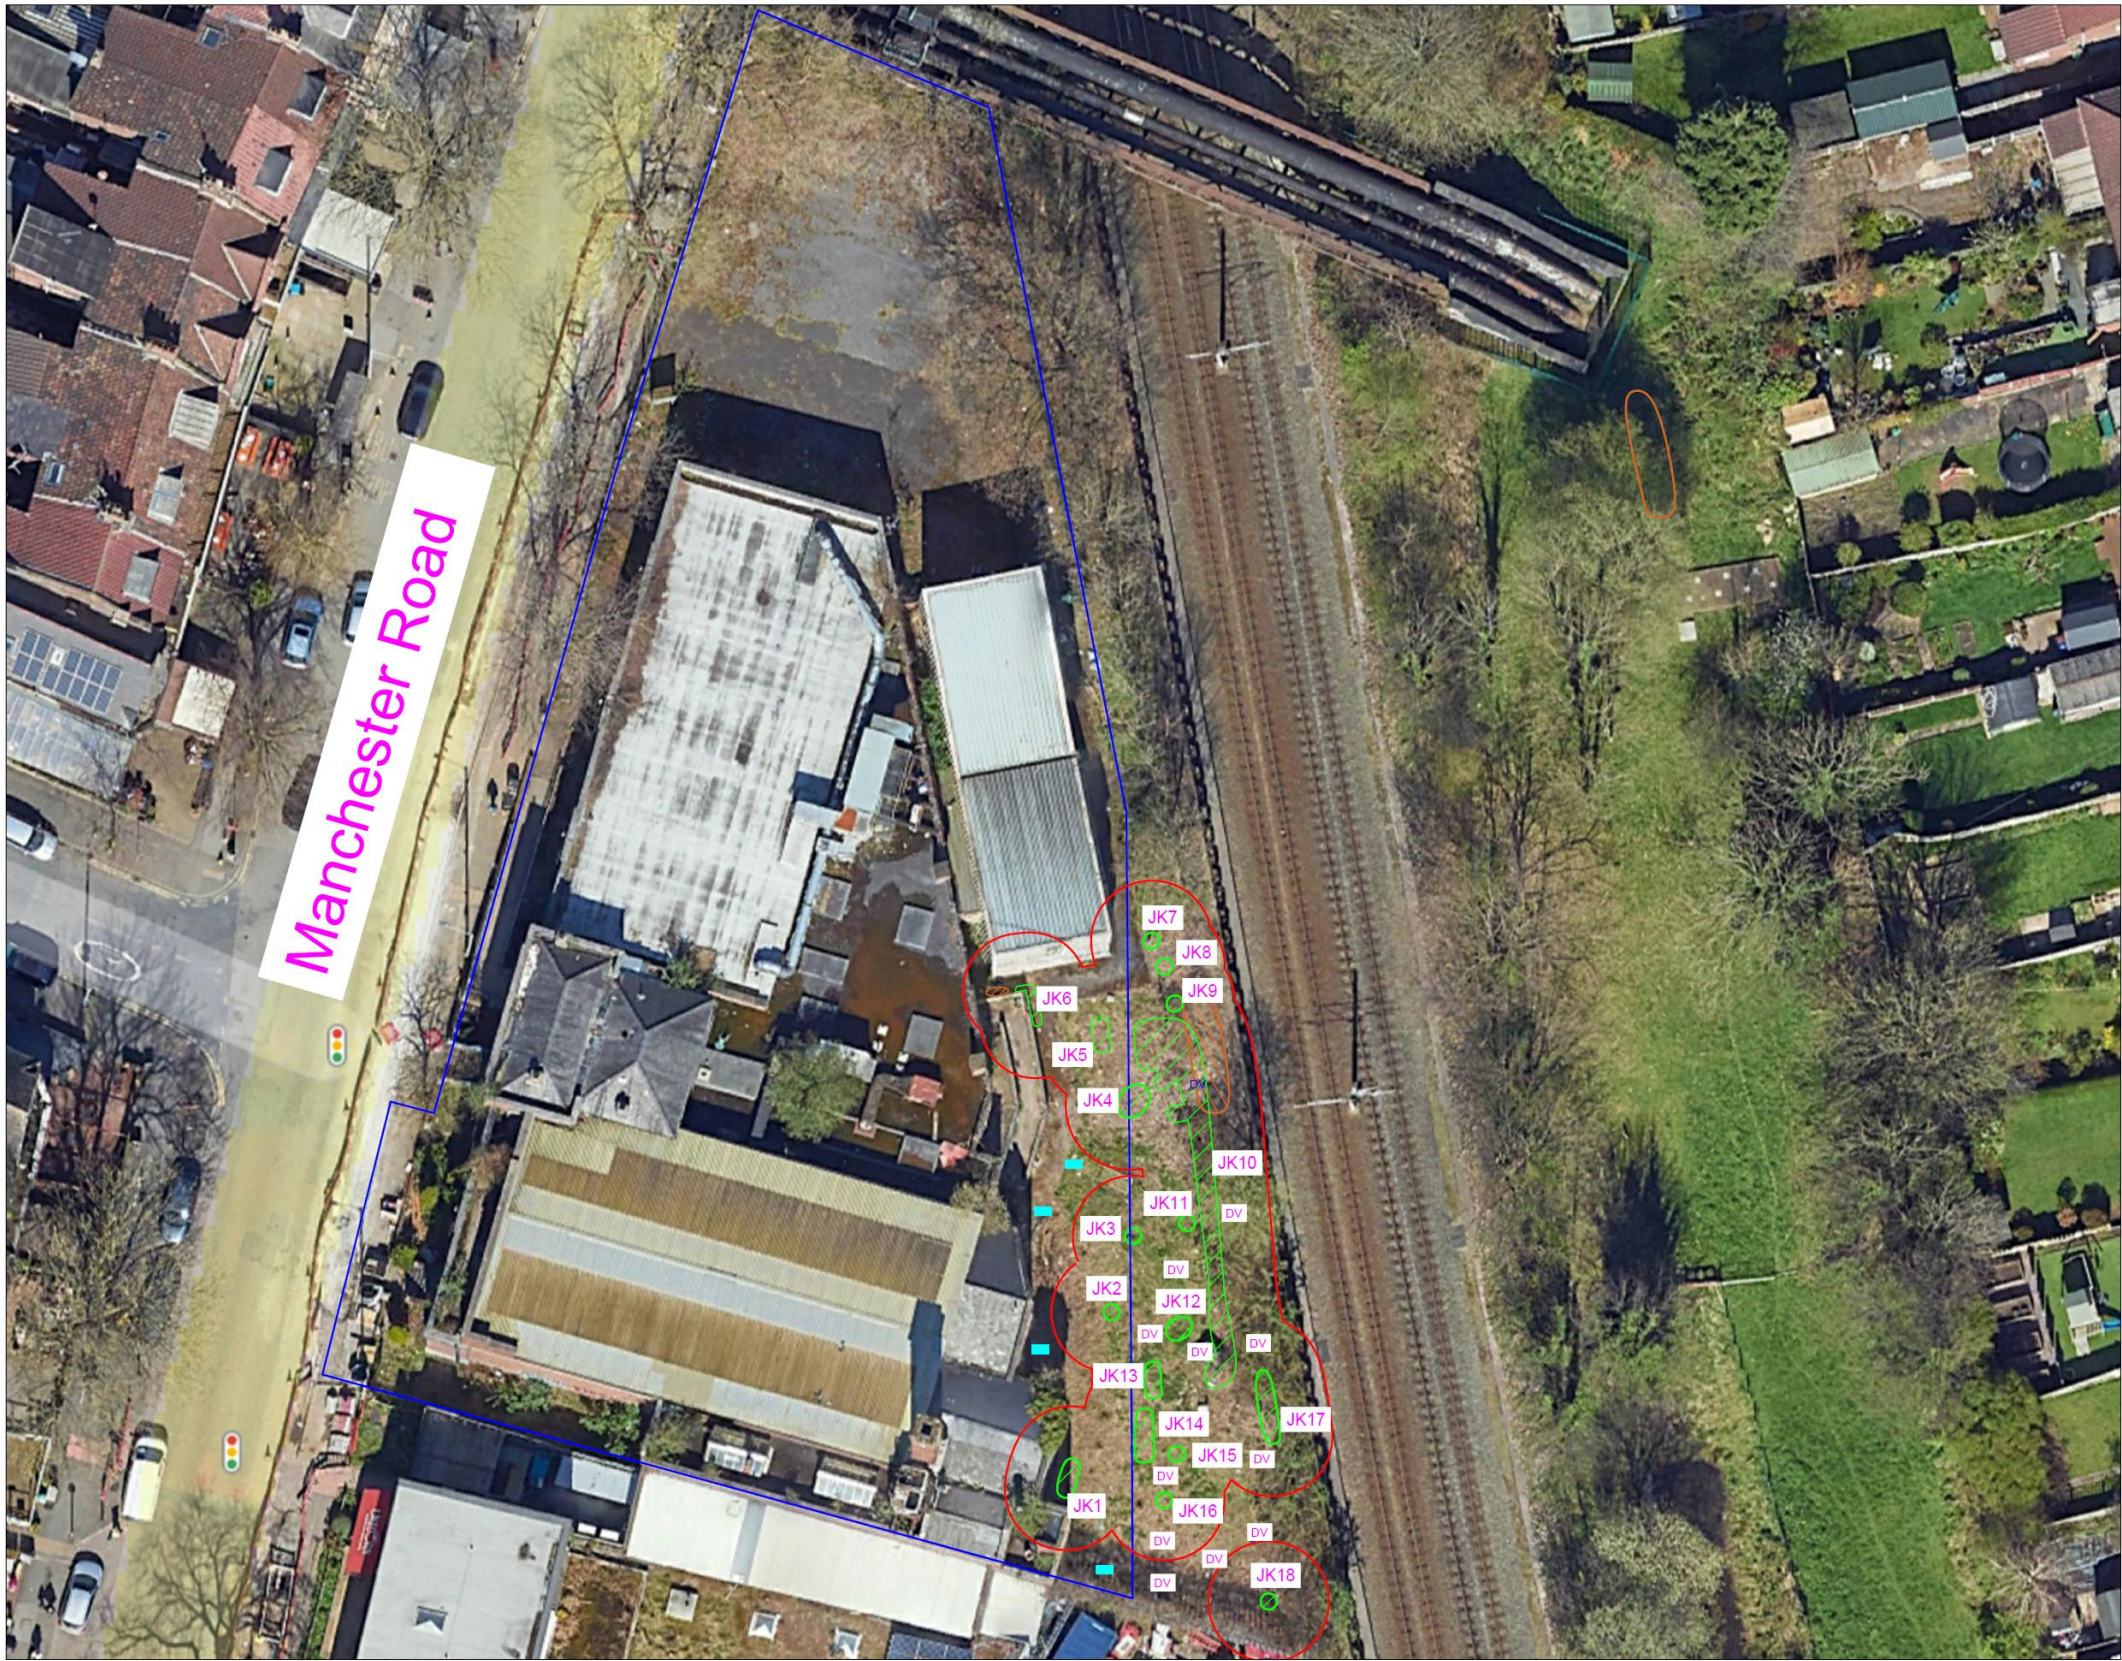
Drawing JK24-9348-05 (Japanese knotweed location plan)

Six areas containing Japanese knotweed (denoted as JK1-JK6 on drawing JK24-9348-05) were recorded within the development boundary. See below table for information relating to these areas of Japanese knotweed.

Additional areas of Japanese knotweed were recorded on immediate neighbouring land to the east, denoted as areas JK7-JK18 on drawing JK24-9348-05 (appendix 2). The majority of these recorded areas of Japanese knotweed are likely to share

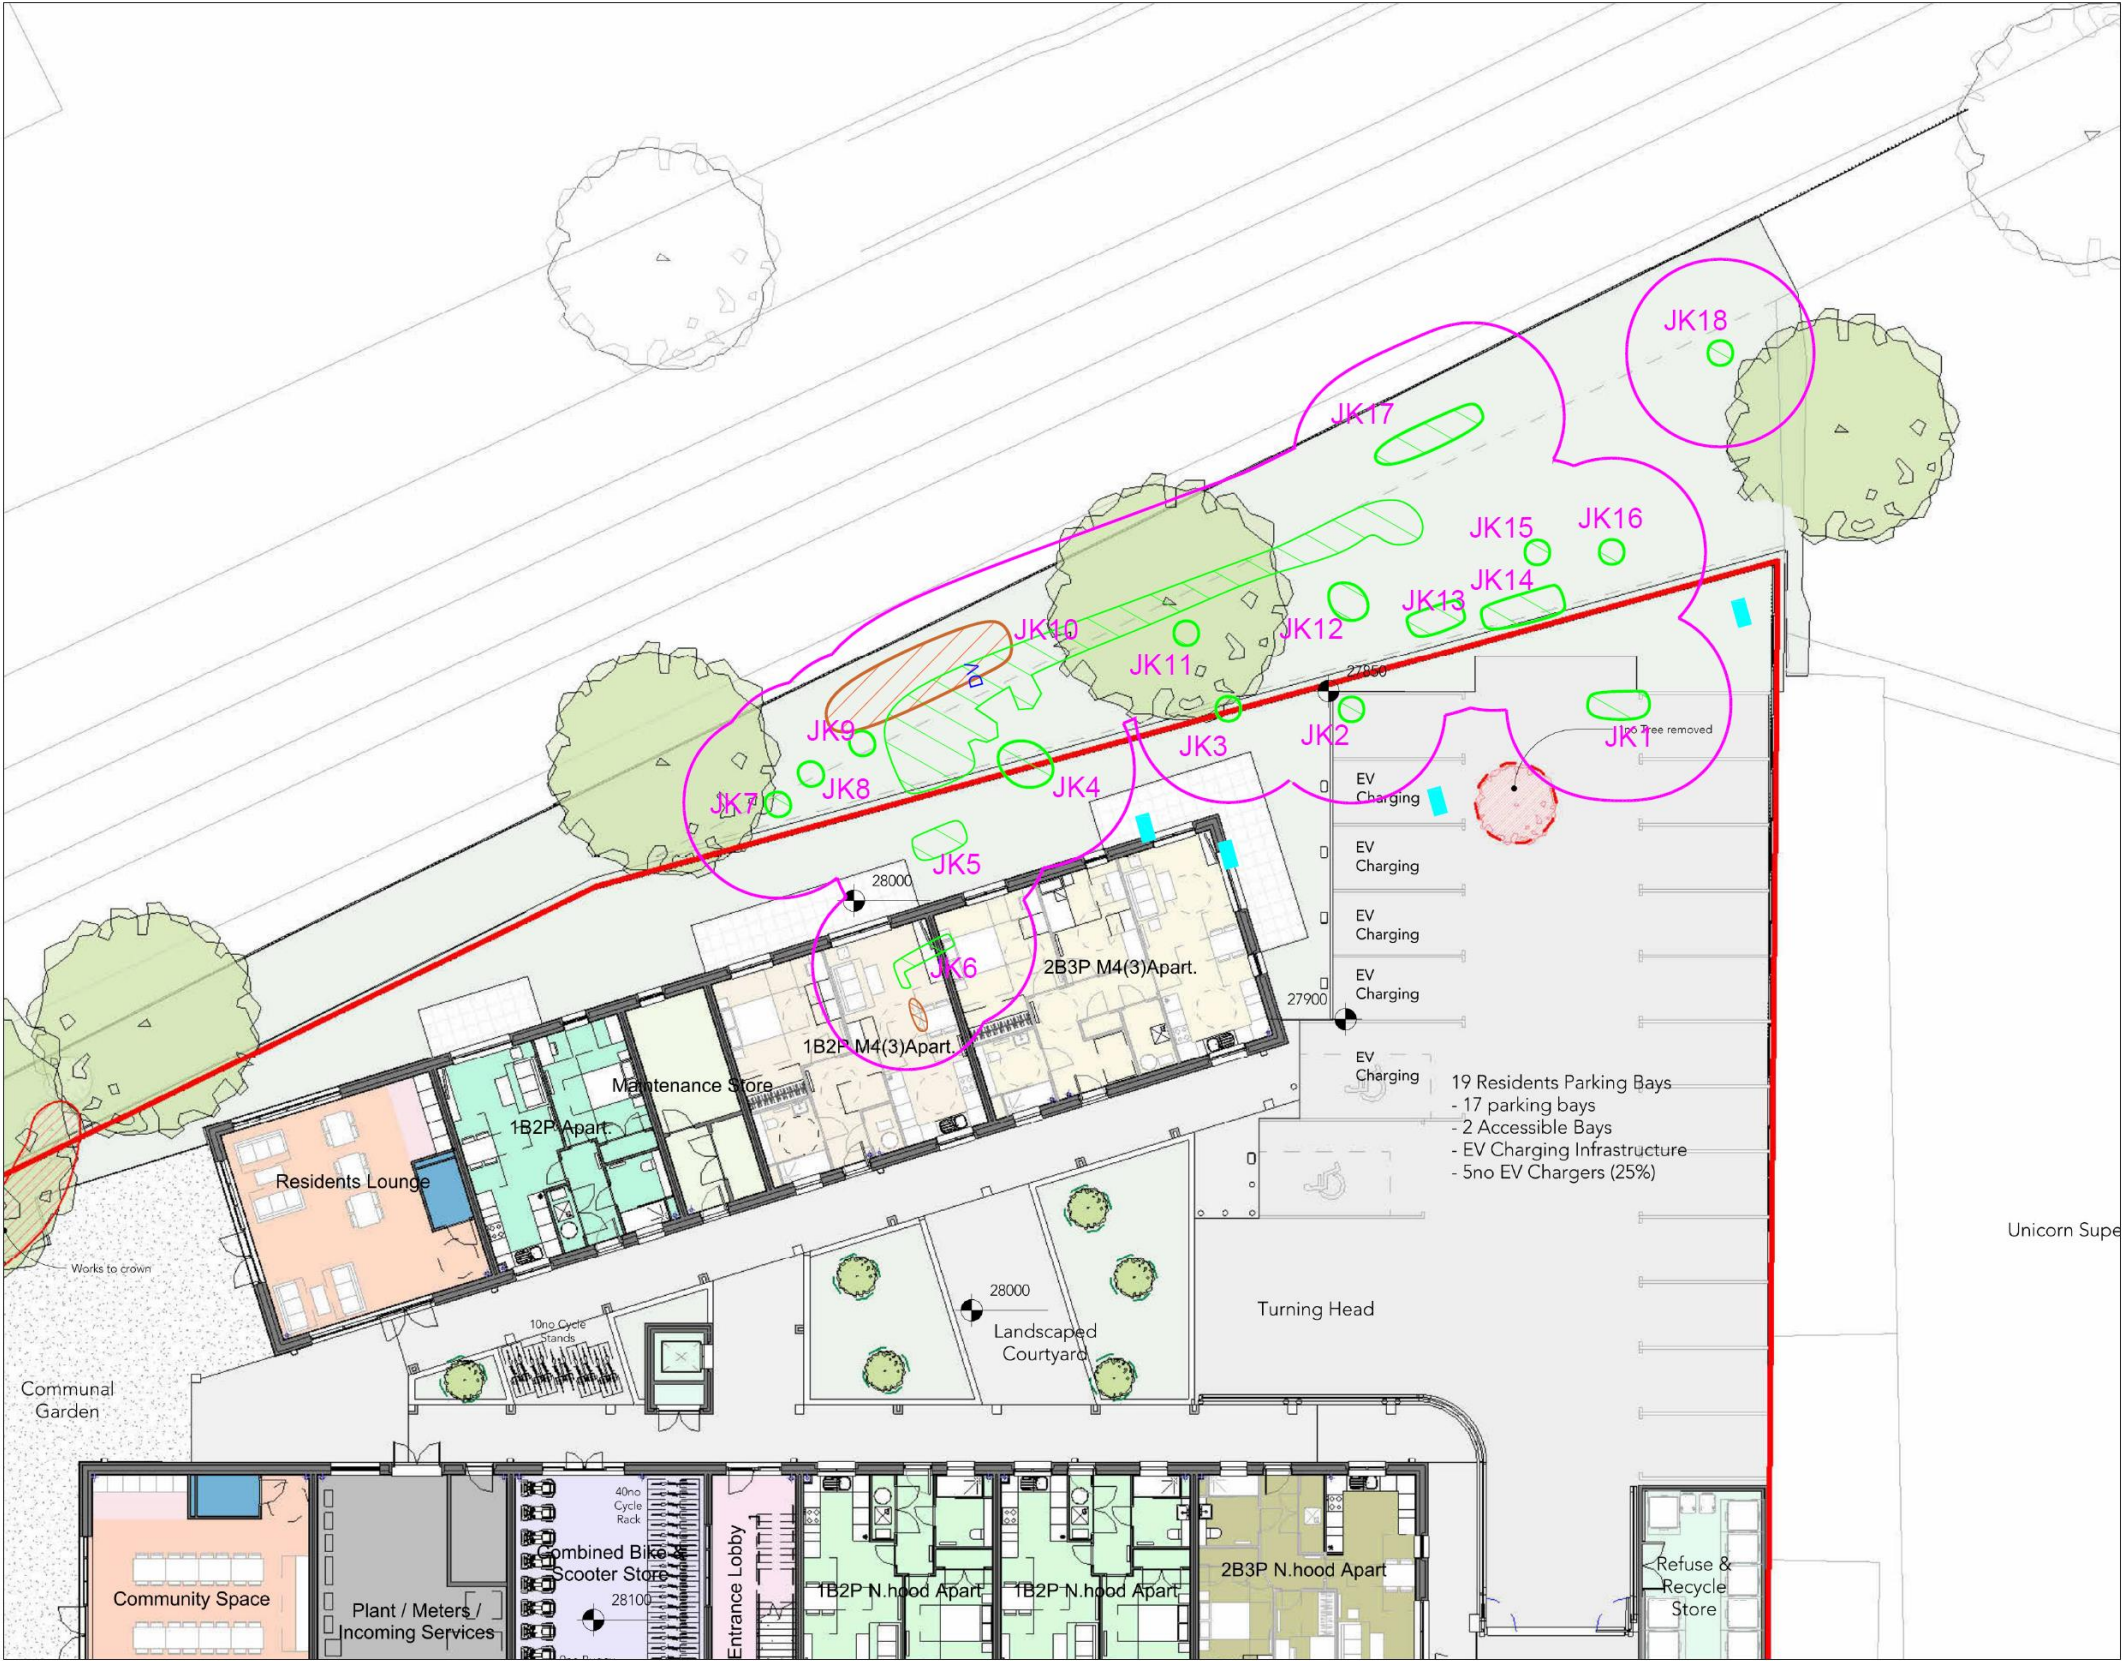
### Drawing JK24-9348-06 (impacts on development)

Drawing JK24-9348-06 (enclosed within Appendix 3) shows that all areas of infestation situated within the development boundary, will be directly affected by the proposals.
