### Outbuildings

## **C8. THE SITE**

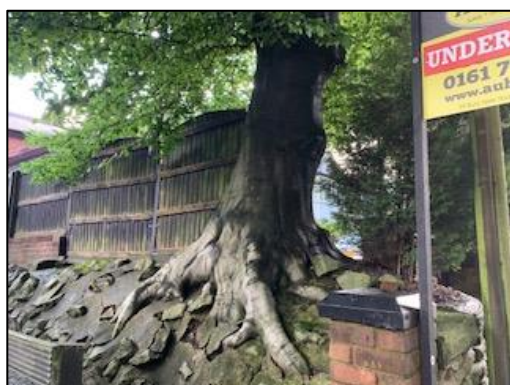
My observation to the front garden was that there is a very large tree located to the right hand side of the boundary (front) garden which you will need to check if there is any tree preservation order on the tree.

Figure 9 Large tree to front garden

Trees this large can affect drains and become a health and safety issue due to the large branches etc. We would therefore recommend a full drains survey due to the close proximity of the tree and roots prior to exchange and completion.

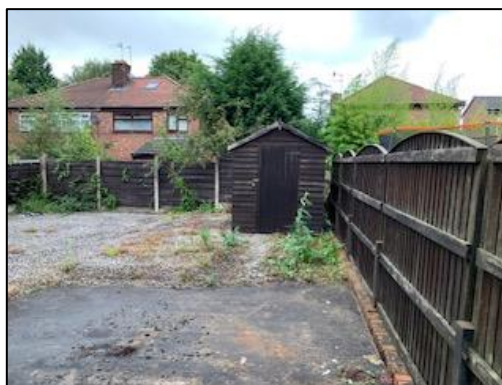
The rear garden was predominantly laid concrete or pebble. There were a number of weeds and blackberry bushes growing in the rear garden which will require treating in the short term however, no invasive species were noted.

Figure 8 Rear garden

Although no faults were noted at the time of the inspection, we would recommend you budget to replace the majority of the rear timber fence panels due to them becoming decayed and quite flimsy to touch.
