**Willmott Partnership Homes Limited**

**Blackley, Moston & Collyhurst Housing Developments**

**PHASE I AND PHASE II GEO-ENVIRONMENTAL REPORT  
JURBY AVENUE, BLACKLEY**

**Doc ref:** 3025-CAU-XX-XX-RP-V-0306.A0-C1

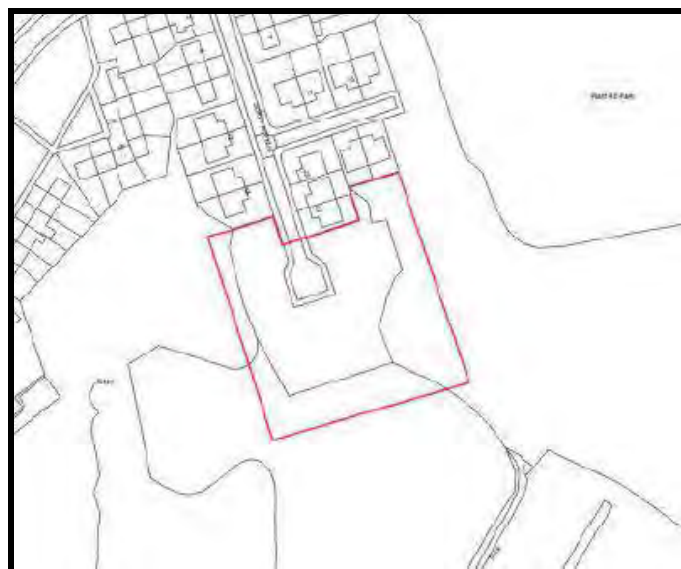
Figure 2 - Site Layout Plan and Red Line Boundary

- 2.1.2 The site is roughly square in shape, measuring approximately 65m x 65m, with an area of 0.58 ha. The site is accessible off Jurby Avenue to the north. The site is generally level and flat, with a gentle fall to the south and west.

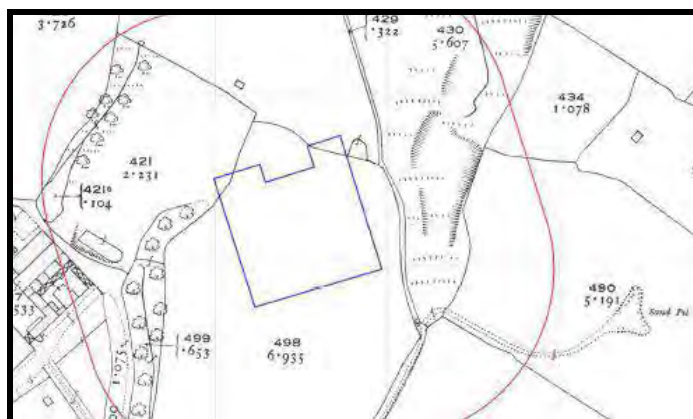
**Figure 3A – 1922 Map Extract** - A sand pit is approximately 150m to the east of the site and more ground disturbance within 30m to the east.

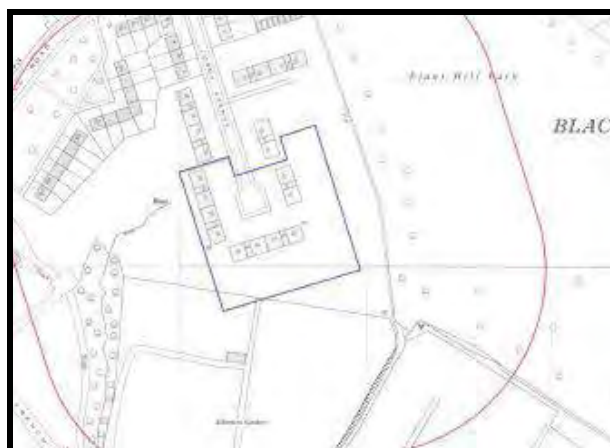
**Figure 3D - 1963/64 Map Extract** – Houses have been built on the northern and central part of the site in the form of three terraced blocks around a cul-de-sac access road. The former worked ground, sandpits and refuse pit are apparently restored and named “Plant Hill Park”.

- 8.2.3 It is possible that former foundations associated with the previous houses remain in the ground, which would represent buried obstructions to the development.

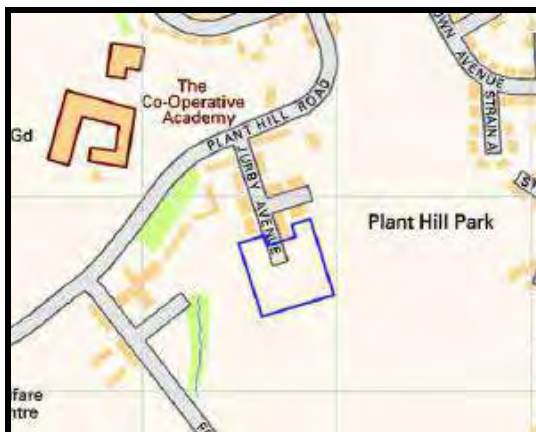
**Figure 3E – 2014 Map Extract** – Housing had been demolished, access road remained in place.

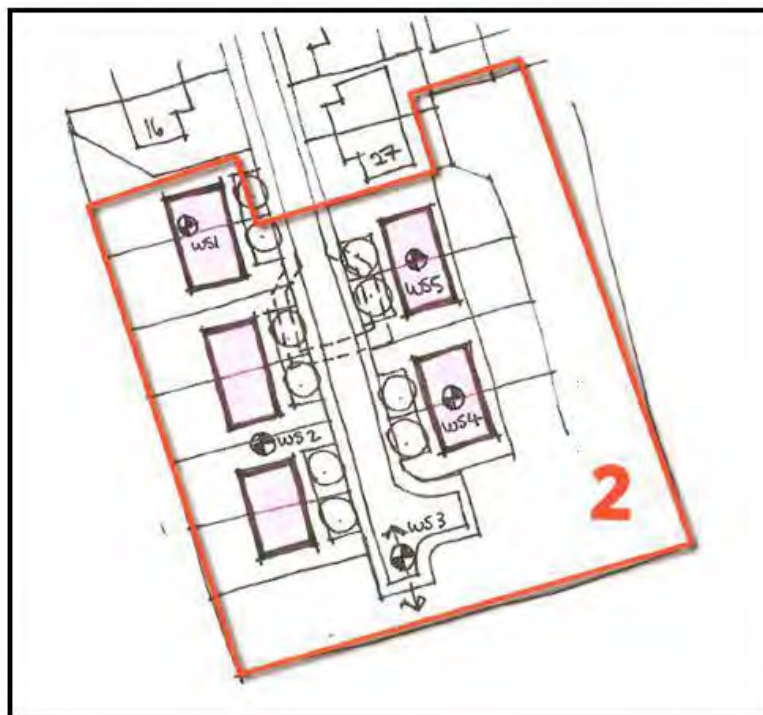
Figure 5. Exploratory Hole Location Plan

- Five boreholes (WS1-6 to WS5-6) were advanced using the percussive “window sampler” drilling technique installed to depths of between 3.45m and 5.45m below ground level (bgl).
- In situ SPT tests at 1m intervals;
- Dynamic probing from the base of borehole WS1-6 from 4.00 to 6.00mbgl;
- One permanent gas and groundwater monitoring well installation (WS4-6);
- One groundwater falling head test (WS3-6).

5.2.2 The position of the exploratory holes are shown on Figure 5 below.

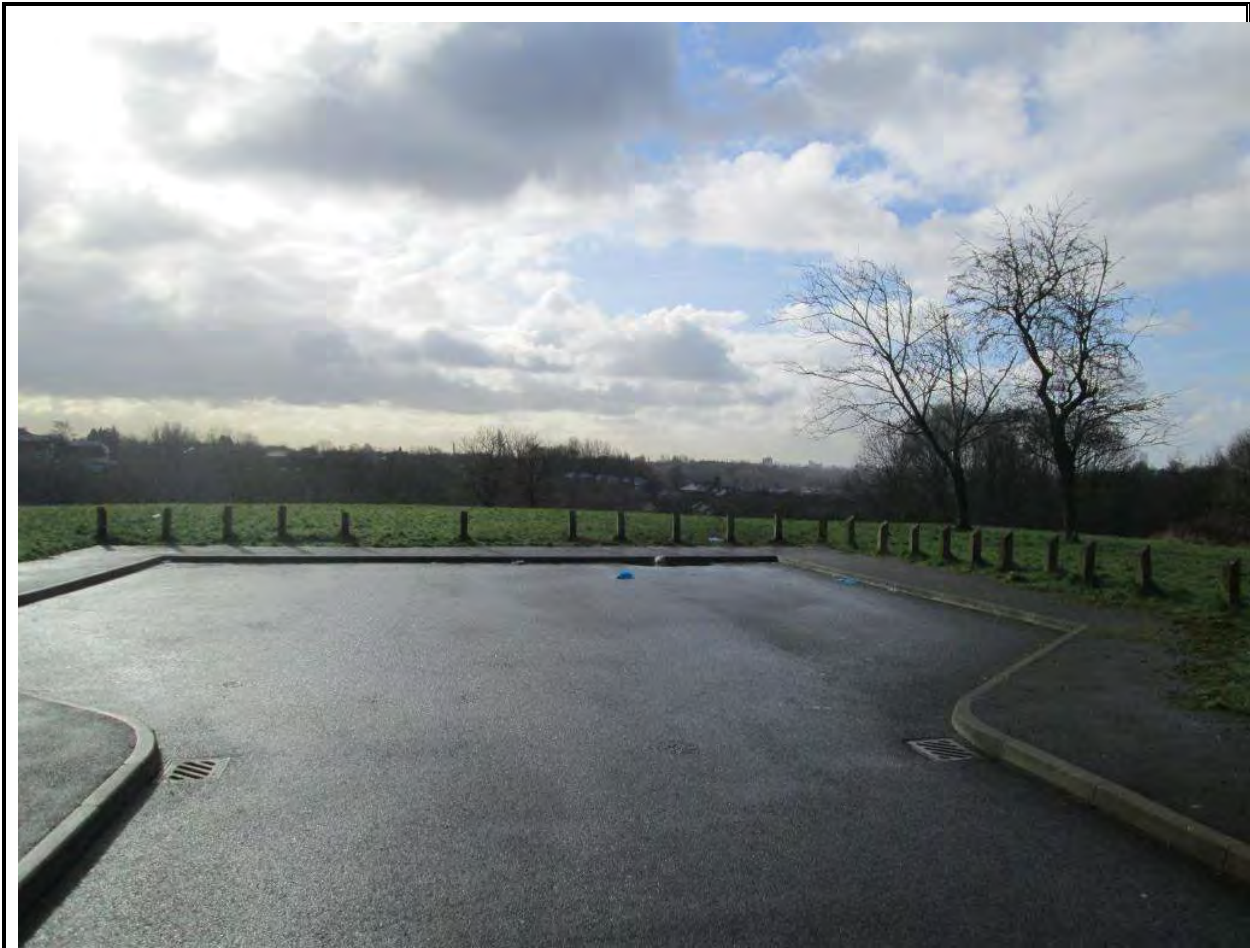
| <b>Photograph Number:</b><br>1 (IMG 3) | <b>Orientation (Direction Facing):</b><br>South | |

| Observations | Comments |
|---|---|
| Buildings and Structures | There are currently no buildings or structures on the site (see photograph 1). |

| <b>Special Features or Observations:</b><br>n/a | | |

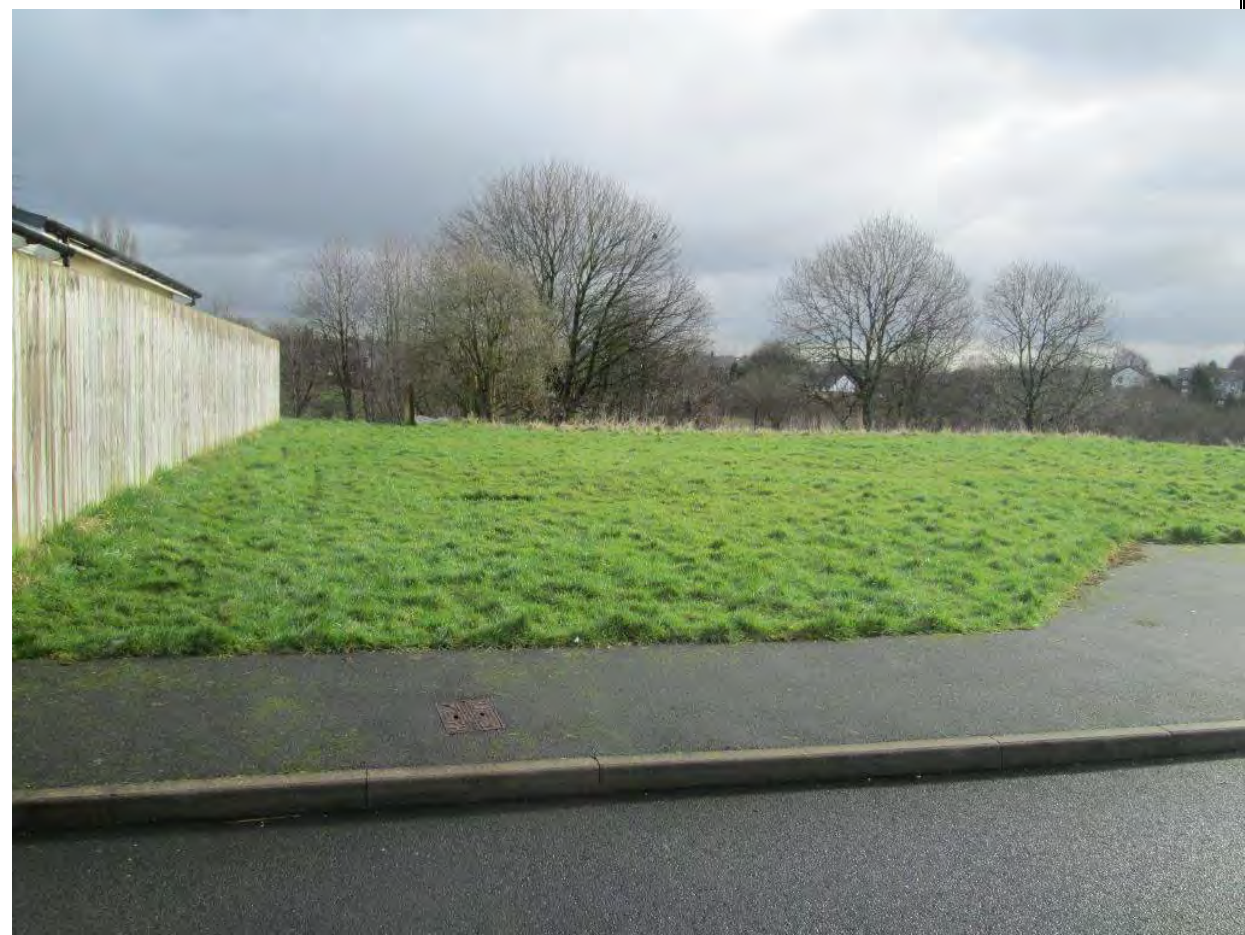
| <b>Photograph Number:</b><br>2 (IMG 5) | <b>Orientation (Direction Facing):</b><br>South-east | |

| Observations | Comments |
|---|---|
| Services | No overhead electrical wires are present at the site.<br>A fire hydrant cover was observed in the pavement towards the north of the site on the eastern side of the road (see photograph 2).<br>No other services were observed on site. |

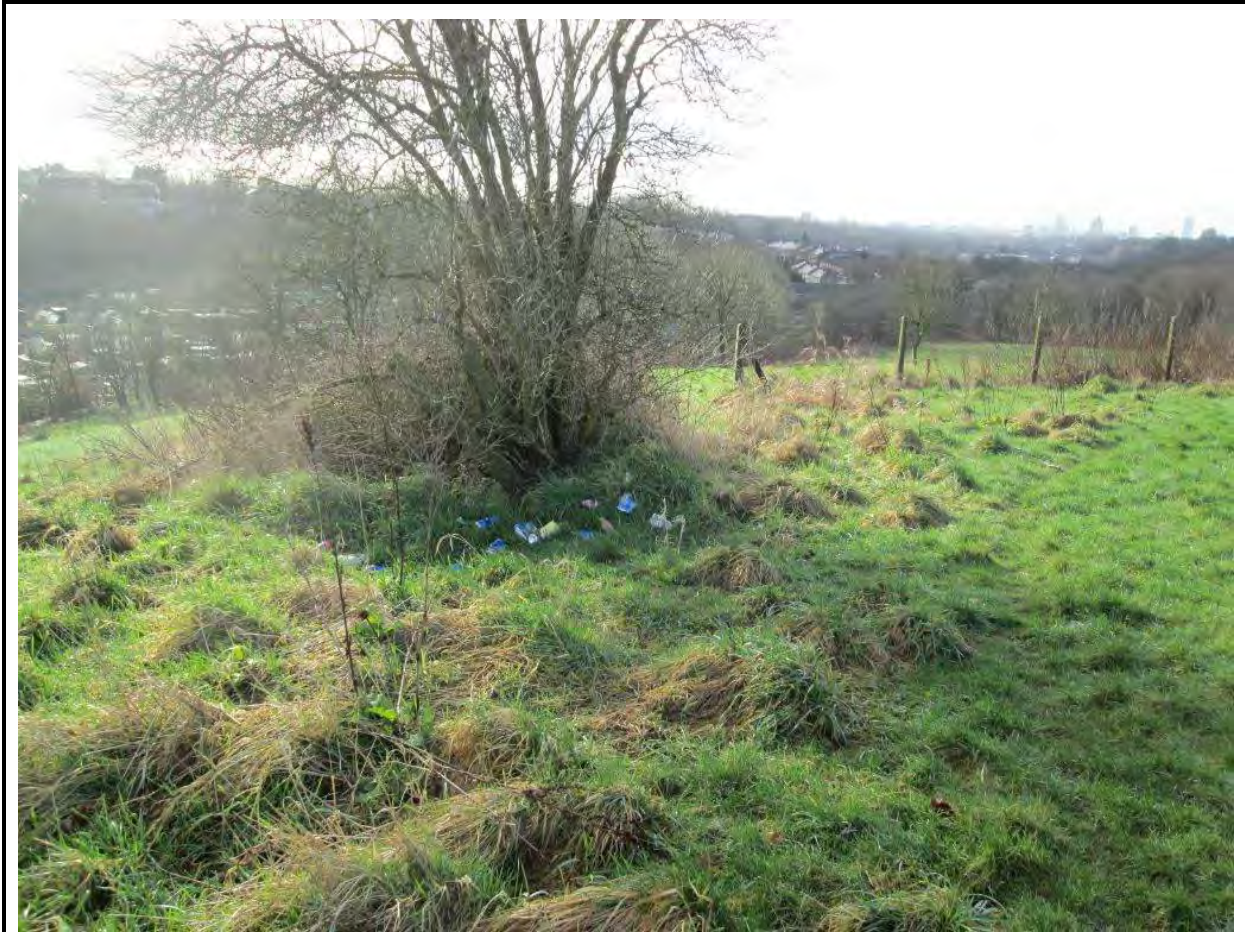
| <b>Photograph Number:</b><br>3 (IMG 12) | <b>Orientation (Direction Facing):</b><br>South-west | |

| <b>Special Features or Observations:</b><br>n/a | | |
